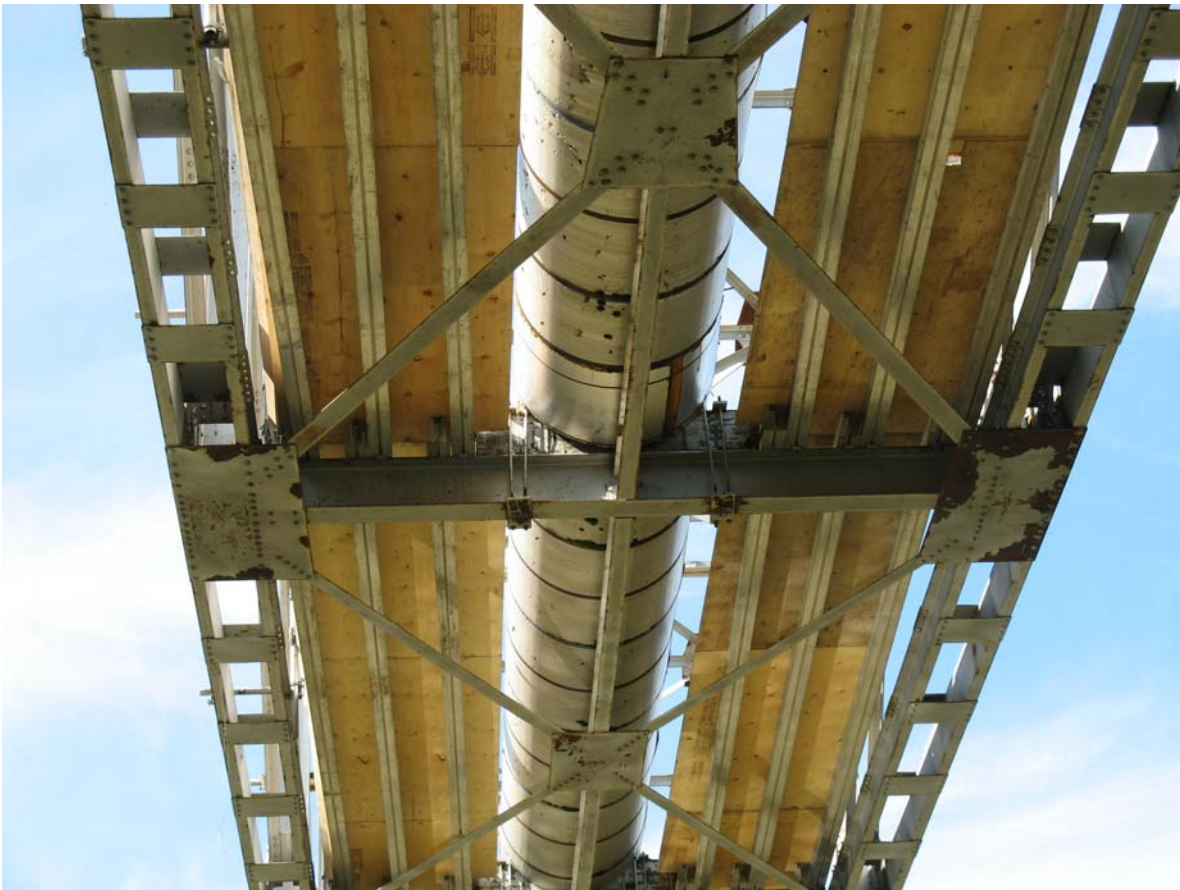
A3-02 - Closeup of Bottom of Bridge (with temp walkways on top).JPG

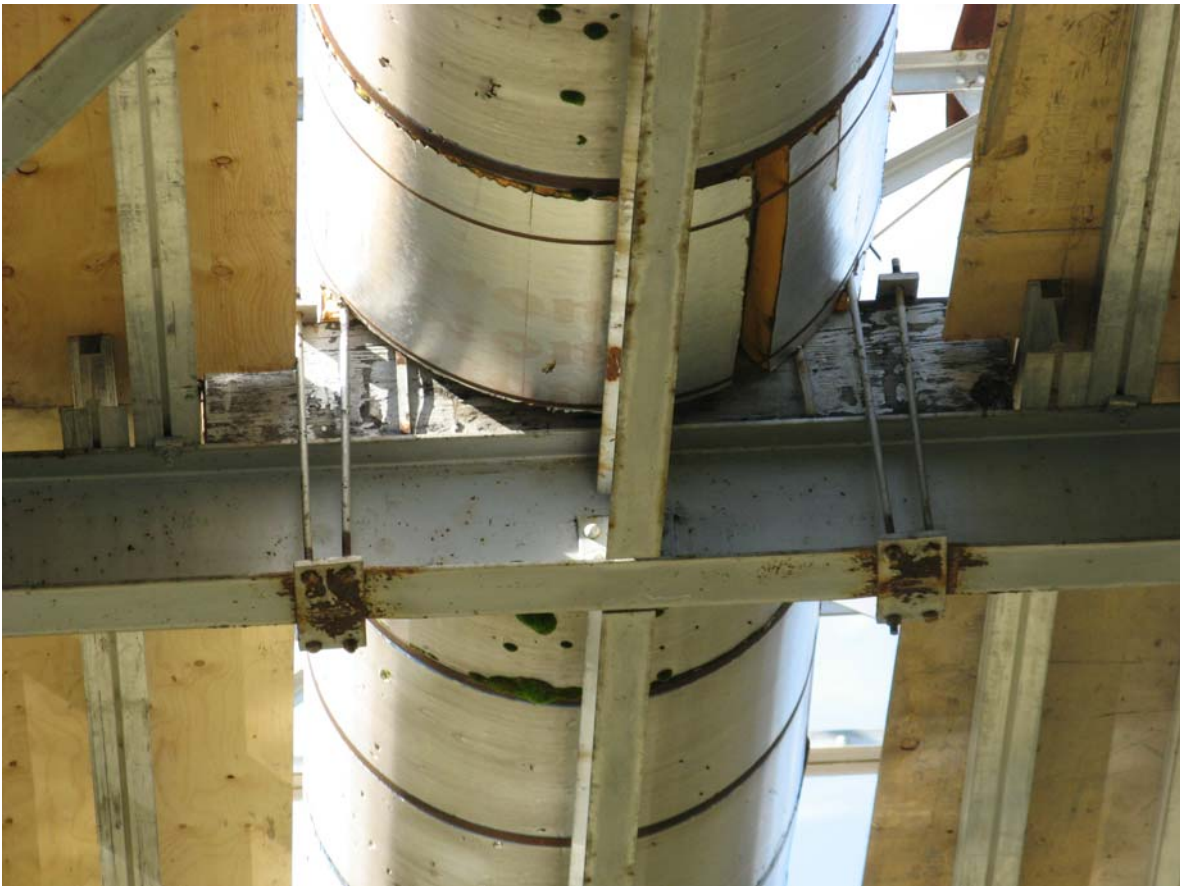
A3-03 - Closeup of Typ Floor Beam and Pipe Cradle (with temp walkways in place).JPG

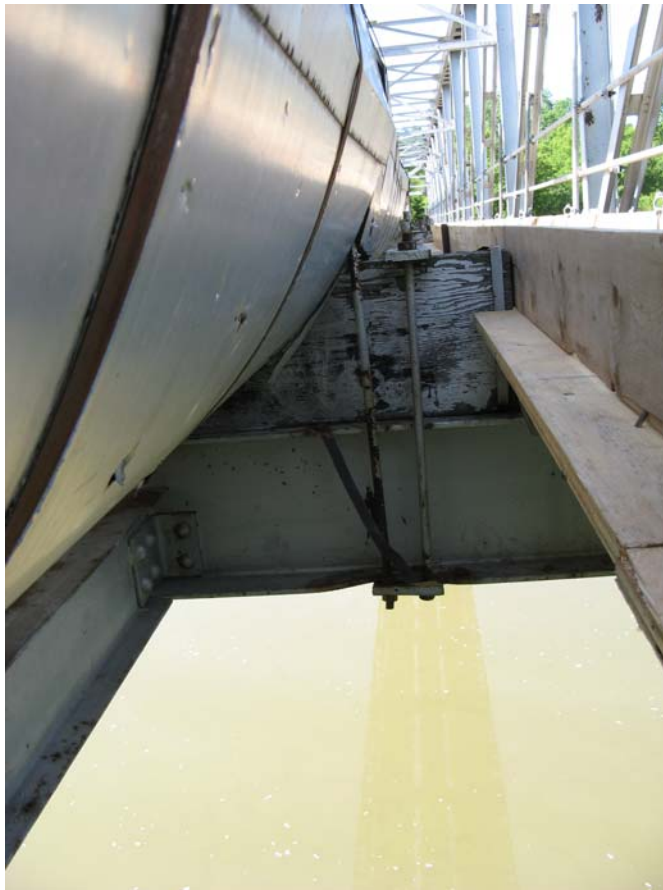
A3-04 - Member i-l West Half Bottom Flange Deformed at Holddown for Pipe.JPG

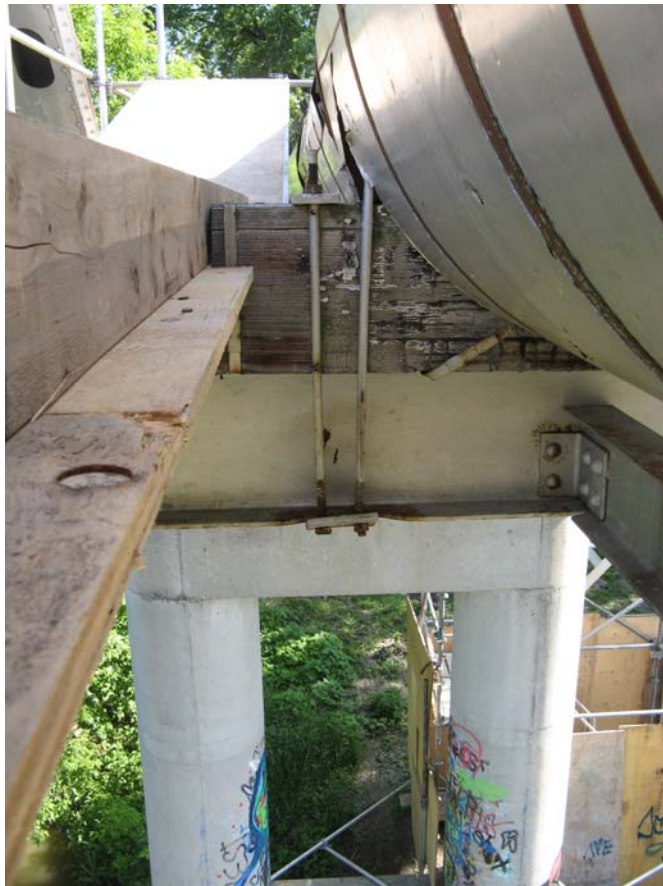
A3-05- Member i=l West Half Bottom Flange Deformed at Pipe Holddown.JPG

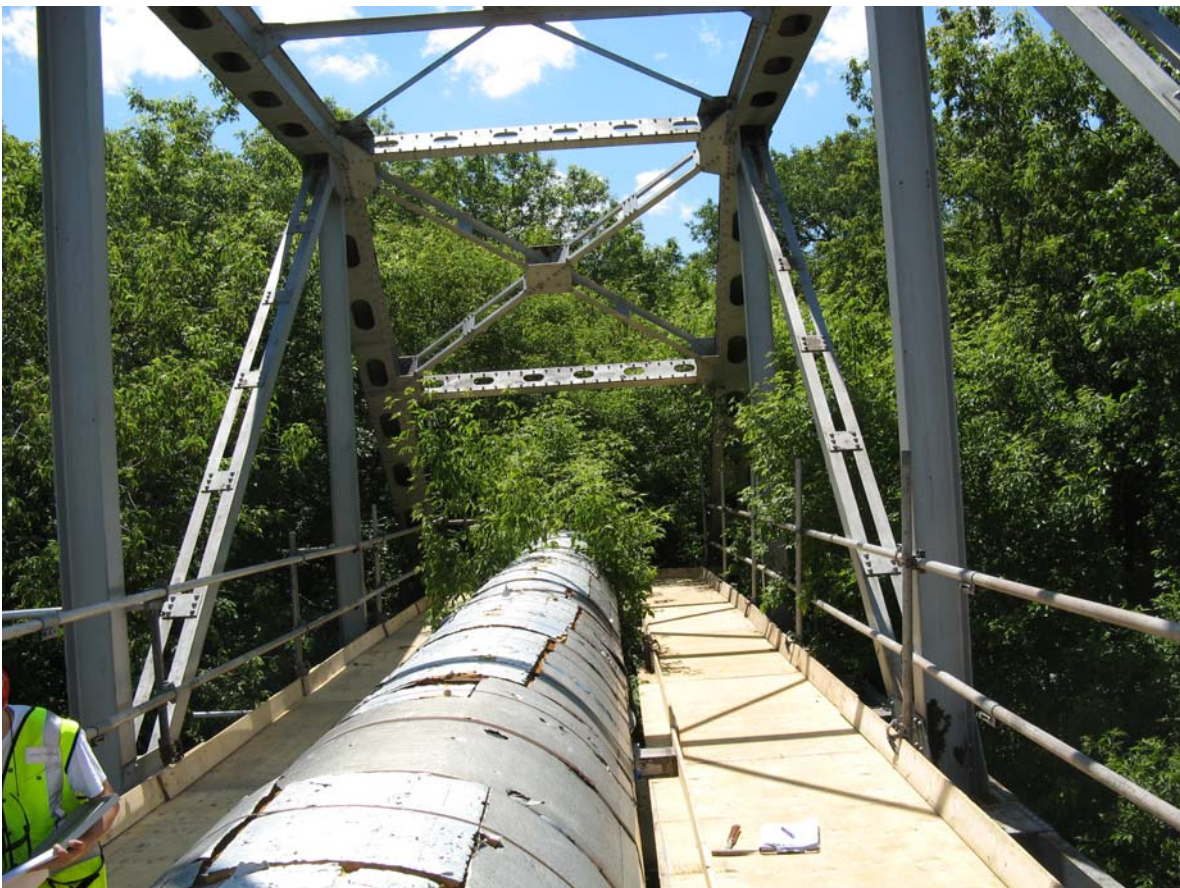
A3-09 - Pipe Insulation and Cladding-South End.JPG

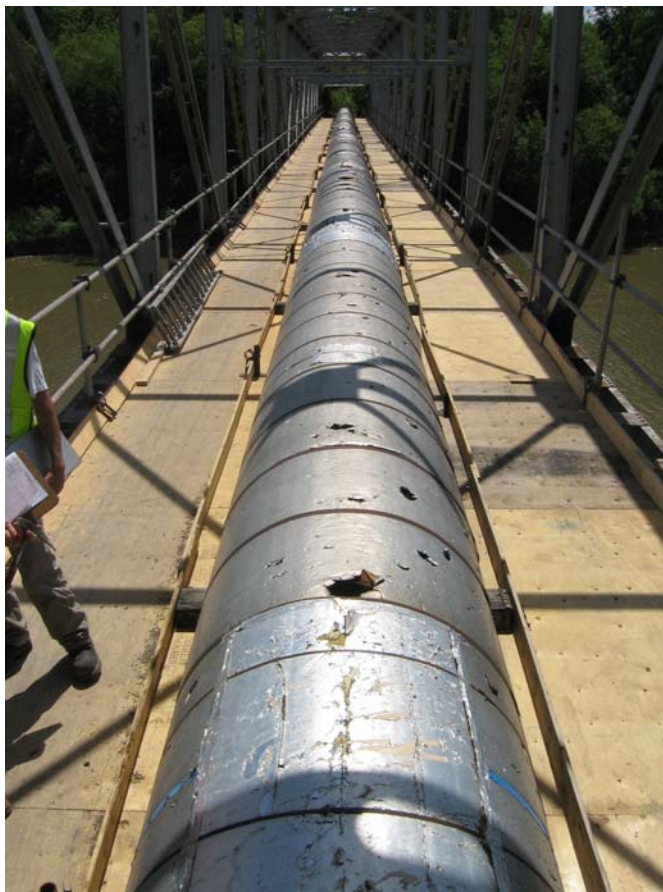
A3-10 - Existing Pipeline and Insulation on Bridge.jpg

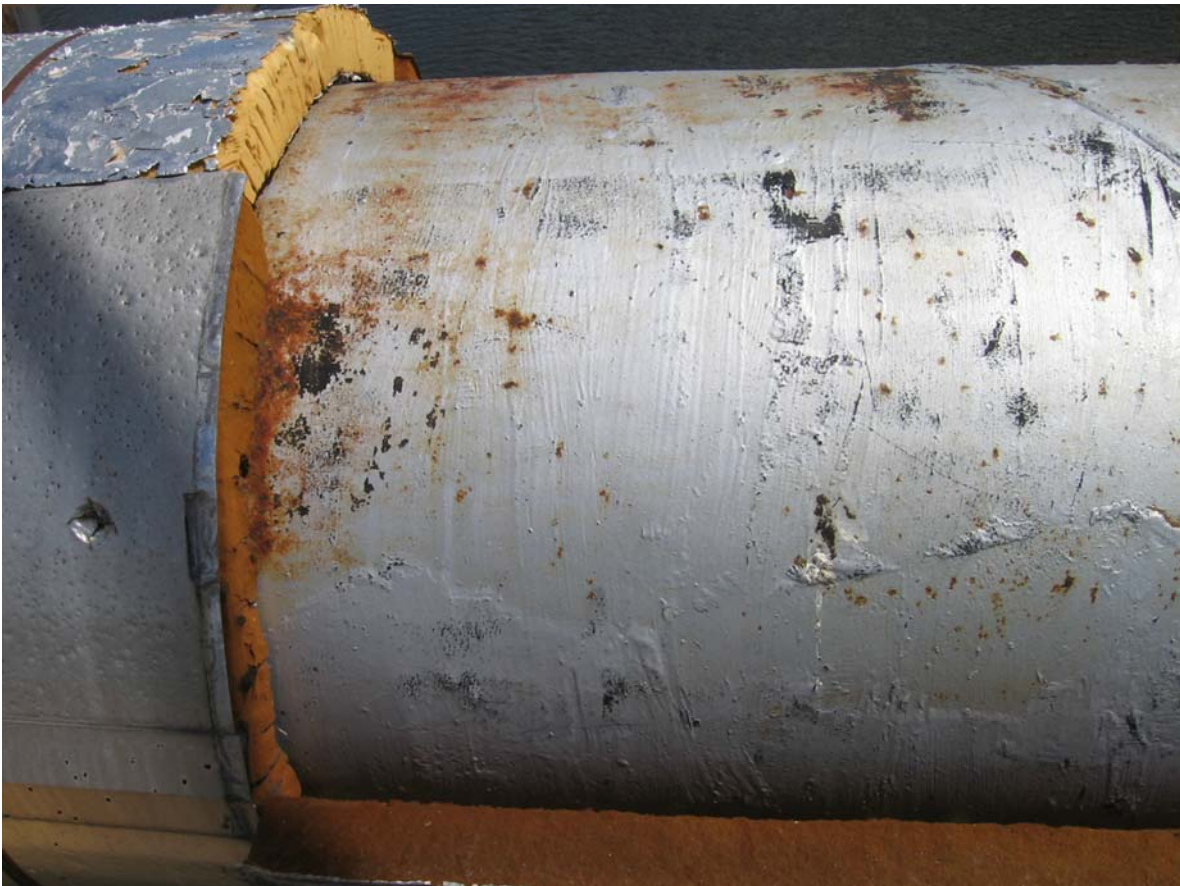
A3-11 - Existing Pipe Coatings, Insulation and Cladding.jpg

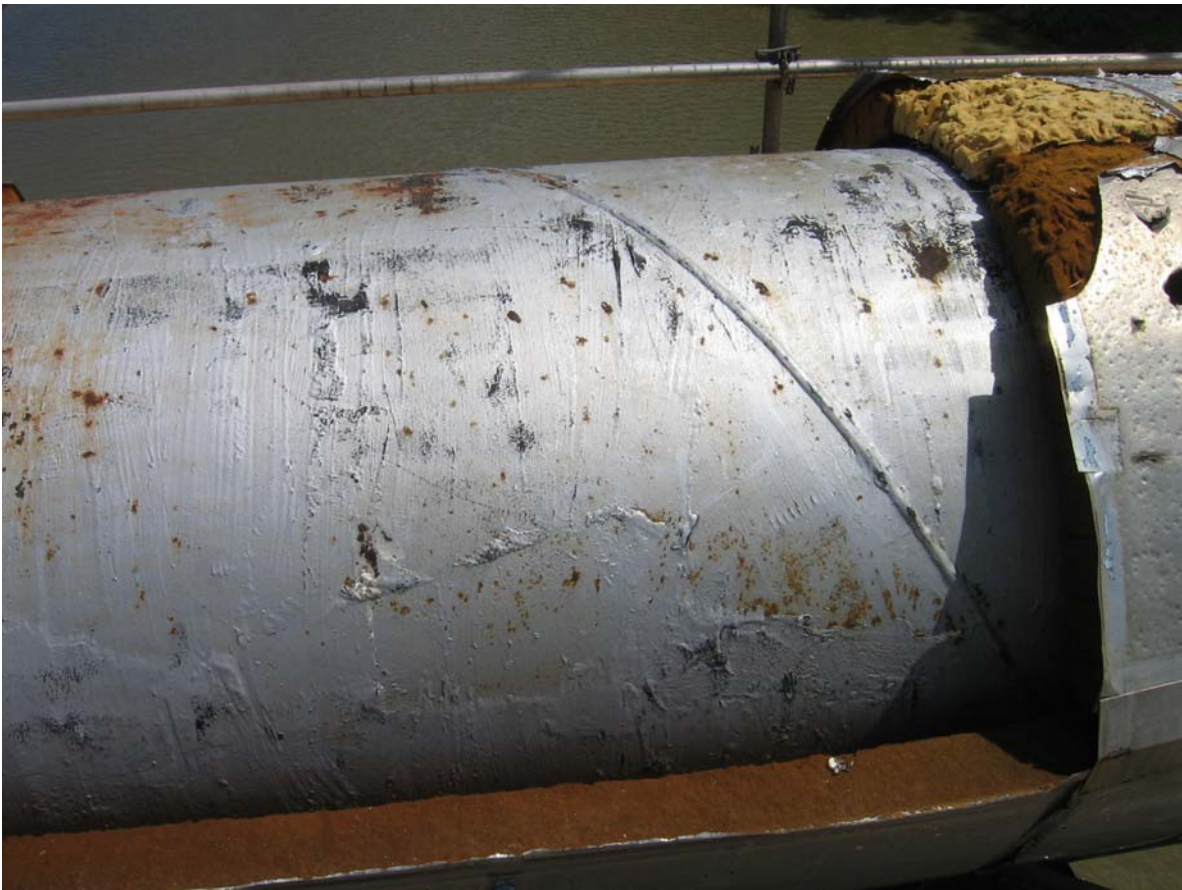
A3-12 - Existing Pipe Coating.jpg
