.....
City of Winnipeg

***Visual Structural Inspection Clubhouse
Harbourview Complex***

March 4, 2003

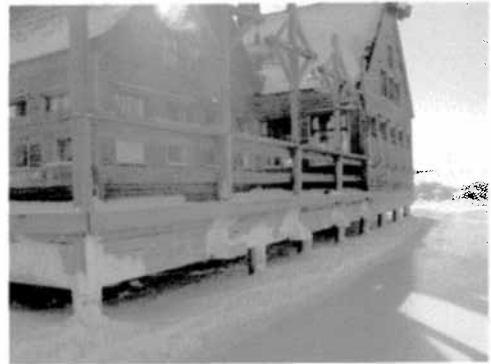
The building substructure is comprised of 250mm wide concrete grade beams on a combination of treated timber piles and concrete friction piles. The exterior decking is comprised of 75x150 treated wood decking on 38x240 wooden beams.

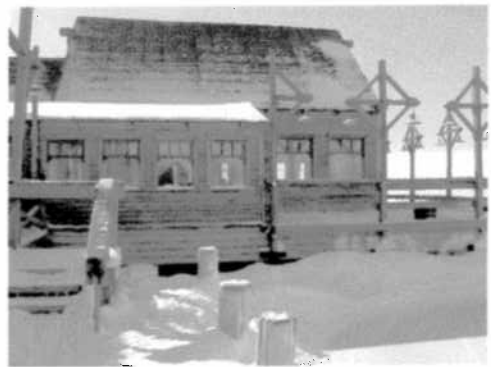
Due to snow embankment around the building it was not possible to adequately determine the grading of the building relative to the retention pond. It appears that the retention pond extends under the exterior deck and portions of the main floor of the building.

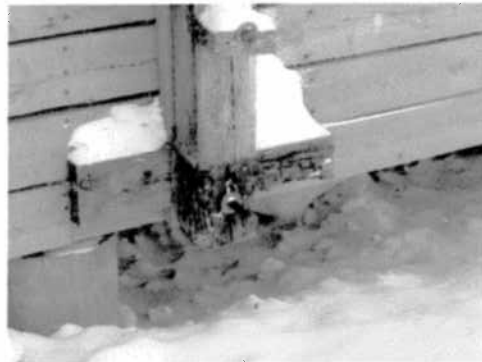
The handrail installed around the deck has a seriously rotted and deteriorated vertical post on the north side of the building.

- Some deterioration of the exterior wood finishes particularly the posts supporting the exterior handrail was detected and should be replaced and or repaired.
 - Estimated Cost: \$2,000.00
- There were several sections of plywood soffit below the exterior crawlspace, which have become loosened and are detached. These sections of plywood should be repaired and the Styrofoam insulation above them replaced as required.
 - Estimated Cost: \$1,000.00
- Installation of additional ventilation in the crawlspace.
 - Estimated Cost: \$5,000.00
- Installation of additional sump pits.
 - Estimated Cost: \$10,000.00
- Installation of Additional granular fill and membrane.
 - Estimated Cost: \$5,000.00

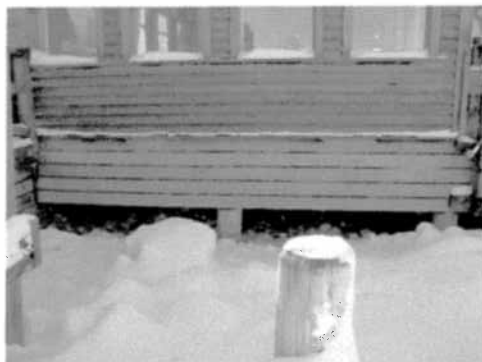
The lower 900mm of skirting around the building is made of pressure treated wood. The exposed tops of the piles appear to be in good condition.

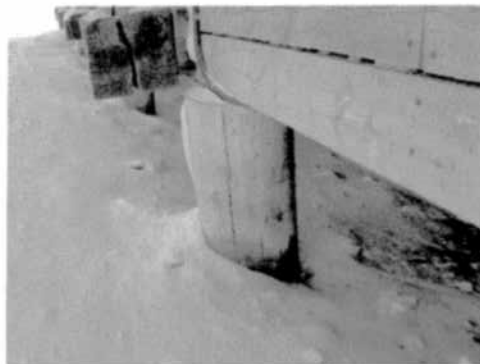
The section of timber pile, which is most at risk of undergoing rot, is that section of pile in the uppermost 300mm section below water level. Due to the frozen conditions, it was not possible to expose this section of pile. It is suggested that an additional inspection be undertaken once the spring thaw has occurred to determine the condition of the timber piles.

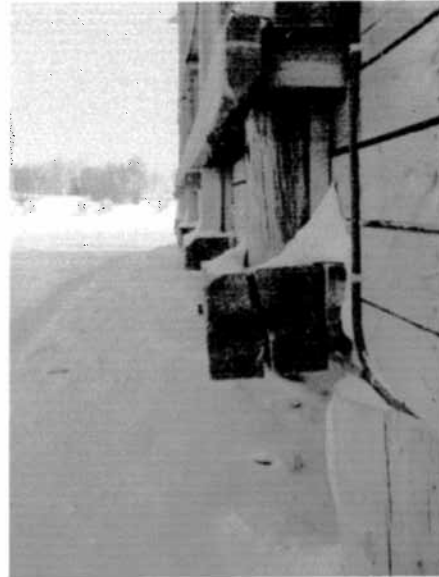
There are a number of blocking pieces installed around the vertical handrails, which are split and broken or missing. Most of the handrail portions are deteriorating and rot is occurring. There are areas of mold and mildew growth in most of the exposed wood surfaces.

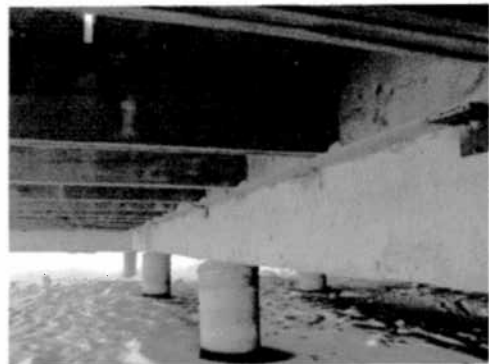
The foundations below the area beneath the building are made up out of concrete piles and grade beams. Wooden joists span across the grade beams at the exterior deck. The rest of the main floor soffit is insulated and covered with plywood.

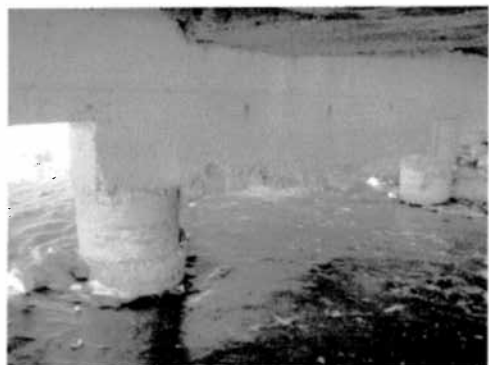
A number of the concrete friction piles were originally constructed with some honeycombing and there are a number of areas where the concrete grade beams also have honeycombing in them.

Deterioration of these sections of piles was not detected although the inspection was limited to that section of the pile exposed above the frozen water level.

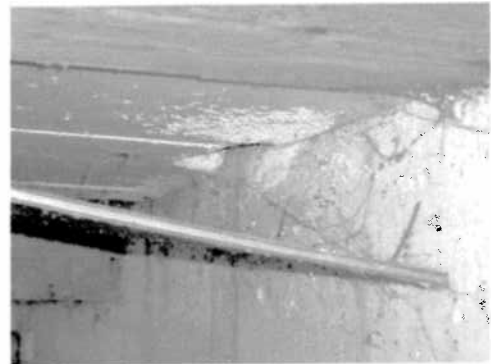
There are a number of areas where the plywood soffits are pulled down and in some instances animal infestation into the insulation has occurred.

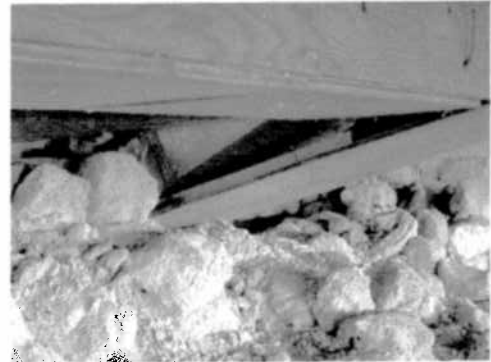
There are a number of areas where ducts are exposed and uninsulated due to the removal or damage of the plywood soffits.

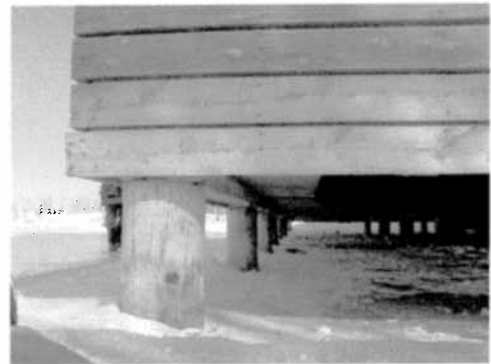
The foundations are comprised of one row of driven treated wooden piles along the exterior perimeter with the remainder of the foundations being cast-in place concrete friction piles.

A number of the timber piles are leaning in various directions however there is no overall systematic leaning or skewing of the sub-structure that could be detected.

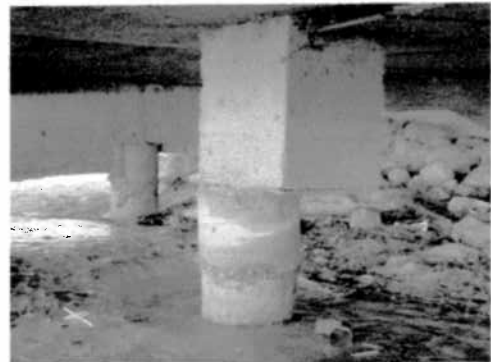
There are a number of original construction deficiencies detected in the concrete work particularly as it relates to the pile caps and the forming that was carried out on the concrete grade beams and piles. Neither of these conditions appears to be affecting the performance of the building.

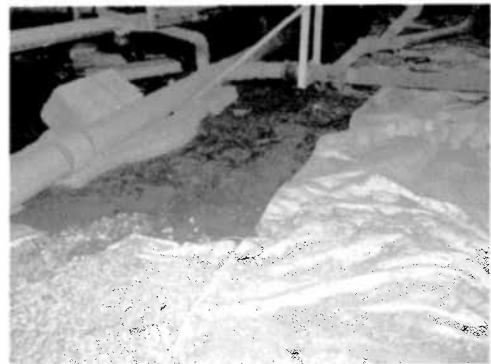
The majority of the existing crawlspace floor has been covered with granular material on a poly vapour barrier however; there are some areas where soil is still exposed. Although the installation of granular backfill makes access into the crawlspace more pleasant, it in no way relieves the excessive moisture in the space caused by intermittent flooding of the space, and likely a high water table due to the retention pond. The City could consider the installation of additional sump pits, and the installation of additional granular fill and ventilation; however, these measures will not solve the overall problem of flooding, they will only help to alleviate the moisture following a flood.

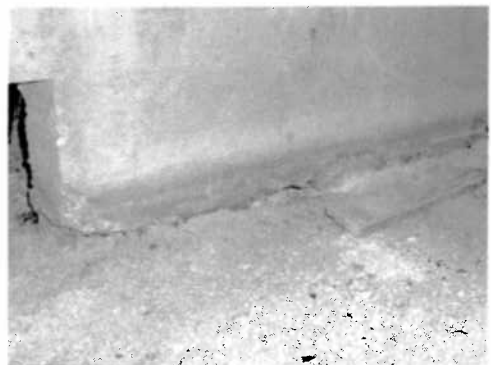
There are watermarks on some of the grade beams within the crawlspace showing levels of the extent of the flooding within the space. Further inspection of the crawlspace indicates that no deterioration of the concrete sub-structure could be detected due to the intermittent flooding of the crawlspace.

A high humidity and damp ground condition does exist within the space however the concrete structure has not suffered any deleterious affects due to the moisture.
