**SEWPCC Upgrading/Expansion  
Conceptual Design Report**

**SECTION 21 - Building Envelope and Structural Assessment**

## 21.0 Building Envelope and Structural Assessment

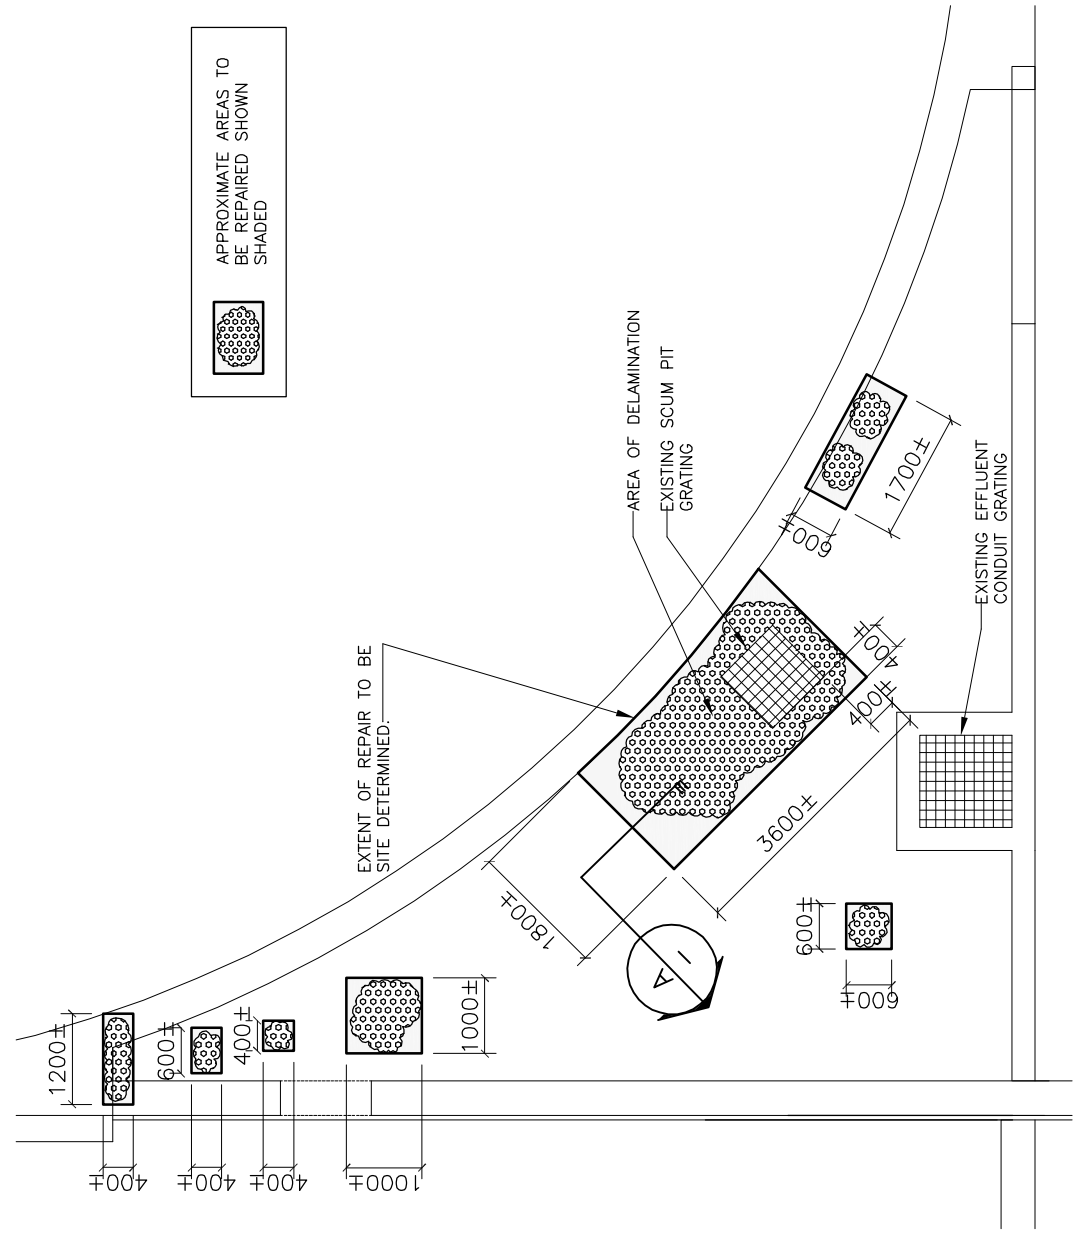
**PARTIAL PLAN**  
1 -  
1:100

6. **Secondary Clarifiers No. 1 and 2 6.3.14.2 – Item – Delamination of concrete at concrete apron at northeast corner of Clarifier No. 2. Preliminary Design recommended action- Investigate integrity of all concrete aprons and repair as required.**

**Comment:** Concrete has delaminated in the location noted. Delamination is likely due to insufficient concrete cover of the reinforcing steel. Moisture is allowed to reach the reinforcing steel surface causing it to rust and expand. The thin concrete cover does not have the strength to resist the expansive forces, resulting in concrete delamination. Loose and delaminated concrete in the area noted should be removed and repaired. Exposed reinforcing steel should be examined to confirm that rust is limited to the surface only. Reinforcing steel surfaces should be cleaned prior to replacing delaminated concrete. Subsequent investigation of the concrete at the other apron areas suggest that the delamination is limited to the area noted in the report. The aprons were checked for delamination by hammer “sounding”. See Figure 21.1.

APPROXIMATE AREAS TO BE REPAIRED SHOWN SHADED

**Action:** Remove loose and delaminated concrete, examine reinforcing steel, and repair concrete surfaces.
