SECOND FLOOR PLAN - Mezzanine level

ASBESTOS LOCATIONS

BUILDING:	PI-13 Pan Am Pool 25 Poseidon Bay Winnipeg, Manitoba
REVISED BY:	REM
DATE:	February 28, 2014
SCALE:	N.T.S.
SHEET #:	2/6

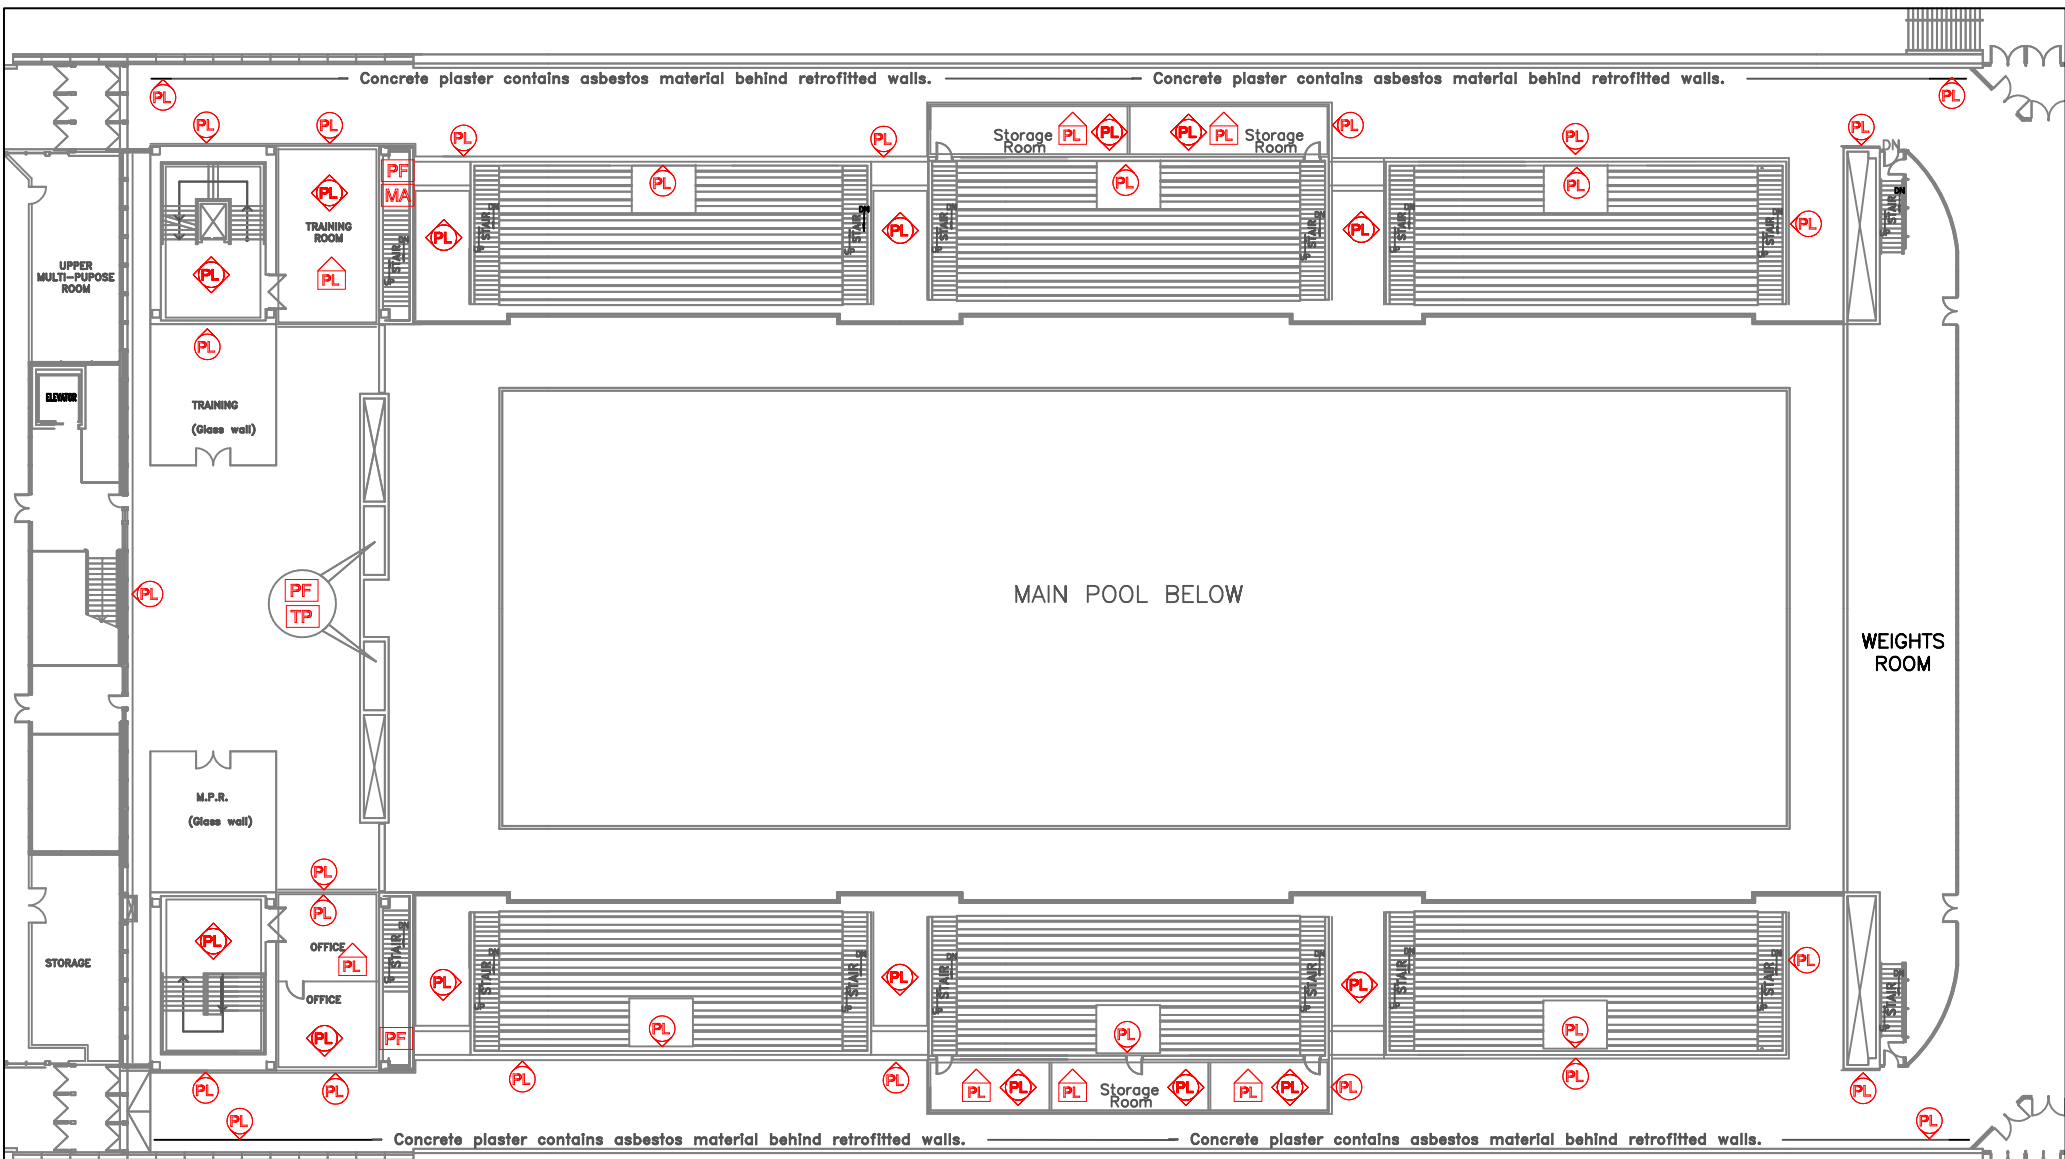
- All concrete plasters in ceilings and walls contained asbestos materials except for the retrofitted walls in north & south exterior concrete wall of which asbestos materials located behind that walls.
