**JOHN BRUCE PARK
SLOPE STABILITY ASSESSMENT
NEAR 581 ST ANNES'S ROAD
WINNIPEG, MANITOBA**

SUBMITTED TO:
**McGowan Russell Group
825 St Joseph St
Winnipeg, MB
R2H 0A8**

File number: WX17992

27 October 2016

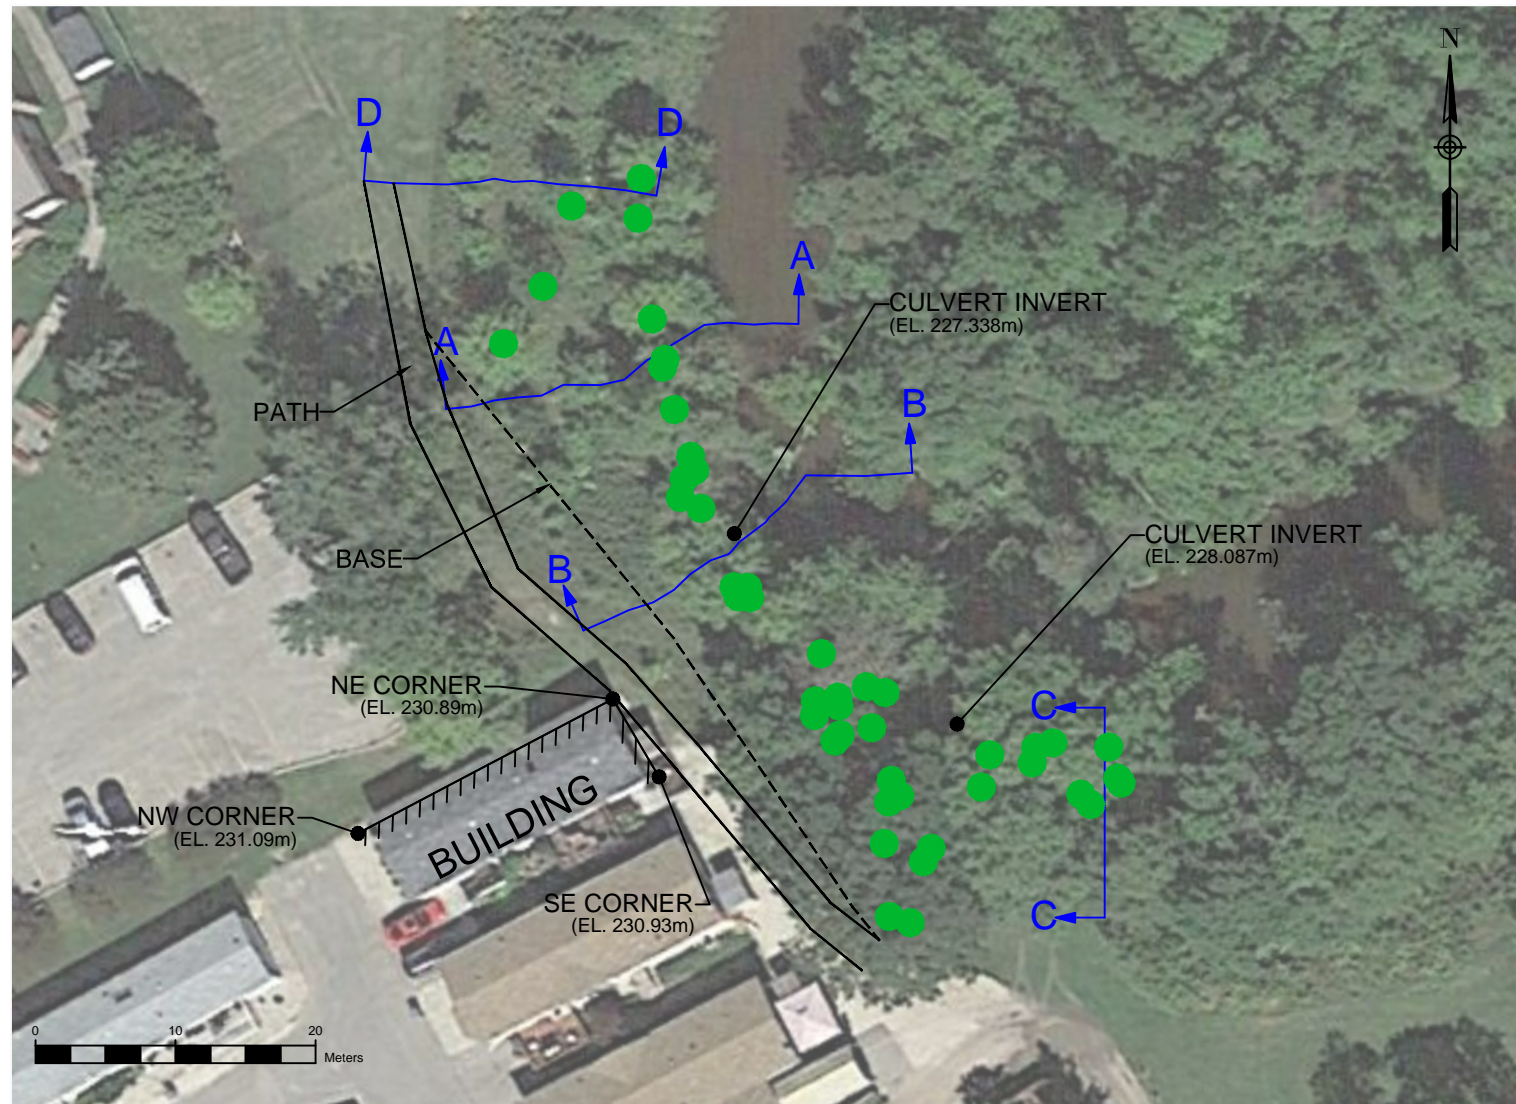
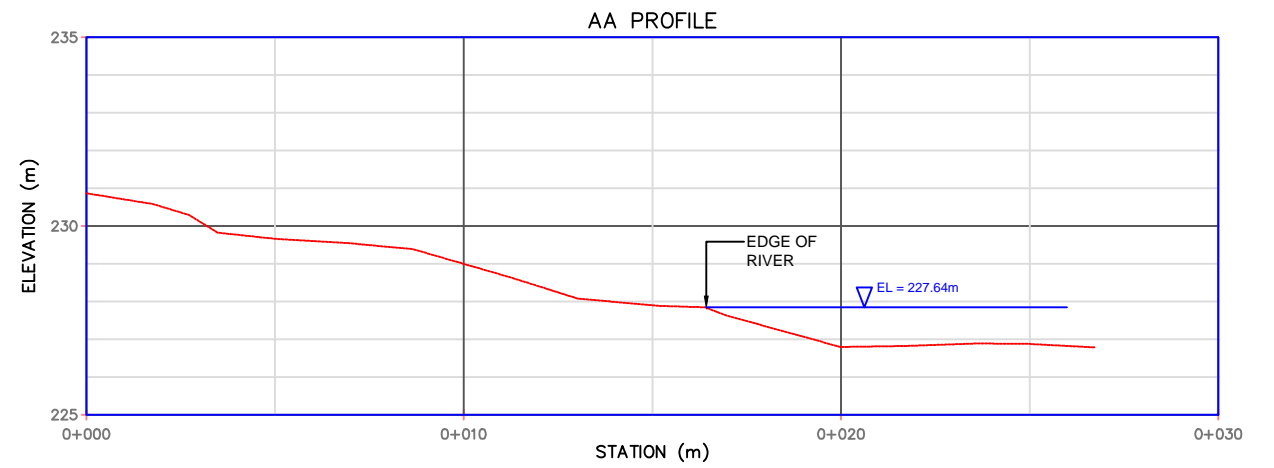
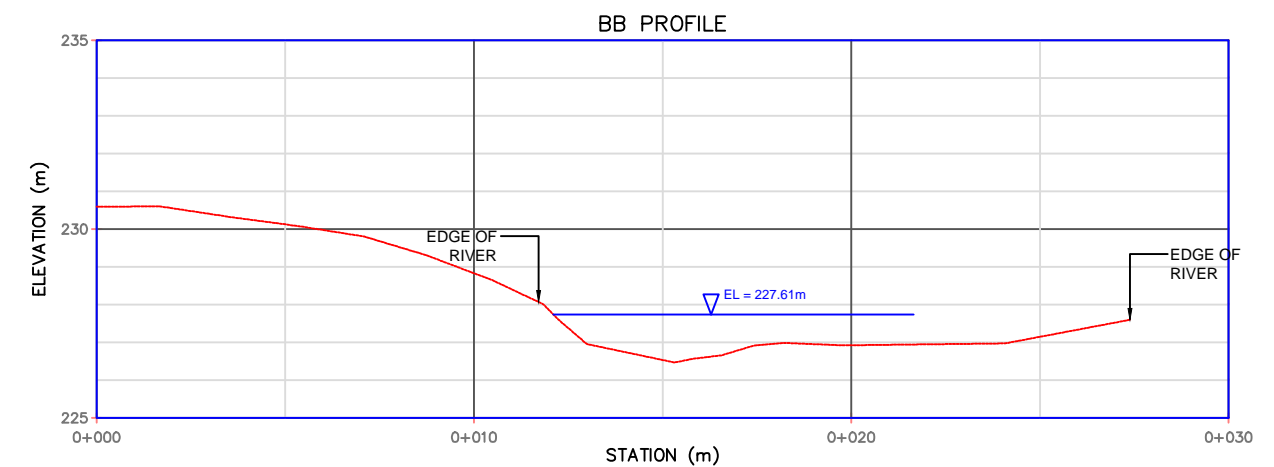
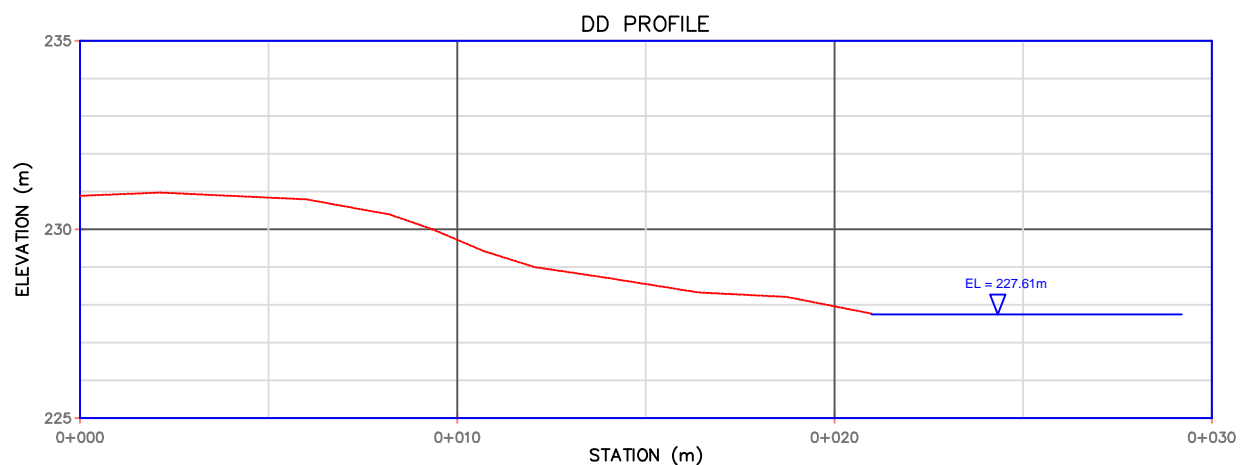
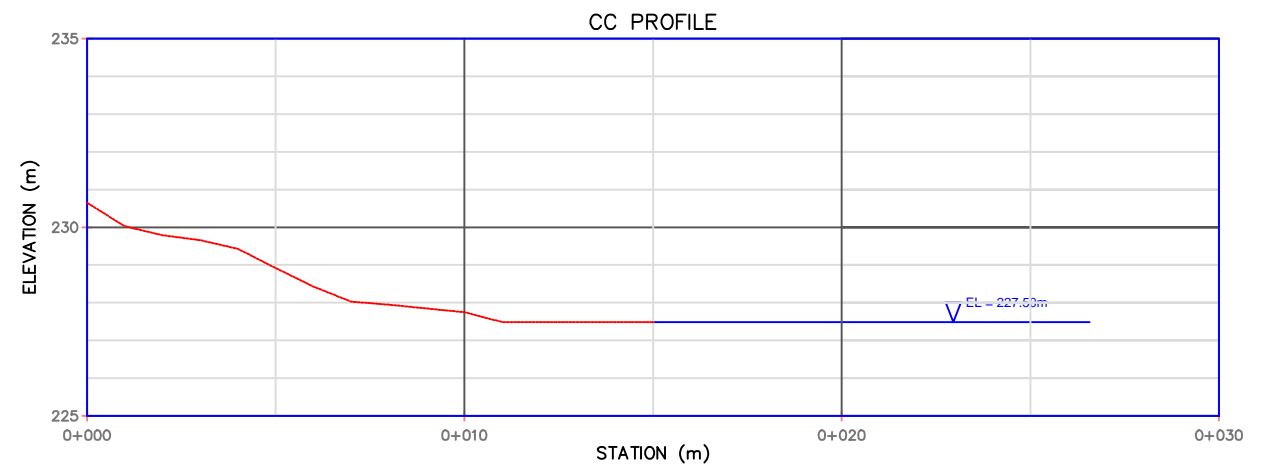
DATE: OCTOBER 2016
 PROJECT NO: WX17992
 REV. NO.: ---
 FIGURE NO: FIGURE 2

Two outfalls were noted within the area of the site. One outfall (outfall #1) was towards the south and followed a northerly alignment; while the location of the second outfall (outfall #2) was inferred from the background information to follow a easterly alignment as it was under water at the time of the site visit and also during completion of a topographic survey. Details of the topographic survey are discussed later in this report. At the location of outfall #2 there was strong evidence of erosion and scouring due to river action. Grouted riprap was observed at outfall #1 around and above the top of the pipe, but had been cracked and separate along

At the time of the visit the site was well vegetated with tall grass, bushes and trees that ranged in size from small to large (i.e., large trees are referred to trees with a caliper greater than 8"). Most of the treed area is concentrated towards the south end of the project limits. Although the riverbank was well vegetated, there were bare soil areas especially towards the south and within the treed area. Leaning of trees was observed at a few locations, assumed to be caused by movements of the bank, however there was no signs of active movement.

As presented in Figure 2, the group of trailer houses was present south from the center of the bend. A bicycle path was under construction at the time of a site meeting between McGowan Russell, The City of Winnipeg and Amec Foster Wheeler. The bicycle path extended along the top of the bank and measured approximately 2 m wide. Immediately upslope from the location of outfall #2 the bicycle path occupied most of the space available between the rear of the most northern trailer house and the top of the bank.

The cross sections were selected at the time of the site visit and reconnaissance at locations where signs of previous instabilities had been noted. The cross sections are presented in Figure 2. Initially Amec Foster selected Cross Section A-A as basis for the back-calculation of soil parameters and evaluation of erosion alternatives. However, as requested by McGowan Russell, additional analyses were conducted along Cross Section B-B to evaluate the effects on a section closer to the closest trailer house.

Based on the survey data, the grades within the project site vary between about El. 231 m and El. 226.5 m for the top of the bank and the riverbed, respectively. The river levels at the time of the survey were in the order of El. 227.6 m

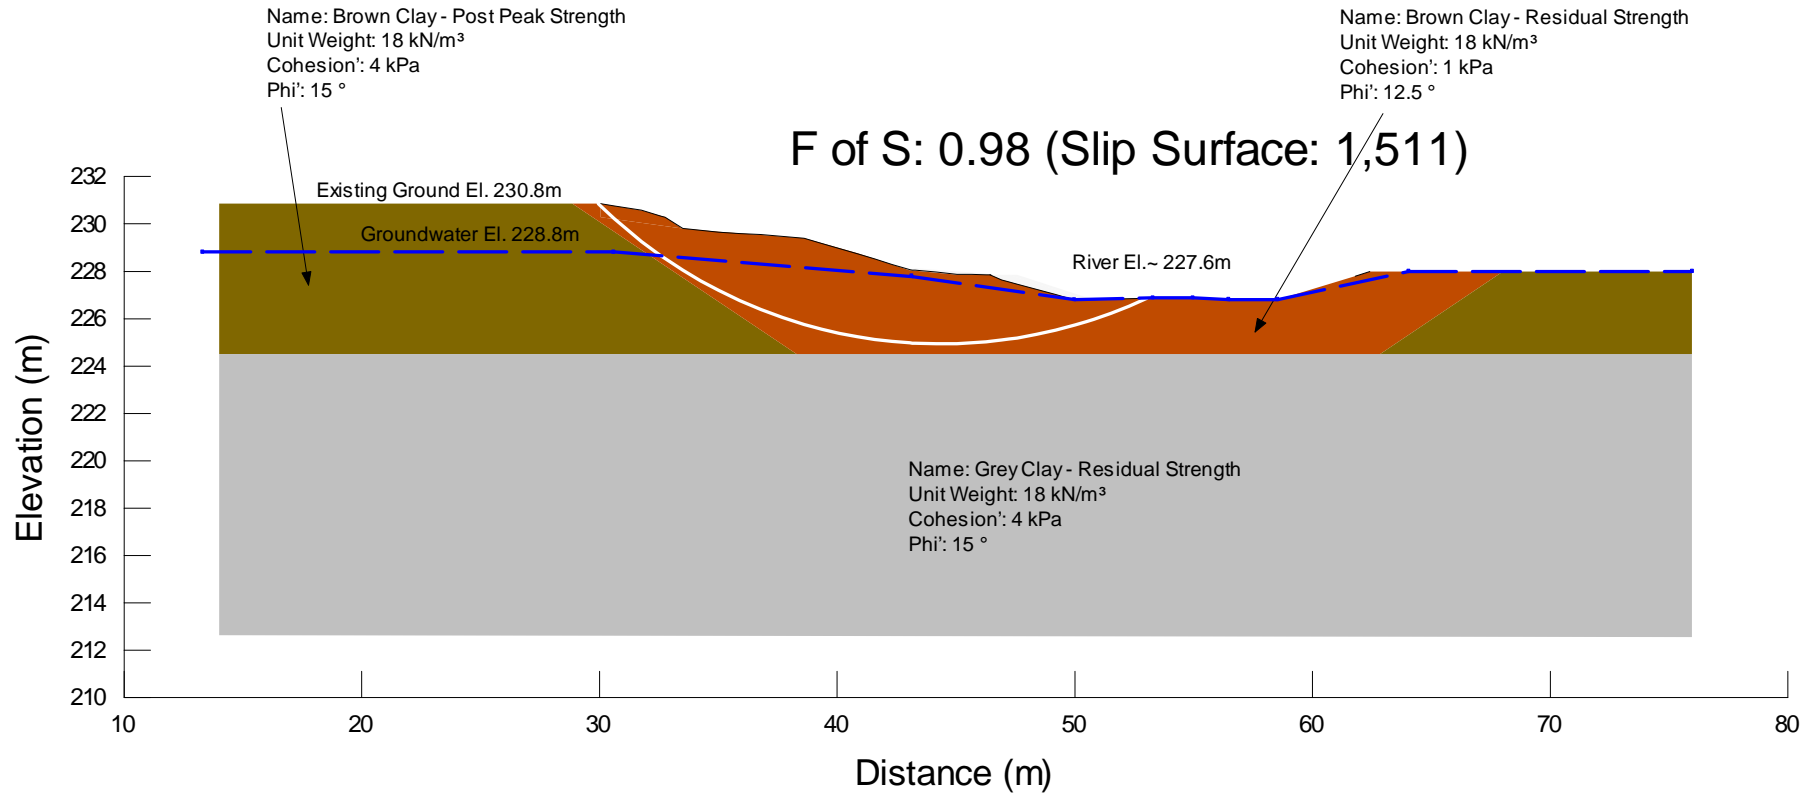
Project No.:	WX17992
Date:	October 2016
Scale:	As Shown
Drawn By:	GC
Figure:	3

Based on the site observations it is not apparent that recent movements have occurred at the site. However, the presence of a backscarp is quite evident, suggesting that slope movements have occurred in the past. Regardless of the site inactivity, it can be reasonably assumed that the backscarp represents a failure zone with a stability of near unity, under worst case operating conditions.

Given the noted site features, Amec Foster Wheeler completed a back-analysis along Cross Section A-A in order to estimate the properties of the soils. A combination of high groundwater (around El. 229 m) and an empty river was selected as the condition that would create the worst case stability state and create an instability as denoted by the back scarp location.

Based on the conditions above and the parameters presented in Table 1, a Factor of Safety (FOS) ~ 0.98 was obtained. A FOS ~ 0.98 is very close to FOS ~ 1.0 (the state of marginal stability) and as such was considered adequate for back-analysis given the historical failures noted. The results are presented in Figure 3.

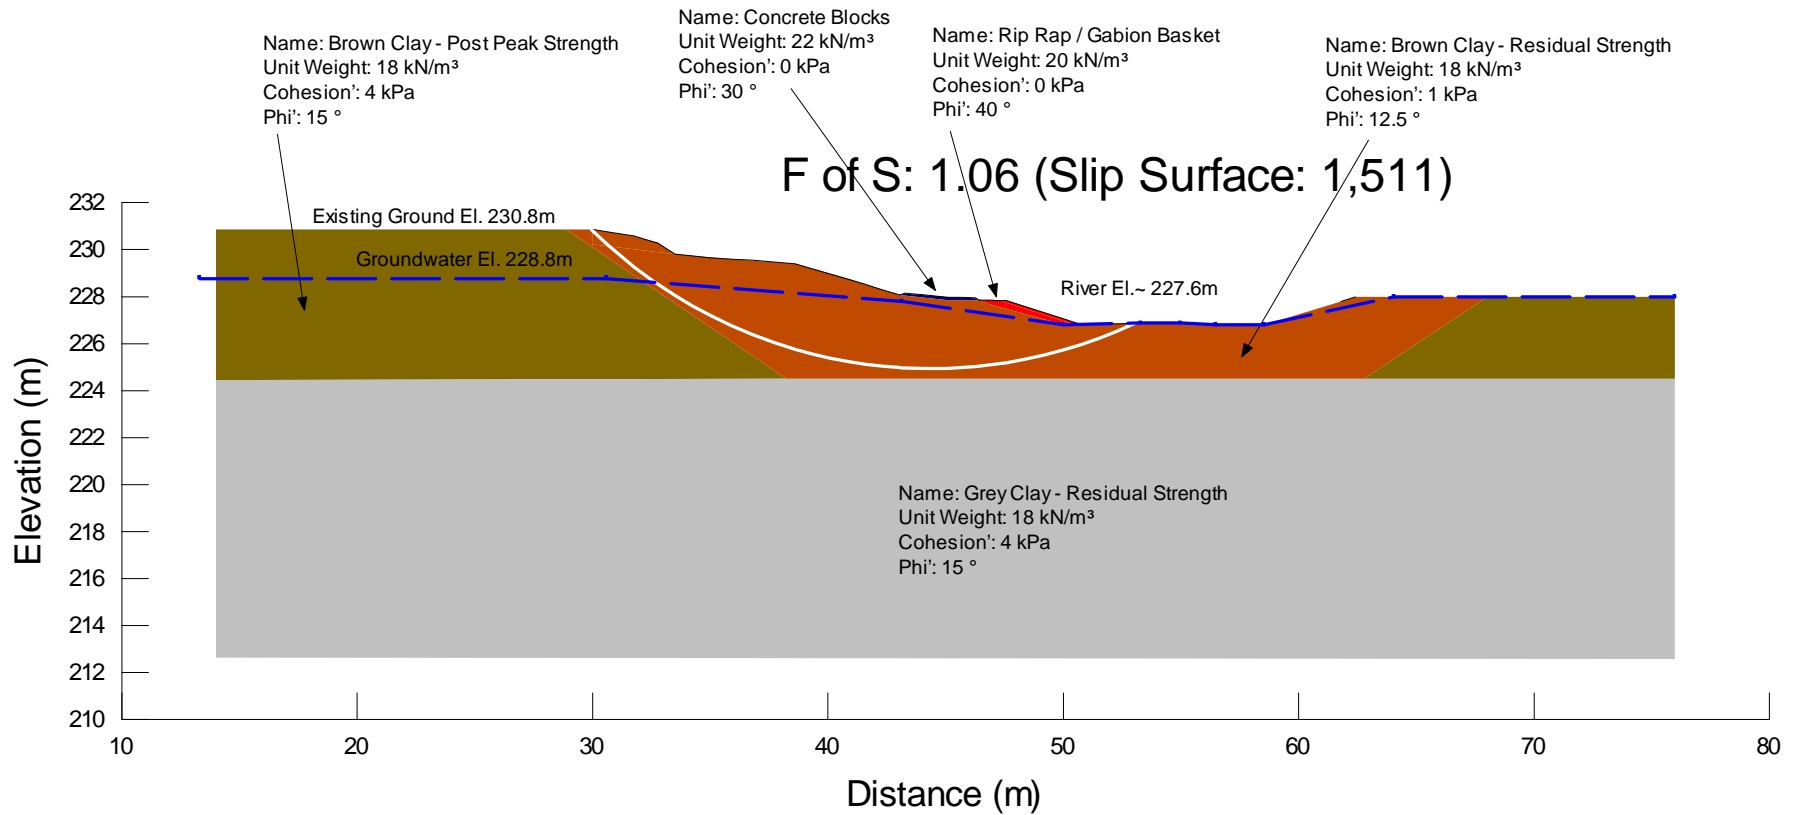
Project No.:	WX17992
Date:	October 2016
Scale:	As Shown
Drawn By:	GC
Figure:	4

Results are presented in Figure 4. Results suggest a FOS ~ 1.06 and a net improvement of about 8% in slope stability as compared to the existing slope under worst case conditions.

1. A gabion basket wall placed from the bottom of the riverbed (about El. 226.7 m) up to a minimum El. ~ 227.8 m;
2. A mat of concrete blocks extending from the top of the gabion basket wall up to a minimum El. ~ 228 m;
3. Vegetation establishment for bare areas or replenishment for areas of existing vegetation. Vegetation is to consist of topsoil and seeding within and above the mat of concrete blocks and willow spilling terraces north of the concrete mats.
