APPENDIX C – OUTFALL SITE INVESTIGATIONS AND GEOTECHNICAL CONDITIONS

BISHOP GRANDIN OUTFALL – (S-MA70015994)

**800 MILLIMETER DIAMETER LAND DRAINAGE SEWER OUTFALL LOCATED EAST OF ST. ANNES
ROAD AT SEINE RIVER**

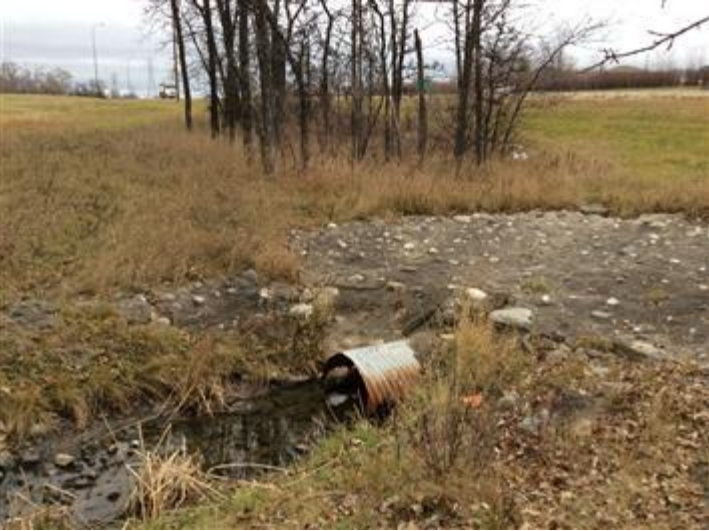
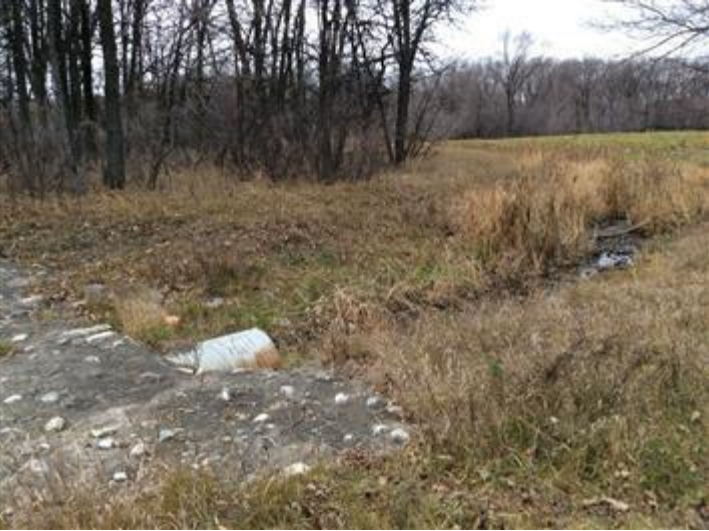
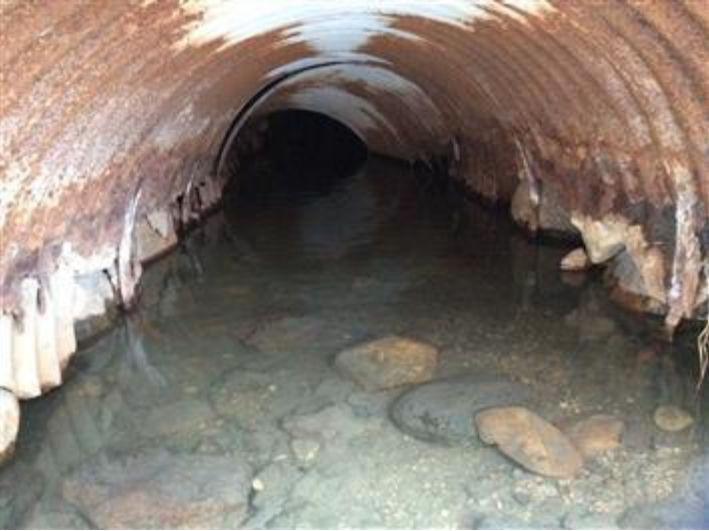
ID	Rip Rap Type	Geotextile	Rip Rap Location
065-01	Grouted Rip Rap		Surrounding Outfall Only

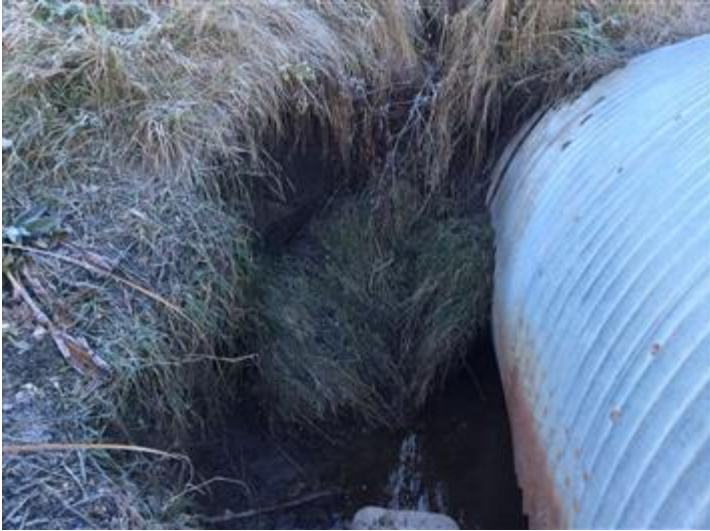
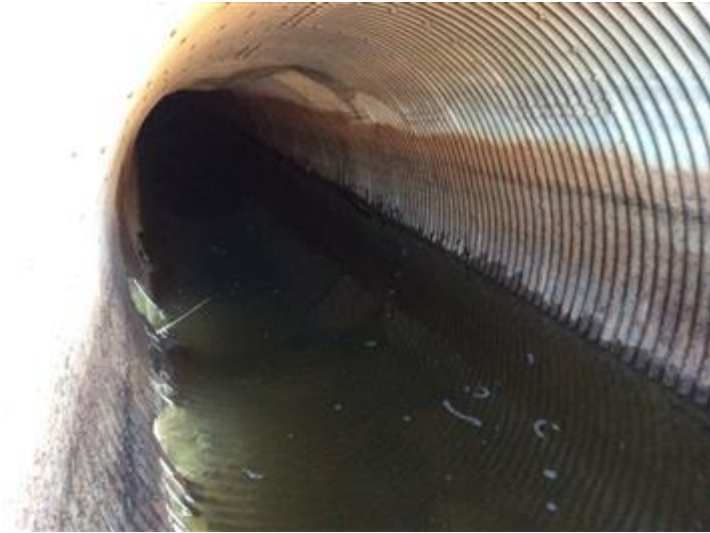
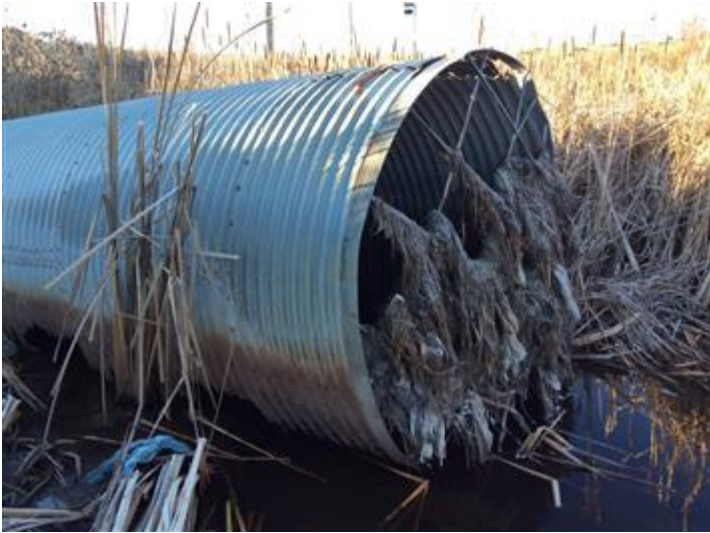
Instability Type	ID	Location	Angle	Vegetation	Terrain
Slump	002-01	Toe	Moderate	Grass Natural	Graded

ID	Height	Location	Angle	Vegetation	Surface Soil
002-01	1200	Toe	Moderate	Grass Natural

ID	Depth	Width	Location	Angle	Vegetation	Surface Soil
002-01	1200	1200	Toe	Moderate	Grass Natural

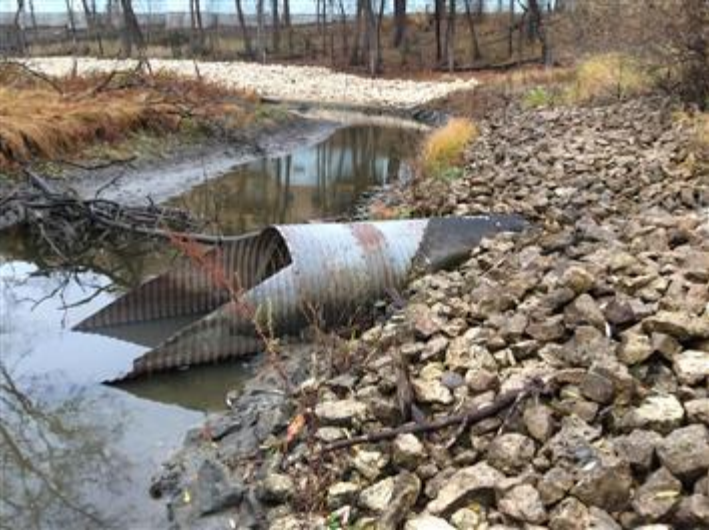
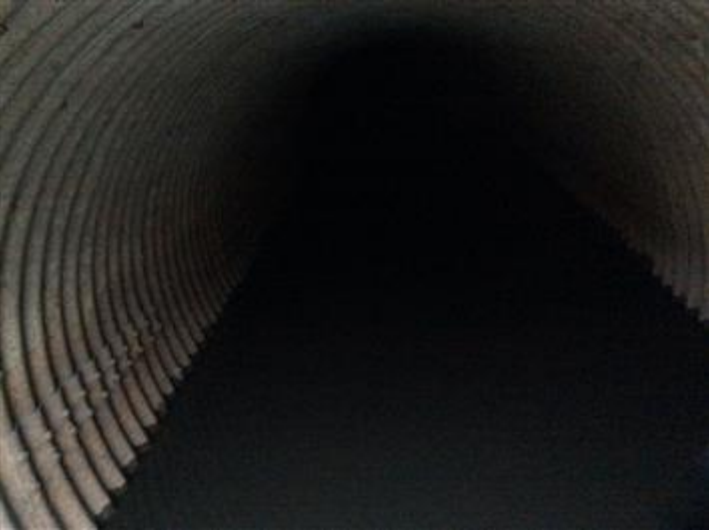
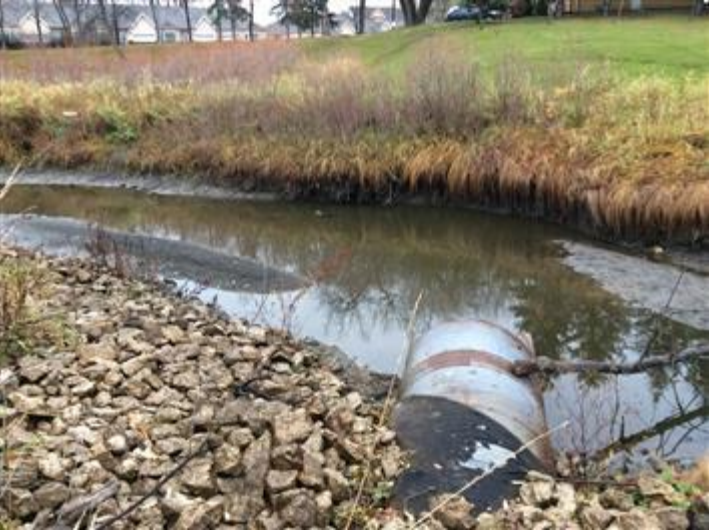
ID	Rip Rap Type	Geotextile	Rip Rap Location
020-02	Loose Rip Rap	Yes	
020-03	Loose Rip Rap	Yes	Surrounding Outfall and Along River Length
020-04	Loose Rip Rap		
020-09	Loose Rip Rap	Yes

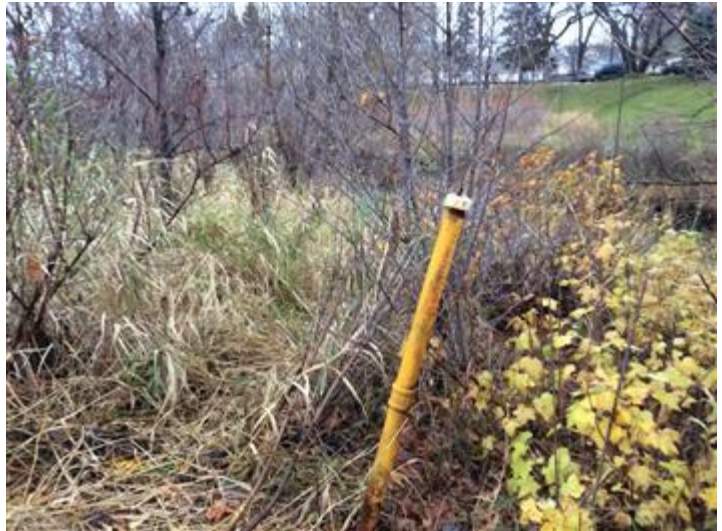
ID	Structure Type	Crack Width
020-05	Manhole	
020-07	Gas line test post

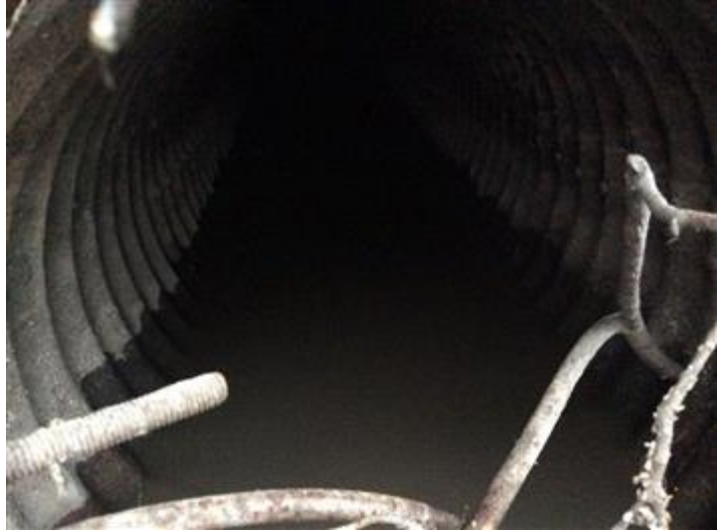
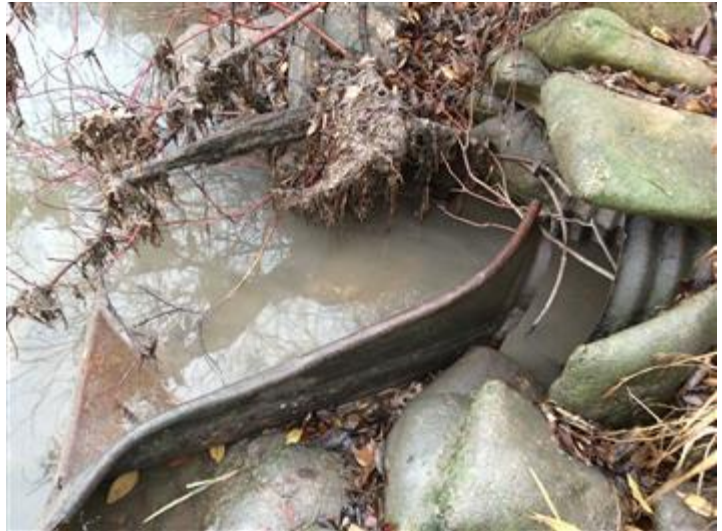
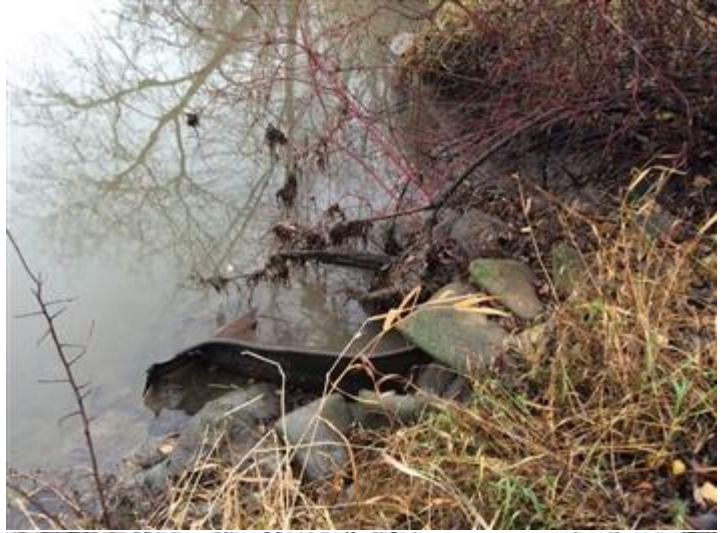
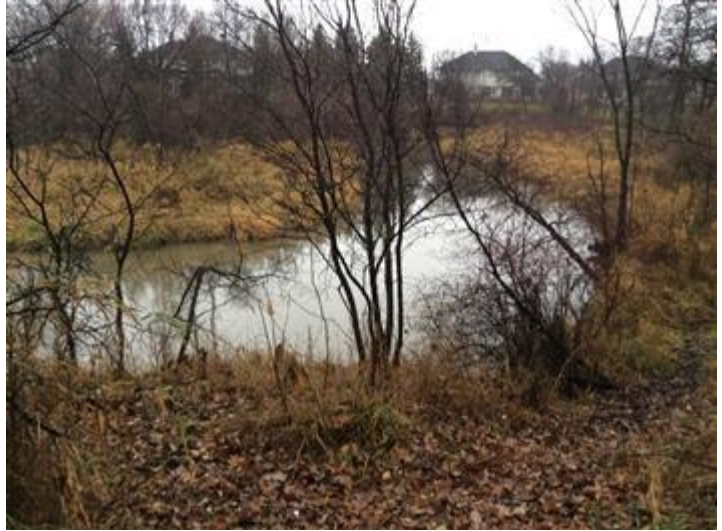
Instability Type	ID	Location	Angle	Vegetation	Terrain
Rotation	082-03	Toe	Steep	Grass Natural	Hummocky
Slump	082-02	Toe	Steep	Small Trees	Graded

ID	Rip Rap Type	Geotextile	Rip Rap Location
082-02	Concrete-filled sandbags	No	Surrounding Outfall Only
082-03	Concrete Rubble

ID	Height	Location	Angle	Vegetation	Surface Soil
	082-02	1000	Toe	Steep	Small Trees	Clay
	082-03	1200	Toe	Steep	Grass Natural	Clay

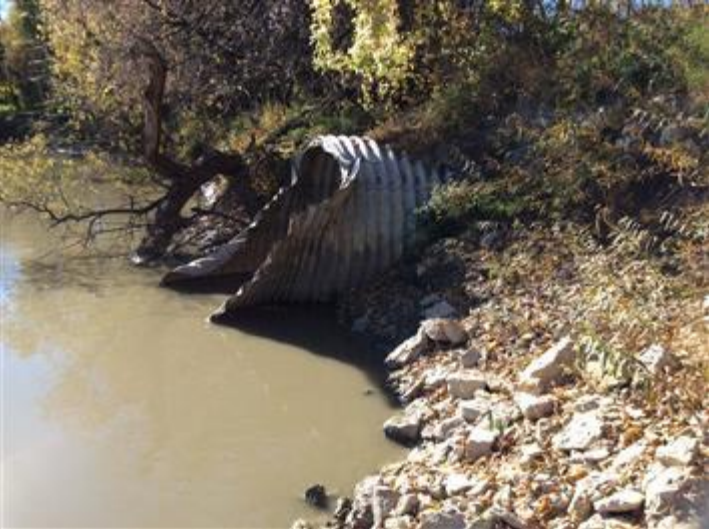
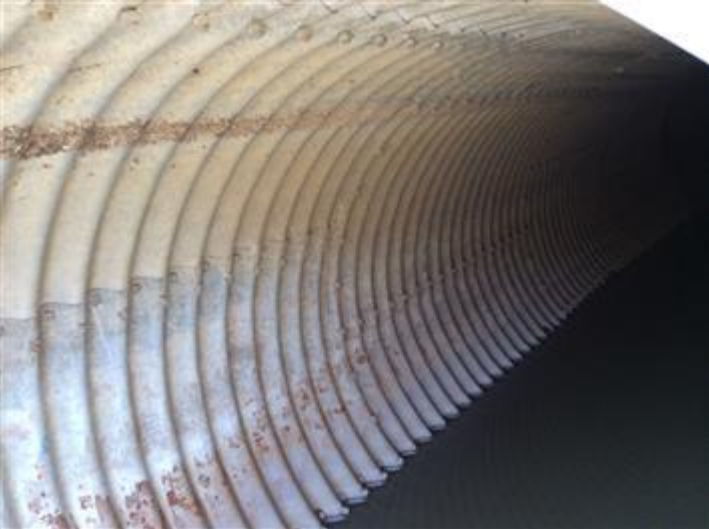
Instability Type	ID	Location	Angle	Vegetation	Terrain
Retrogressive	263-10	Crest	Steep	Small Trees	Natural
Slump	263-04	Toe	Steep	Large Trees	Natural
Slump	263-09	Mid Slope	Steep	Large Trees	Natural

ID	Rip Rap Type	Geotextile	Rip Rap Location
263-04	Loose Rip Rap	No	Invert and Sides

ID	Height	Location	Angle	Vegetation	Surface Soil
	263-04	3000	Toe	Steep	Large Trees	
	263-05	1800	Toe	Vertical	Small Trees	
	263-07	6000	Crest			
	263-09	3000	Mid Slope	Steep	Large Trees	
	263-10	1000	Crest	Steep	Small Trees

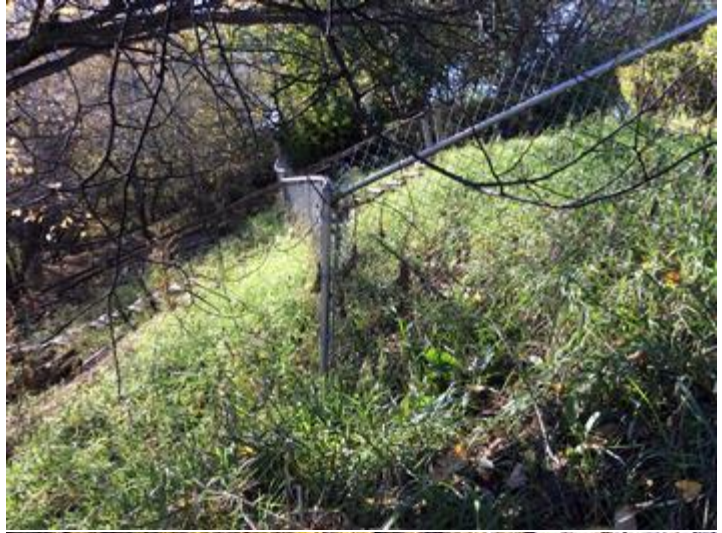
ID	Structure Type	Crack Width
263-06	Retaining Wall	
263-07	Fence

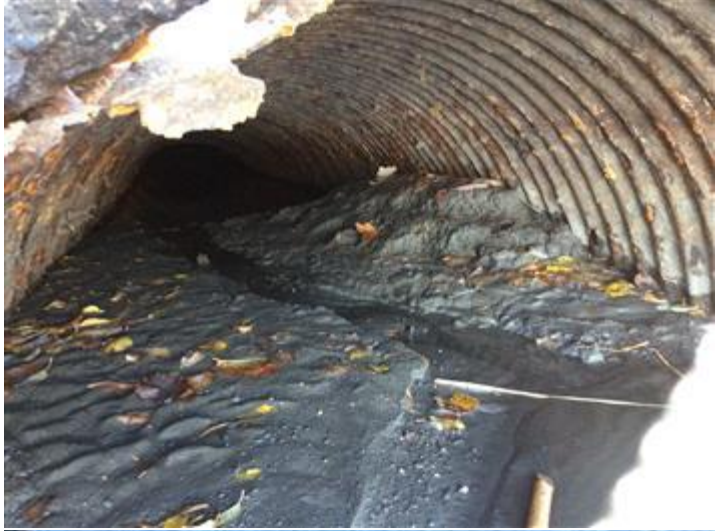
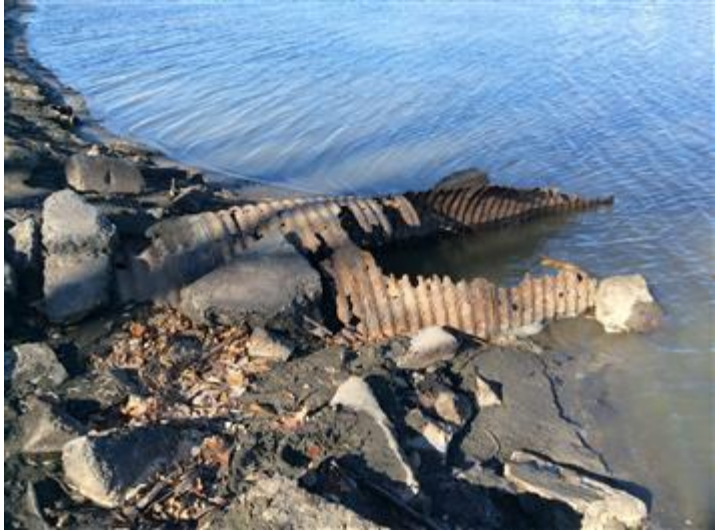
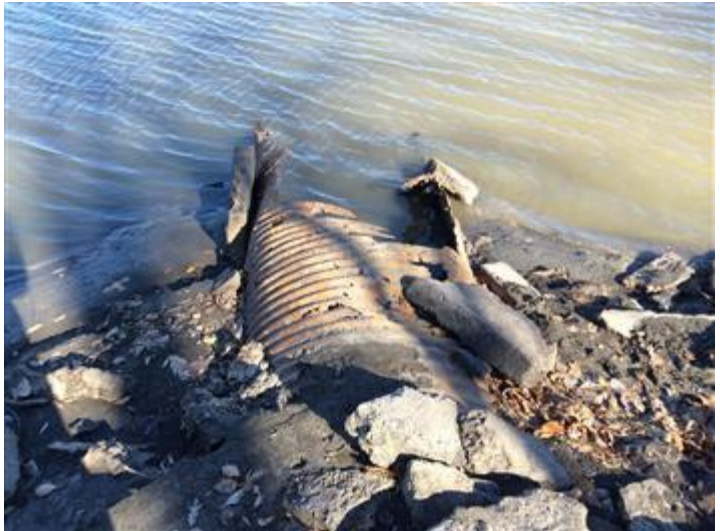
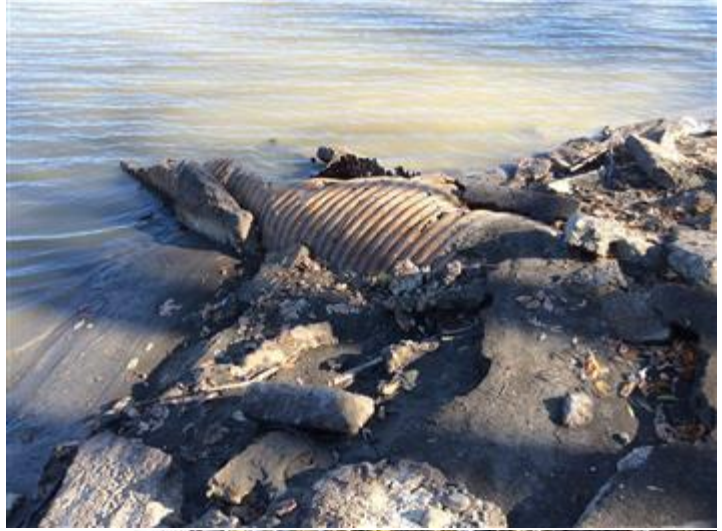
Instability Type	ID	Location	Angle	Vegetation	Terrain
Planar	163-03	Mid Slope	Moderate	Large Trees	Natural
Retrogressive	163-01	Toe	Vertical	Large Trees	Natural
Retrogressive	163-06	Mid Slope	Steep	Large Trees	Natural
Retrogressive	163-07	Mid Slope	Moderate	Large Trees	Natural
Rotation	163-04	Mid Slope	Moderate	Large Trees	Natural

ID	Rip Rap Type	Geotextile	Rip Rap Location
163-01	Concrete Rubble	No	Surrounding Outfall Only

ID	Height	Location	Angle	Vegetation	Surface Soil
	163-01	300	Toe	Vertical	Large Trees	Clay
	163-02	1200	Mid Slope	Steep	Large Trees	
	163-03	300	Mid Slope	Moderate	Large Trees	Clay
	163-04	1800	Mid Slope	Moderate	Large Trees	
	163-05	1500	Mid Slope	Moderate	Large Trees	
	163-06	300	Mid Slope	Steep	Large Trees	
	163-07	300	Mid Slope	Moderate	Large Trees

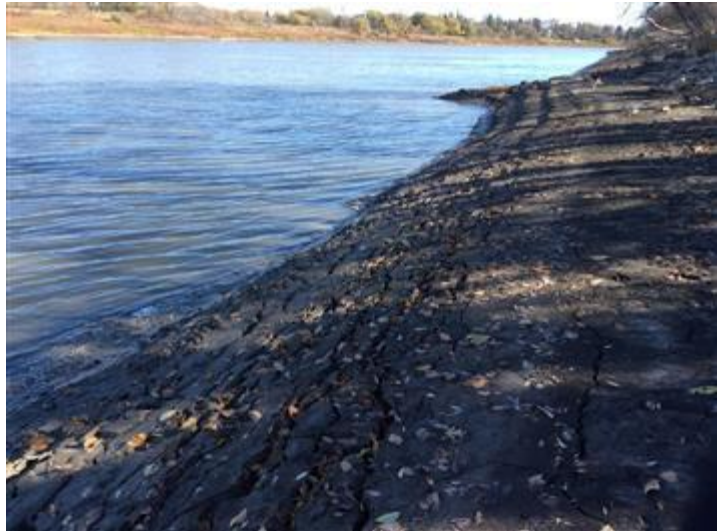
ID	Width	Location	Angle	Vegetation	Surface Soil
	163-07	50	Mid Slope	Moderate	Large Trees

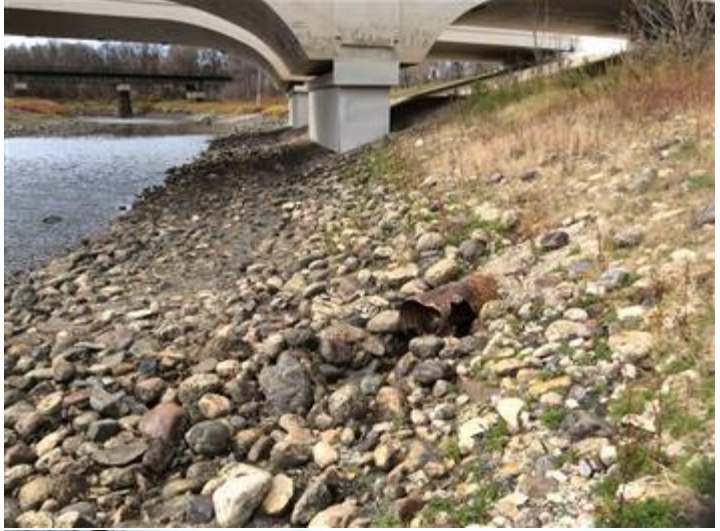
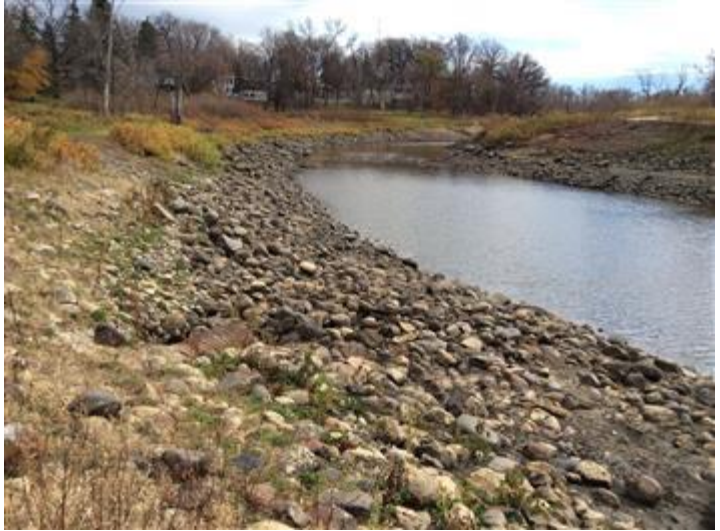
ID	Rip Rap Type	Geotextile	Rip Rap Location
142-01	Loose Rip Rap	No	Surrounding Outfall and Along River Length

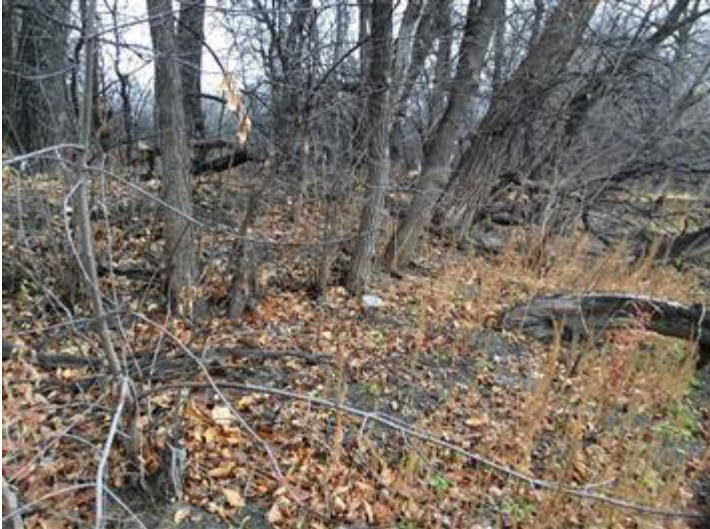
Instability Type	ID	Location	Angle	Vegetation	Terrain
Creep	340-02	Mid Slope	Moderate	Large Trees	Natural
Planar	340-05	Toe	Moderate	Large Trees	Natural
Planar	340-06	Toe	Moderate	Large Trees	Natural

ID	Height	Location	Angle	Vegetation	Surface Soil
	340-02	800	Mid Slope	Moderate	Large Trees	Silt
	340-05	1000	Toe	Moderate	Large Trees	Silt
	340-06	800	Toe	Moderate	Large Trees	Silt

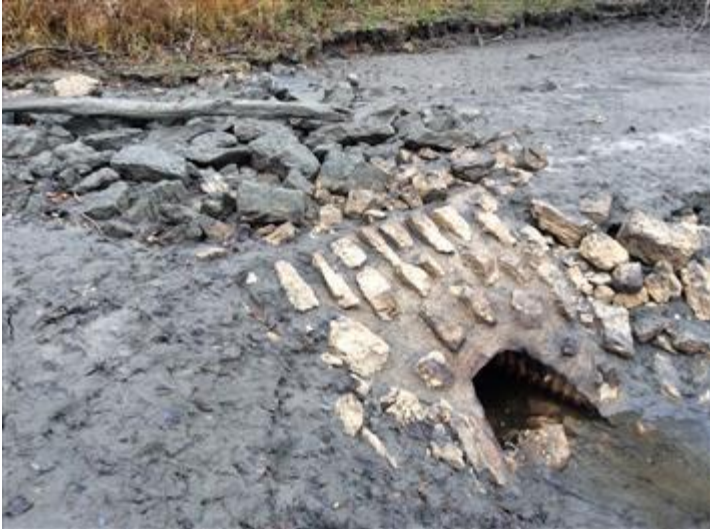
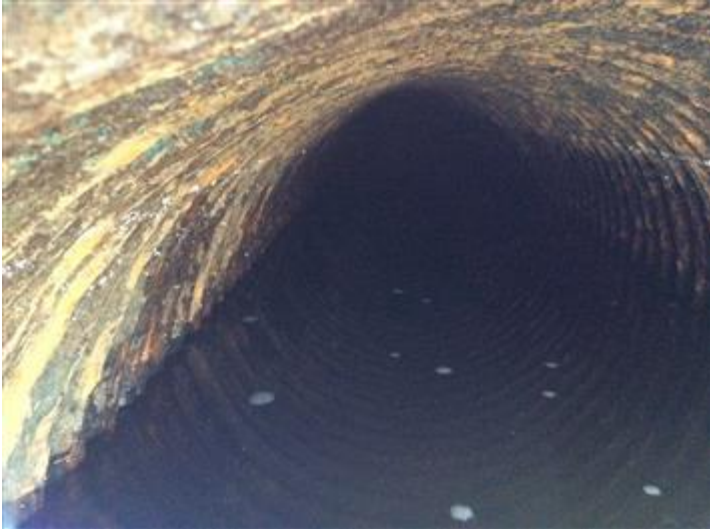
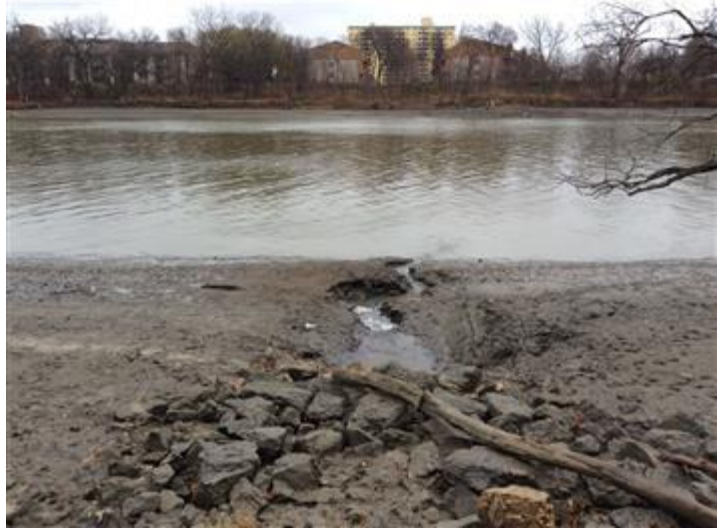
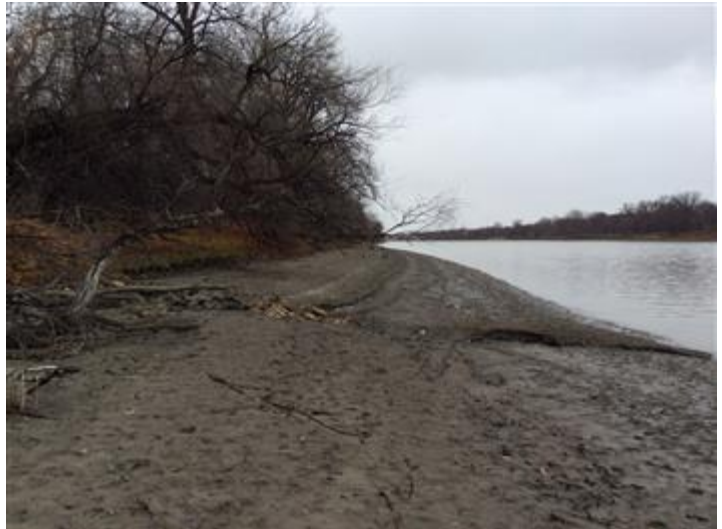
ID	Rip Rap Type	Geotextile	Rip Rap Location
340-03	Grouted Rip Rap	Not Observed	Surrounding Outfall Only

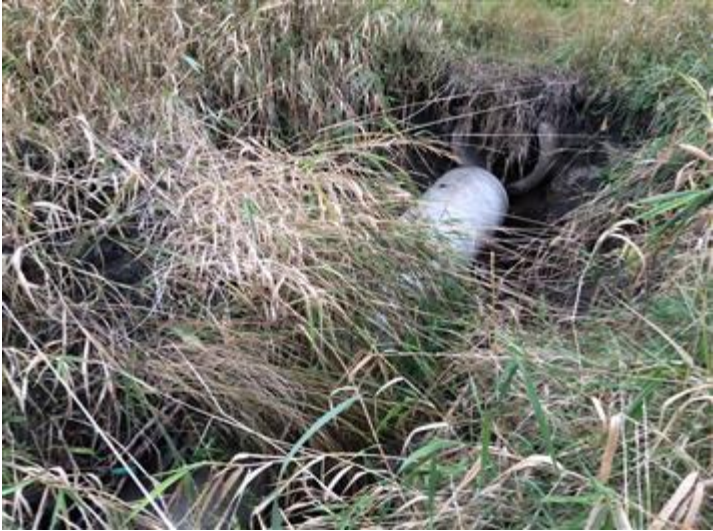
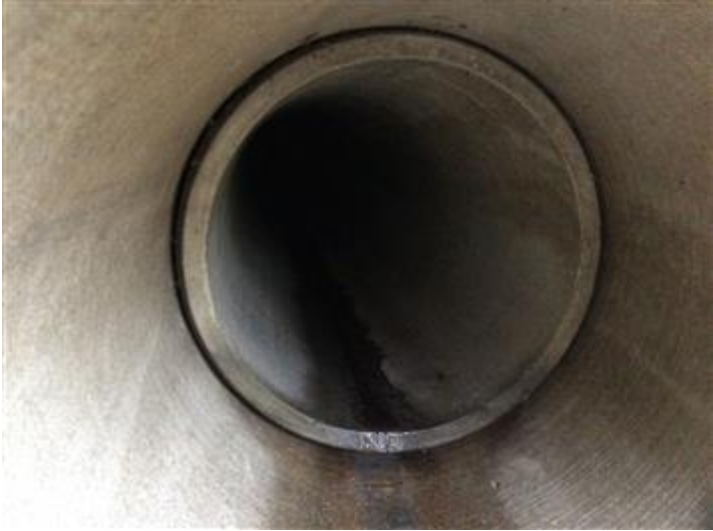
Job Number:	692-2015	Waterway:	Sturgeon Creek
Map Number:	240	Asset Location:	38 VALLEY VIEW DR
Flow Type:	LDS	Sewer District:	HERITAGE
Inspection Date:	2015-10-08	Surveyed By:	Darren Yarechewski
Physical Details at Time of Inspection			
Size 1 / Height:	475 mm	Size 2 / Width:	475 mm
Length:	59.1 m	Material:	AC
Grating Type:	Not Present	Exit Submerged:	
Exit Type:	Straight		
Waterway Shape:	Straight		
Sedimentation Level:	0%	Debris in Asset:	
Identified Damage:	Missing End Section		
Geotechnical Condition Grades			
Slope Condition Grade:	1	Erosion Condition Grade:	5
Recommended Treatments:	Erosion Protection		
Comments:	Two pipe lengths undermined, separated, and sank in erosion gully.

Instability Type	ID	Location	Angle	Vegetation	Terrain
Slump	240-03	Toe	Small	Grass Natural	Graded

ID	Height	Location	Angle	Vegetation	Surface Soil
240-03	1300	Toe	Small	Grass Natural	Clay

ID	Depth	Width	Location	Angle	Vegetation	Surface Soil
240-03	700	2700	Toe	Small	Grass Natural	Clay
