# Hazardous Materials Survey Report

## Mission Flood Pumping Station

**LOCATION:** Mission Flood Pumping Station  
91 Archibald St  
Winnipeg, Manitoba

**INSPECTION DATE:** May 9, 2019

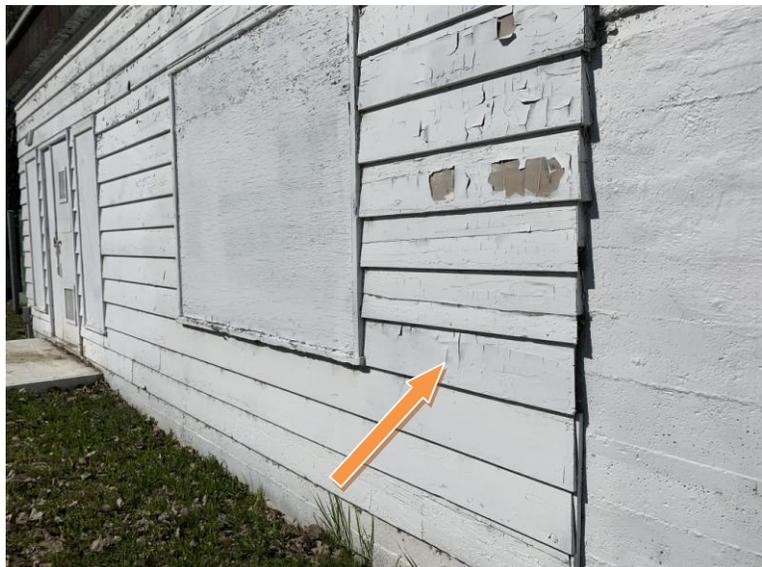
**Photo 3**

The white exterior paint present on the east side of the building was found to contain 0.9% lead w/w. Location of Lead Sample 1.

Same or similar paint is elsewhere in the building.

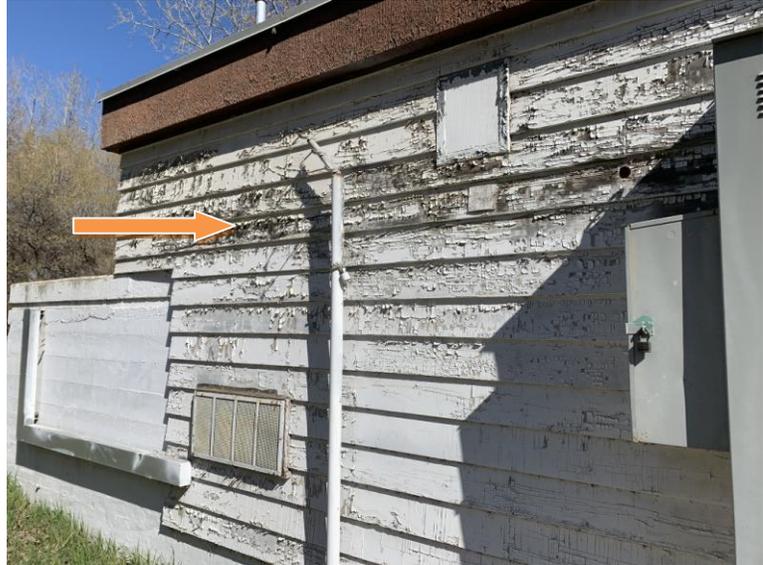
**Photo 4**

The white exterior paint present on the south side of the building was found to contain 2.5% lead w/w. Approximate location of Lead Sample 2.

Same or similar paint is elsewhere in the building.

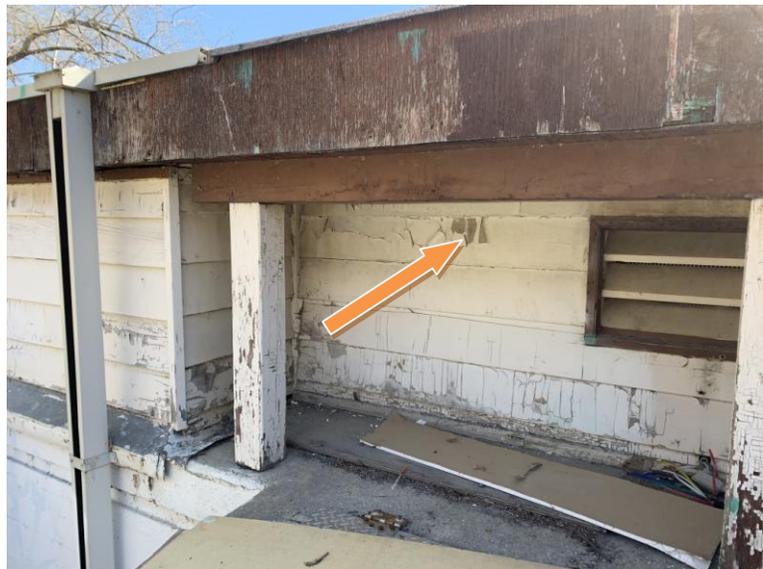
**Photo 5**

The white exterior paint present on the west side of the building was found to contain 0.8% lead w/w. Location of Lead Sample 3.

Same or similar paint is elsewhere in the building.

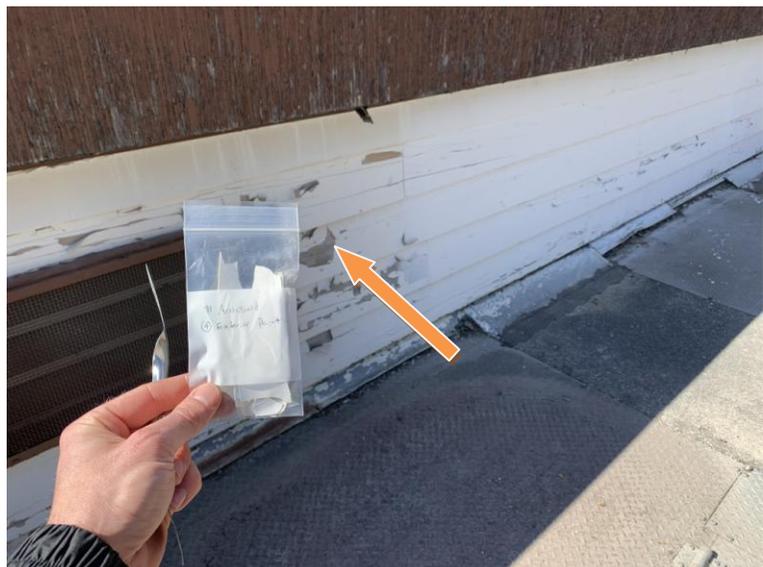
**Photo 6**

The white exterior paint present on the north side of the building was found to contain 2.4% lead w/w. Location of Lead Sample 4.

Same or similar paint is elsewhere in the building.

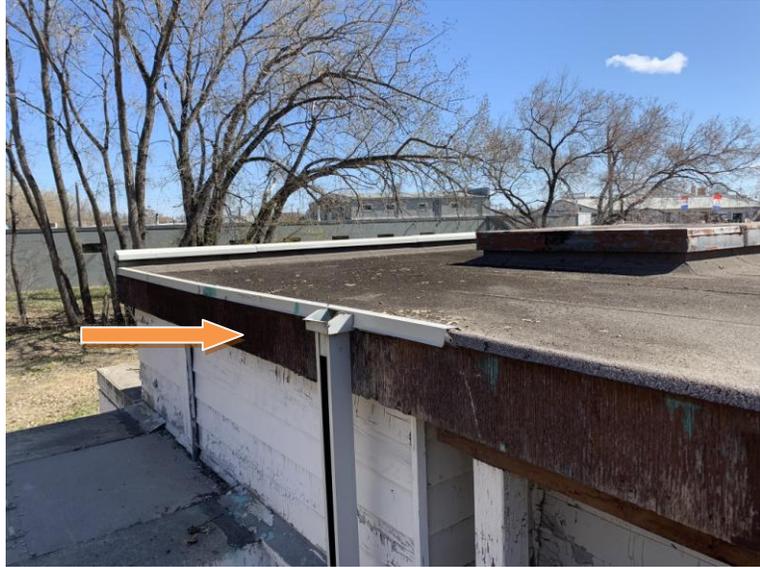
**Photo 7**

The brown exterior paint present on the wood trim at the roof line on all sides of the building was sampled. The sample collected from the west side of the building was found to contain 0.08% lead w/w. Approximate location of Lead Sample 6. Similar result was obtained for a sample collected from the east side.

Same or similar paint is elsewhere in the building.

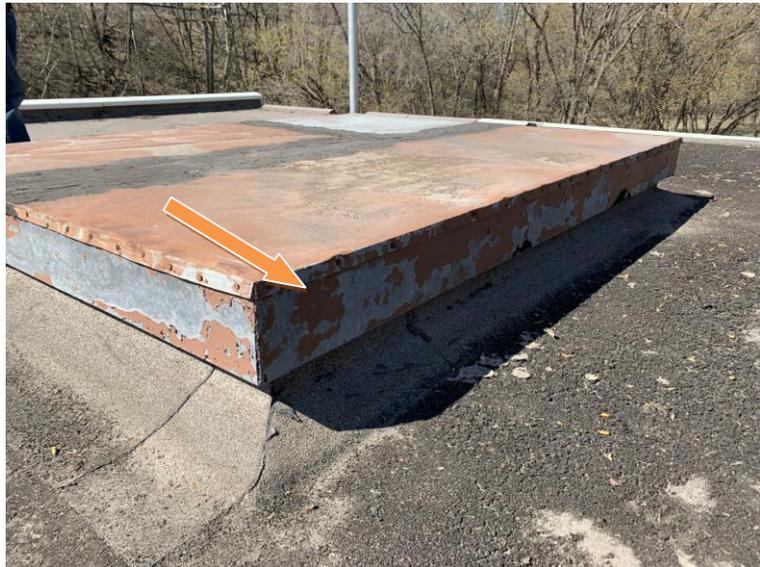
**Photo 8**

The brown exterior paint present on the metal roof access hatch was found to contain 0.3% lead w/w. Approximate location of Lead Sample 7.

Same or similar paint is elsewhere in the building.

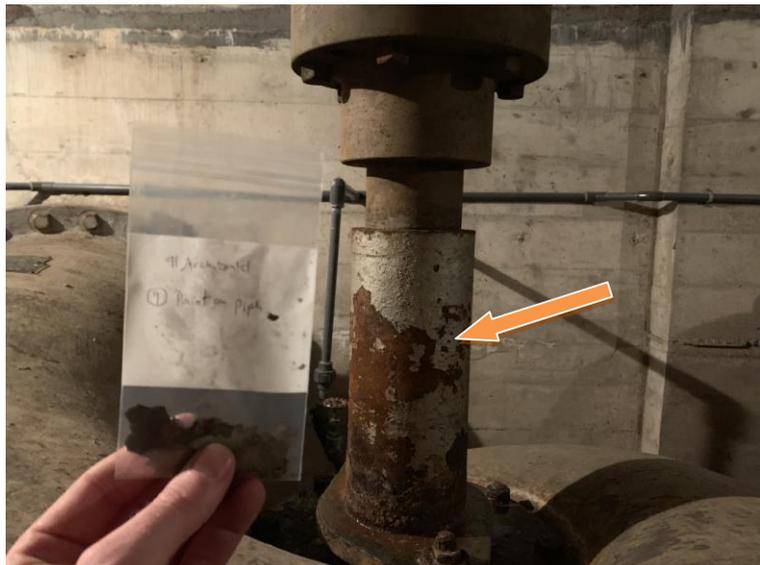
**Photo 9**

The silver paint present on utility piping at the base of the interior structure was found to contain 1.6% lead w/w. Sample collected from smaller vertical pipe associated with unit 2 (labelled).

Approximate location of Lead Sample 8.

Same or similar paint is elsewhere in the building.

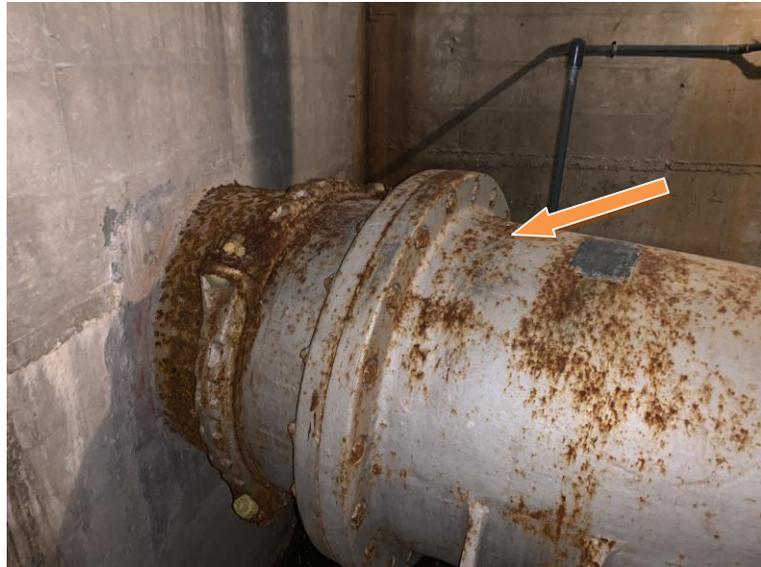
**Photo 10**

The silver paint present on utility piping at the base of the interior structure was found to contain 1.6% lead w/w.

Sample collected from large pipe labelled as unit 1.

Approximate location of Lead Sample 9.

Same or similar paint is elsewhere in the building.

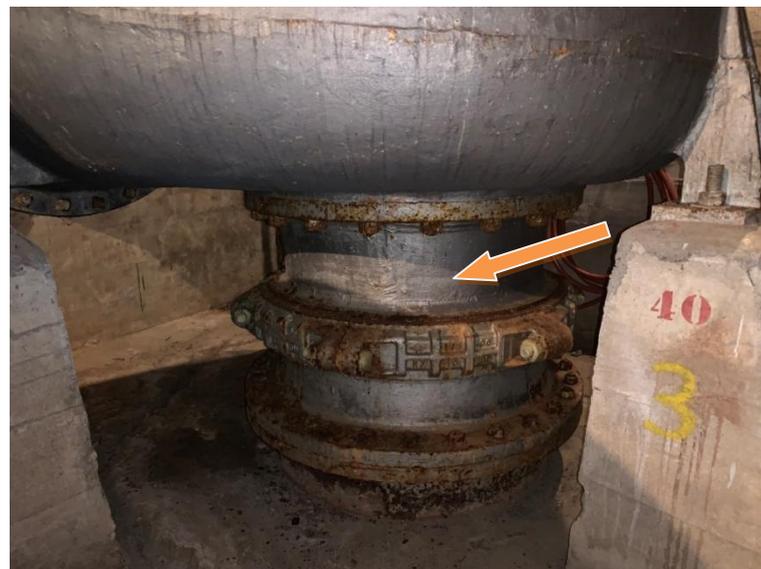
**Photo 11**

The silver paint present on utility piping at the base of the interior structure was found to contain 6.9% lead w/w.

Approximate location of Lead Sample 10.

Same or similar paint is elsewhere in the building.

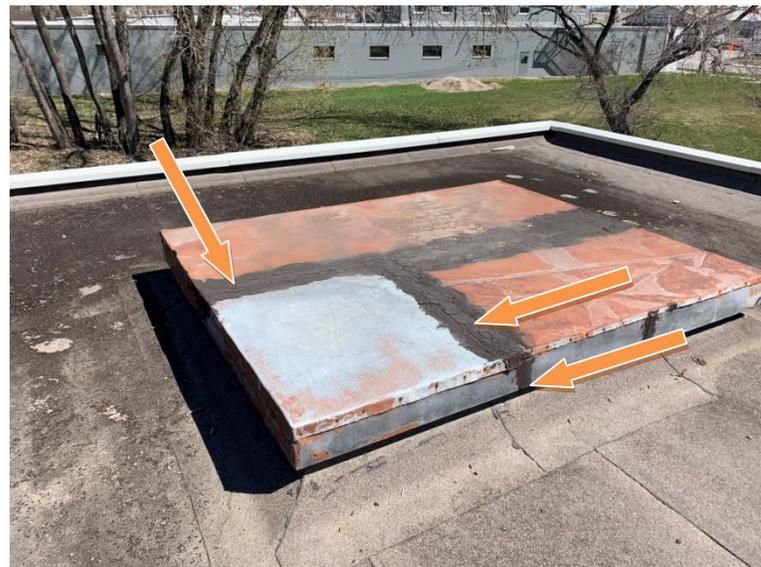
**Photo 12**

The black mastic or fiber putty in place on the large square roof hatch was found to contain 8% chrysotile asbestos.

The black fiber putty/mastic in place on the square roof hatch was found to contain 8% chrysotile asbestos.

Location of Asbestos Sample 4.

- 5.1.6. The removal of the asbestos containing mastics from the roof top hatch should generally be completed following Type 1 procedures as outlined in the guidelines.
