Pembina Highway and Bishop Grandin Boulevard Interchange Southwest Corner Slope Failure **Slope Stability Assessment Report**

Project Number: 0015 034 00

Date: May 26, 2020 (2nd Revision)

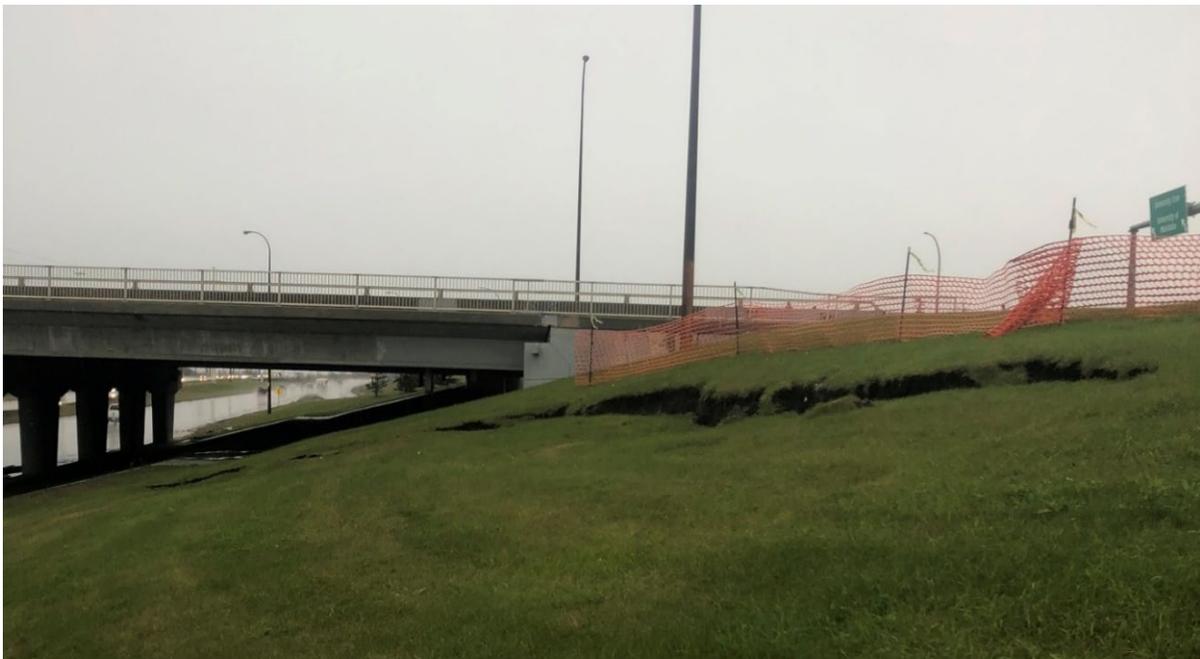
Photo 1 (2019-10-21) Looking East at Head Scarp (Pembina Highway bridge in background)

The instability occurred after an exceptionally wet fall, with total precipitation of over 150 mm in September compared to the typical monthly total of approximately 45 mm. On October 11th, Winnipeg also experienced an unprecedented storm of over 35 cm of snow, sleet and rain within 2 days; the instability was observed within a few days after the storm. It is likely that the accumulation of soil moisture through September combined with the October 11th storm triggered the instability.

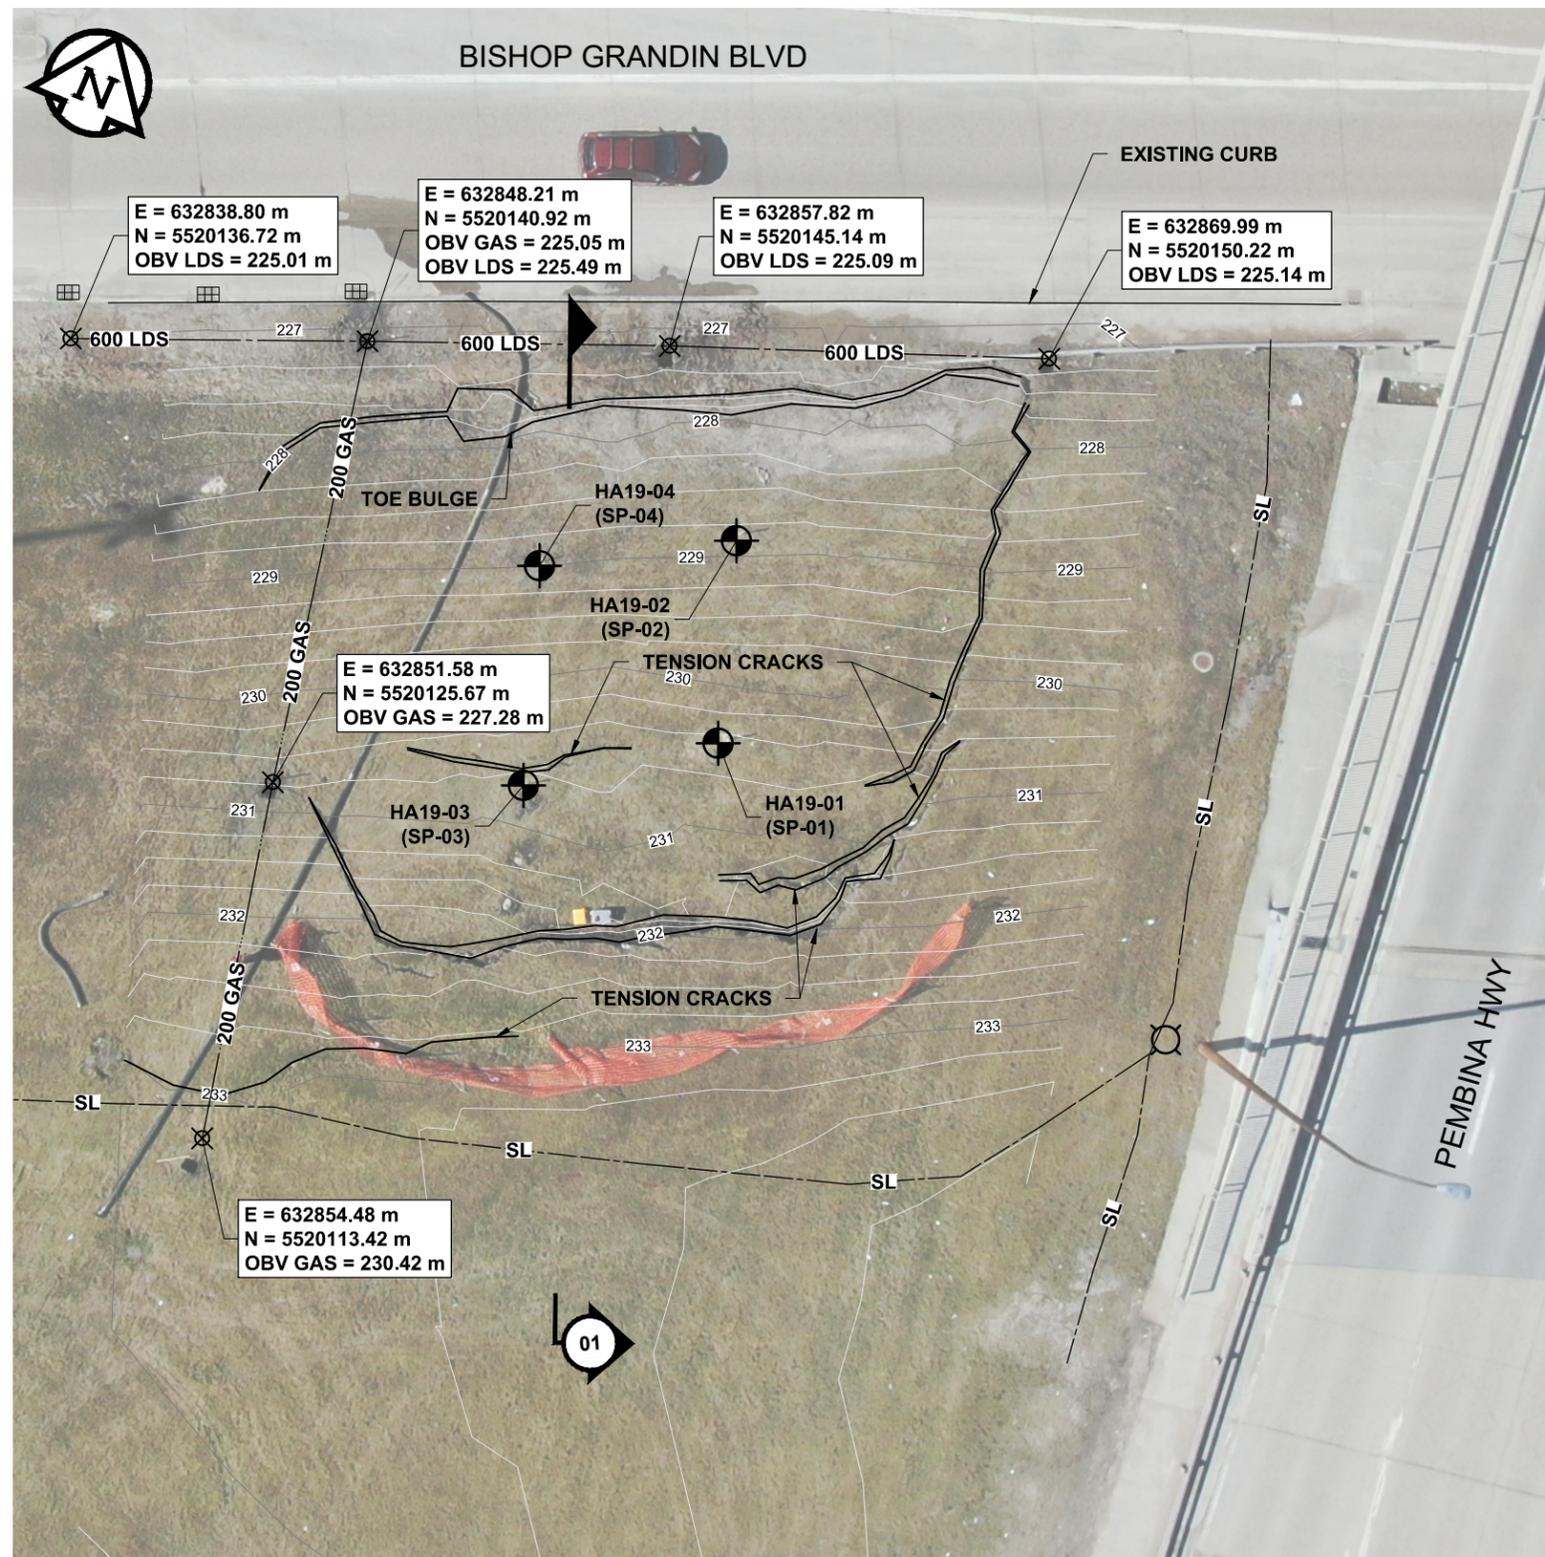
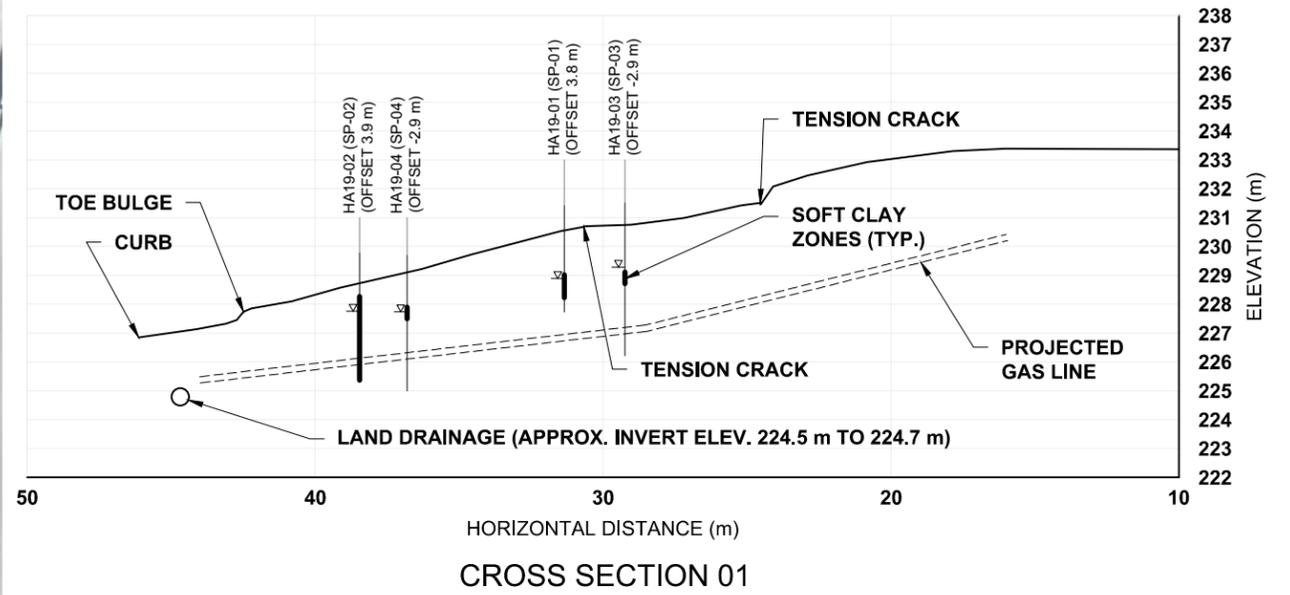
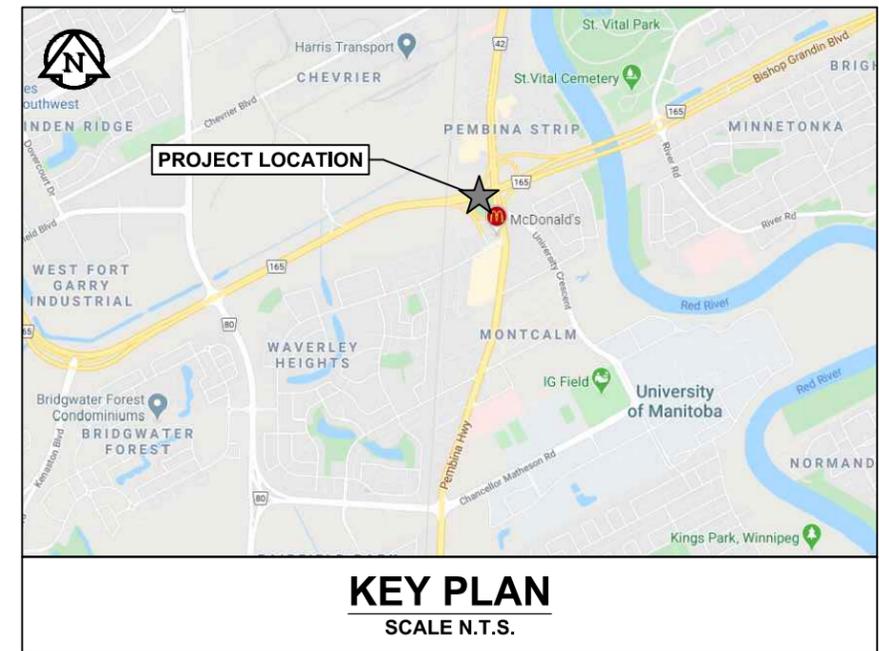
Figure 01
Existing Conditions

Cross-section 1 is located through the middle of the instability, as shown on Figure 01, and was assumed to represent a critical cross-section for analysis. The soil stratigraphy assumed in the model is based on TREK's test holes, which are shown in cross-section on Figure 01. Zones of soft clay, measured groundwater levels, and the observed zone of movement in TH19-02 are also shown in cross-section on Figure 01.

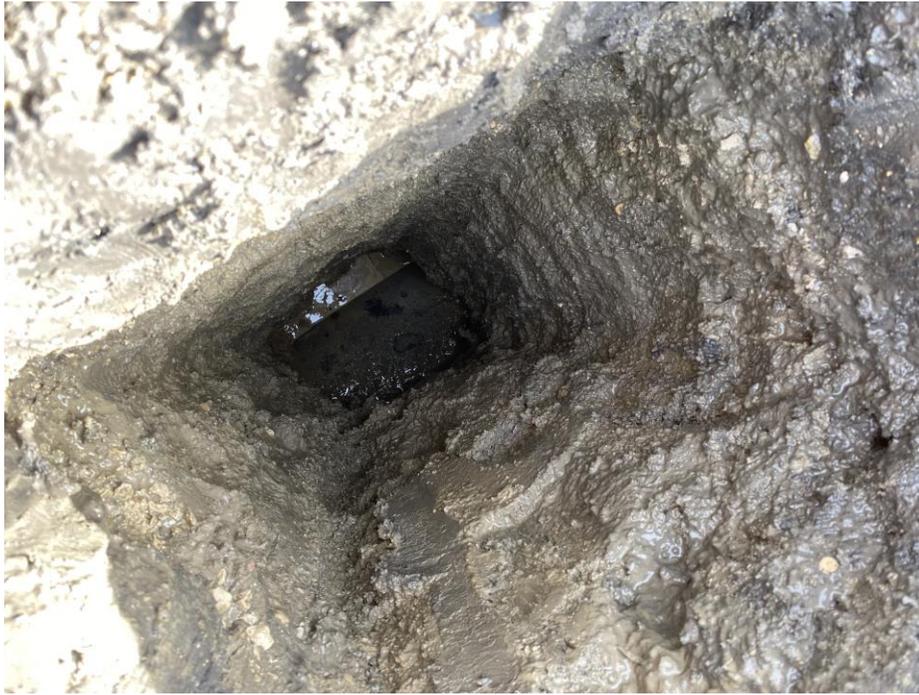
Photo 3. Land drainage sewer (LDS), obvert at 2.0 m below surface

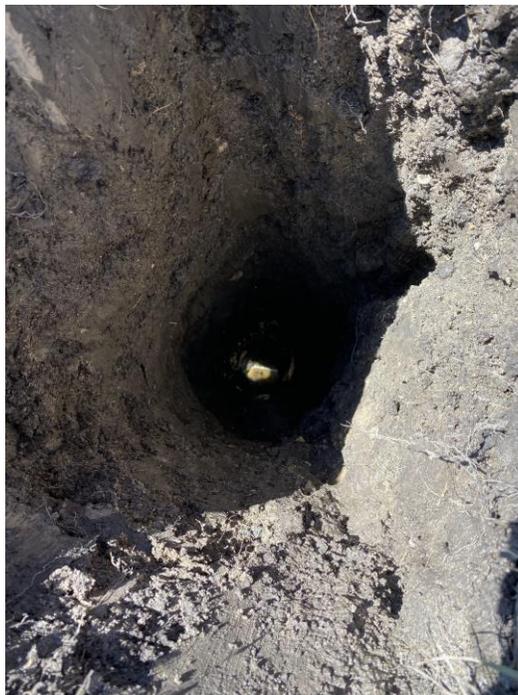
Photo 6. High pressure gas line at the cress, obvert at 2.7 m below surface

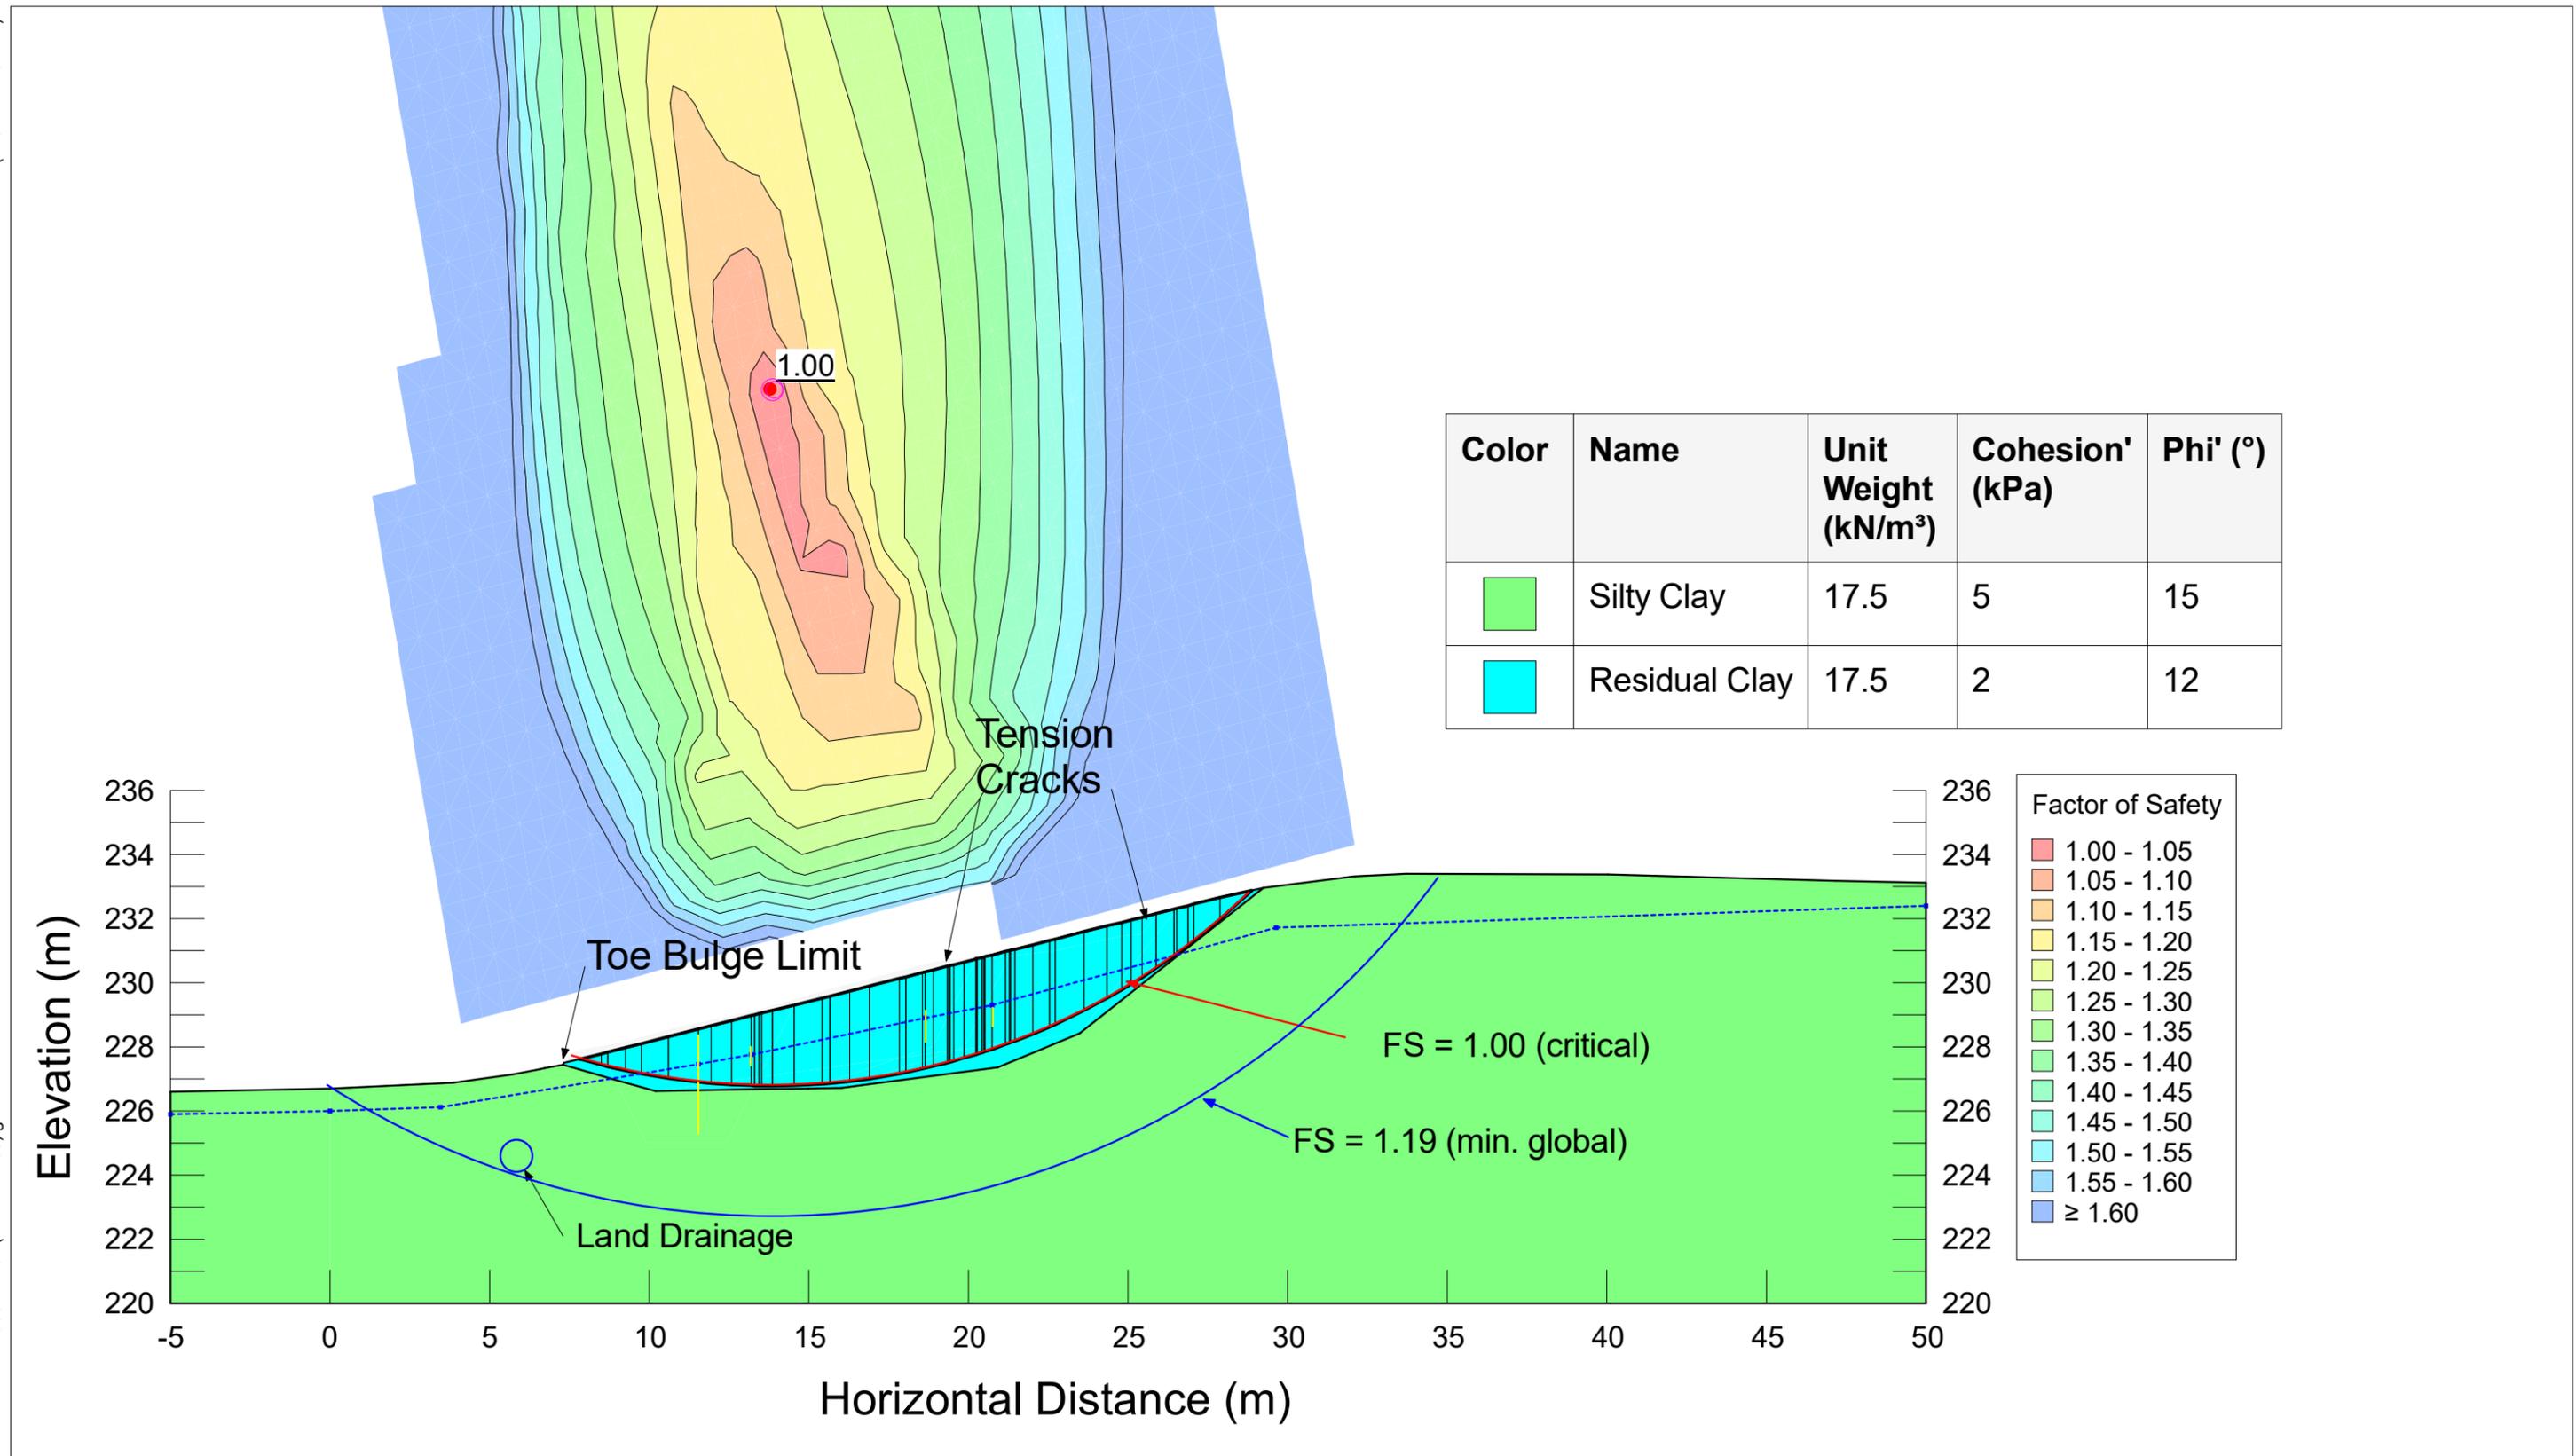
Figure D-01

The back-analysis was performed on both an assumed pre-failure and surveyed post-failure (existing) slope geometry. The calculated factor of safety along the critical slip surface within the zone of residual clay is 1.00 (Figure D-01) for pre-failure geometry, whereas the critical factor of safety increases to 1.12 for the post-failure geometry (Figure D-02). The factor of safety along the critical global (deep-seated) slip surface ranges from 1.19 to 1.23 for pre- and post- failure back-analyses.

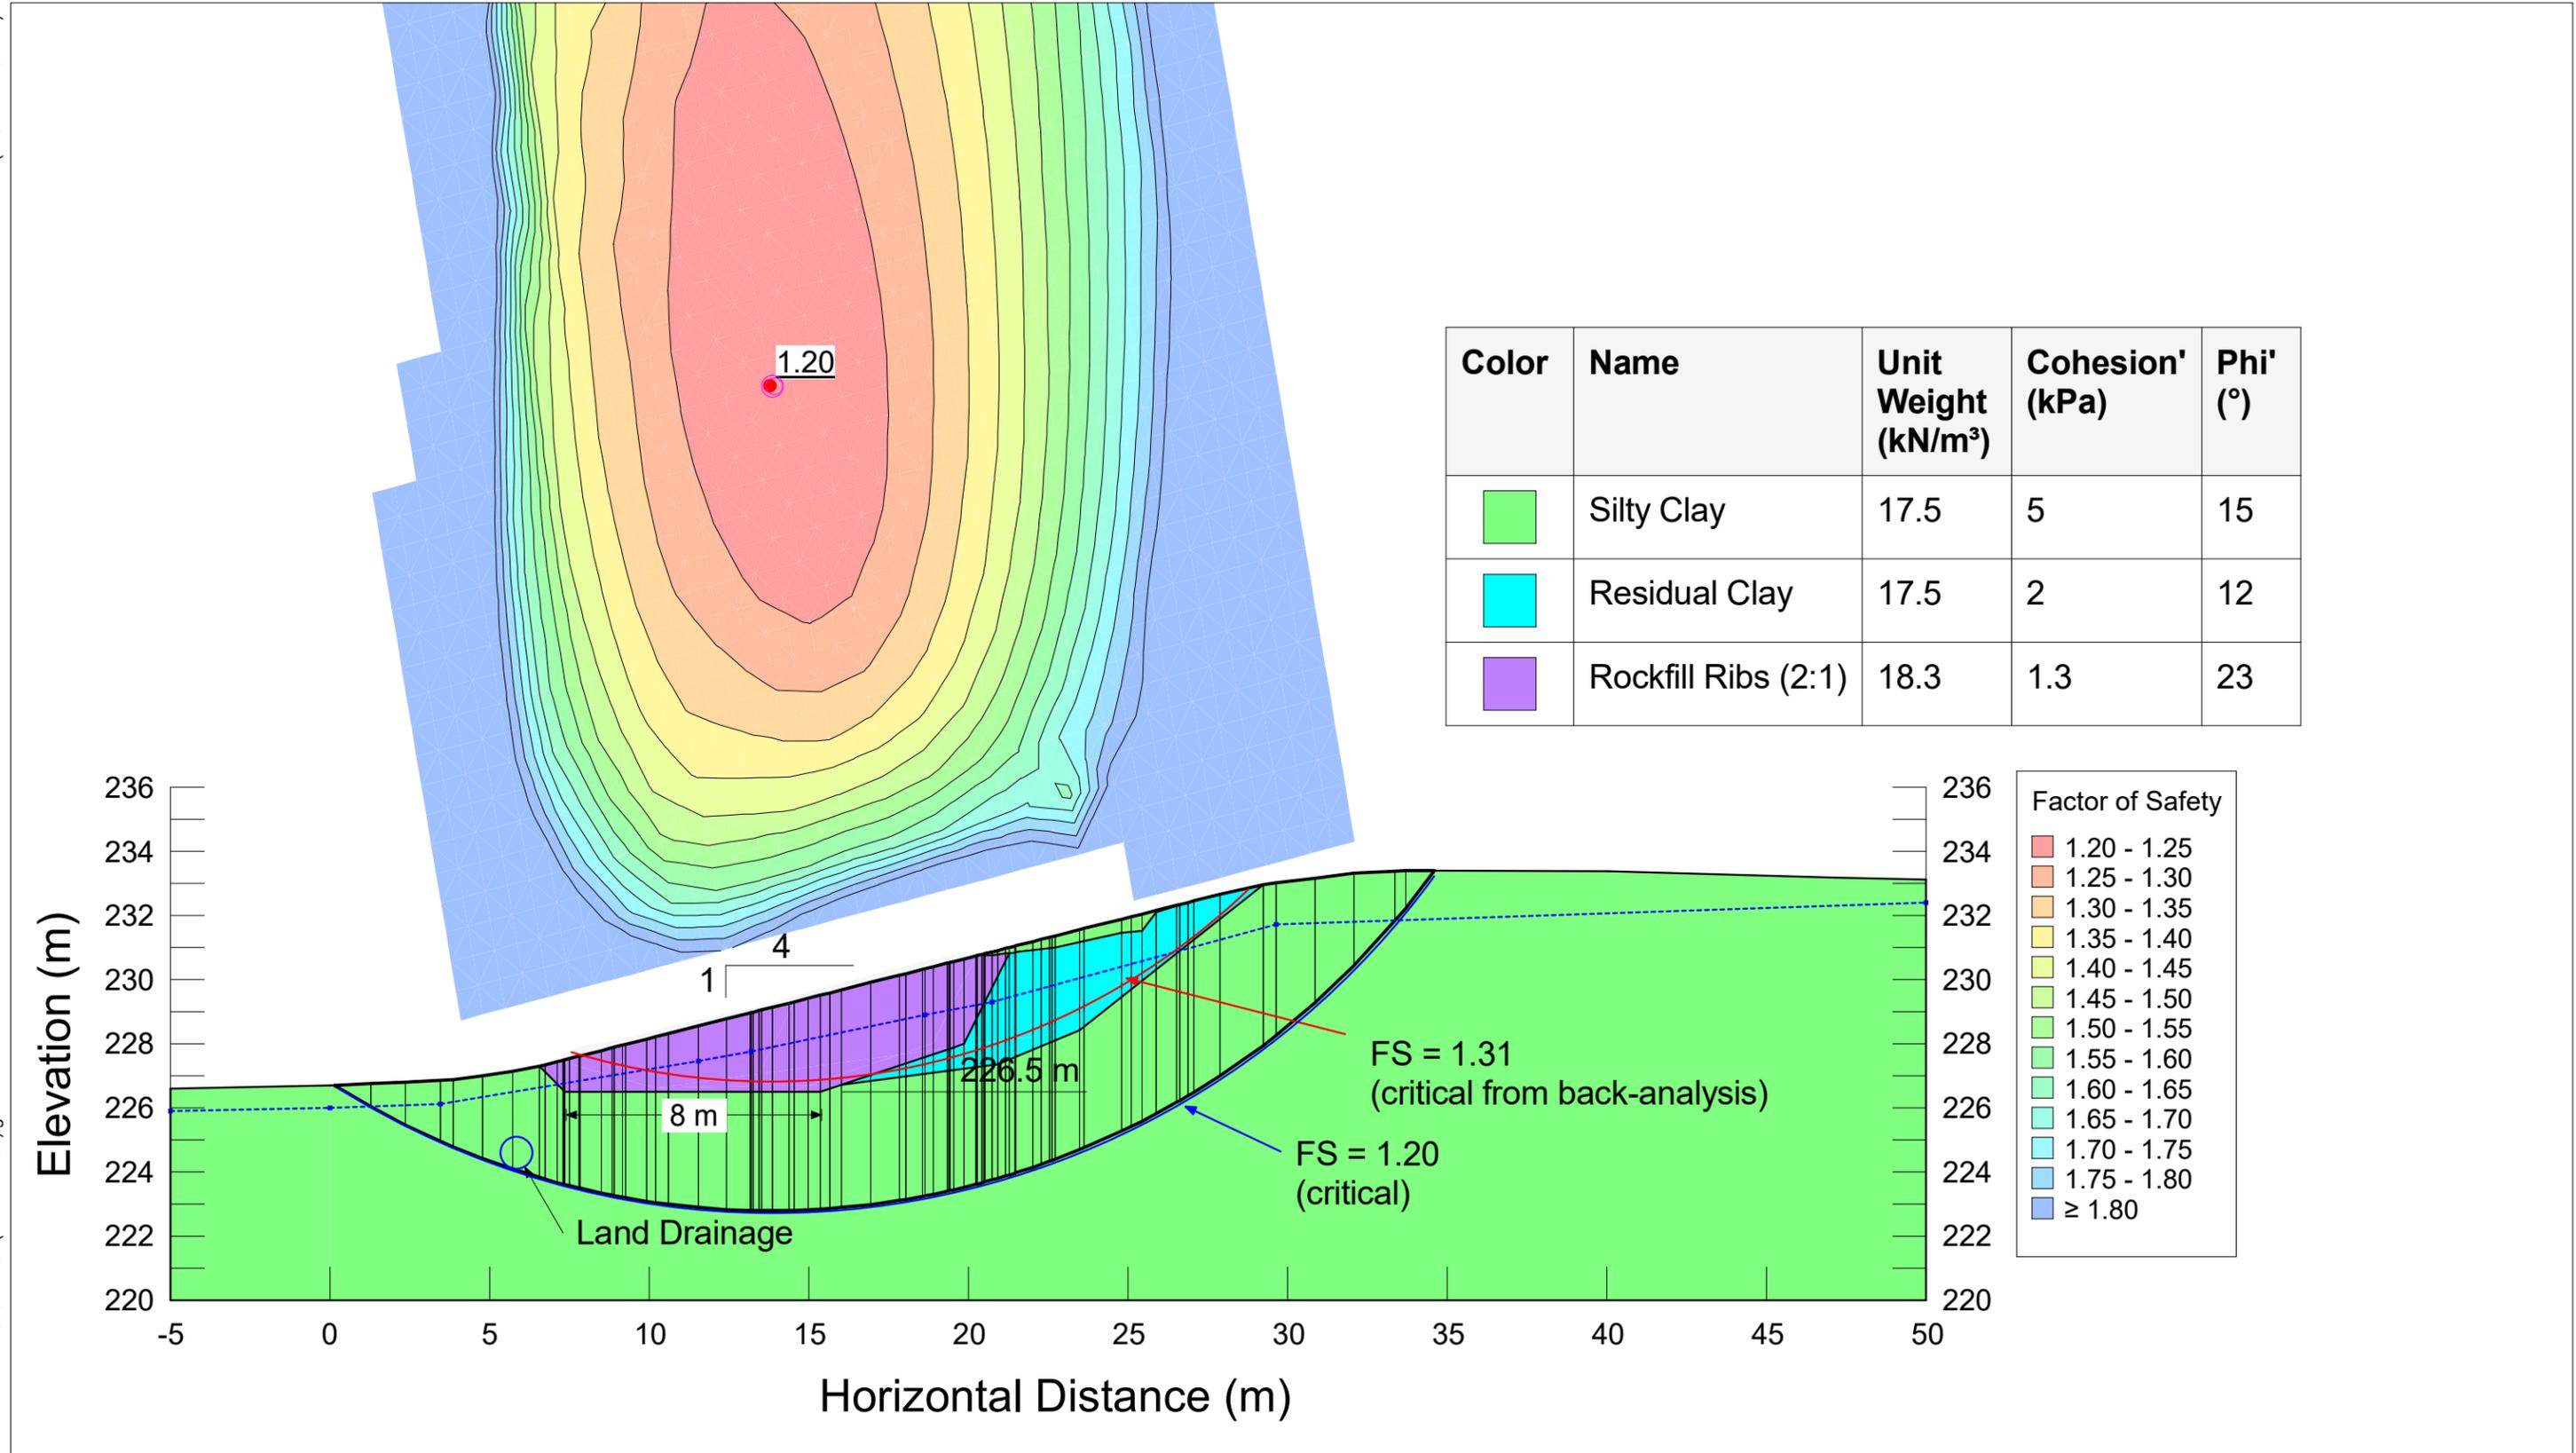
Rockfill ribs installed at a 2:1 replacement ratio in plan view (e.g. 1.5 m wide with 3.0 m clear spacing between ribs) and a base width of 8 m satisfy the design stability targets (Figure D-03). The calculated factors of safety with rockfill ribs and regrading to pre-existing grades (4H:1V) increases to 1.31 (+31%) for the observed slip surface and to 1.20 (+1%) for the critical deep-seated (global) slip surface.

Rockfill ribs satisfy the target factor of safety of 1.30 for the critical slip surface and provide a marginal benefit to global stability. The selected piezometric line is considered conservative for deep-seated slip surfaces, as noted previously. It should be noted that all of the observed instabilities at the grade separation were of similar geometry to the shallow instability observed at the current site; no deep-seated global instabilities have been observed at the grade separation. Since it is difficult to predict any reductions in groundwater levels associated with the rockfill ribs, the piezometric conditions considered with rockfill ribs were not changed from the back-analysis and the analysis is therefore considered to be conservative.
