ASBESTOS INVENTORY CONTROL

Building Name:	Concourse - Underground (various areas)	Inspection Date:	November 20, 2020
Building Code:	Concourse	Inspected By:	A Brodbeck & N Richardson
Building Address:	365 Main Street	Construction Date:	1976

ASBESTOS LOCATIONS			
BUILDING:		C-01 to 07 Underground Concourse 365 Main Street Winnipeg, Manitoba	
REVISED BY:	DATE:	SCALE:	SHEET #:
AB	Novembr 20, 2020	N.T.S.	1/1

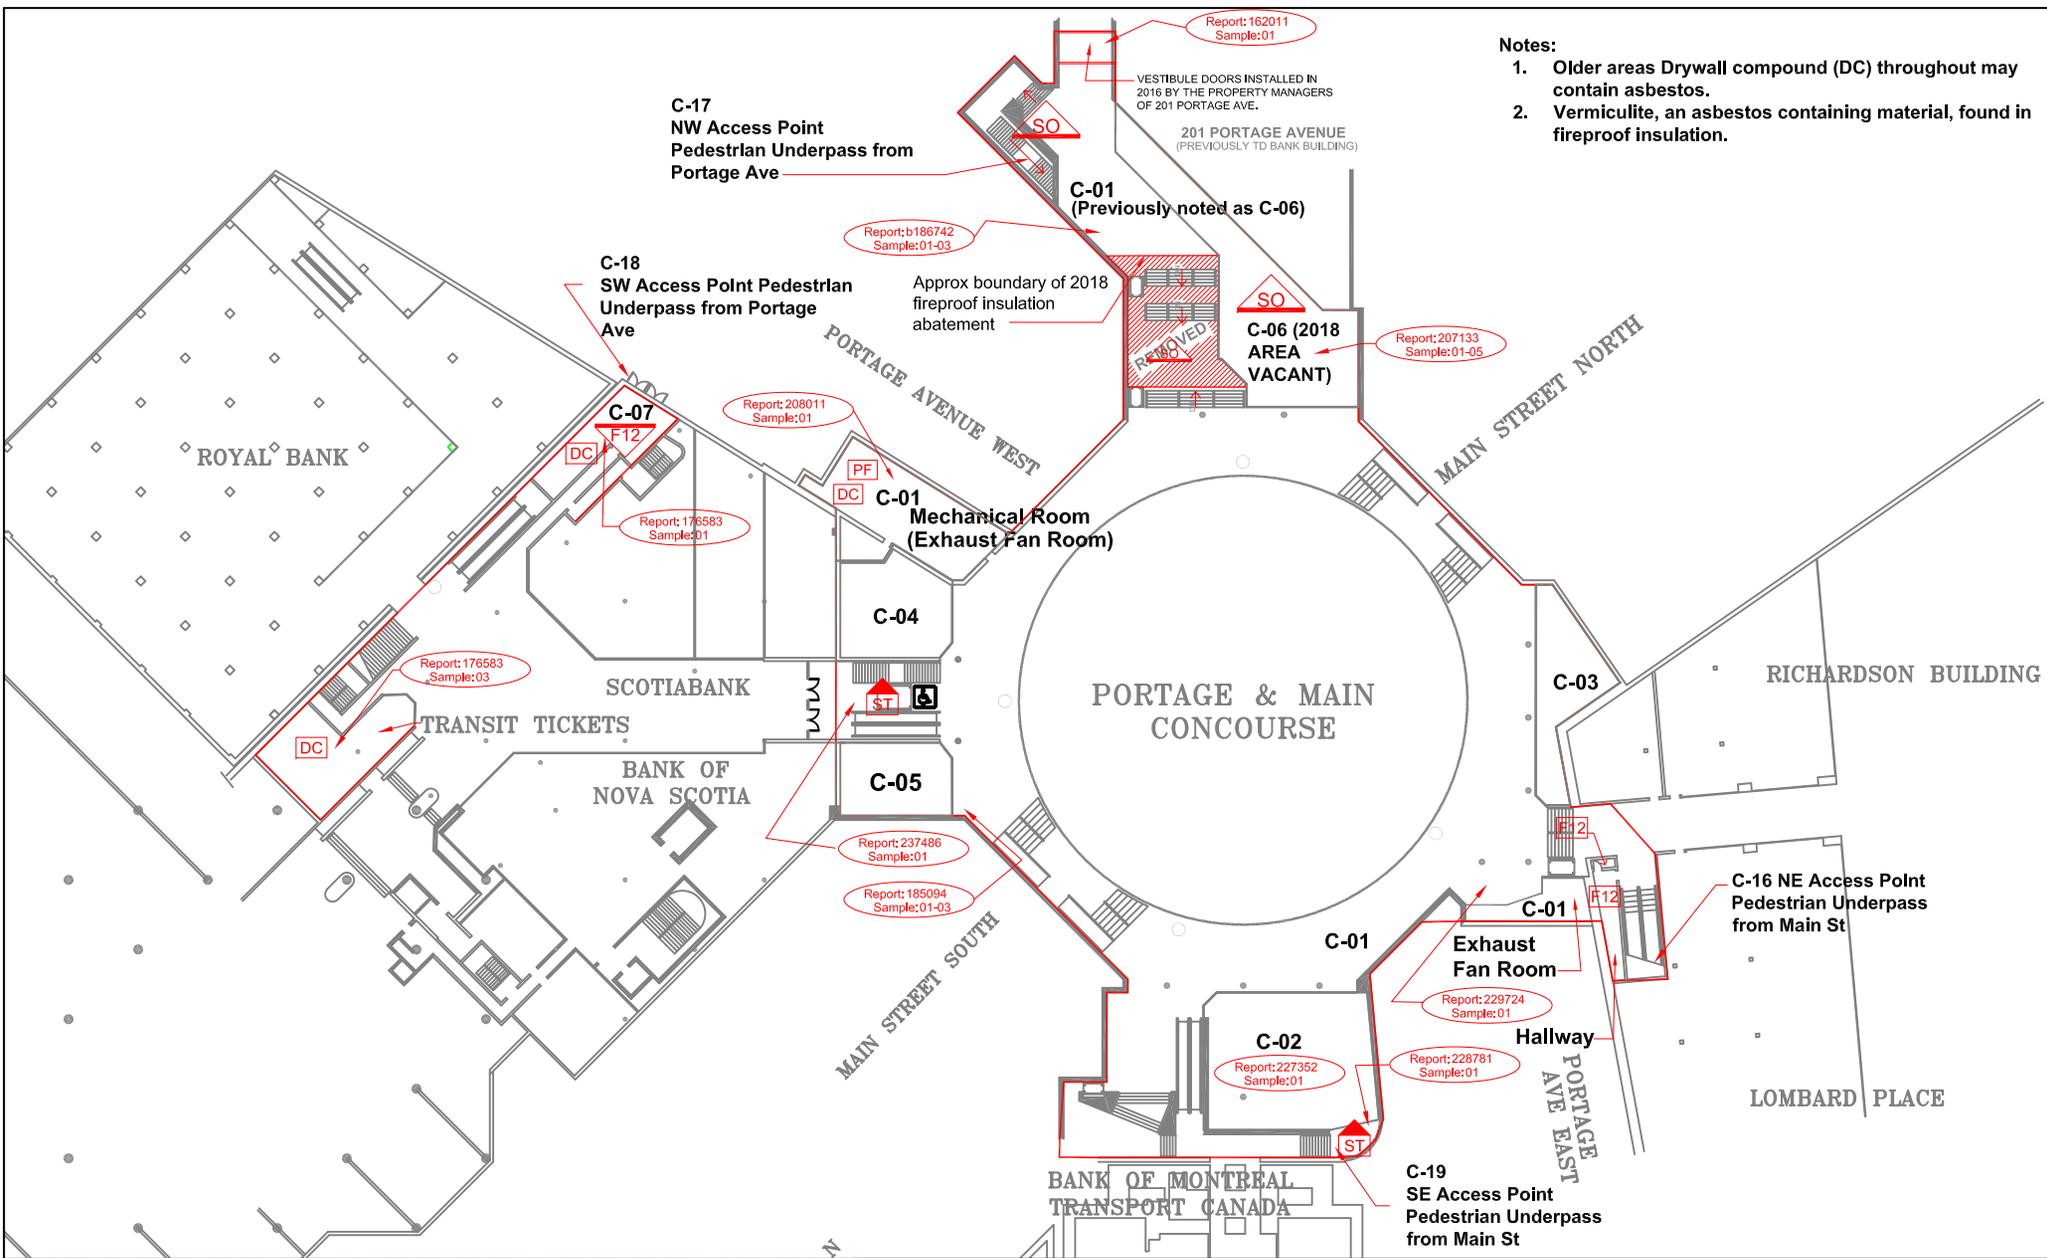
Concourse

- Notes:**
- Older areas Drywall compound (DC) throughout may contain asbestos.
 - Vermiculite, an asbestos containing material, found in fireproof insulation.
