CITY OF WINNIPEG

WASTEWATER LIFT STATION CONDITION ASSESSMENT PHASE II - 2020

Document IV: Linden Lift Station Assessment

Date: 2021-01-25

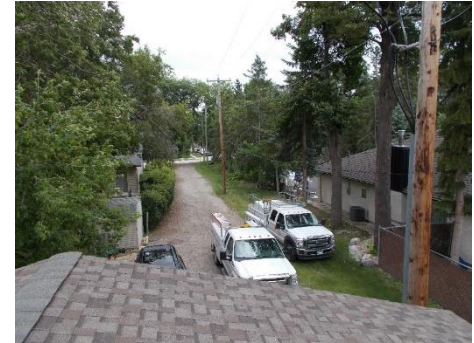
No significant ponding or potential for ponding was noted. The site is on the riverbank but appears to have no riverbank stability problems. Some grassy areas are difficult to keep mowed. Trees and vegetation have grown into contact with the structures and should be trimmed back.

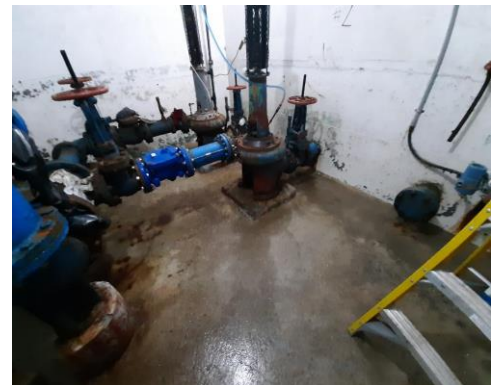
The foundation consists of a below grade cast-in-place concrete wet well and dry well. A flood pumping station is also included in the foundation, but this was not assessed as it is outside the assessment scope. The base slab shows minor surface wear and cracking. The finish has worn off. The floor was wet when assessed, and some water was not properly draining to the sump. The base slab is structurally sound.

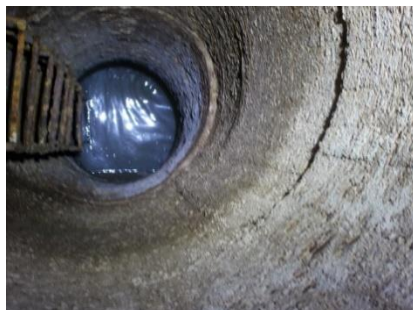
Evidence of infiltration through the foundation walls was noted at pipe penetrations near the pumps. Paint is peeling off in some areas. The concrete in the comminutor room has lost surface paste from the previous H₂S environment, though the concrete is still structurally sound. Confined space entry is required for the comminutor room. The foundation walls and beams are in sound structural condition.

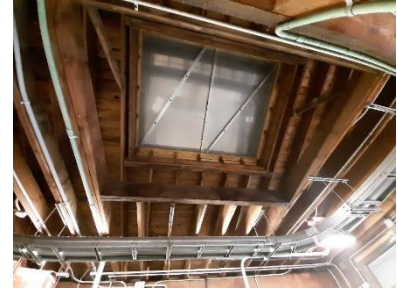
The roof structure has been modified to include a hatch. Several top chords have been cut. The girders that support the cut members bear on previous, uncut top chords. These supporting members have not been properly reinforced after the modification and require reinforcing to meet Code requirements. The top chords need to be built up with two additional members on each side.

The roof structure was built without proper hangers. Joist and truss hangers should be installed on all members.

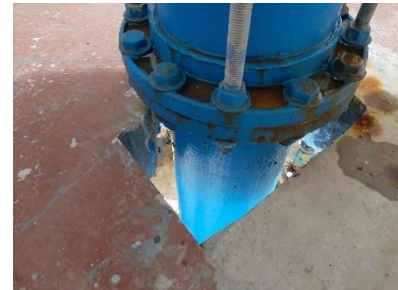
The suspended floor has been modified accommodate changes to the pipework. Previous penetrations have been patched and new penetrations have been cut/cored. A structural analysis is recommended to determine if the suspended slab still has adequate load capacity.

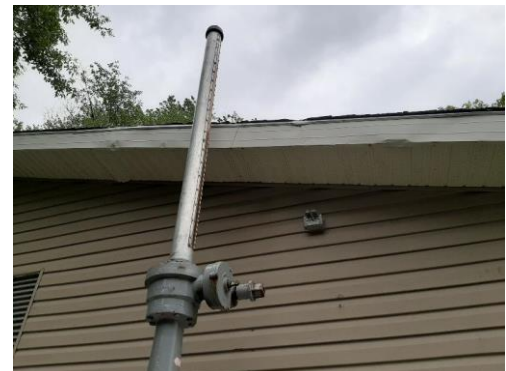
There is some minor damage to flashings and soffit. These should be replaced.

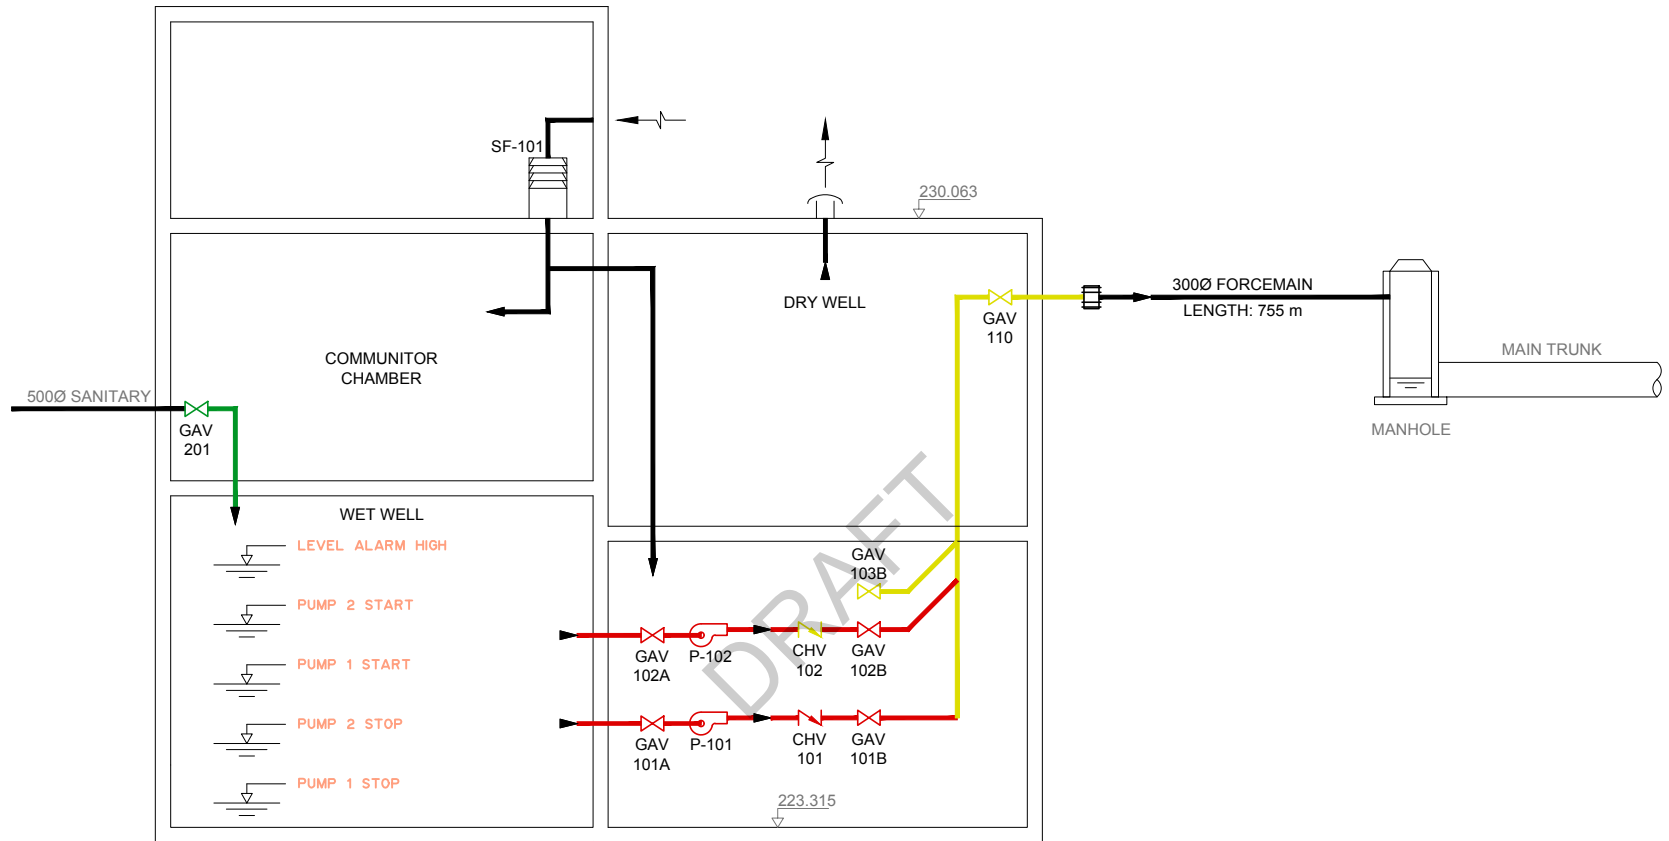
LIFT STATION ASSESSMENTS 2020
 LINDEN
 CONDITION ASSESSMENT SUMMARY

Figure 7.1 provides a graphical summary of the condition assessment of the mechanical components of the Linden Lift Station.
