Primary Clarifier 1 Structural Inspection Report

Project name:
NEWPCC Primary Clarifier 1 Condition
Assessment

Technical Memorandum

Subject: NEWPCC Primary Clarifier 1 – Structural Condition Assessment

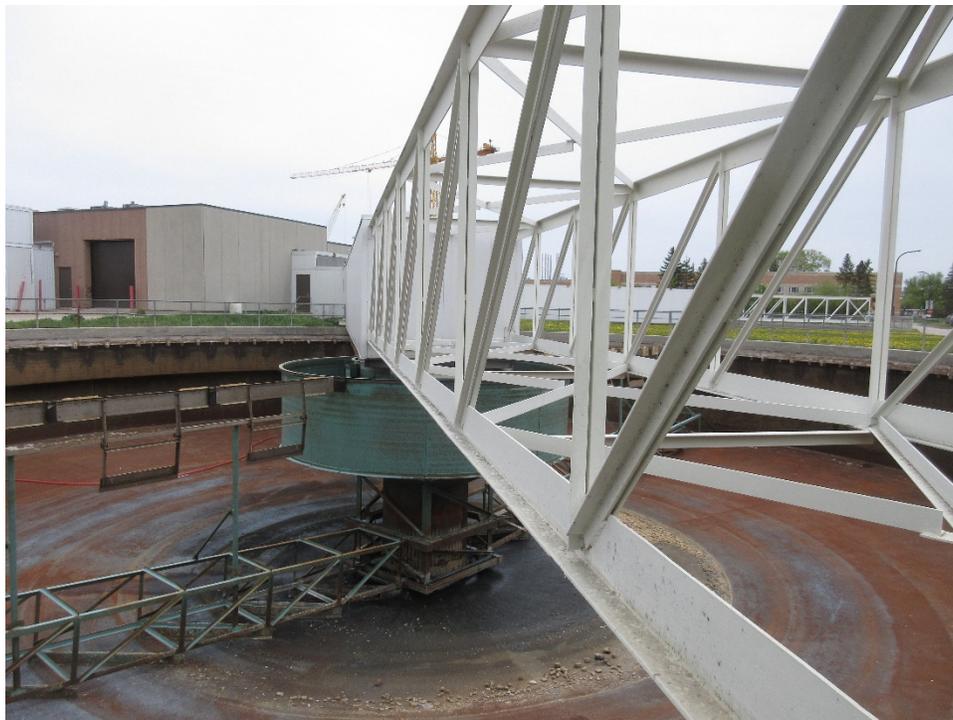
In general, Primary Clarifier 1 is in good condition. No deficiencies were noted that would require immediate repair.

Photo 1: Overall view of drained Primary Clarifier 1

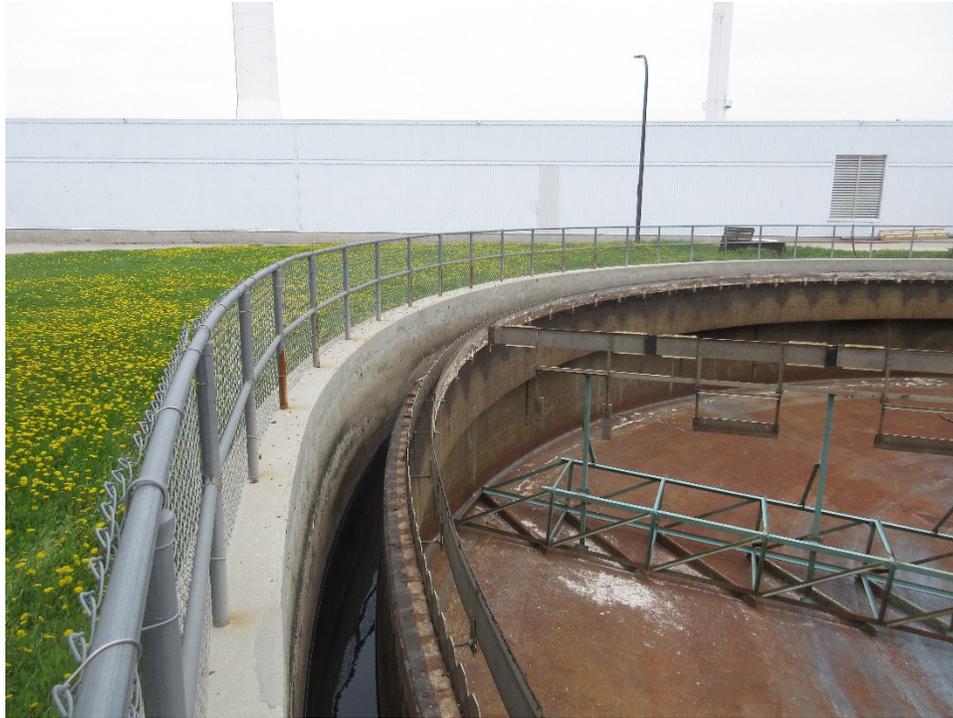
The upper surfaces of the launder are in good condition with no signs of degradation or cracking. At the time of review, water was still present in the bottom of the launder so this portion could not be reviewed.

Photo Error! No text of specified style in document.: View of launder from above

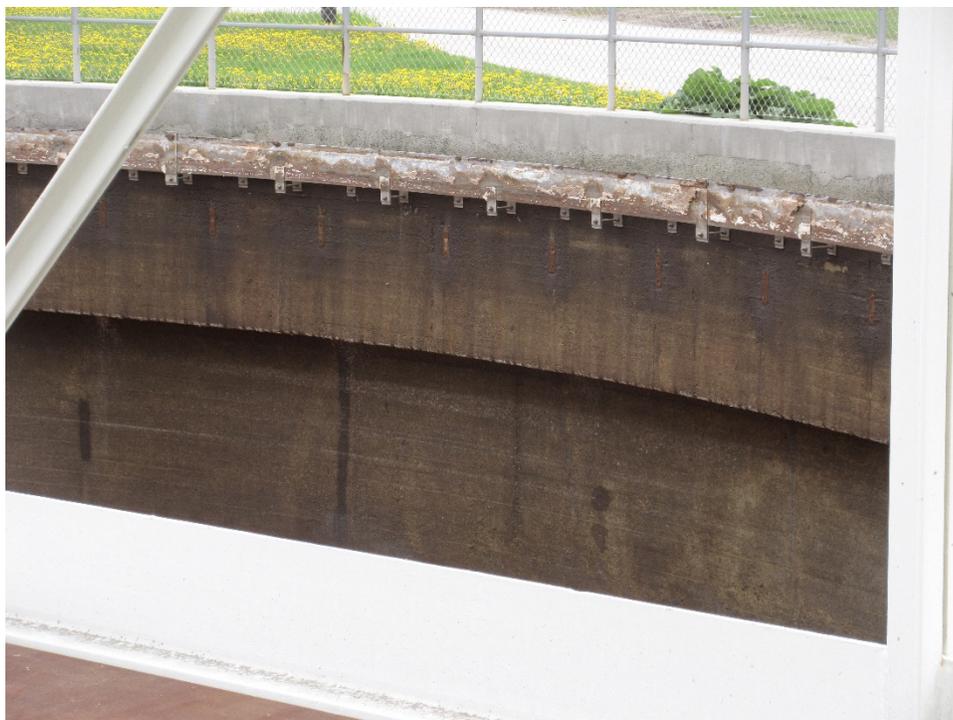
Photo 3: View of side of launder from above

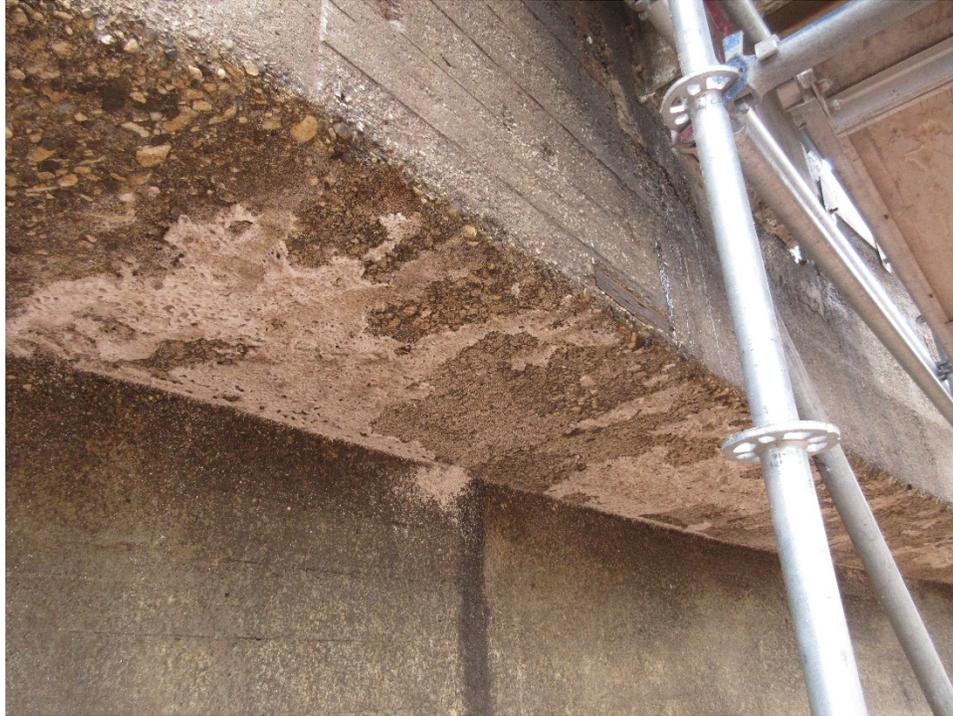
Within the clarifier, damage was noted at the underside of the launder. It appears that cement has eroded from the concrete surface, leaving aggregate exposed. In several locations pieces of steel were visible, although the steel did not appear to be reinforcing steel and are likely related to form supports from the original construction. This damage was consistent around the entire perimeter of the clarifier. No cracking was noted on the inside vertical face of the launder.

Photo 4: Eroded concrete at underside of launder

The erosion of the concrete on the underside of the launder should be repaired in the future before the erosion progresses to the point of exposing the reinforcing steel to the water. If this occurs, the steel will corrode and cause spalling of the concrete. At that point, required repairs would be much more extensive than what is currently required.

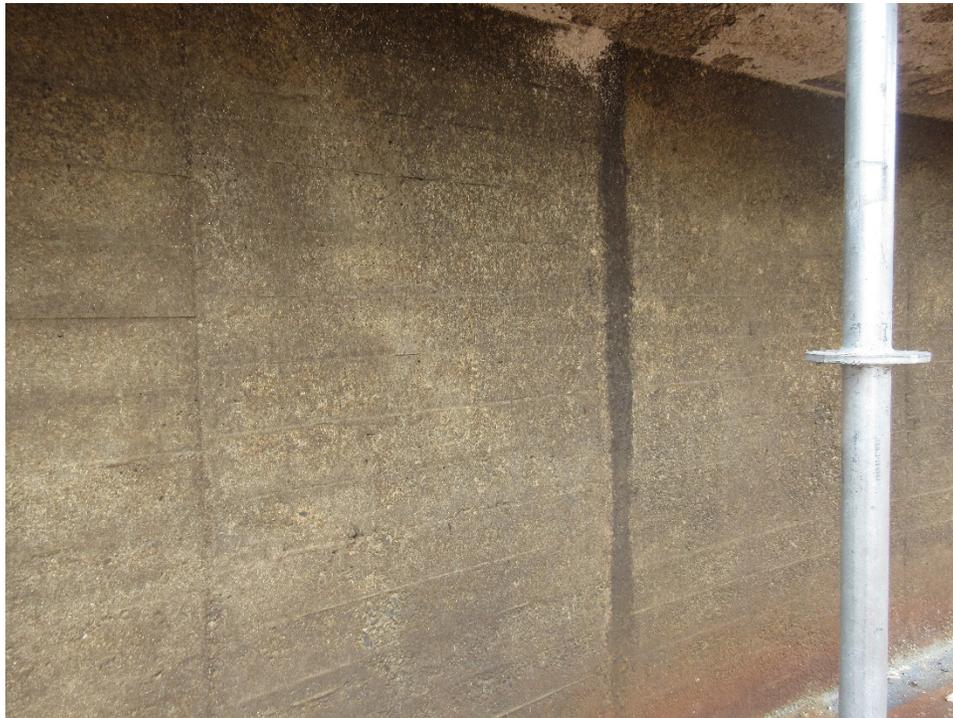
The concrete walls of the clarifier below the launder appeared to be in relatively good condition. The erosion noted on the underside of the launder was not apparent on the walls. There were signs throughout that there have been issues with cracks in the wall in the past that appear to have been repaired with some type of sealant or coating. Due to this, the width and

extent of these repaired cracks could not be determined. However, it should be noted that no cracks were visible through the repairs. No further active cracks were noted in the walls.

Photo 5: Repaired crack in wall of clarifier

The cracks in the walls of the clarifier appear to have been adequately repaired. It was not determined when these repairs were completed, however there is currently no sign of further cracking. No further repairs are required at this time; however, the repairs should be reviewed as part of regular maintenance to catch early signs of failure of the repairs.

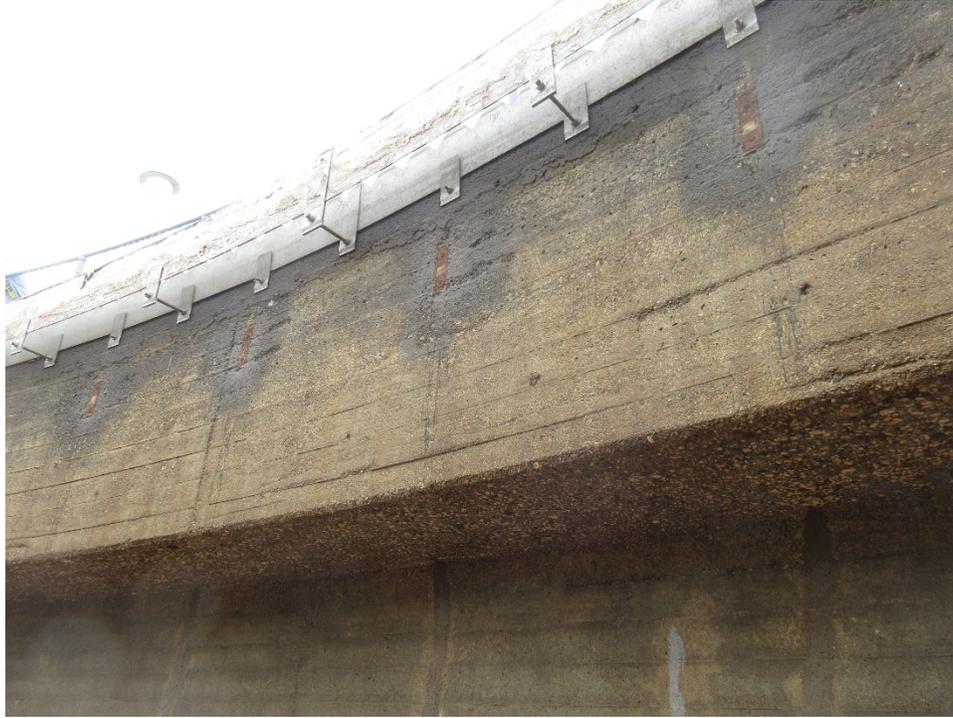
Photo 6: Corroded connection brackets in the side of launder

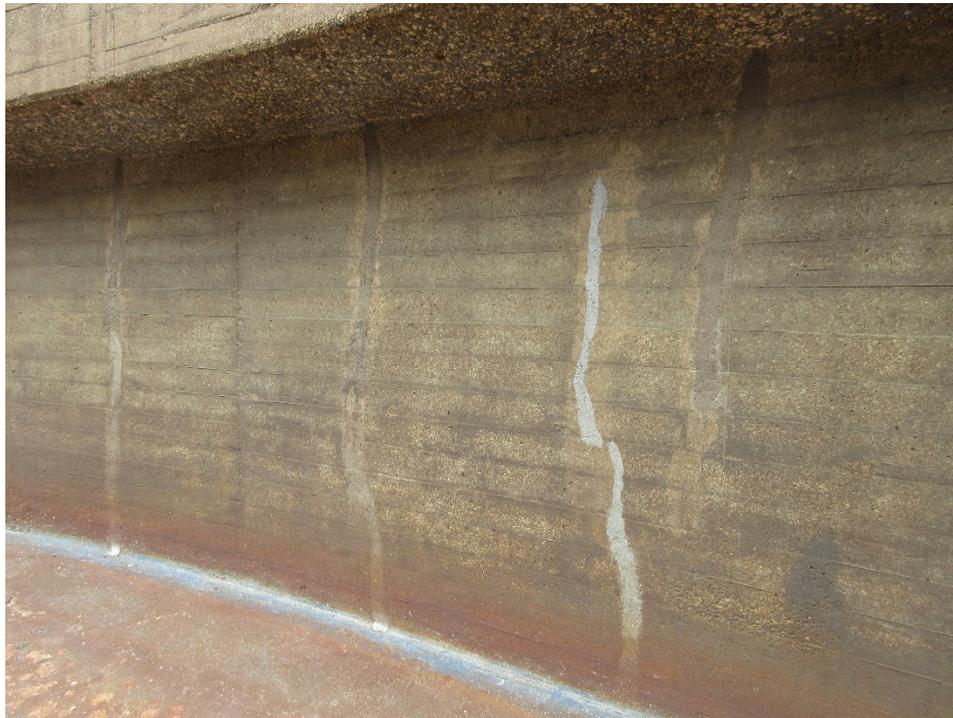
Photo 7: Signs of repaired cracks in wall of clarifier

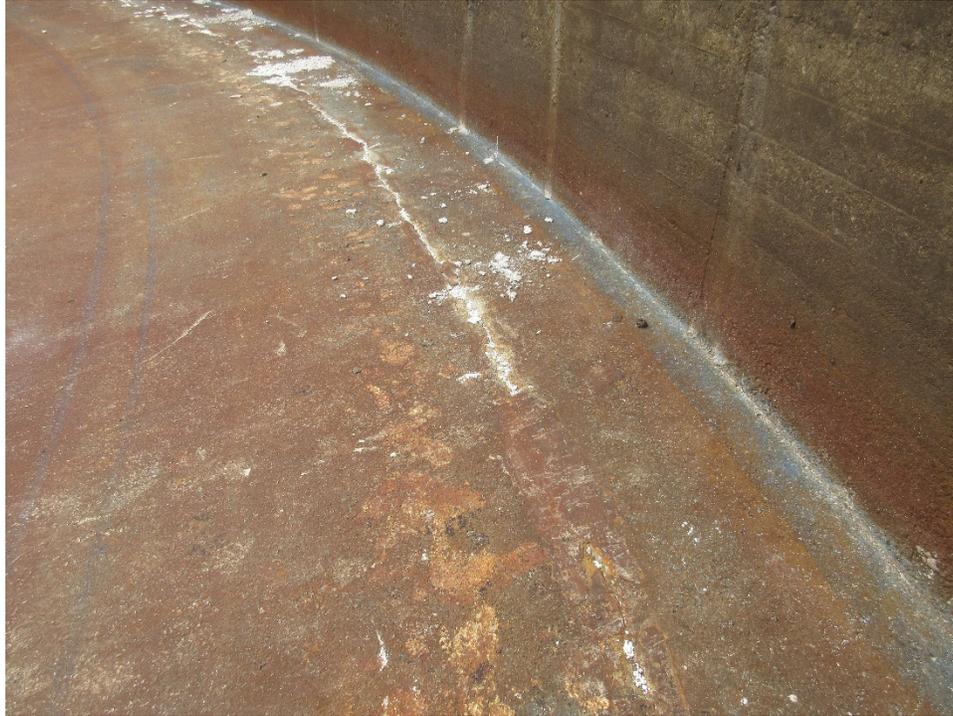
As with the walls, the base slab of the clarifier was noted to be in relatively good condition. The concrete appeared to be covered by a protective coating. The coating appeared to be generally intact and no signs of erosion of the concrete were apparent. One large crack was noted that extended from the centre of the clarifier to the perimeter wall. In addition, cracks were noted in the base slab approximately 300 mm from the perimeter wall. These cracks were present around approximately 2/3rds of the perimeter of the tank. The cracks did not appear to have been repaired at any point in the past. No reinforcing steel was visible in any of the cracks and there were limited signs of spalling.

Photo 8: Crack in base slab of clarifier parallel to perimeter of tank

The cracks in the base slab appear more extensive than those in the walls and show no signs of repair. As the City of Winnipeg has not noted any large loss of water volume from the clarifier, the cracks likely do not extend through the entire depth of the slab at this time, though this could not be confirmed by a visual review. There were no signs of corrosion staining around the cracks and limited concrete spalling was observed, so it would appear that at this time the reinforcing steel has not been subject to corrosion. The cracks should be adequately repaired before they become more extensive.

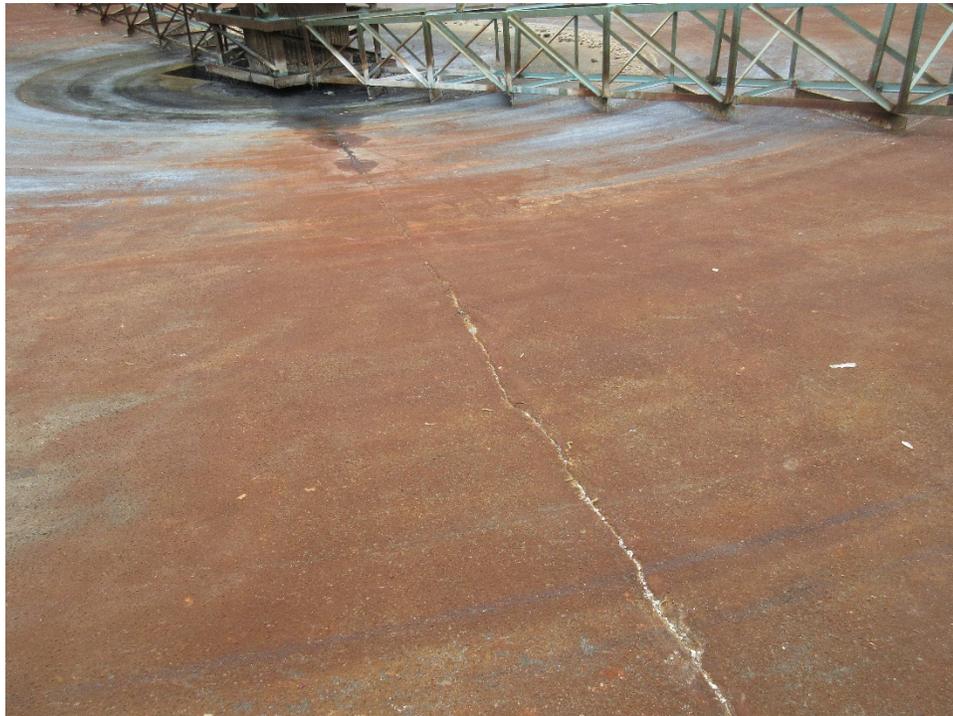
Photo 9: Crack in base slab of clarifier extending from center to exterior wall
