# **GEOTECHNICAL REPORT**

Project: Pembina Highway  
Grant Ave. to Harrow St.

**Pembina Highway Southbound Lanes  
Pavement Inspection**

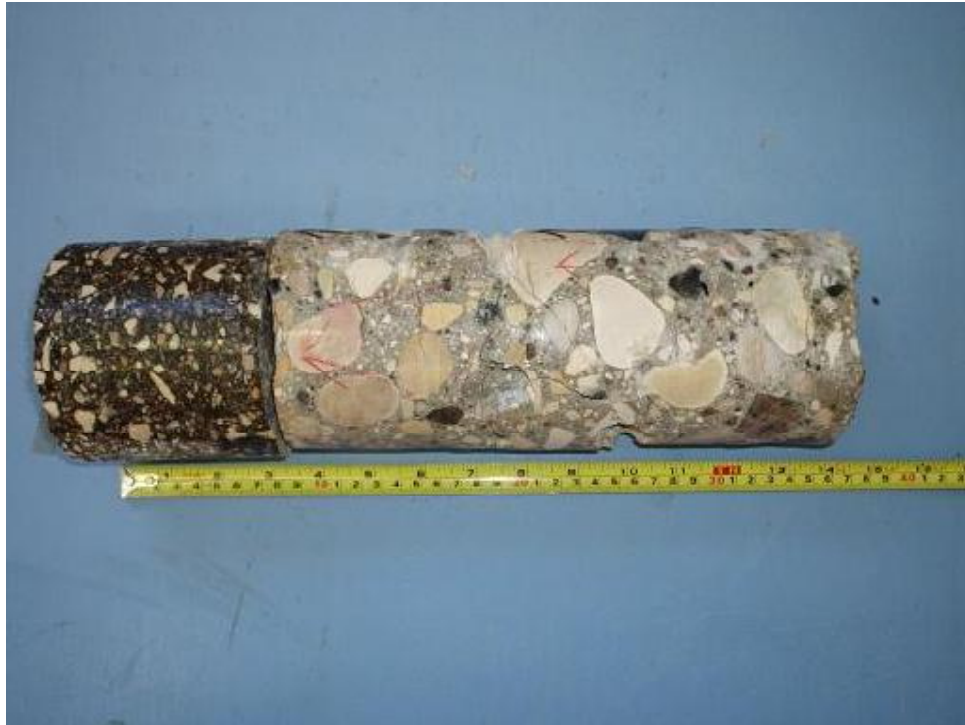
**Photo No. 1: Curb lane, 20 m south of Weatherdon Avenue**

Core No.	Location	Core Depth (mm)		Remarks
		Asphalt	Concrete	
1	curb lane, 20 m south of Weatherdon Avenue	95	260	visible fracture throughout the concrete
2	centre lane, 13 m south of Arbuthnot Avenue	135	230	visible fracture throughout the concrete
3	median lane, 31 m north of Ebby Street	125	230	fractured from 70 mm to 110 mm below surface of concrete, possibly due to vibration during coring
4	centre lane, 17 m north of Jackson Avenue	145	150	major fracturing of the concrete , came out from the hole as rubble
5	centre lane, 19 m south of Taylor Avenue	130	175	major fracturing of the concrete pavement, came out from the hole as rubble
6	median lane, 31 m north of Stafford Street	105	240	sound concrete
7	curb lane, 25 m north of Harrow Street	150	200	a fracture was observed at 80 mm from top of concrete, sound concrete
