B.M. ELEV. 1 ISSUED FOR TENDER 06/07/11 MRD 0 ISSUED FOR CITY REVIEW 06/07/11 MRD NO. REVISIONS DATE BY CITY BRIDGE ENGINEER	DESIGNED BY: M.R.D. DRAWN BY: M.R.D. CHECKED BY: R.A.W. REVIEWED BY: R.A.W. SCALE: HORIZ. AS SHOWN VERT. JULY 2006 DATE:			THE CITY OF WINNIPEG PUBLIC WORKS DEPARTMENT 2006 BRIDGE MAINTENANCE ST. VITAL BRIDGE CONCRETE REPAIRS	CITY DRAWING NUMBER B116-06-02 SHEET 2 OF 2
	AUTHORIZED BY: DATE: CONSULTANT PROJECT NO. 06-5919-1001				DETAILS 2 OF 2 BID OPP NO. 464-2006

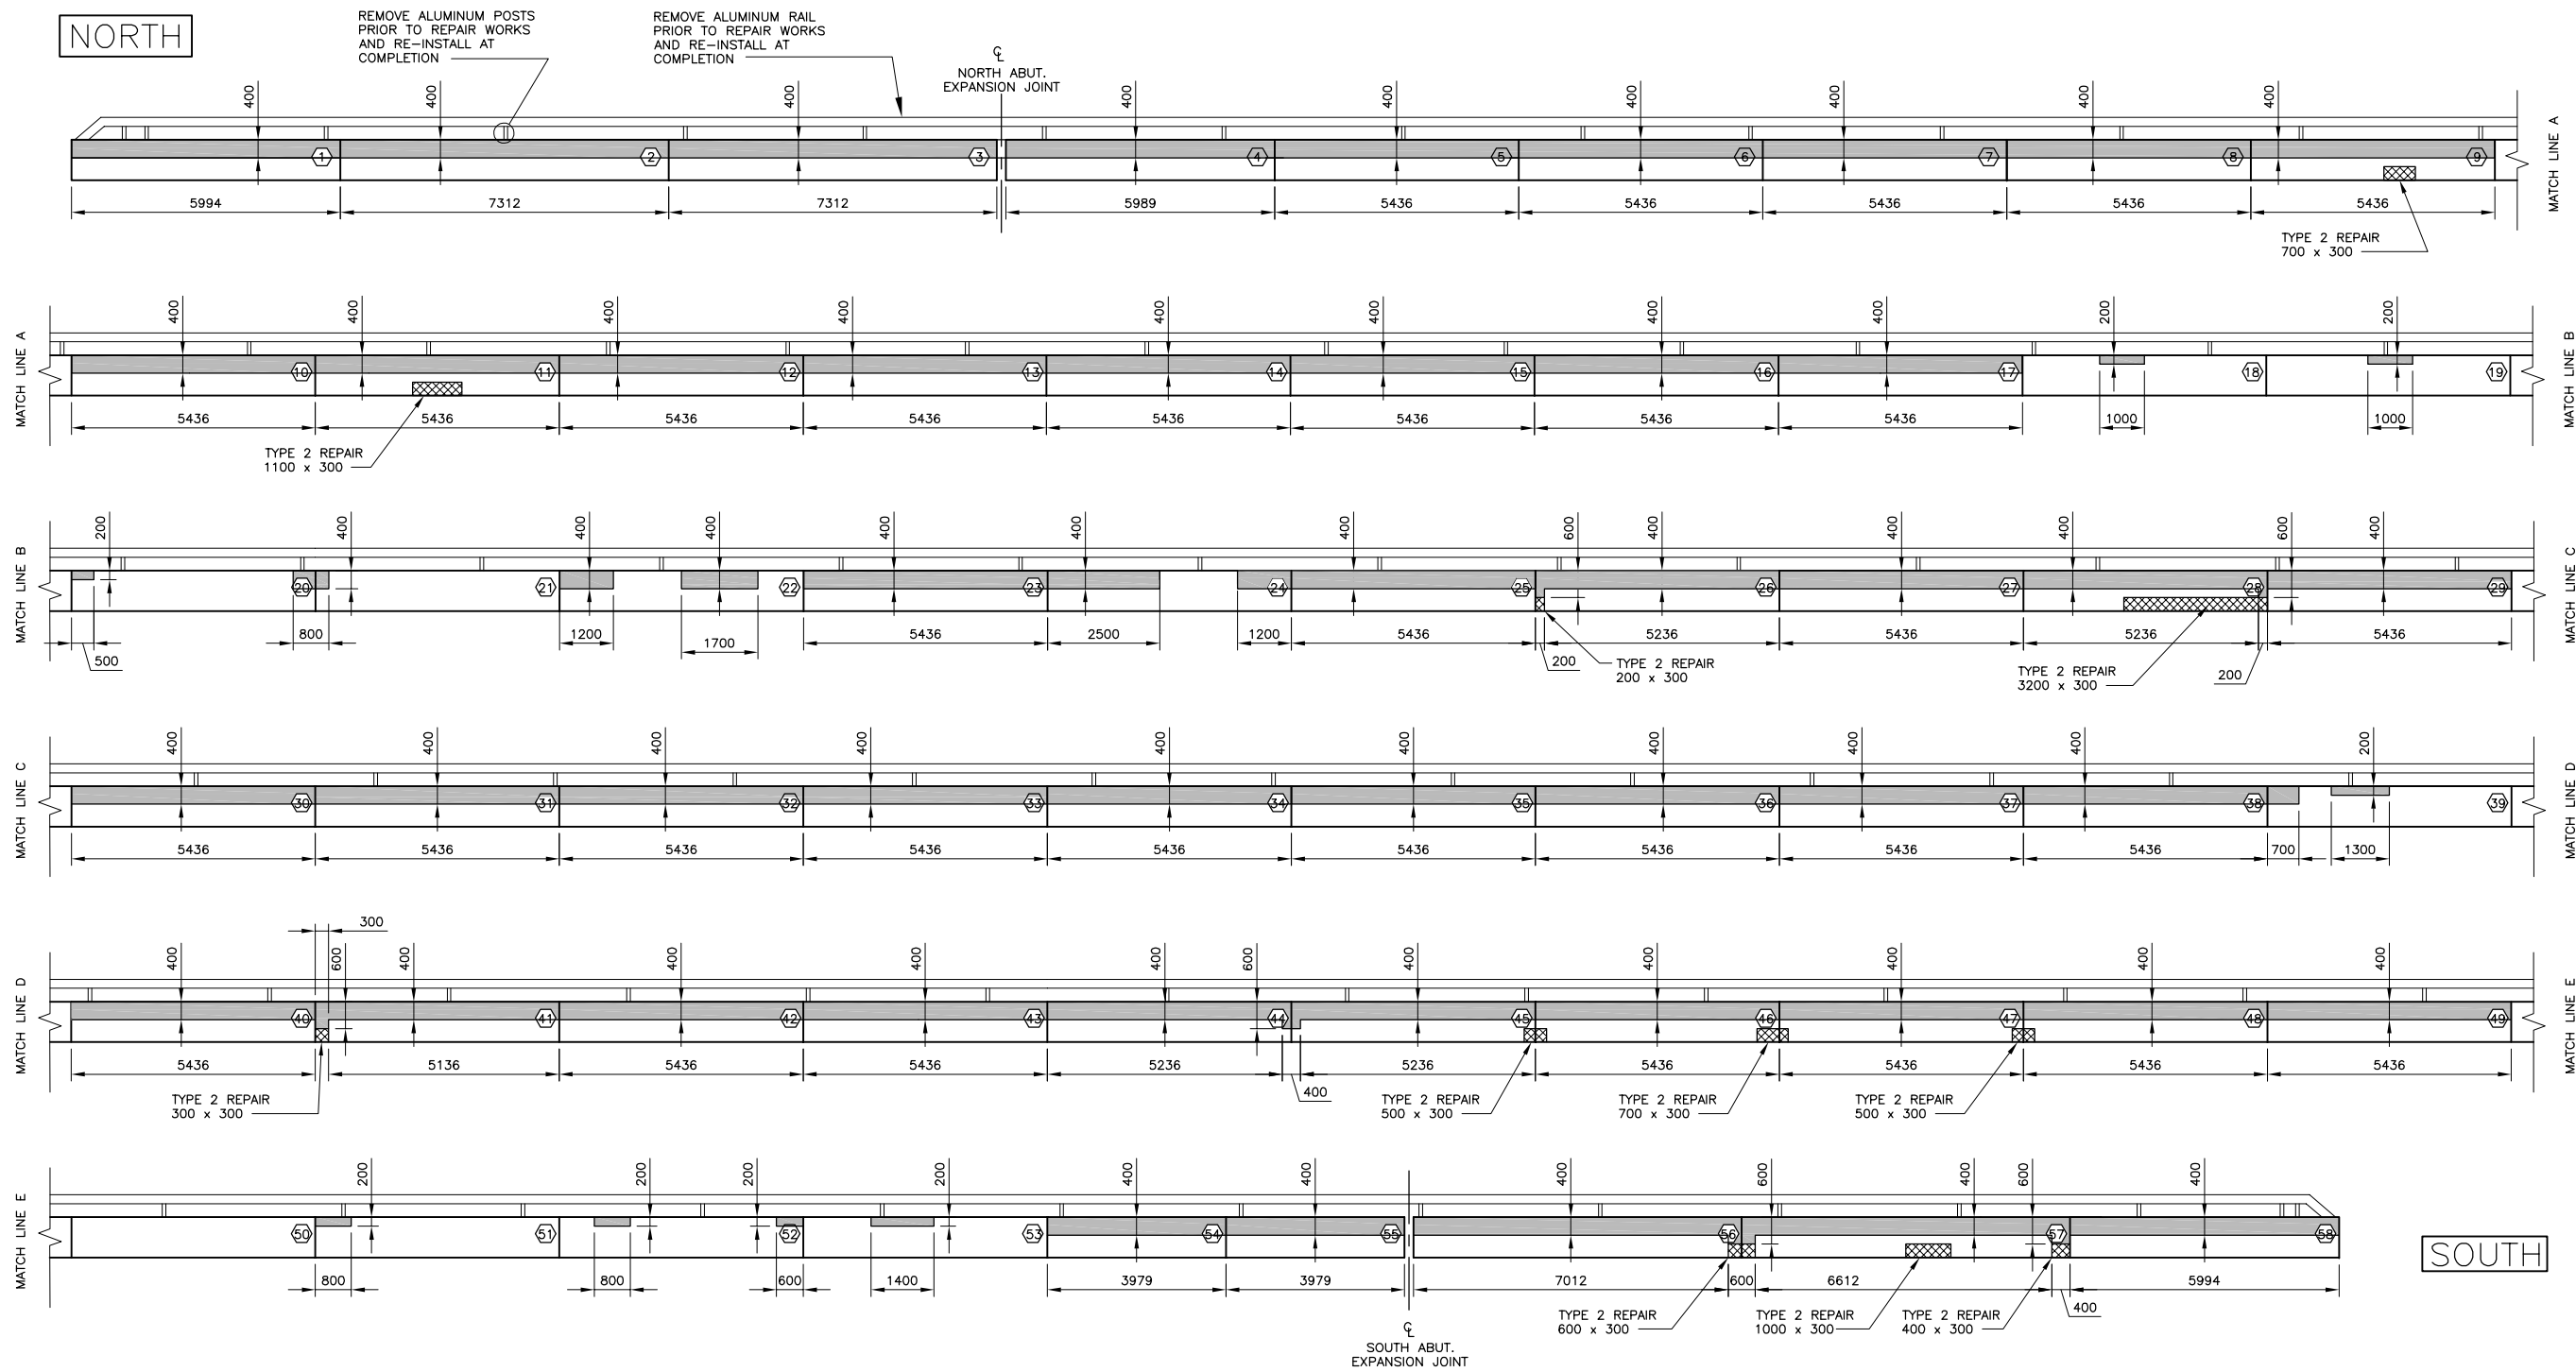
NORTHBOUND CURB LANE BARRIER ELEVATION  
1 : 75 (LOOKING EAST)

REPAIR LEGEND	APPROX. AREA
TYPE 1 REPAIR	276 L.M.
TYPE 2 REPAIR	3.0 SQ.M.
BARRIER LOCATION NO.

1. REPAIRS PREDOMINATELY ALONG NORTHBOUND CURB LANE BARRIER. NORTHBOUND MEDIAN LANE REPAIRS AT BARRIER 50.
2. DIMENSIONS SHOWN OF REPAIR AREAS ARE APPROXIMATE. LAYOUT ACTUAL REPAIR AREAS WITH CONTRACT ADMINISTRATOR IN FIELD.
3. SEE SPECIFICATION FOR REPAIR PREPARATION & CONCRETE REPLACEMENT DETAILS.
4. PROVIDE MINIMUM 20MM DEEP SAWCUT AROUND ALL REPAIR AREAS.
