PAVEMENT CORE REPORT

Pavement Core Report for Higgins Avenue from Austin Street to Annabella Street

Project: Pavement Inspection
Bid Opp. No. 181-2007

**HIGGINS AVENUE, AUSTIN TO ANNABELLA
PAVEMENT INSPECTION**

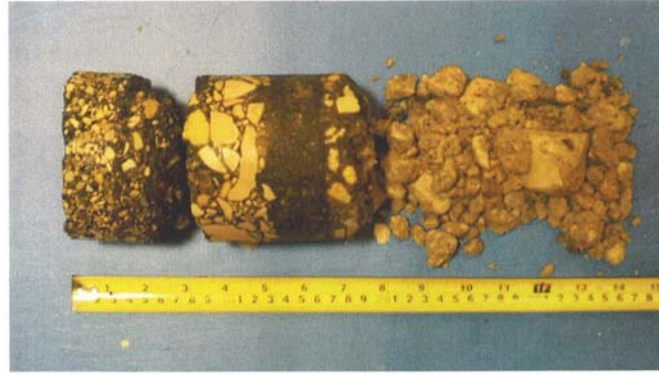
Core No. 4

Core No.	Location	Core Depth (mm)			Remarks
		Asphalt	Concrete	Total	
1	eastbound curb lane, 8 m east of Austin St	90	165	255	Sound pavement
2	eastbound curb lane, 38 m west of Argyle St	180	200	380	Pavement fractured from 185 to 285 mm, pavement is rubble below 285mm
3	eastbound curb lane, 8 m east of Waterfront Dr	220	180	400	Pavement fractured from 220 to 340 mm, pavement is rubble below 340 mm
4	eastbound curb lane, 6 m west of Annabella St	180	190	370	Pavement is rubble below 180 mm
5	westbound curb lane, 50 m east of Gomez St	85	90	175	Sound pavement
6	westbound curb lane, 46 m west of Waterfront Dr	120	190	310	Sound pavement
7	westbound curb lane, 8 m east of Meade St	180	160	340	Sound pavement
8	westbound curb lane 27 m west of Meade St	140	160	300	Sound pavement
