**GEOTECHNICAL INVESTIGATION AND
RIVERBANK STABILTY ASSESSMENT
CRANE – WILLOW INTERCEPTOR
SEWER REPLACEMENT**

FINAL REPORT

NOVEMBER, 2007

**KGS
GROUP**

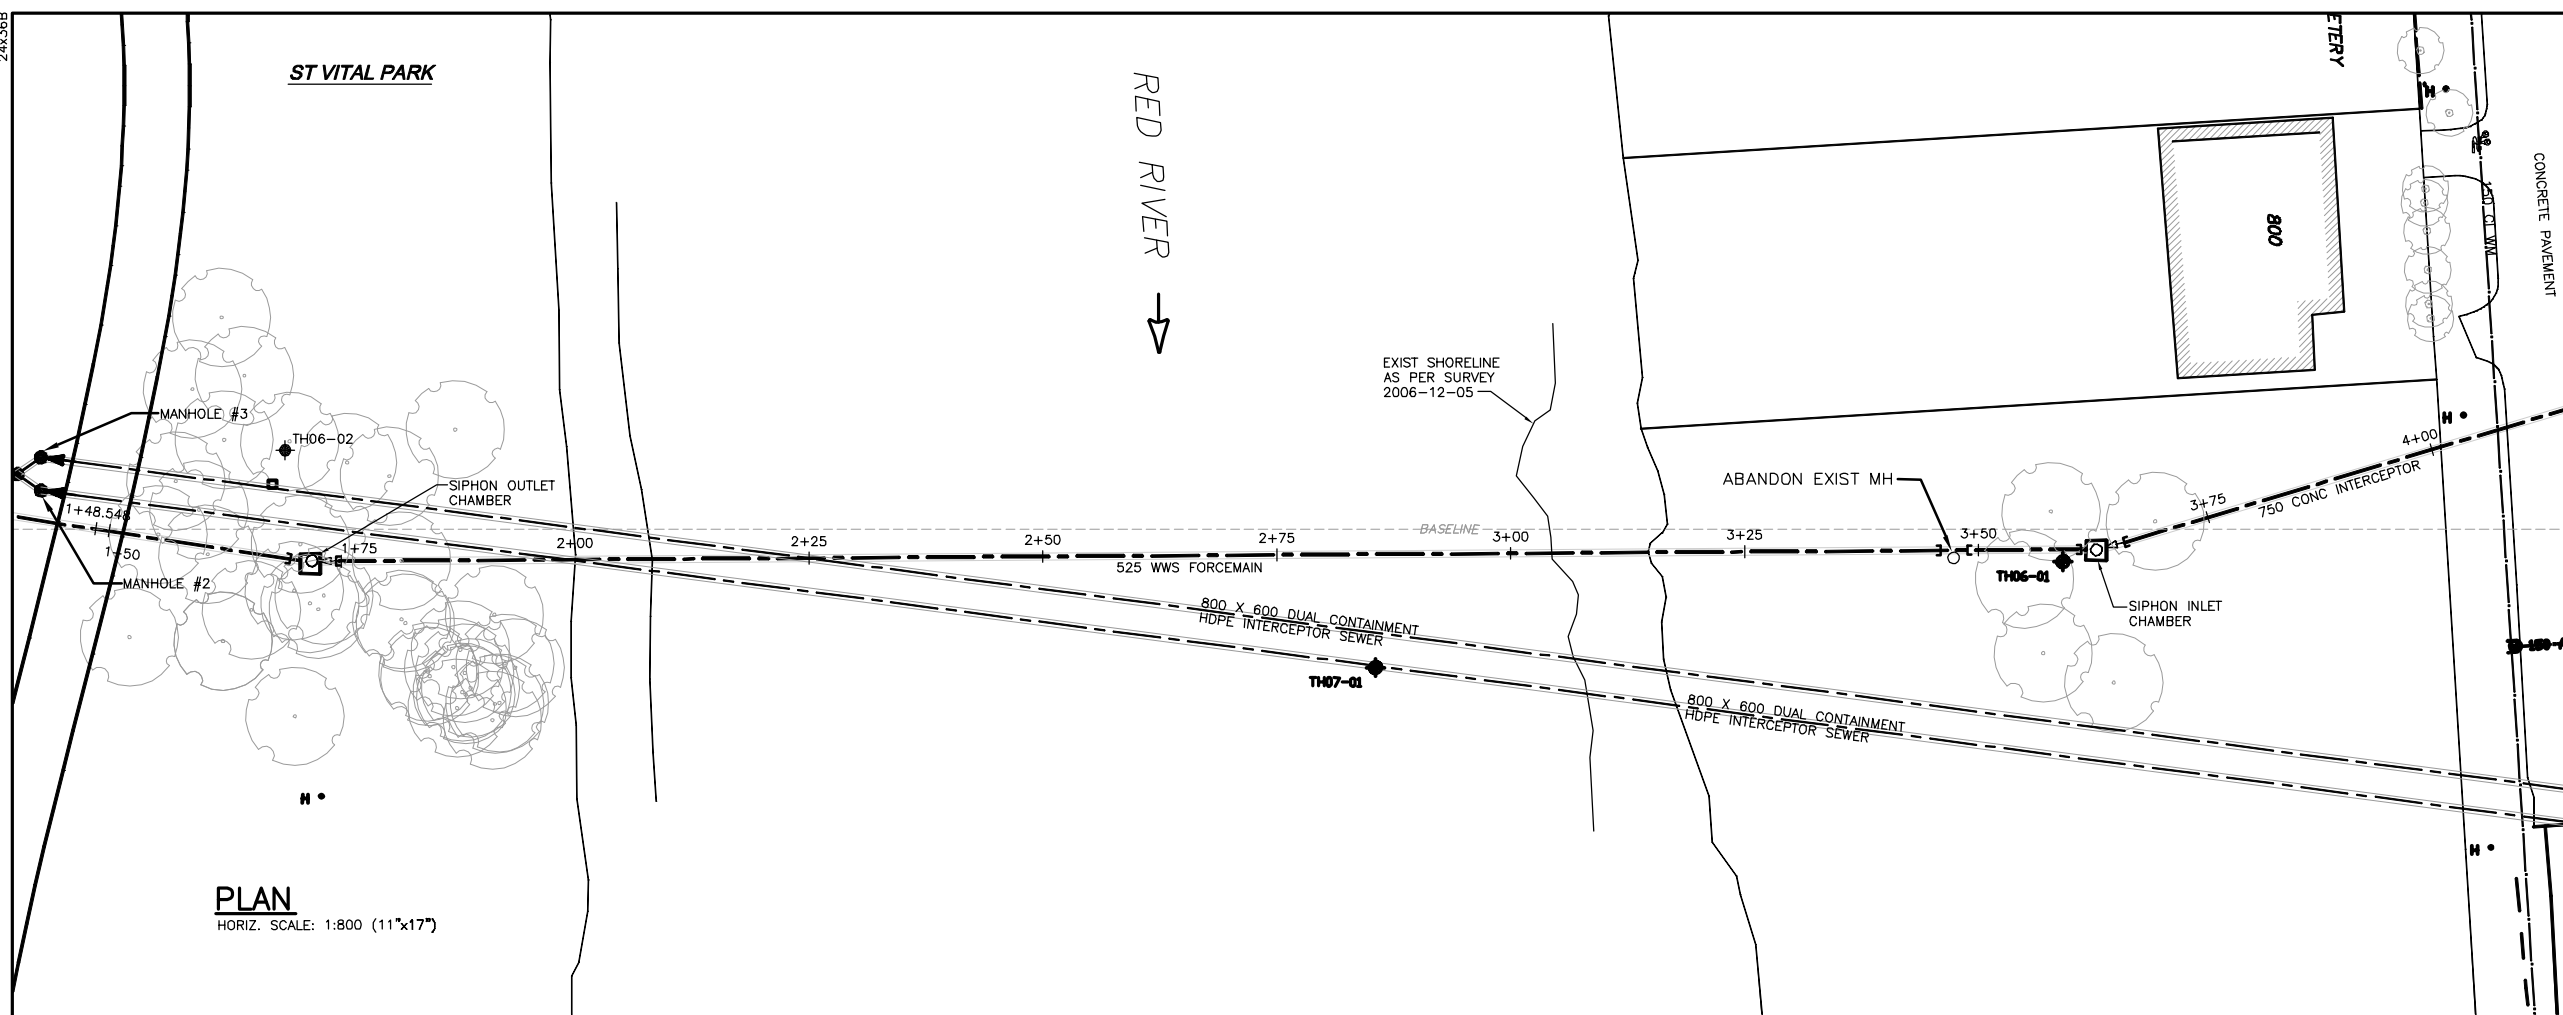
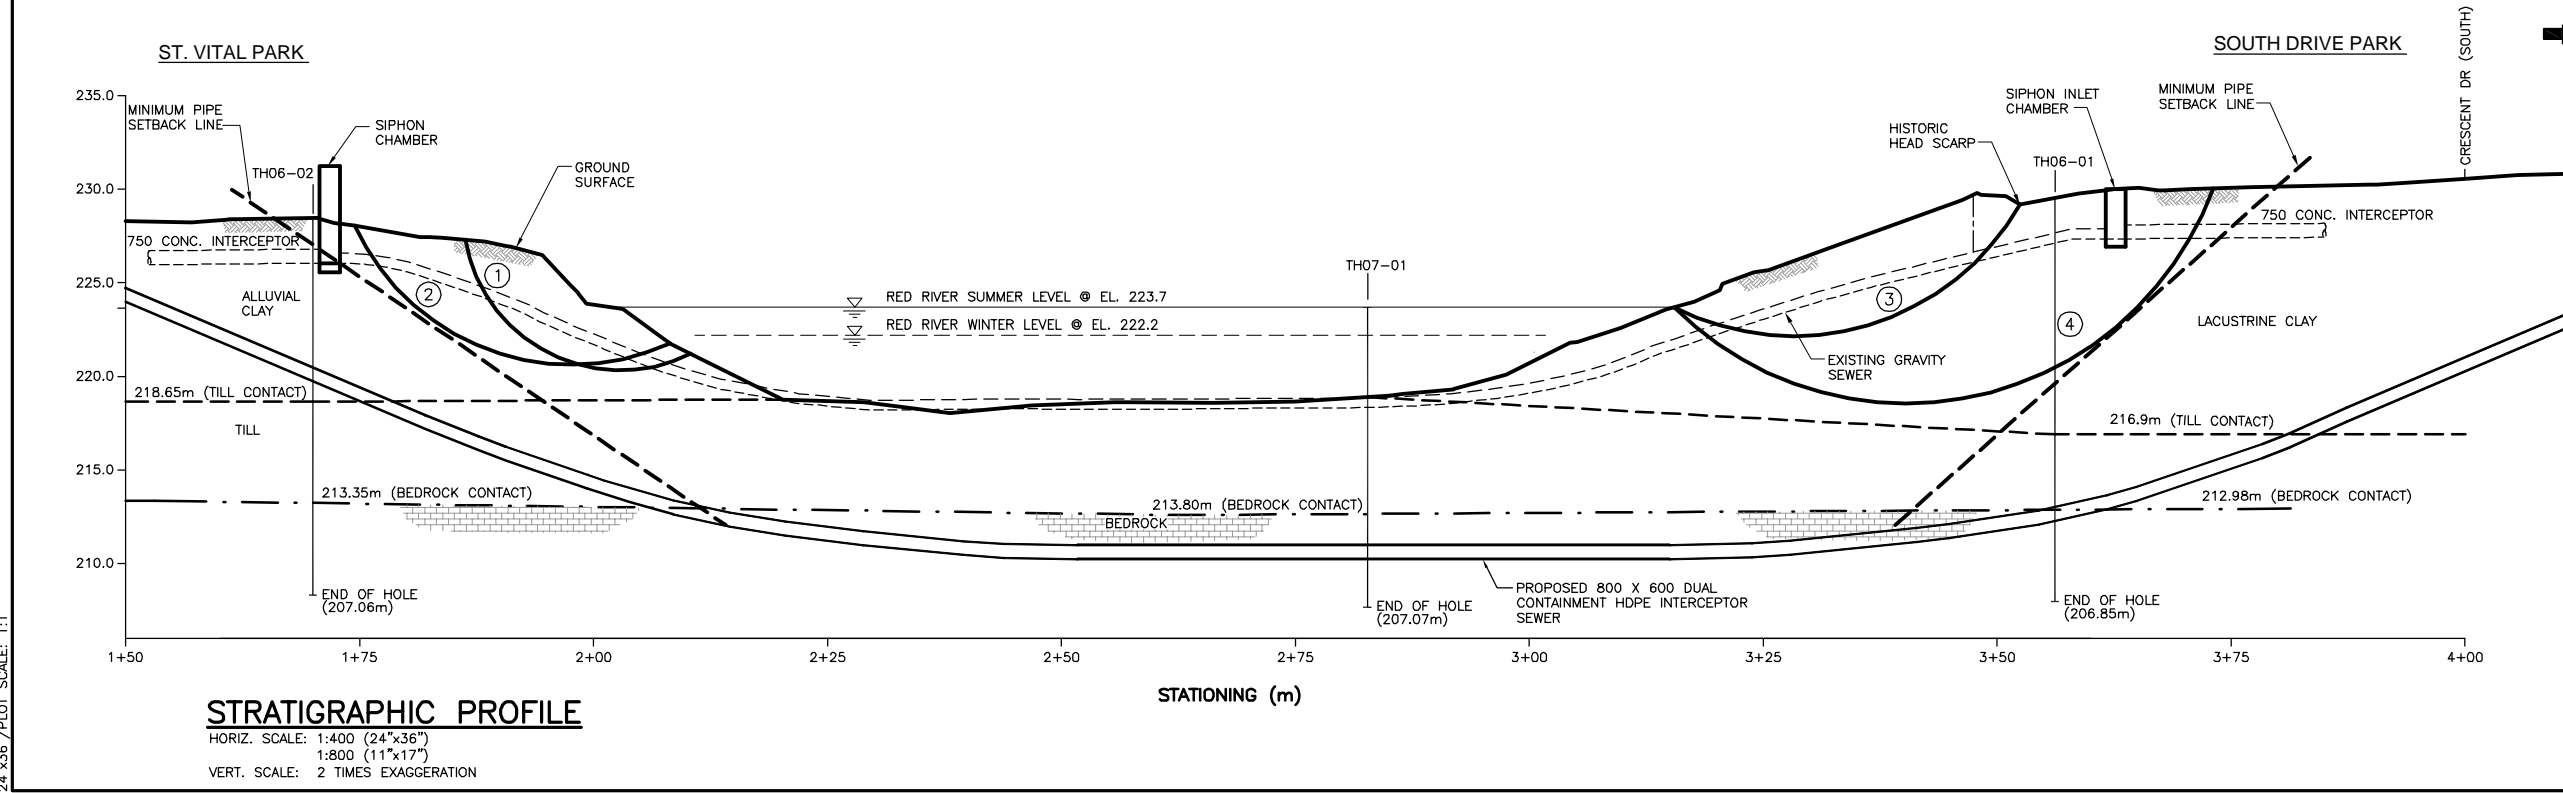
DWG. DESCRIPTION: **GRAVITY SEWER ALIGNMENT PLAN AND STRATIGRAPHIC PROFILE**

With Regulated Summer River Level (RSRL) (Elev. 223.7 m \pm) and saturated groundwater conditions, the estimated FS for SS1 is 1.24 and SS2 has an estimated FS of 1.51. Under the conditions of Unregulated Winter River Level (UWRL) (Elev. 222.2 m \pm) and saturated groundwater conditions, the estimated FS for SS1 is 1.09 and SS2 has an estimated FS of 1.40. The estimated factors of safety for RSRL and saturated groundwater conditions represent the

Table 2 summarizes the estimated factors of safety (FS) for each potential slip surface and under the assumed groundwater conditions. Under the conditions of Unregulated Winter River Level (UWRL) (Elev. 222.2 m \pm) and saturated riverbank, SS3 has an estimated FS of <1.0 (0.89), and SS4 has an estimated FS of 1.30. With Regulated Summer River Level (RSRL) (Elev. 223.7 m \pm) and saturated groundwater conditions, the estimated FS for SS3 is <1.0 (0.93) and SS4 has an estimated FS of 1.33.

Typically, it is recommended by KGS Group that all critical infrastructure on a riverbank be placed behind a line defined by an estimated FS of 1.3 for a critical geotechnical assumption of RSRL and saturated riverbank for alluvial banks and UWRL and saturated riverbank for lacustrine banks. The estimated FS for a potential slip surface that impacts upon the proposed minimum setback locations of the pipes on either side of the river is at or above 1.3. Therefore the pipes would not experience any adverse impacts assuming the riverbank geometry were to remain unchanged and as shown on Dwg. 07-107-11 01 throughout the lifespan of the pipe.

As shown on Dwg. 07-107-11 01, no additional erosion protection is being proposed by the City of Winnipeg Water and Waste Department to be placed along either shoreline. Based upon KGS Group's experience, typically riverbank erosion can lead to the cutting back of the crest of the riverbank by an average of 1 foot per year. Therefore, with an expected lifespan of the pipes of 50 years, the pipes should be offset an additional 15 m (50 feet) in order to prevent any adverse impact to the pipes due to potential riverbank movements during the lifespan. That increased set back is shown on these report drawings and the tender package.

On the St. Vital Park side, the minimum setback distance for the pipe has an estimated FS of 1.3 for the most critical design condition of RSRL and saturated bank as shown on KGS Drawing 07-107-11 01. KGS Group recommends that the pipes be offset an additional minimum of 15 m (50 feet) back from the minimum setback line in order to prevent any adverse impact to the pipes during the expected 50 year lifespan of the pipes.

On the South Drive Park side, the minimum offset distance is estimated to be behind a factor of safety in the order of 1.3 under either summer or winter river levels and saturated groundwater conditions as shown on KGS Drawing 07-107-11 01. That setback recognizes that bank movements have occurred in the past along this riverbank, which have impacted upon the existing pipe and there is a need to minimize any potential impact on the new pipes in the future. KGS Group recommends that the pipes must be offset an additional of 15 m (50 feet) behind the minimum setback line in order to prevent any adverse impact to the pipes due to riverbank movements during the expected 50 year design lifespan of the sewer crossing.

The sewer pipe profile shown on KGS Drawing 07-107-11 01 meets KGS Group recommendations for the design lifespan of the pipes.

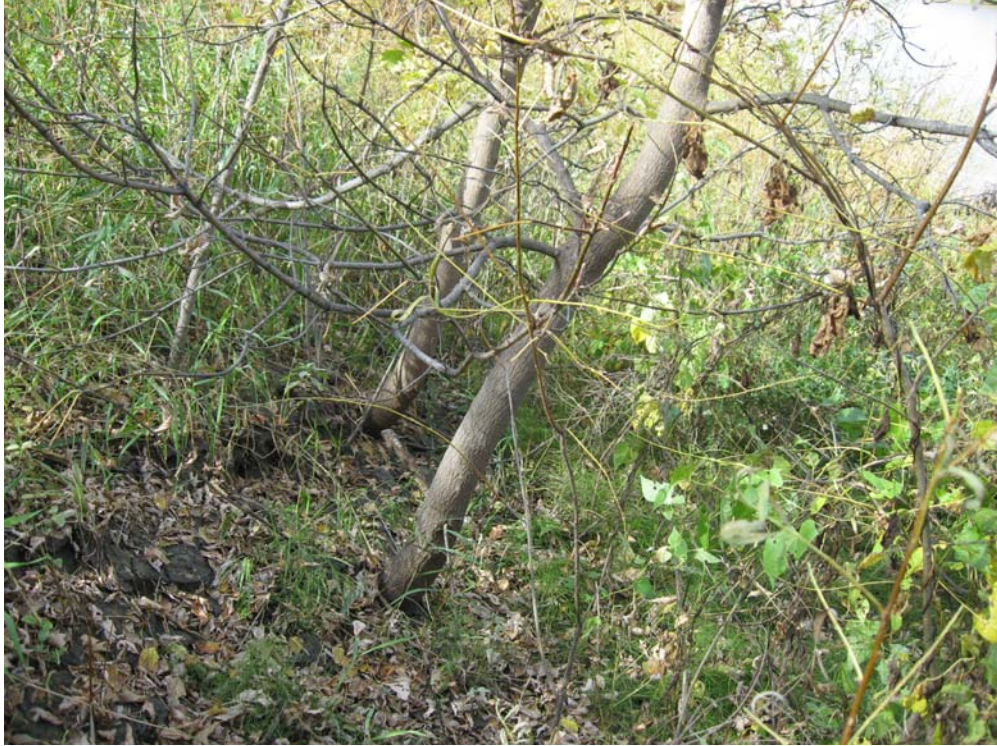
Approximately 15 m upstream of the crossing there is a headscarp present, which extends approximately 300 m± upstream of the pipe.

PHOTO 1 – HEADSCARP 15 M UPSTREAM OF PIPE CROSSING IN ST. VITAL PARK

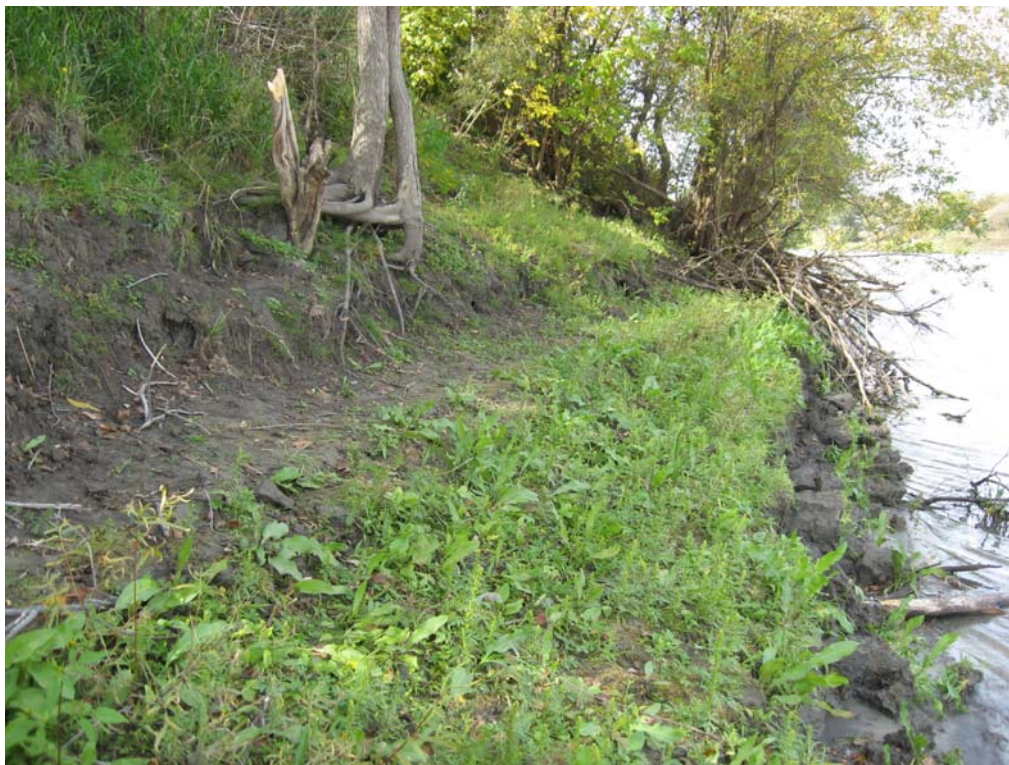
Presently there are numerous large mature deciduous and evergreen trees and smaller bushes growing along the riverbank and down to the river water edge. The riverbank shows no signs of overall bank instability. However, as seen on the aerial photography, approximately 15 m± upstream of the pipe crossing a headscarp is present along the crest of the riverbank as shown on Photo 1. There is also evidence of ongoing erosion along the shoreline of the riverbank in the vicinity upstream and downstream of the pipe crossing as shown on Photo 2. The upstream headscarp is a result of erosion of the bank, which leads to oversteepening of the bank face and result in shallow sloughing or slides.

PHOTO 2 – SHORELINE EROSION ALONG ST. VITAL PARK SIDE OF RED RIVER AT THE PIPE CROSSING

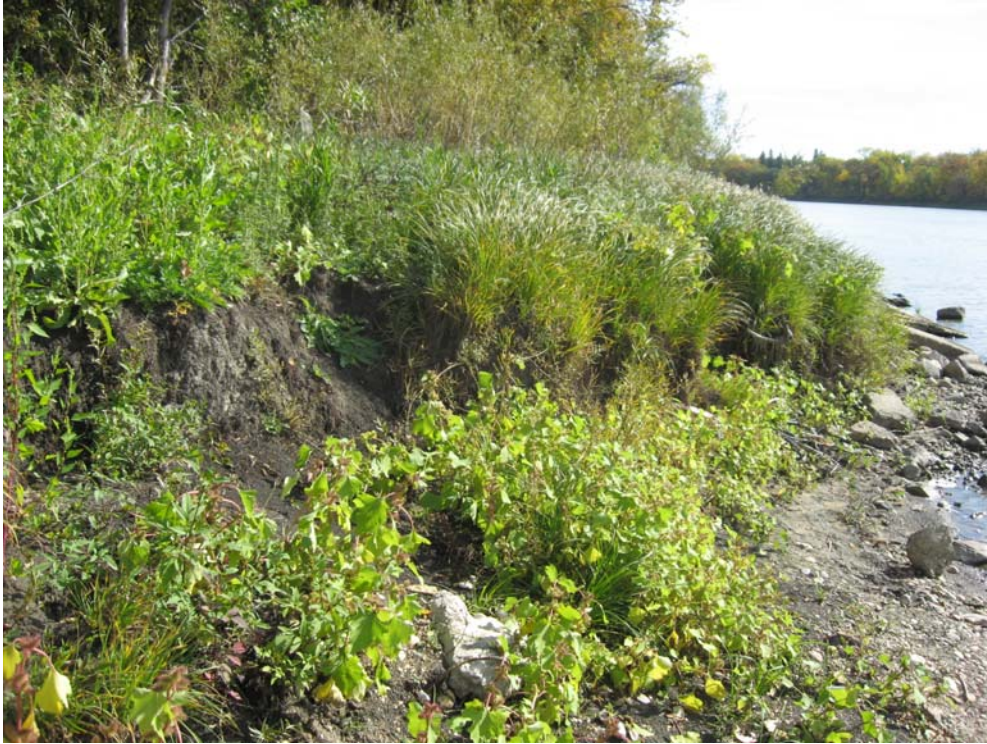
Generally, the riverbank looks to be in a similar condition as it was in 1988 with ongoing erosion of the shoreline both upstream and downstream of the riprap section and pipe crossing. The cleared area on the riverbank appears to have trees and bushes now growing on it versus 1988. Upstream of the rockfill, the shoreline shows signs of continued erosion and cutting back, which has led to the crest of the riverbank moving back approximately 2 to 3 m± since the 1988 photos.

**PHOTO 3 – SHORELINE EROSION ALONG SOUTH DRIVE PARK
SIDE OF RED RIVER AT PIPE CROSSING**

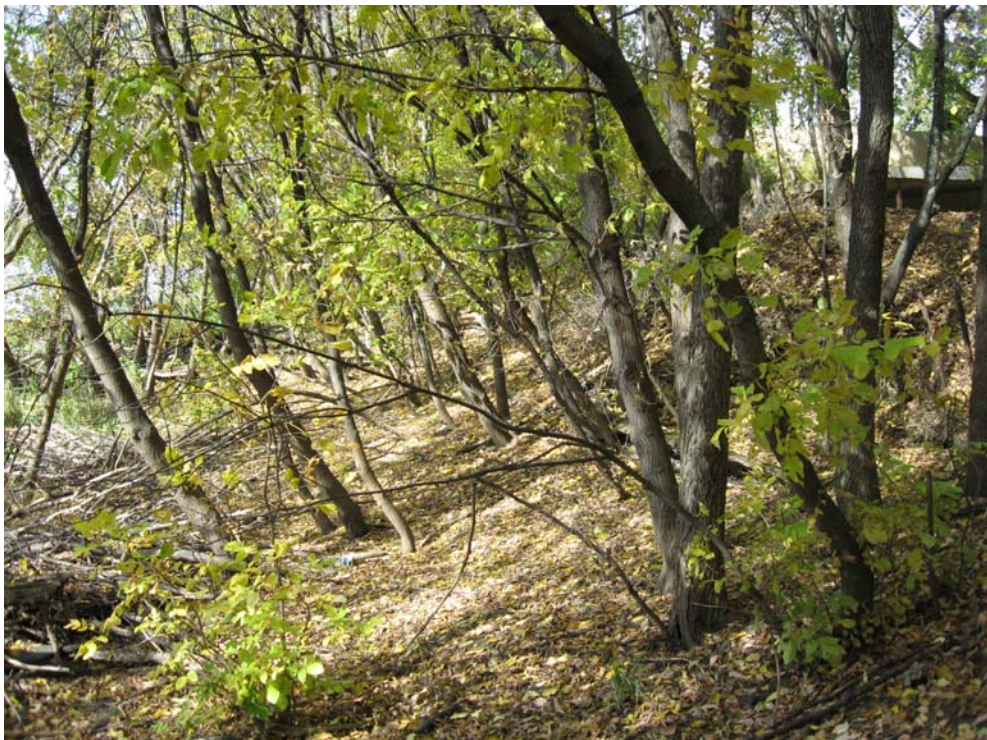
**PHOTO 4 – HISTORIC HEADSCARP 30 M UPSTREAM OF PIPE CROSSING
ON SOUTH DRIVE PARK SIDE OF RED RIVER**

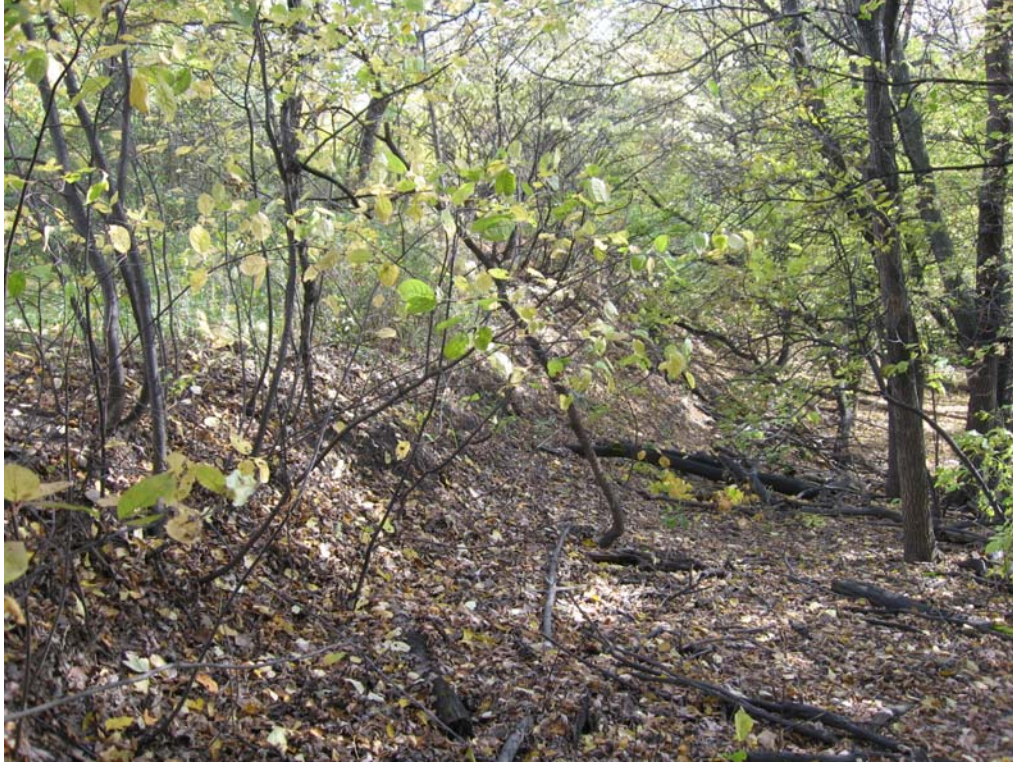
**PHOTO 5 – HISTORIC HEADSCARP 30 M DOWNSTREAM OF PIPE CROSSING
ON SOUTH DRIVE PARK SIDE OF RED RIVER**
