APPENDIX 'A'

GEOTECHNICAL REPORT

APPENDIX 'A' - GEOTECHNICAL REPORT

Geotechnical Report for Portage Avenue North Alley

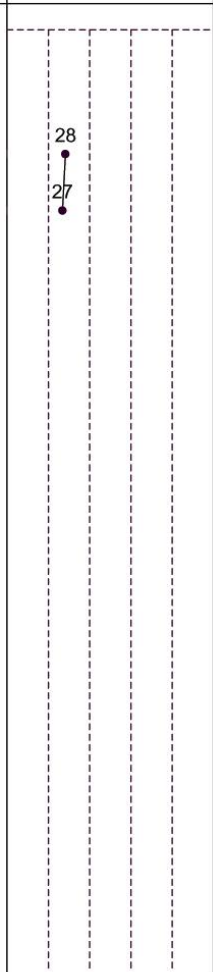
TESTHOLE TH1

Clay Fill - brown, stiff, moist, high plasticity, trace sand and gravel		
0.5				
1.0				
1.5				
2.0				
2.5		<ul style="list-style-type: none"> • Auger refusal at 0.5 m on a suspected abandoned concrete duct. • Frost present to testhole depth. • No soil sloughing or water seepage were observed during or after the completion of drilling.
