CLIENT:  
**CITY OF WINNIPEG**

PROJECT:  
**SEINE RIVER WALKWAY  
RE-CONSTRUCTION AT DESAUTELS  
STREET, WINNIPEG, MANITOBA**

DWG DESCRIPTION:  
**PHOTOGRAPHS 9-16**

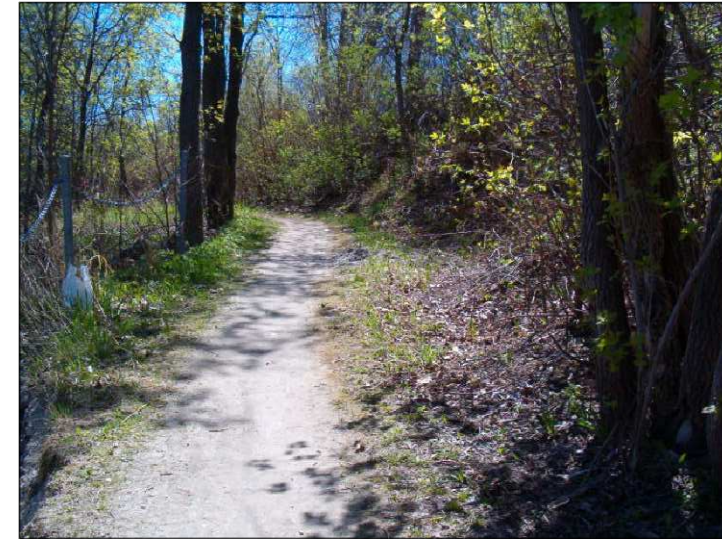
PHOTOGRAPH 11: FACING SOUTH - AT STATION 1+95, PRIMARY FAILURE ZONE ON LEFT

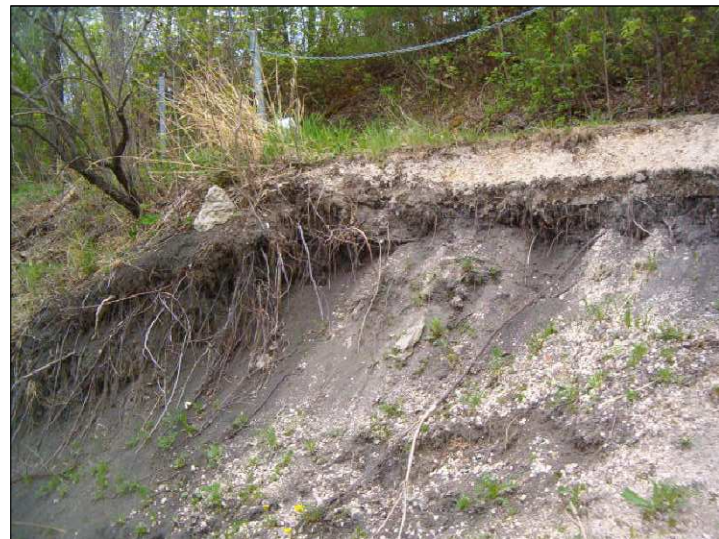
PHOTOGRAPH 12: FACING SOUTH - AT STATION 1+95, PRIMARY FAILURE ZONE, AREA OF GABION BASKET RETAINING WALL AND RIP-RAP PROTECTION BLANKET

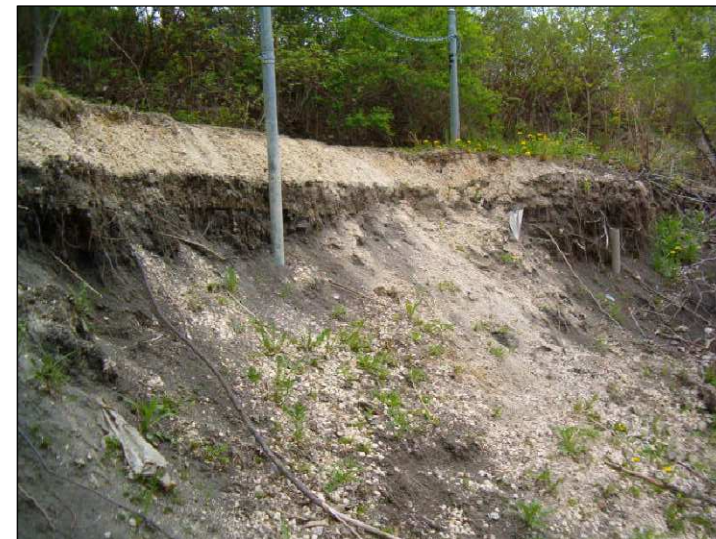
PHOTOGRAPH 13: FACING NORTH - AT STATION 1+95, PRIMARY FAILURE ZONE, AREA OF GABION BASKET RETAINING WALL AND RIP-RAP PROTECTION BLANKET

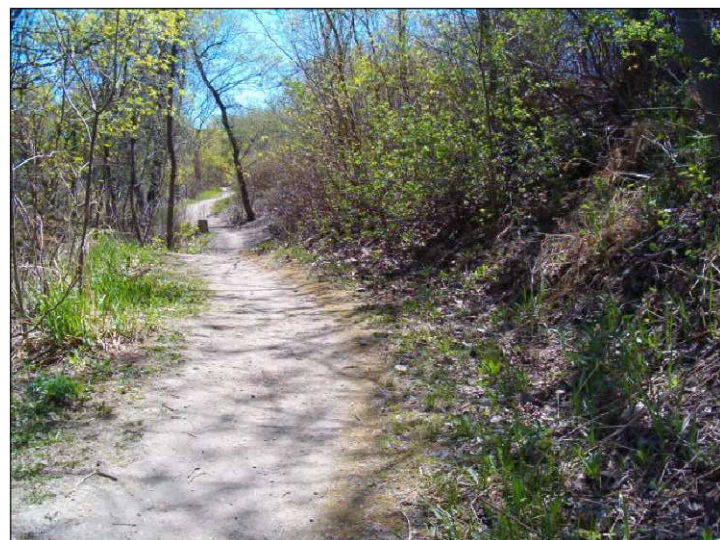
PHOTOGRAPH 14: FACING SOUTH - AT STATION 2+25 AREA WITH NO RETAINING WALL

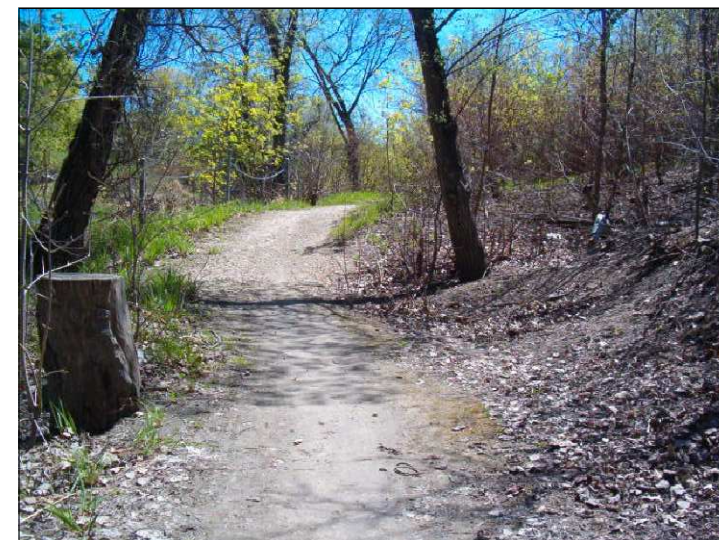
PHOTOGRAPH 15: FACING SOUTH - AT STATION 2+35, AREA WITH NO RETAINING WALL
