APPENDIX C

SITE PHOTOGRAPHS

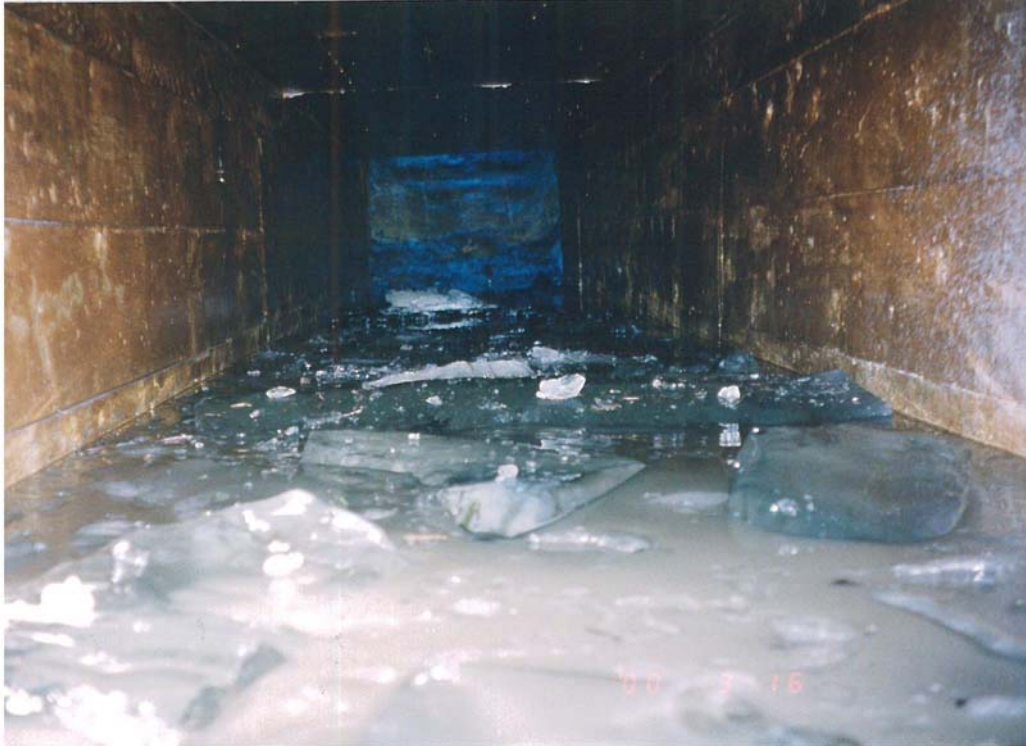
Mile 53.75 Drainage Siphon Lower Box at S. End Looking N. (Note: Good condition)

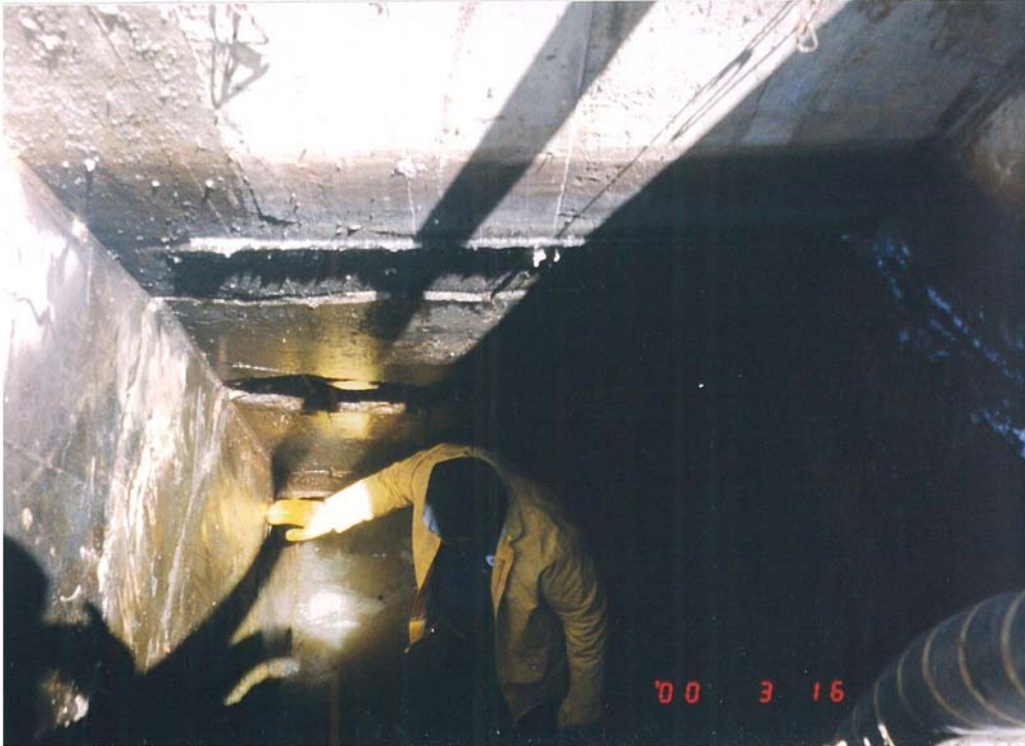
Mile 53.75 Drainage Siphon S. Side Looking Down S. Throat (Note 2 Transverse Cracks)
