GEOTECHNICAL REPORT

APPENDIX 'A' - GEOTECHNICAL REPORT

Project No.: KGS-905	Drawn by: JB	Figure: 1	Testhole Location Plan Corydon Avenue East Bound Pavement Rehabilitation, between Waterloo Street to Montrose Street
	Date: Feb. 26, 2009	Reviewed by: DF	Scale: NTS

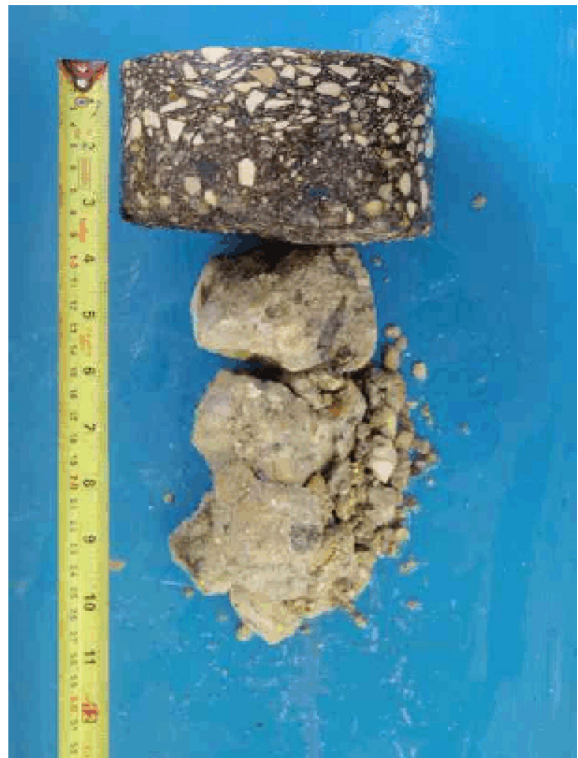
Testhole TH4

Subsurface Profile			Laboratory Testing					
Depth (m)	Symbol	Description	Water Content (%)		Gravel (%)	Sand (%)	Silt (%)	Clay (%)
			PL	LL				
0.0		Ground Surface						
		Asphalt						
		Concrete						
		Granular Base - 20 mm maximum aggregate size						
0.5		Clay - grey, stiff, moist, high plasticity with trace fine gravel to 0.5 m - brown below 0.5 m - layers of tan silt between 1.2 m to 1.5 m - layers of silty clay at 2.0 m						
1.0					0.0	2.5	20.5	77.0
1.5								
2.0								
2.5		<ul style="list-style-type: none"> Frost present to 1.5 m No water seepage or sloughing observed during or upon completion of drilling Testhole was terminated at 2.1 m

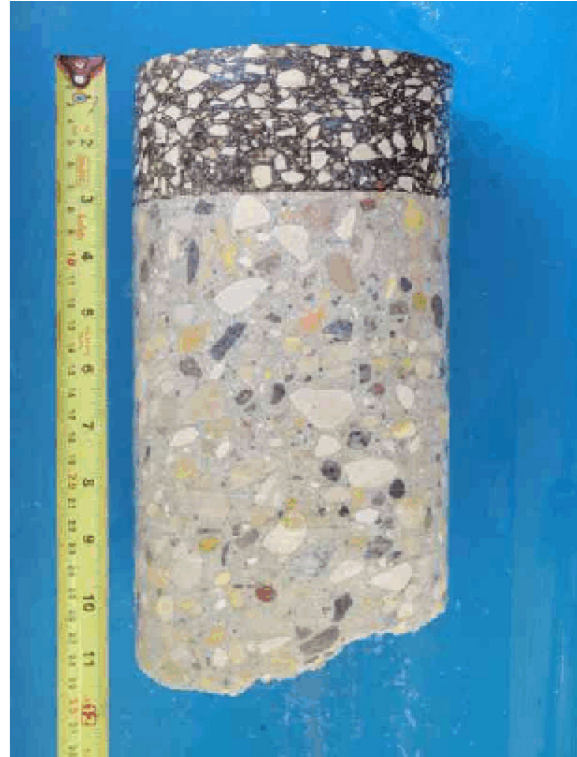
Testhole TH6

Subsurface Profile			Laboratory Testing					
Depth (m)	Symbol	Description	Water Content (%)		Gravel (%)	Sand (%)	Silt (%)	Clay (%)
			PL	LL				
0.0		Ground Surface						
		Asphalt						
		Concrete						
		Crushed Limestone - 20 mm maximum aggregate size						
0.5		Silt - tan, firm, moist, low plasticity, some sand and fine gravel - layers of brown clay below 1.7 m	20	20	0.2	6.4	71.2	22.2
1.0			24					
1.5			24					
2.0		Clay - brown, stiff, moist, high plasticity	24	40				
2.5		<ul style="list-style-type: none"> Frost present to 1.7 m No water seepage during or upon completion of drilling Sloughing observed below 1.8 m Testhole was terminated at 2.1 m
