THE CITY OF WINNIPEG
PUBLIC WORKS DEPARTMENT

ALUMINUM OVERHEAD SIGN SUPPORT STRUCTURES - 2010 MAINTENANCE WORKS

STRUCTURE NO. A813 DETAILS

CITY DRAWING NUMBER
OHSS-10-07
SHEET **7** OF **9**

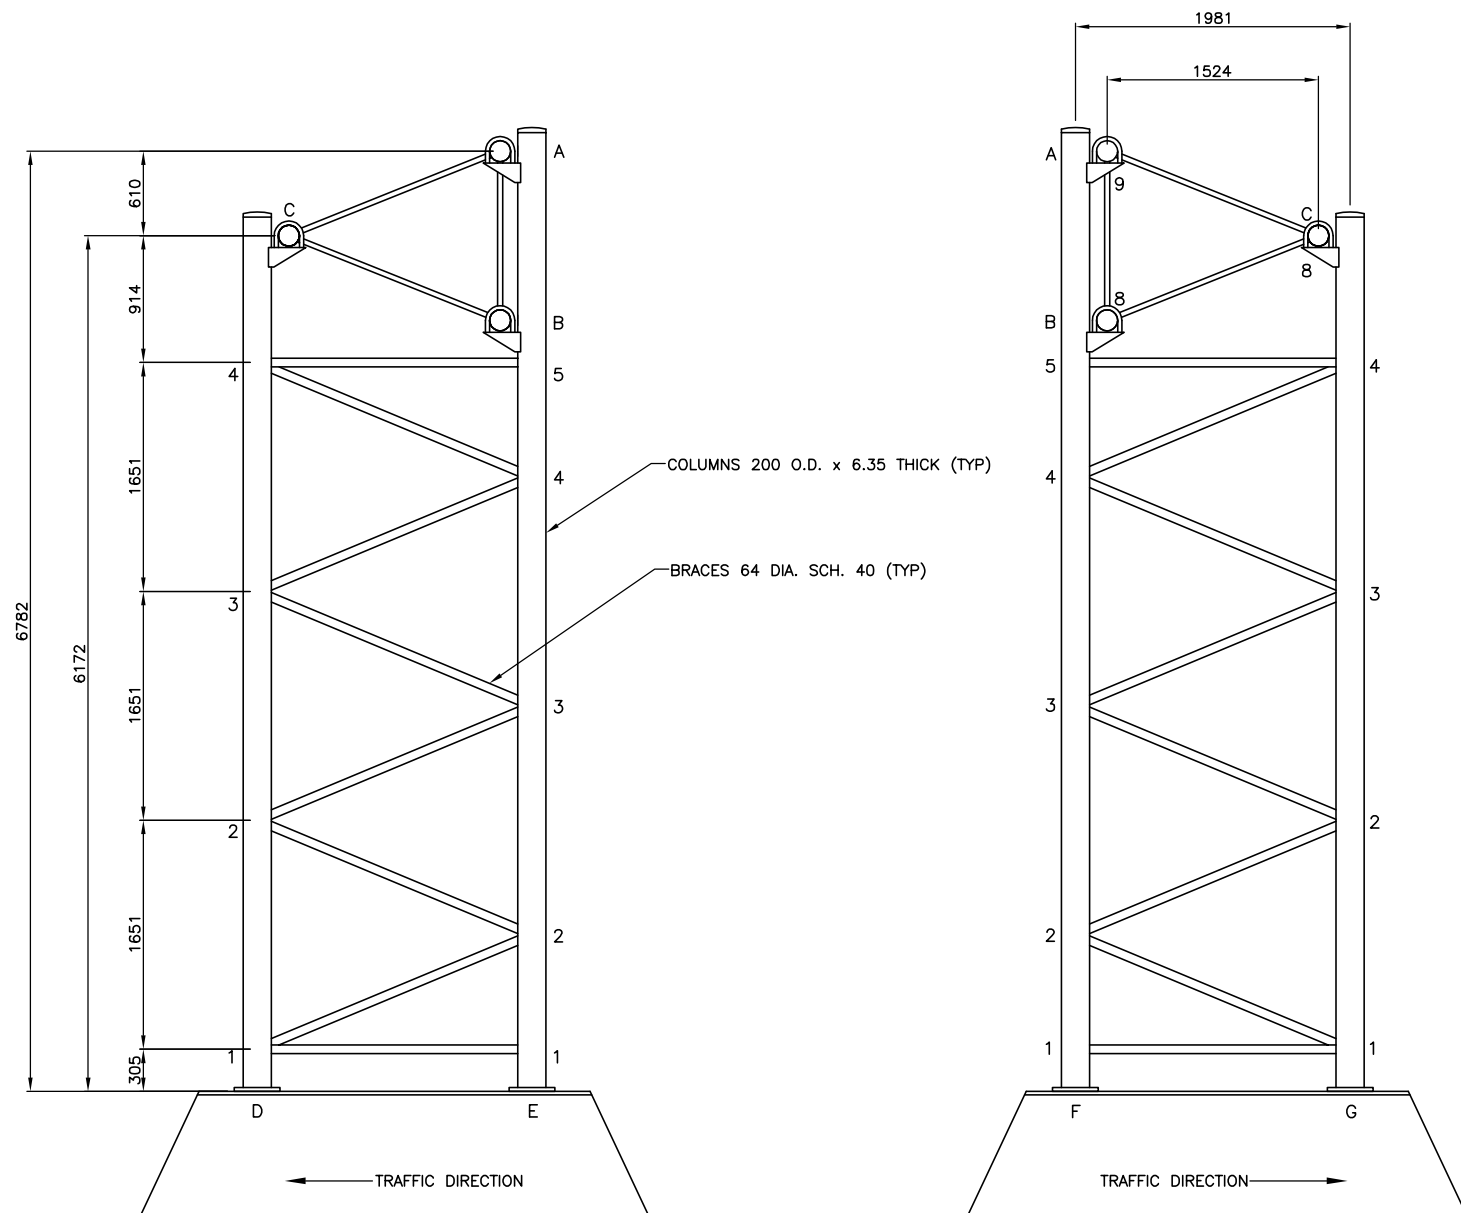
**BRACE JOINT WELD REPAIR LOCATIONS:
(IDENTIFIED BY FIELD INSPECTION)**

HORIZONTAL SUPPORT TOP FACE:

- C3 (A3) - 1 cm

HORIZONTAL SUPPORT BOTTOM FACE:

- C6 (B7) - 1 cm

EAST VERTICAL SUPPORT:

- D1 (E2) - 15 cm
- D2 (E3) - 8 cm

C3 (A3) INDICATES WELD REPLACEMENT IS REQUIRED AT NODE C3 FOR THE BRACE ORIGINATING AT NODE A3.

TOTAL ESTIMATED WELD REPAIR LENGTH IDENTIFIED BY FIELD INSPECTION = 25 cm
TOTAL ESTIMATED WELD REPAIR LENGTH IDENTIFIED BY SHOP INSPECTION = 20 cm

DRAINAGE HOLES

- TWO DRAINAGE HOLES SHOULD BE PROVIDED FOR HORIZONTAL BRACES, LOCATED AT EACH END OF THE BRACE ON THE UNDERSIDE OF THE BRACE.
- ONE DRAINAGE HOLE SHOULD BE PROVIDED FOR VERTICAL BRACES, LOCATED AT THE BOTTOM ON THE SIDE OPPOSITE TO ON COMING TRAFFIC.
- ONE DRAINAGE HOLE SHOULD BE PROVIDED FOR ANGLED BRACES, LOCATED AT THE BOTTOM ON THE UNDERSIDE OF THE BRACE.
- THE DIAMETER OF THE DRAINAGE HOLES SHALL BE A MAXIMUM OF 4 mm. TORCHING OF HOLES WILL NOT BE PERMITTED.

ELECTRICAL HOLES

- SEAL ALL ELECTRICAL HOLES IN THE CHORDS WITH WATERPROOF WHITE POLYETHYLENE PLUGS.
- THERE ARE APPROXIMATELY 2 HOLES THAT REQUIRE SEALING FOR STRUCTURE NO. A813.
