**THE CLOUTIER DRIVE OUTFALL (RR-7)
OUTFALL INSPECTION/CONDITION ASSESSMENT**

AUGUST, 2009

RE: 2009 Cloutier Drive Outfall (RR-7) Condition Assessment

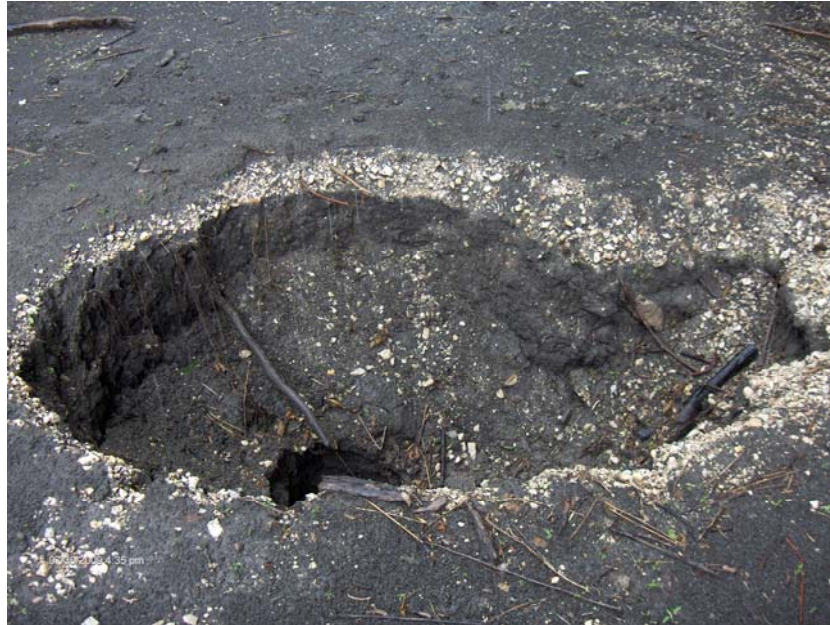
Figure 1: Sinkhole above Outfall RR-7

In July of 2009 a sinkhole formed over the 1.2 m pipe approximately 23 m +/- south of the MH (approximately at station 1+77).

KGS group recommends an immediate repair pipe at the location directly below the sinkhole. This may be achieved through a localized point repair. While the pipe is currently functional, the flow of water will continue to eat away at the surrounding soil. This poses a risk to pedestrians walking in the vicinity of the sinkhole as well as to the pipe itself.

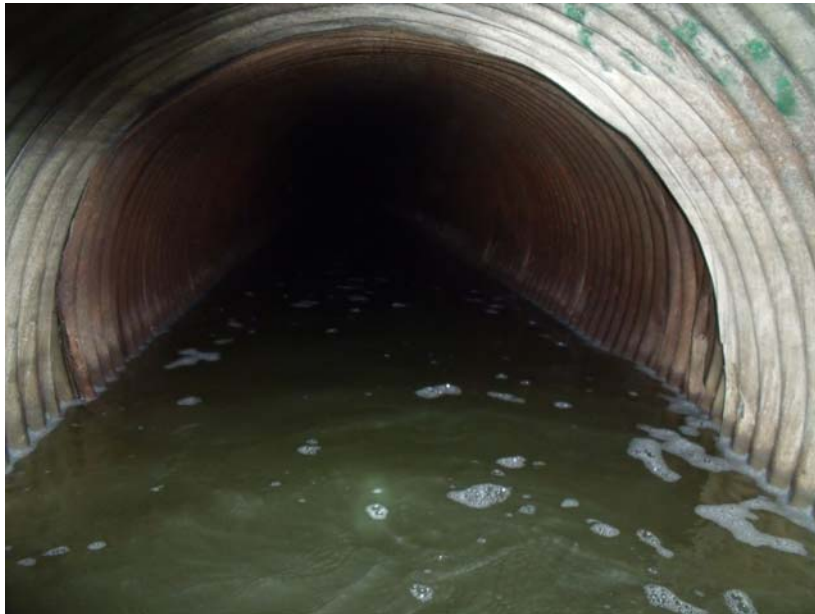
1. Reverse Grade on pipe
 - Occurs just past the 1.5 m x 1.2 m transition

Figure 2: Reverse grade on pipe – looking down-stream

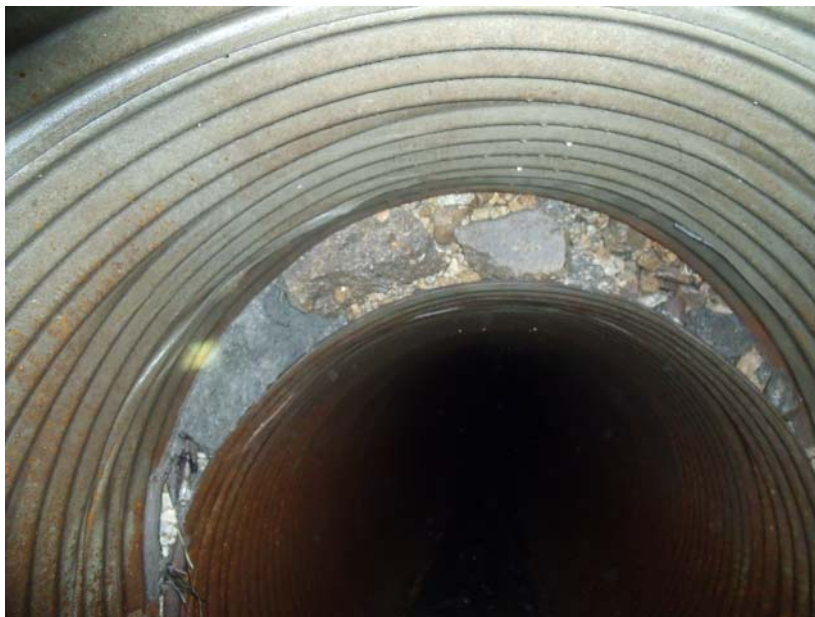
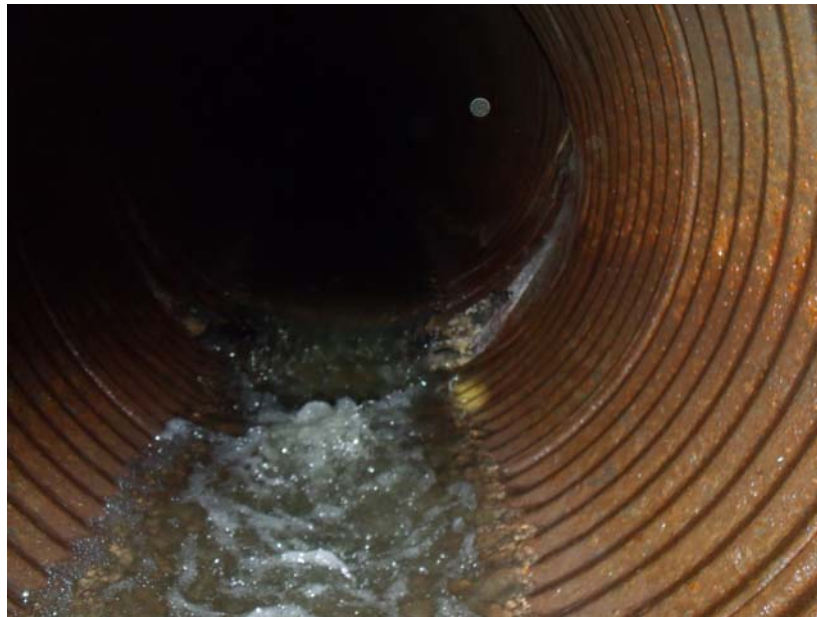
2. Large Displaced Joint
 - Approximately 190 mm (7.5")
 - Approximately 22 m downstream from manhole
 - Probable location of sink hole

Figure 3: Large displaced joint (Probable location of sink hole) looking downstream

Figure 4: Large Displaced Joint (Probable location of sink hole) looking upstream

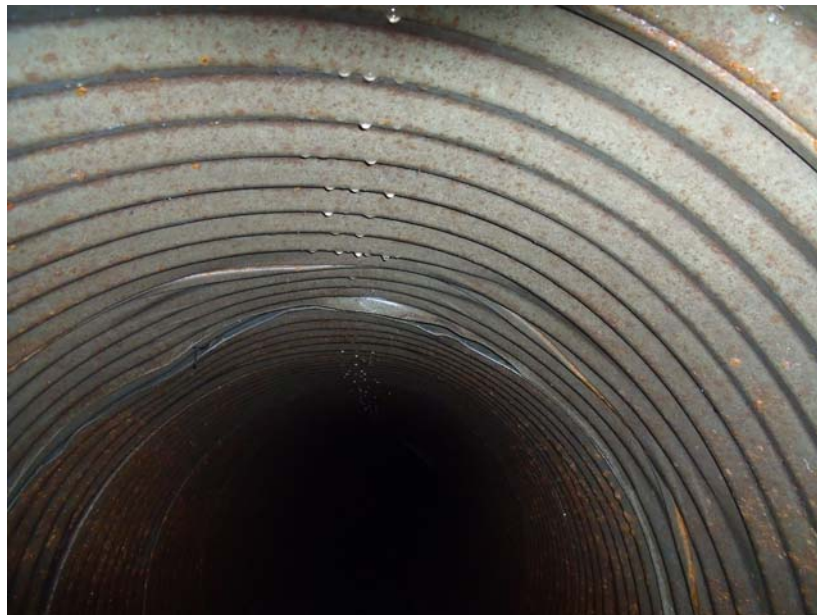
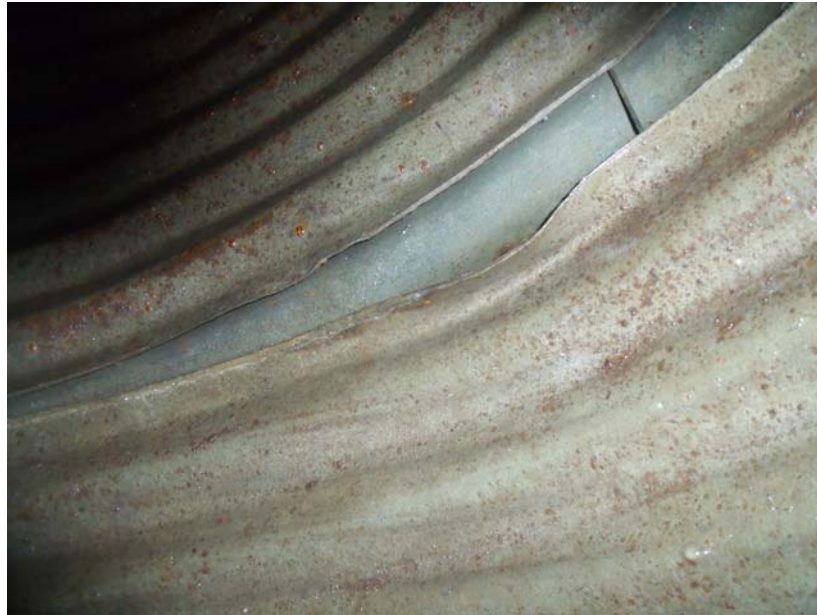
3. Open Joint 1

Figure 5: Open joint 1 - Looking downstream

Figure 6: Open Joint 1 – Looking west from middle of pipe showing extent of opening

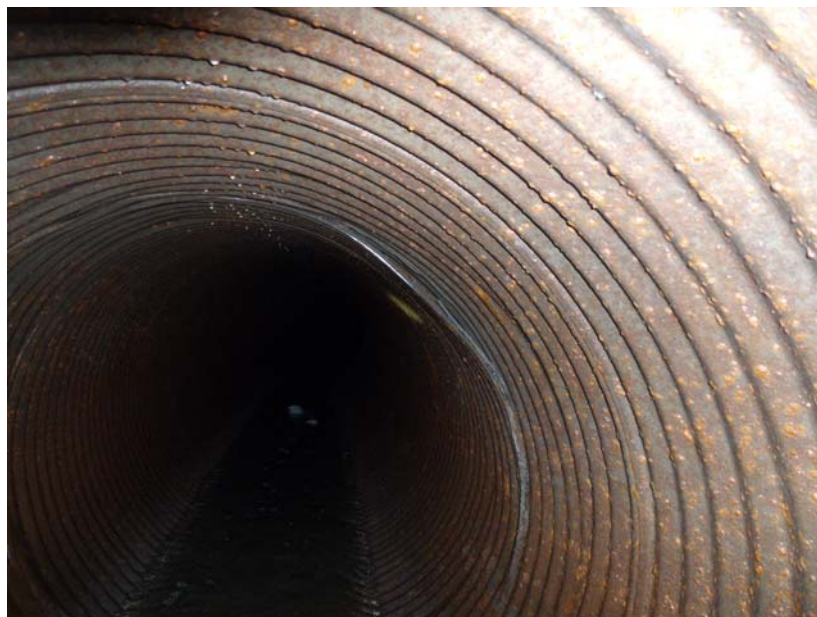
4. Open Joint 2

- Pipe appears to be out of round in the upper west quadrant of the pipe (Top right in Figure 7)

Figure 7: Open Joint 2 – Looking down stream

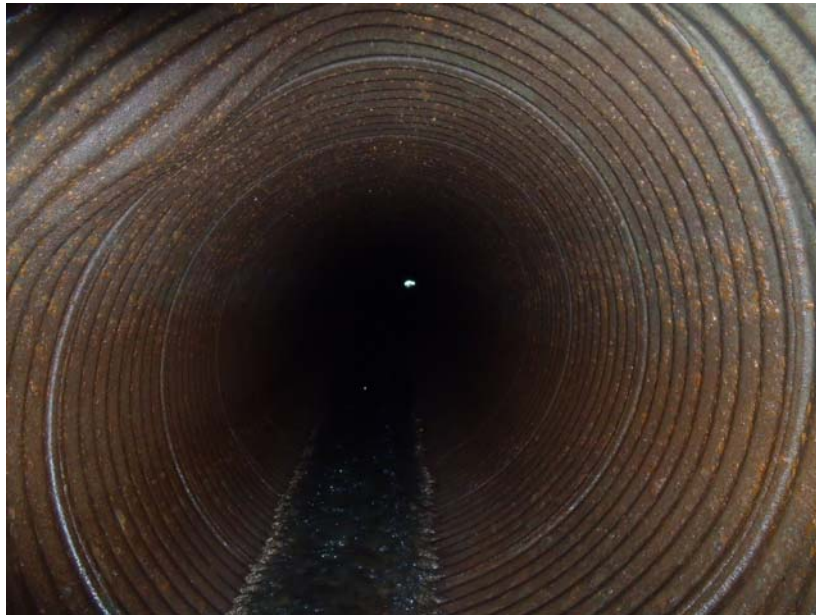
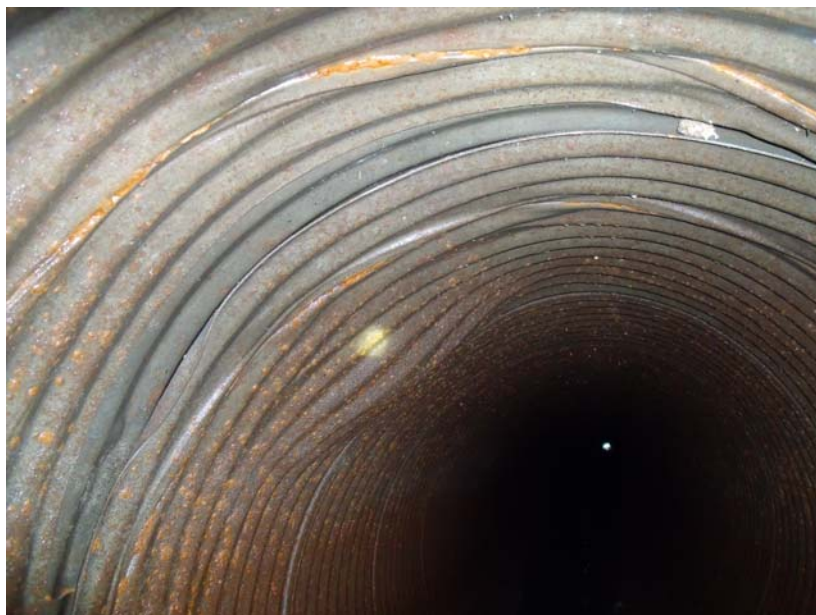
5. Deformed Sewer at Joint

- Pipe is deformed on upper east quadrant of the pipe (Top left in Figures 8 & 9)
- Joint is open

Figure 8: Deformed sewer at Joint – looking downstream

Figure 9: Deformed sewer at Joint – Looking at bulge in pipe
