**Re: NEWPCC Digester Number 11 – Condition Assessment of Roof**

MMM Group Limited (MMM) is pleased to present this condition assessment report of the cast-in-place two way concrete roof slab of Digester 11 at the North End Water Pollution Control Centre (NEWPCC).

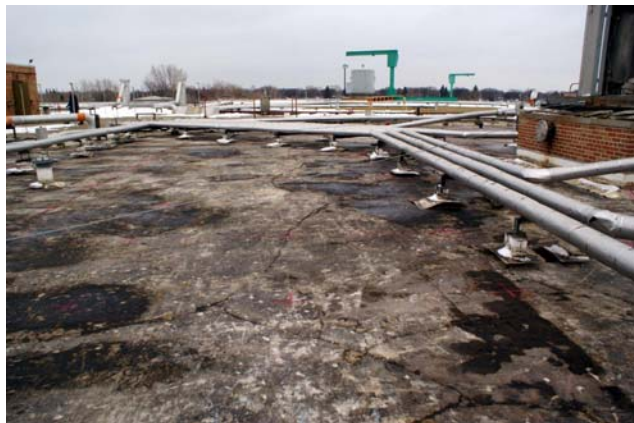
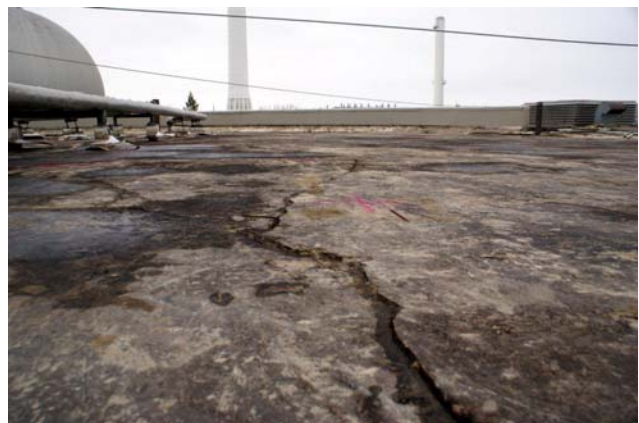
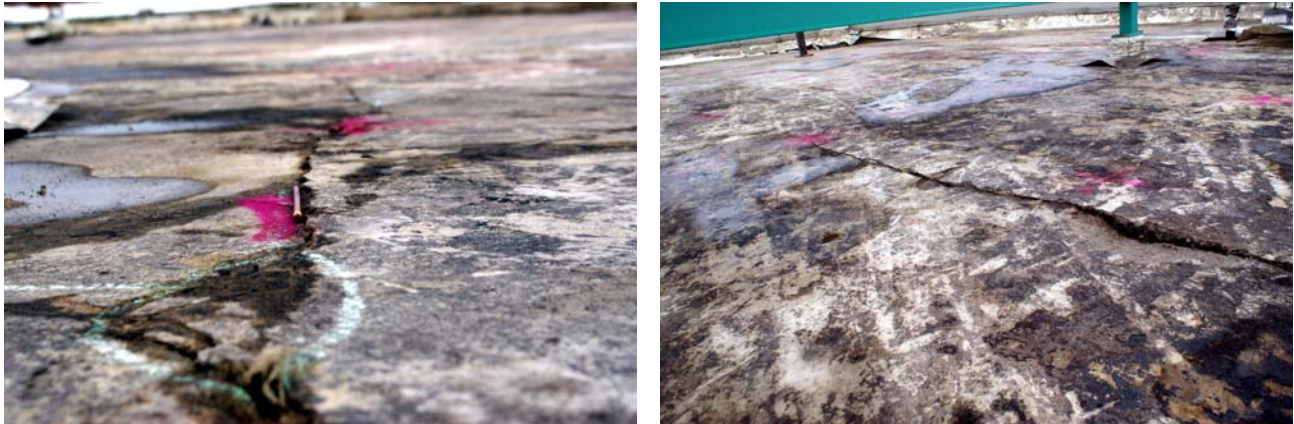
The extensive hairline cracking appears to have been caused by concrete shrinkage, whereas the larger cracks appear to be as a result of structural failure of the slab (see photos below).

This failure was likely the result of over pressurization of the interior of the digester that caused a stress reversal of the concrete slab so that a negative bending was induced into the middle strip region that was designed only for positive bending.

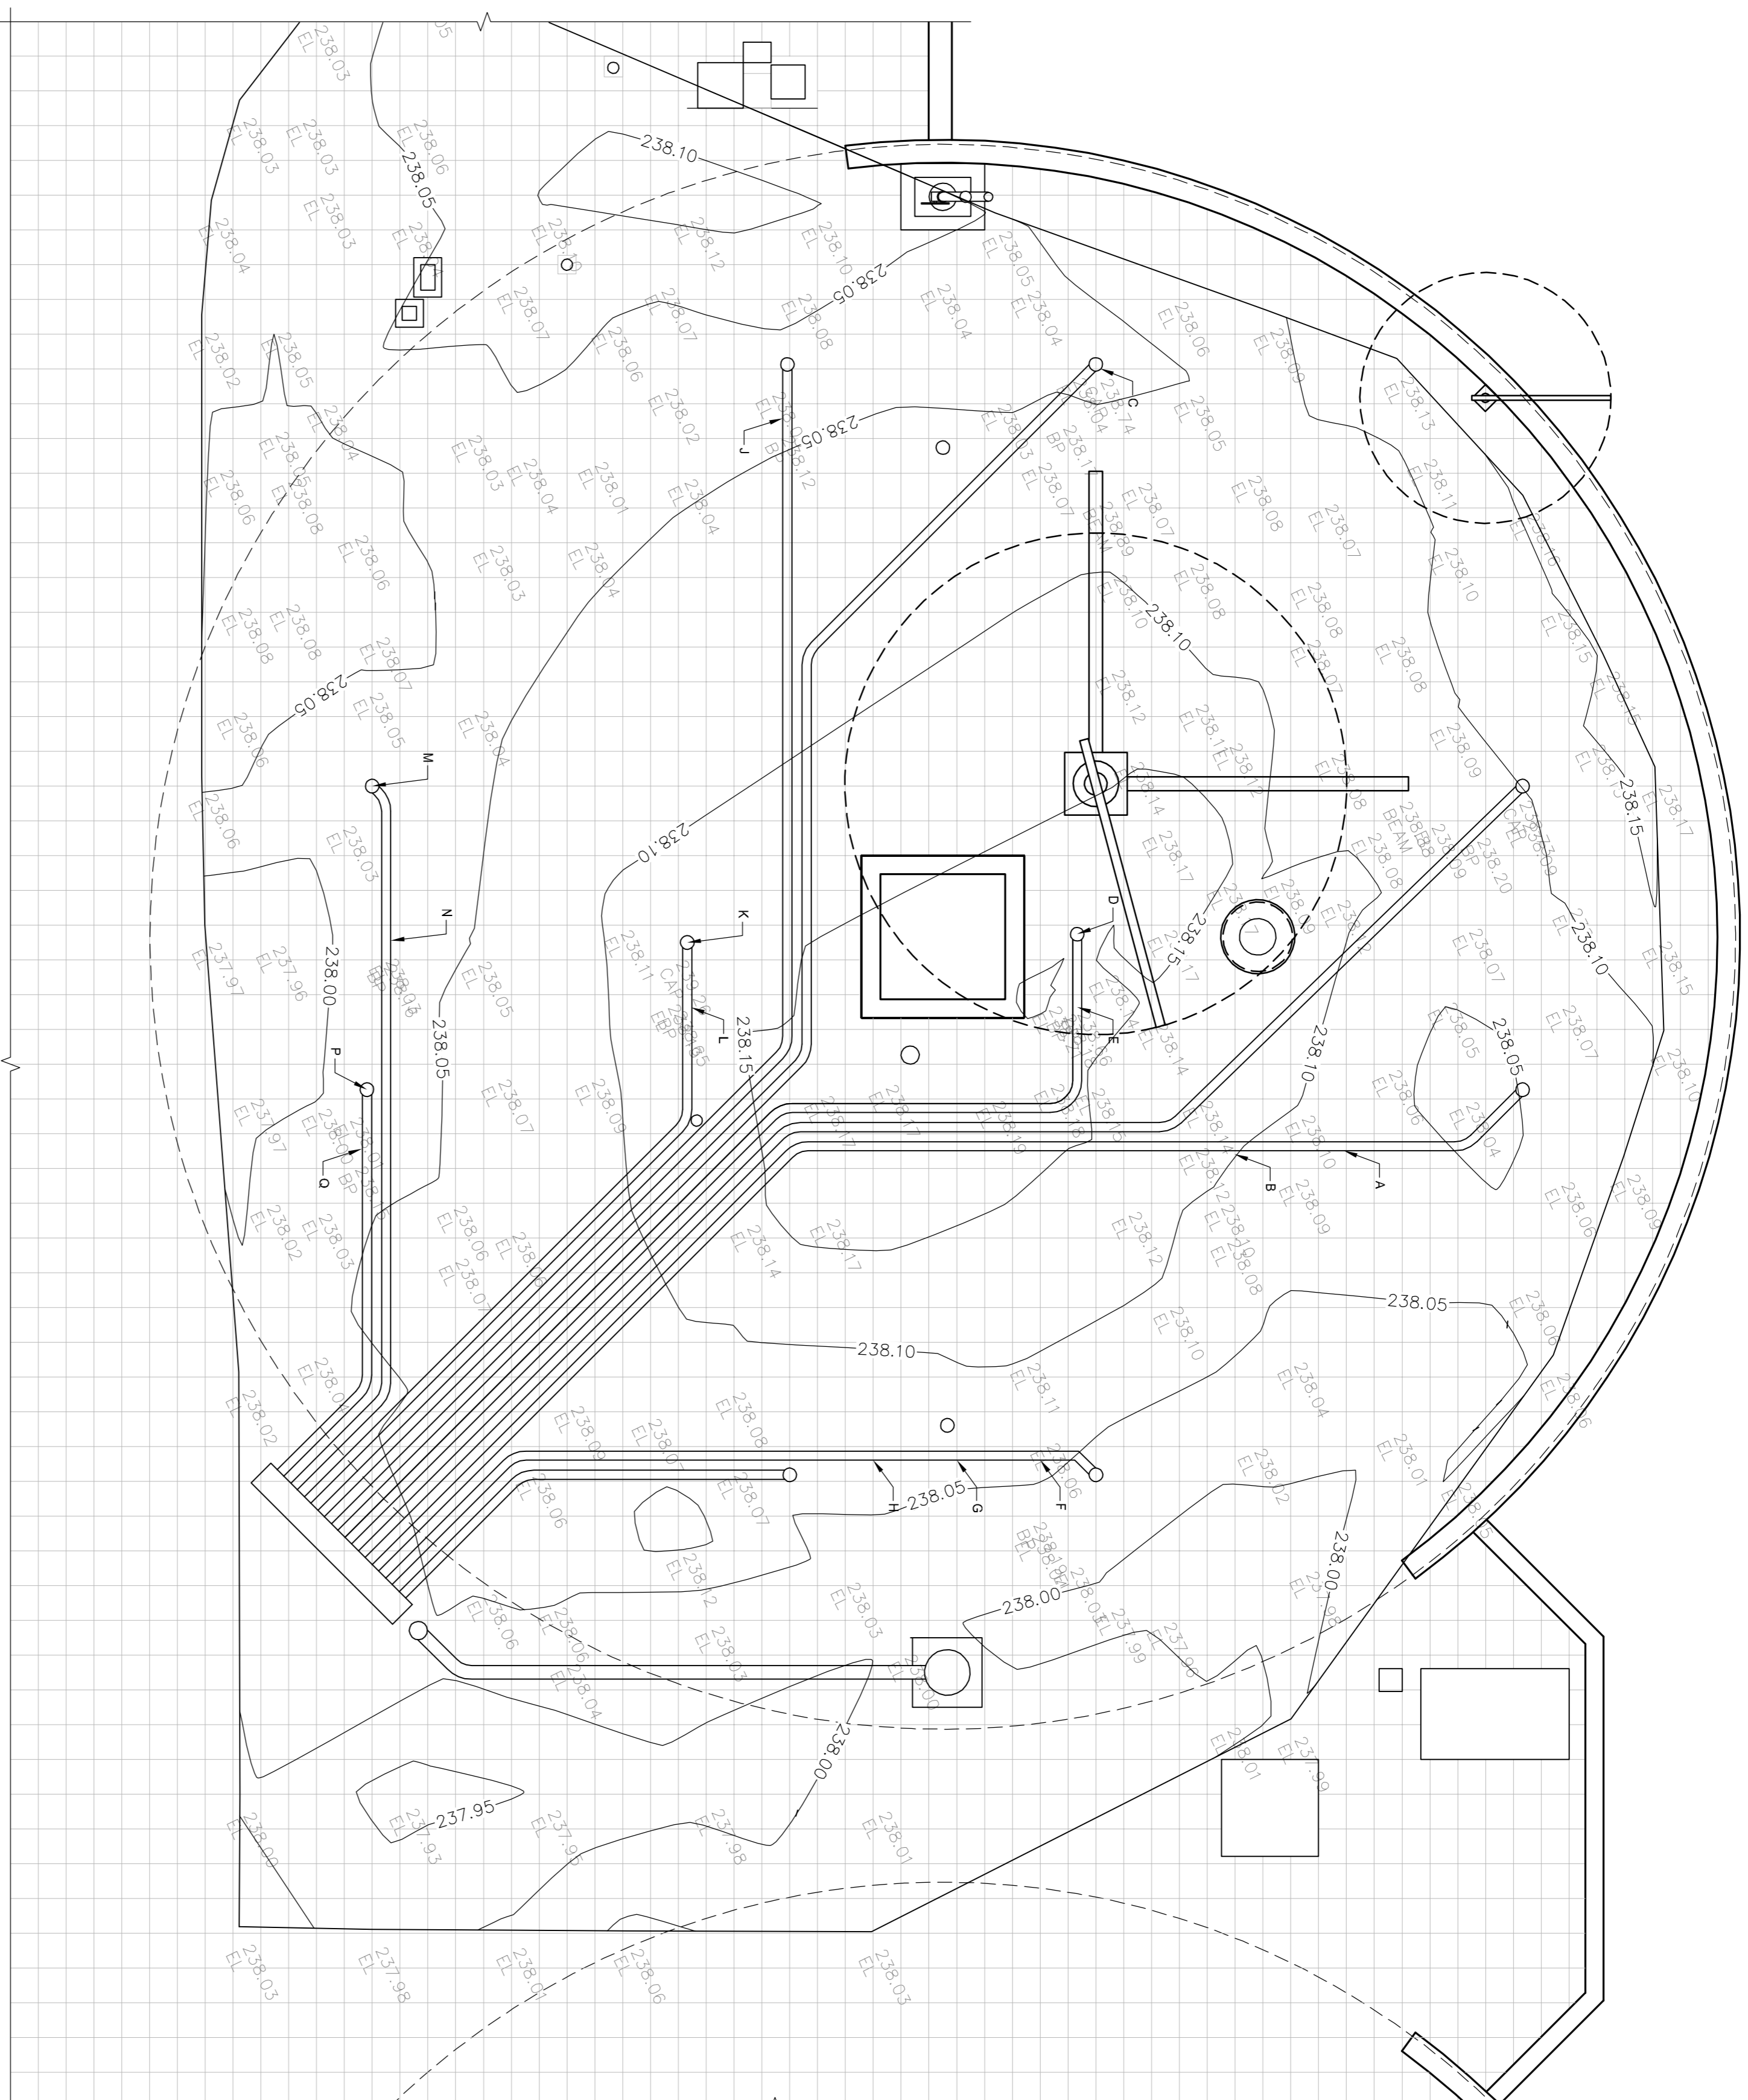
DIGESTER #11 - PAVES SURVEY PLAN  
 1:100

MMM surveyed the top of the roof pavers on December 4, 2009 to record the event and also to estimate the maximum deformation of the roof based on piping damage. The results of this survey can be seen on the attached drawing 5509123-C-01.

LOCATION	'A'
A	75mm
B	75mm
C	100mm
D	500mm
E	480mm
F	125mm
G	100mm
H	75mm
J	60mm
K	50mm
L	125mm
M	100mm
N	75mm
P	75mm
Q	75mm

'A' equals the measured girth of mechanical piping base on field observation of damage, measured on December 4, 2009.

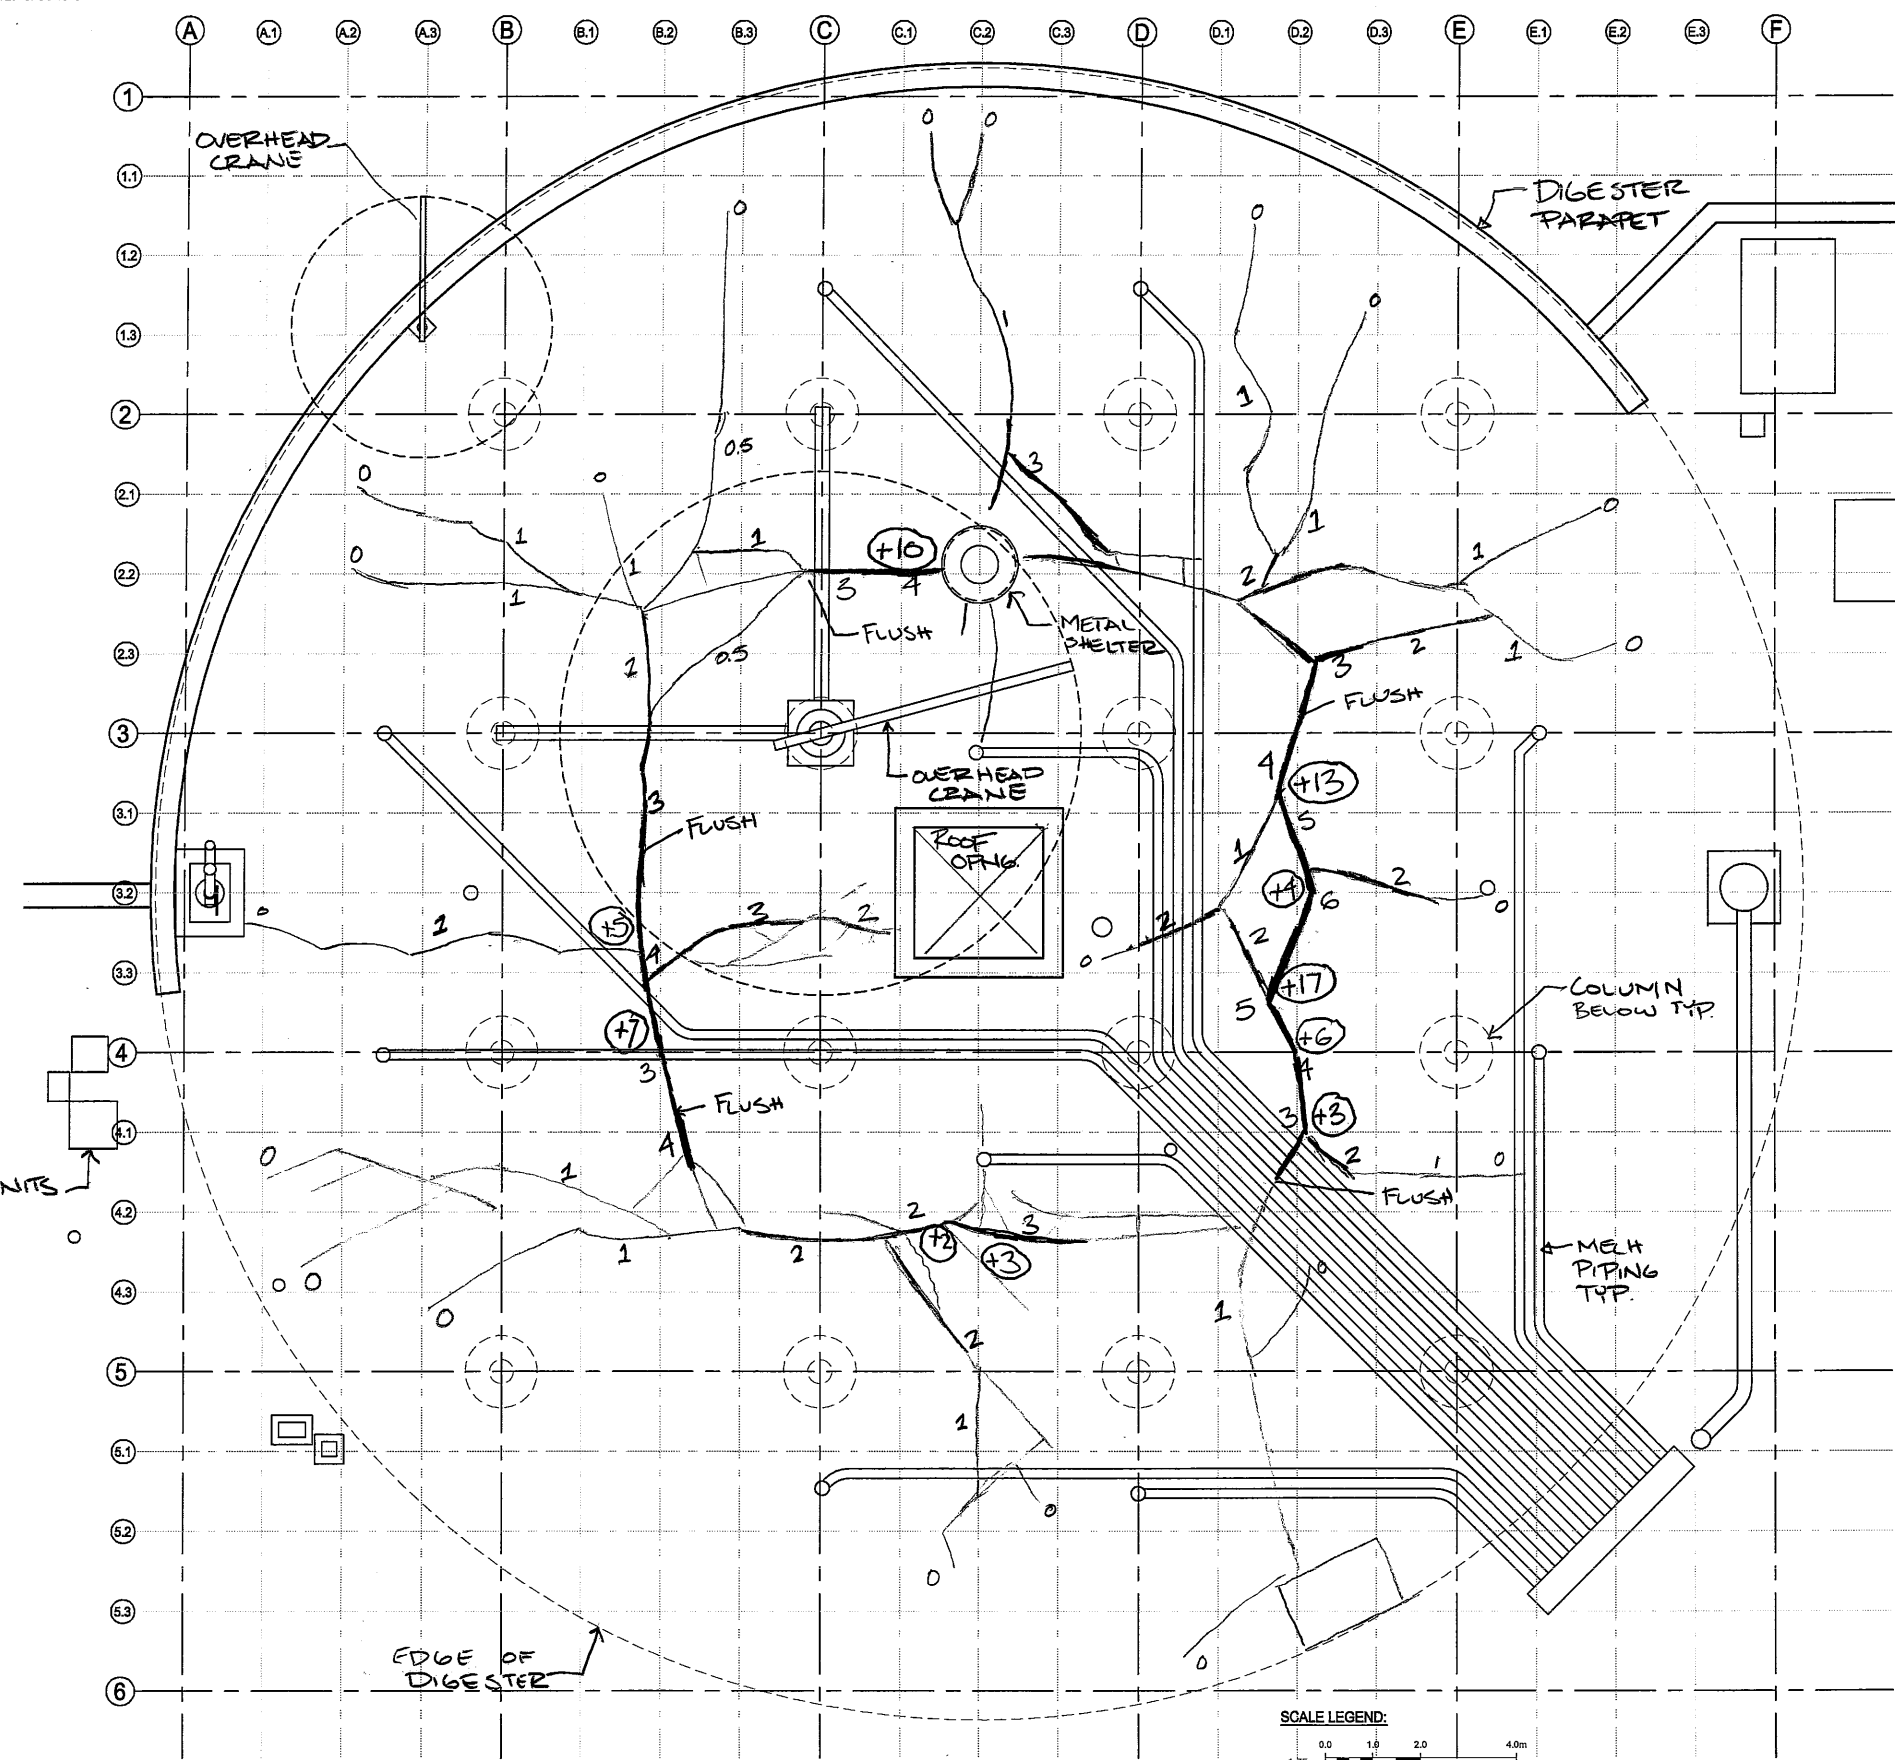
**DIGESTER #11 - ROOF SURFACE CRACK MAP**  
OBSERVED ON JANUARY 22/2010  
BY CARLIN LETKEMAN (MMM GROUP) A/C

- Numerous cracks were observed ranging in width from hairline to 6 mm. These cracks appear to have been created years ago. A drawing indicating the mapped cracks is attached (dwg. 5509123-C-02);
- Several spalls were observed in the surface of the roof; and
- The concrete at the location of the larger cracks is displaced vertically relative to each side of the crack. (i.e. the concrete is dropped on one side of the crack). These measurements are also shown on the attached drawing.

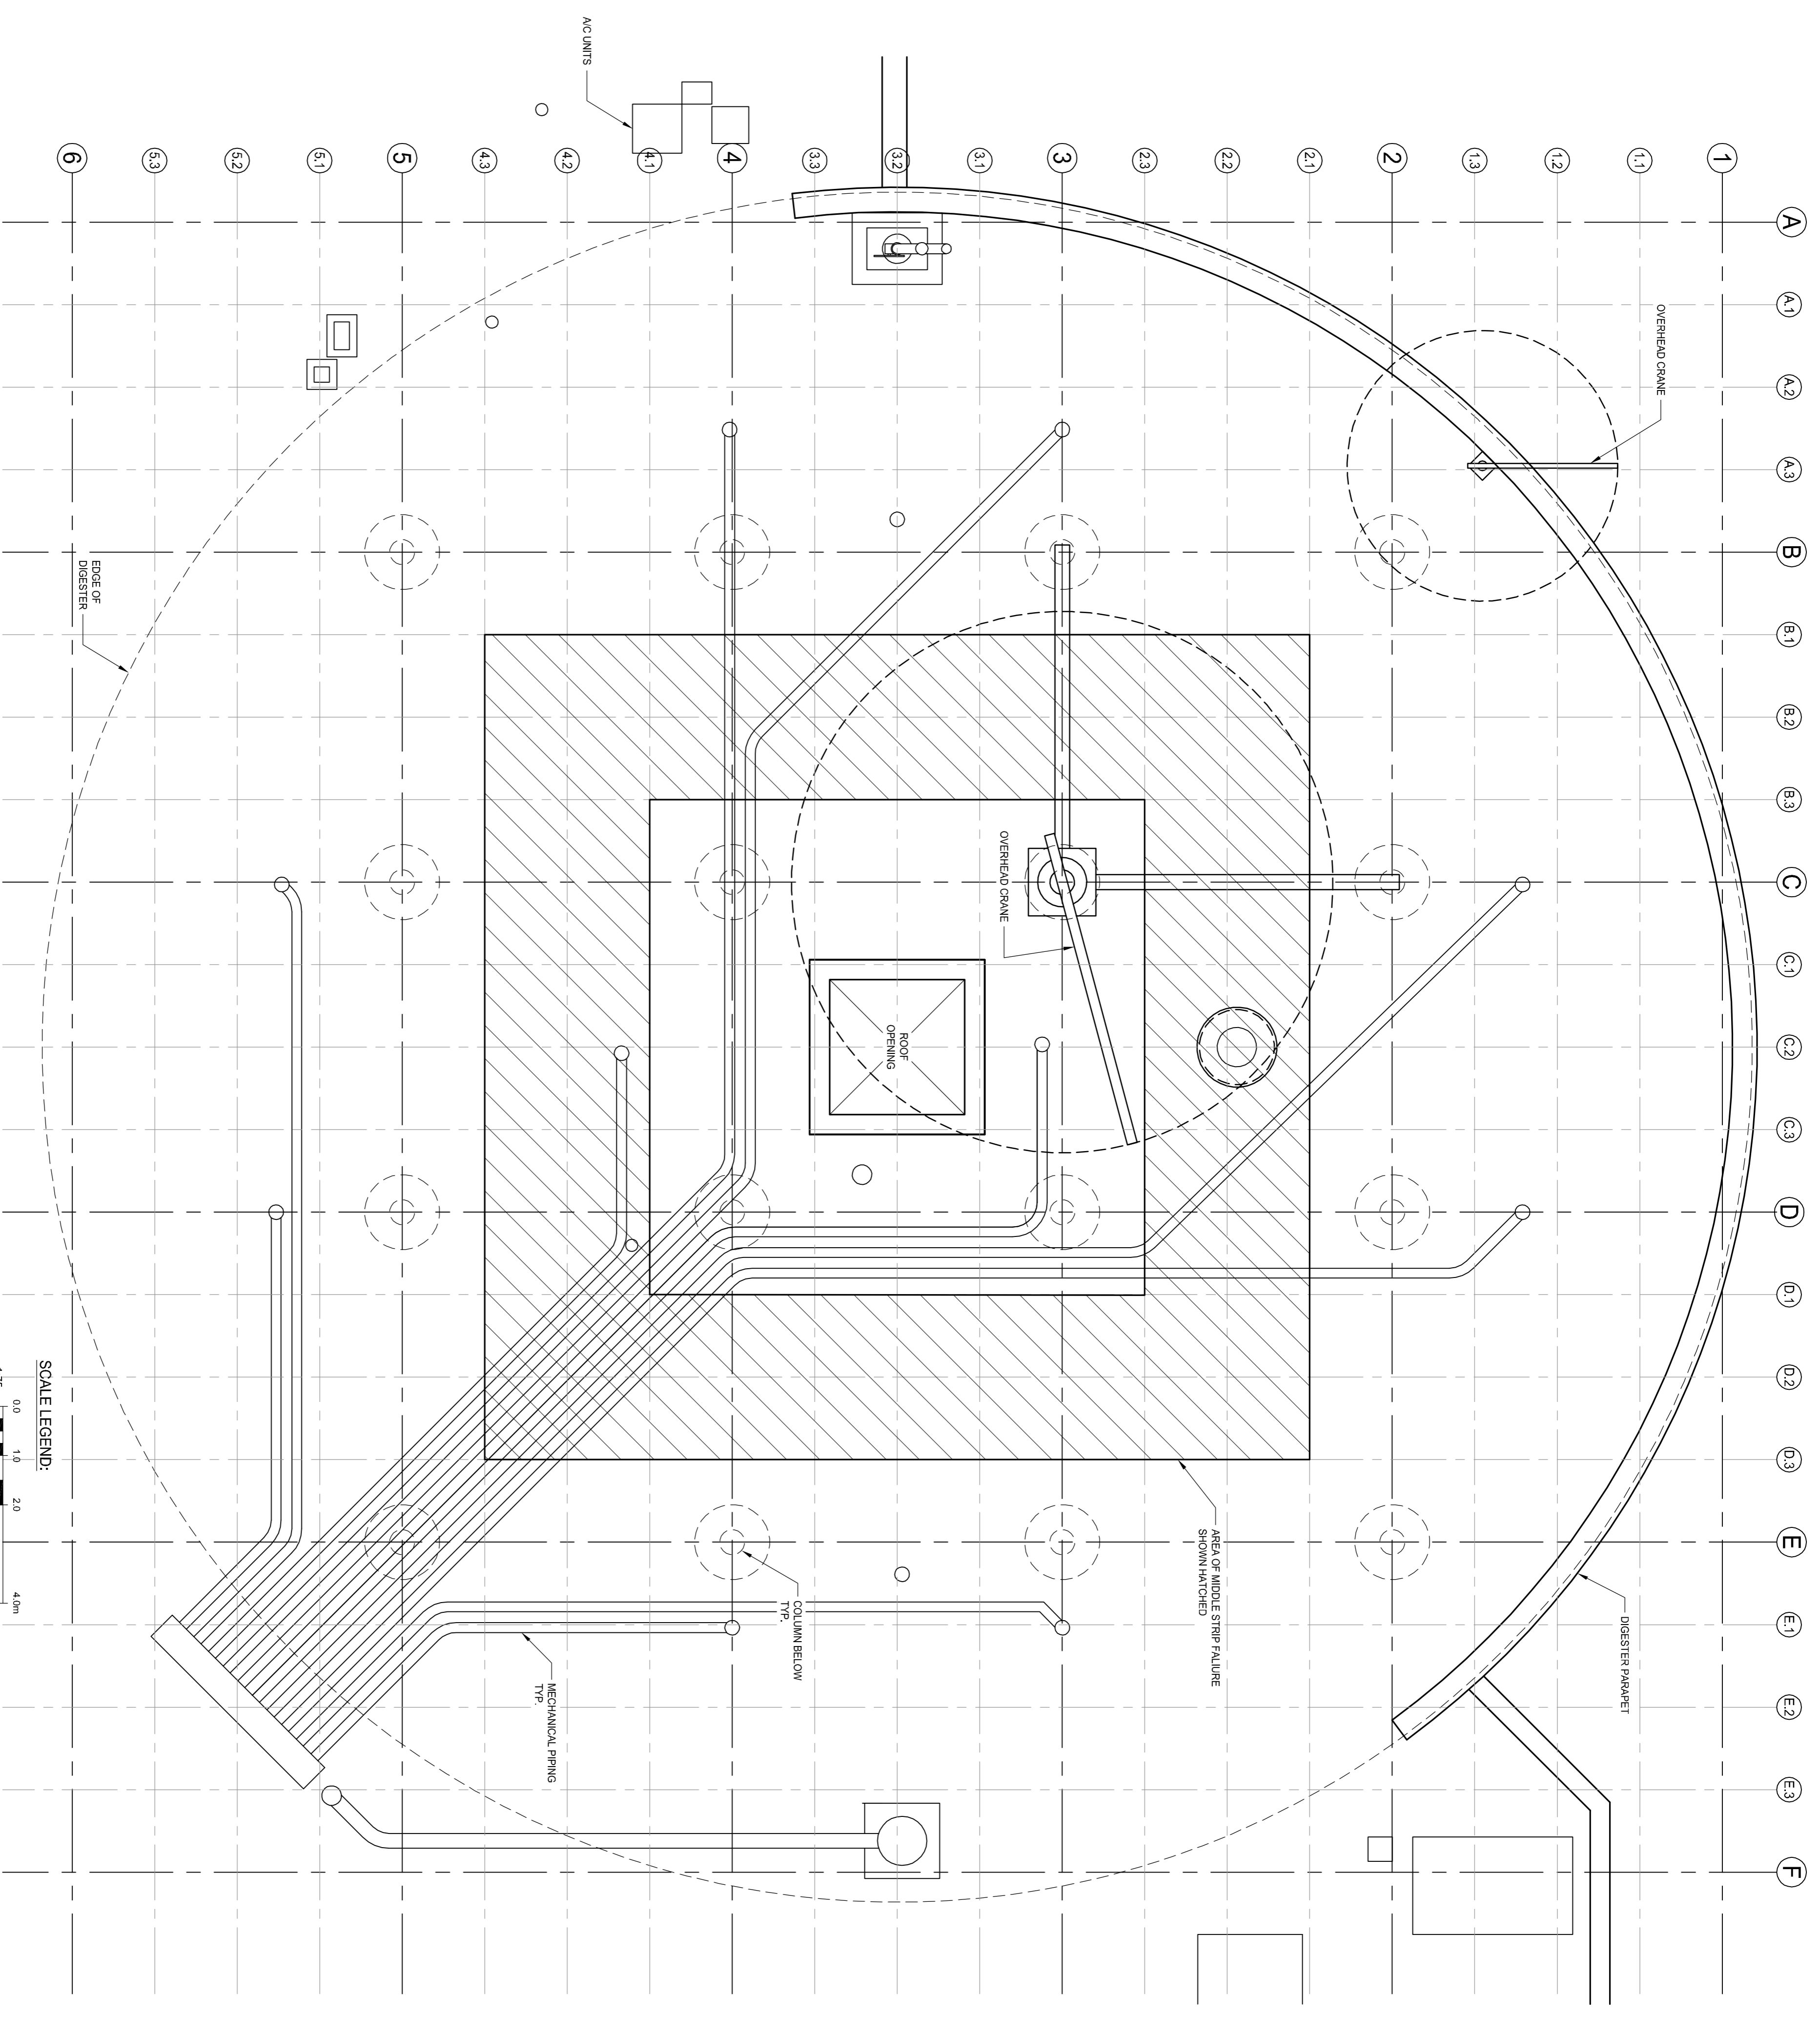
NORTH END POLLUTION CONTROL CENTRE  
**DIGESTER #11**  
**ROOF REPAIR**  
 MIDDLE STRIP FAILURE PLAN - FEB 1, 2010

It is our opinion that the roof slab has failed along a middle strip roughly concentric about the centre of the digester. We recommend that no additional load be applied to the failed area shown on the attached drawing 5509123-C-03. Access to the interior of the digester is allowed only if the indicated area remains unloaded (i.e. no snow loading, water loading, etc.).

It is also recommended that any heavy point loads that must be placed on the roof be located directly over column locations.
