**GEOTECHNICAL INVESTIGATION AND
ENGINEERING REPORT FOR
FERMOR AVENUE OUTFALL
MAGER COMBINED SEWER DISTRICT
SEWER SEPARATION
WINNIPEG, MANITOBA**

Prepared for
STANTEC
905 WAVERLEY STREET
WINNIPEG, MANITOBA
R3T 5P4

Prepared by
THE NATIONAL TESTING LABORATORIES LIMITED
199 HENLOW BAY
WINNIPEG, MANITOBA
R3Y 1G4

December 7, 2010

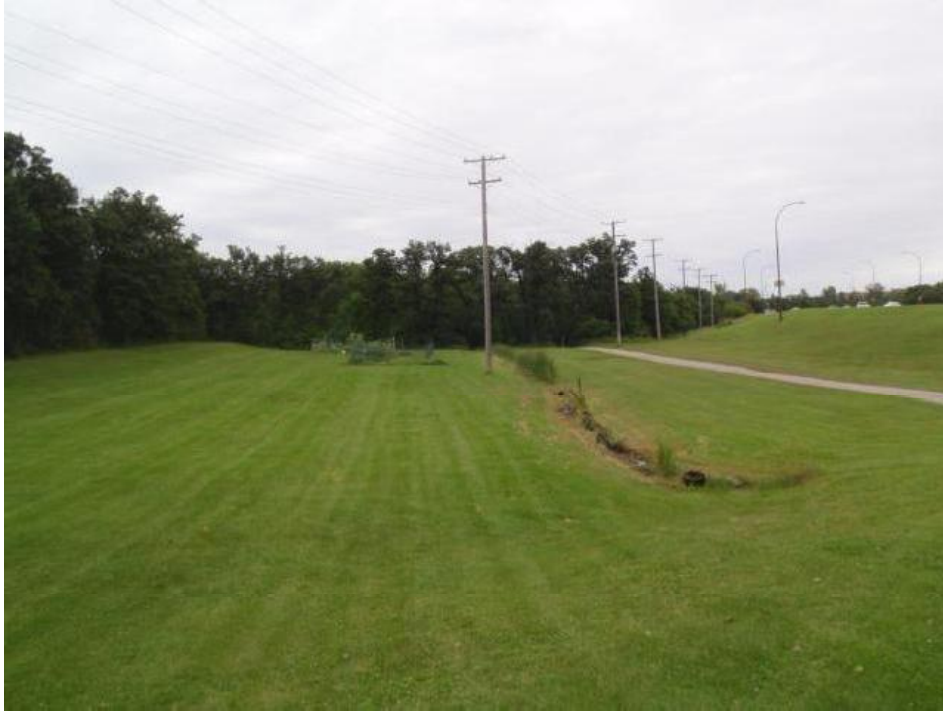
Photo 1: Grass covered upper bank area looking east towards the Seine River. Pedestrian path and drainage ditch visible on right side of photo.

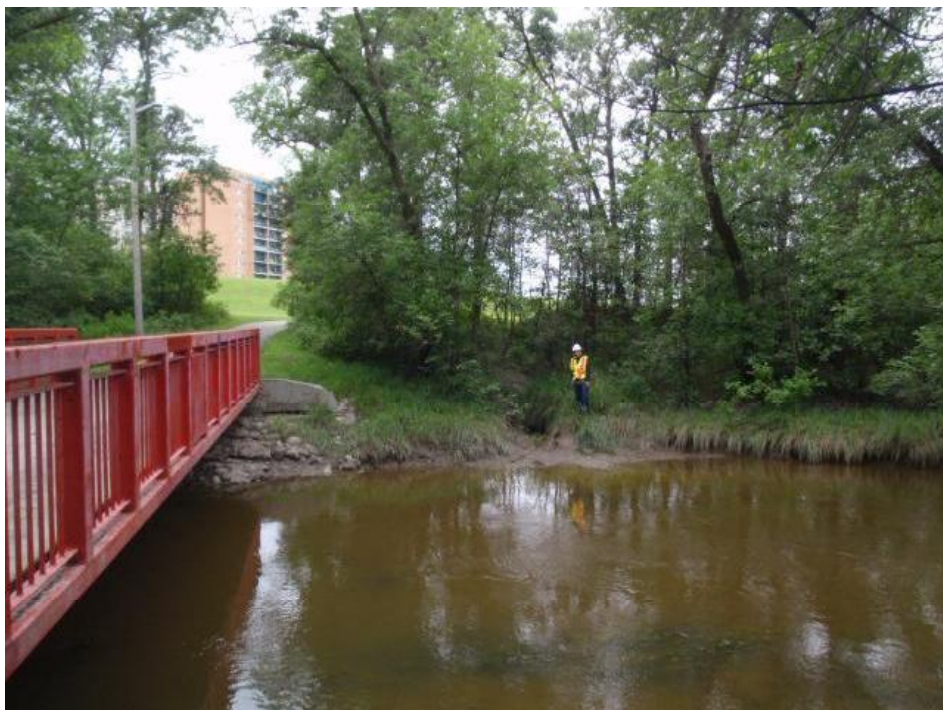
Photo 2: Pedestrian bridge and west bank of the Seine River. Proposed LDS pipe outfall location near right side of photo.

The outfall pipe should conform to the existing bank geometry to reduce potential erosion of the riverbank adjacent to the outfall. Installation of riprap at the discharge point and on either side of the outfall is recommended to minimize erosion of the riverbank. It is also recommended that the riprap be extended to the pedestrian bridge located approximately 10 m upstream of the proposed outfall location.

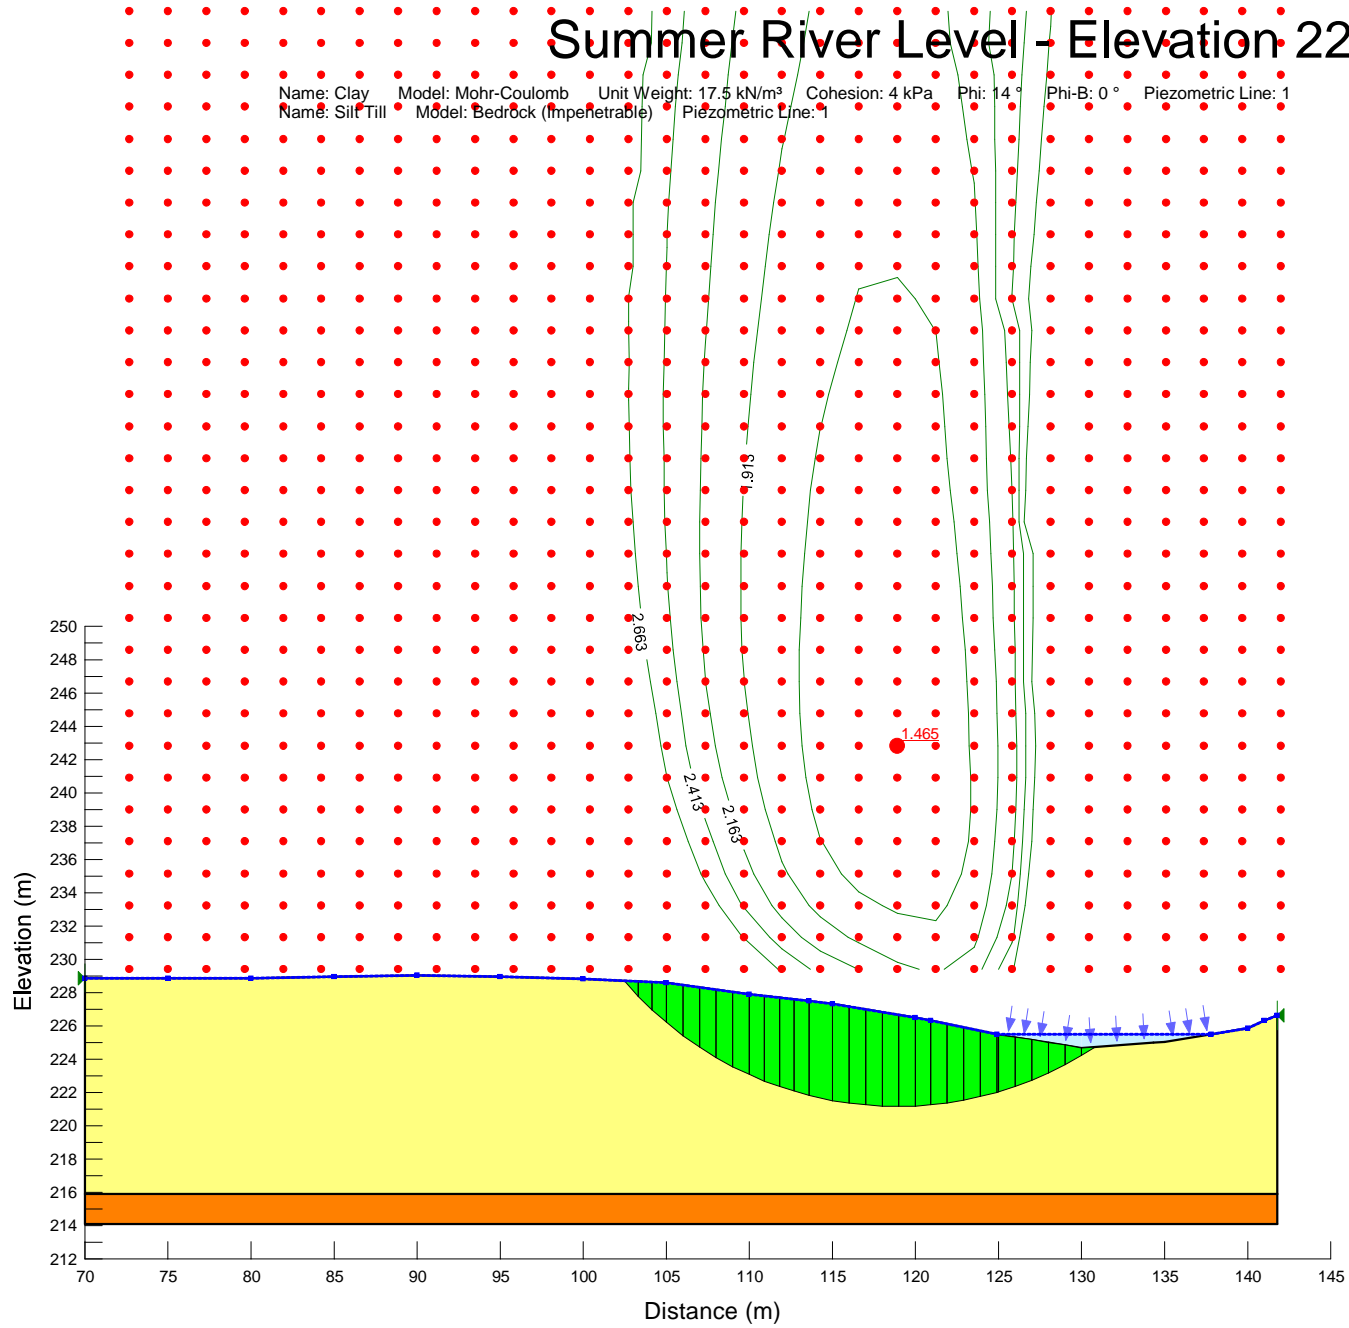
Summer River Level - Elevation: 225.5 m

A minimum factor of safety of 1.4 is considered acceptable for construction of the proposed outfall. Based upon the modelled riverbank geometry, the soil shear strength parameters and the Seine River water levels, the estimated Factors of Safety for the critical slip surfaces are 1.5 for summer conditions and 1.4 for winter conditions. For both summer and winter conditions, the modeled critical failure surface viewed through a cross section of the riverbank begins near the top of the relatively flat upper bank area. Results of the slope stability analysis indicate the critical failure surface will intersect the top of the riverbank approximately 20 to 25 m from the Seine River. The critical failure surface extends along a concave-up arc towards the river and exits near the deepest point of the Seine River. Outputs from the stability analysis showing the critical failure surface are provided in Appendix E.
