# **APPENDIX “A”**

<b>Project Name:</b>	<b>City of Winnipeg, Administration Bldg.</b>		
	<b>North End Water Pollution Control Centre, 2230 Main St., Winnipeg, MB</b>		
<b>Project No.:</b>	<b>68112</b>		
<b>Prepared For:</b>	<b>L. Cruz / J. Combe</b>	<b>Date Received:</b>	<b>May 16, 2011</b>
<b>Lab Reference No.:</b>	<b>b80899</b>	<b>Date Analyzed:</b>	<b>May 25, 2011</b>
<b>Analyst(s):</b>	<b>N. Barinque</b>	<b># Samples submitted:</b>	<b>5</b>
		<b># Phases analyzed:</b>	<b>5</b>

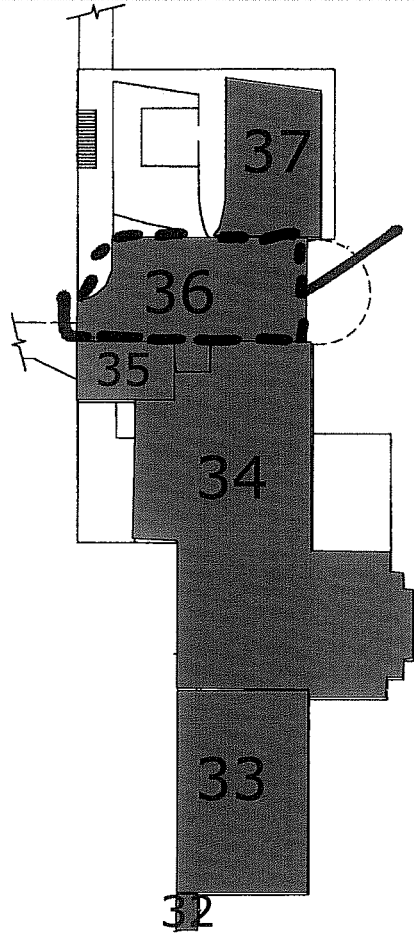
PROJECT  
AREA

**Note:** Parging debris on dirt. Lab report b80899, Sample No 0004. Project 68112 reflected as Sample 0010 in HMIS

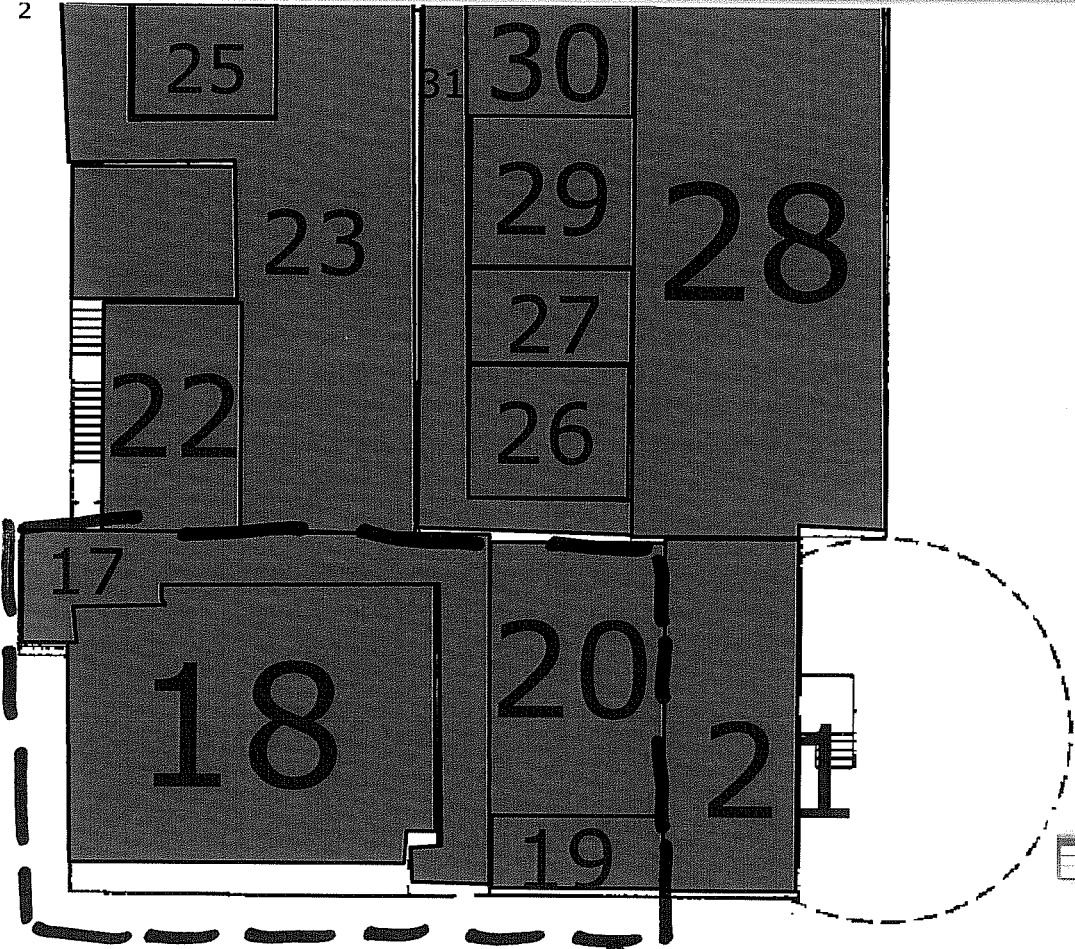
PROJECT  
AREA

**Note:** Mastic sealant on seams of galvanized ductwork contains Chrysotile Asbestos, Lab report b80899 Sample No. 0003 Project 68112 reflected as Sample 0009 in HMIS
