APPENDIX 'A' - GEOTECHNICAL REPORT

Geotechnical Report for Bison Drive and Pembina Highway (April 2011)

PEMBINA HIGHWAY AND BISON DRIVE GEOTECHNICAL INVESTIGATION

Geotechnical Report for Bison Drive and Pembina Highway (May 2011)

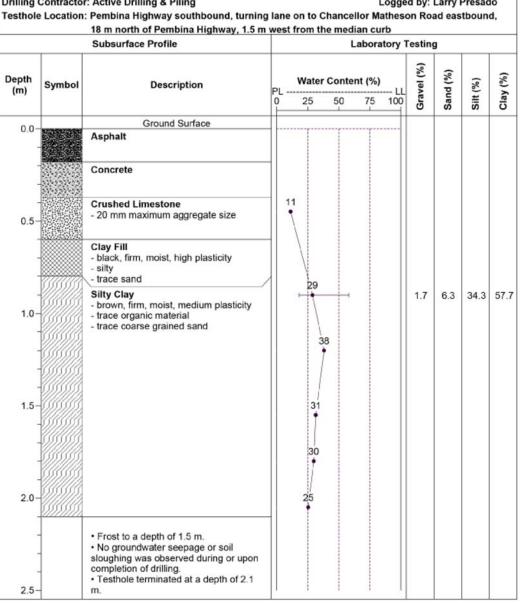
Test Hole Log for TH3-

TESTHOLE TH3

Date Drilled: March 25, 2011 Depth of Testhole: 2.1 m Logged by: Larry Presado
