October 23, 2008
Stantec File: 113731470

Reference: City of Winnipeg GWWD Bridge Inspections
Deacon Railway Bridge (buried) – Initial Inspection Results

**Reference: City of Winnipeg GWWD Bridge Inspections
Initial Results of the Inspection of the Deacon Bridge**

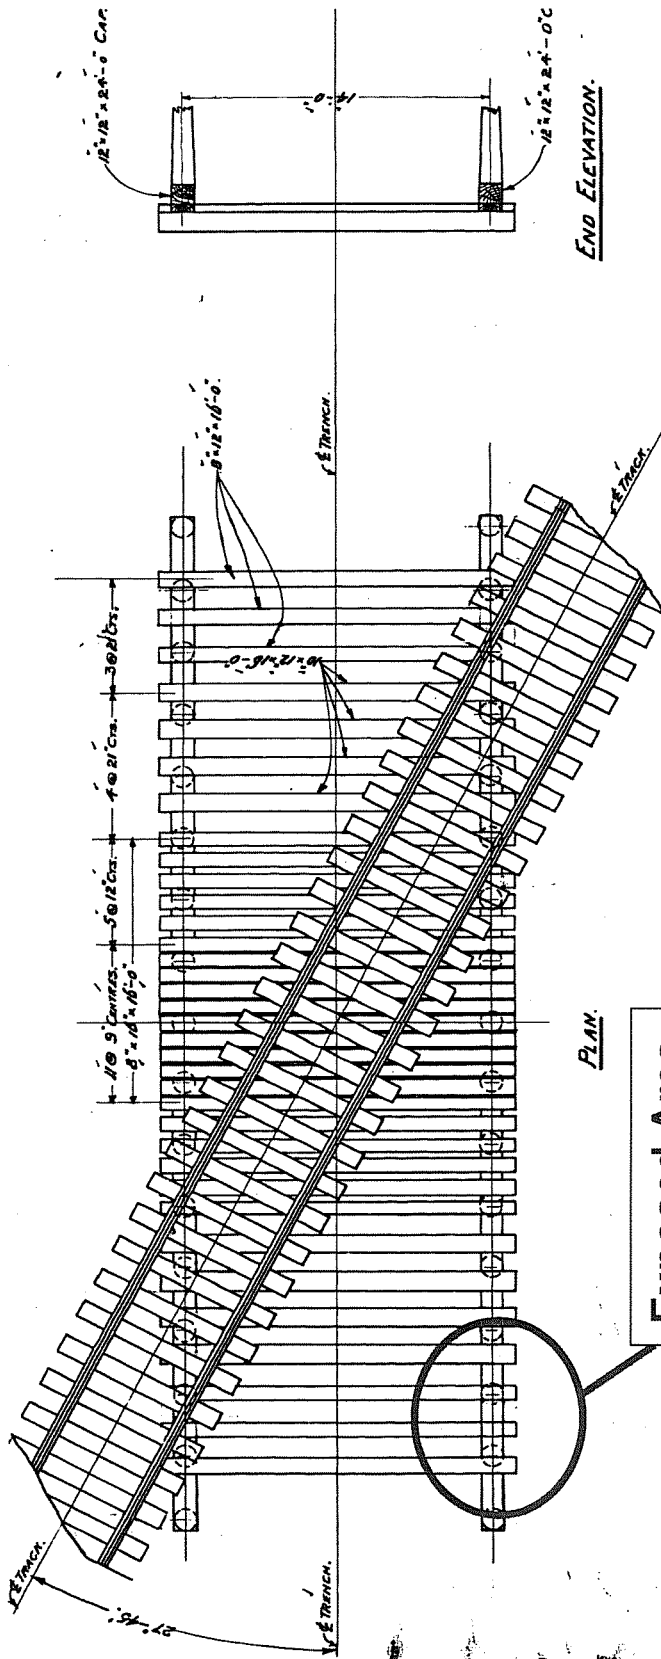
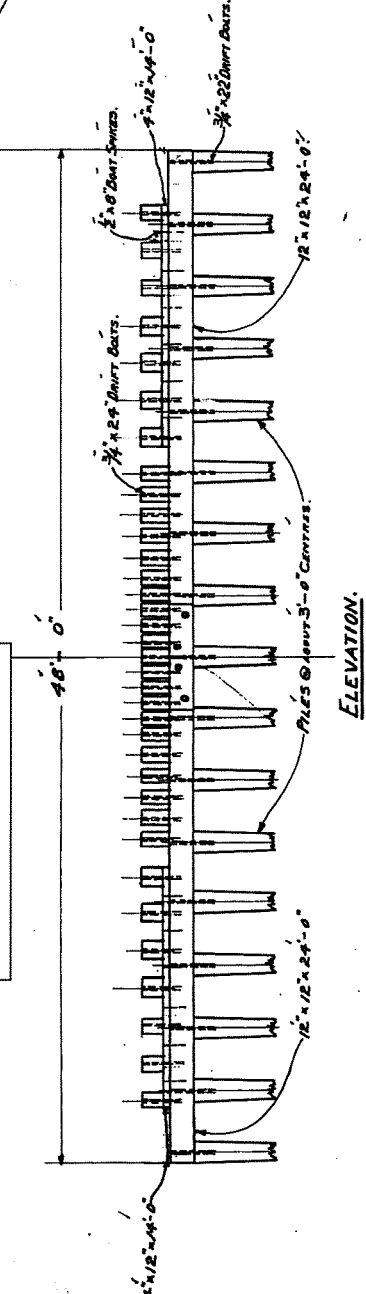
Figure 1

Exposed Area
