NEWPCC Secondary Clarifier #1
Examination
December 03, 2010

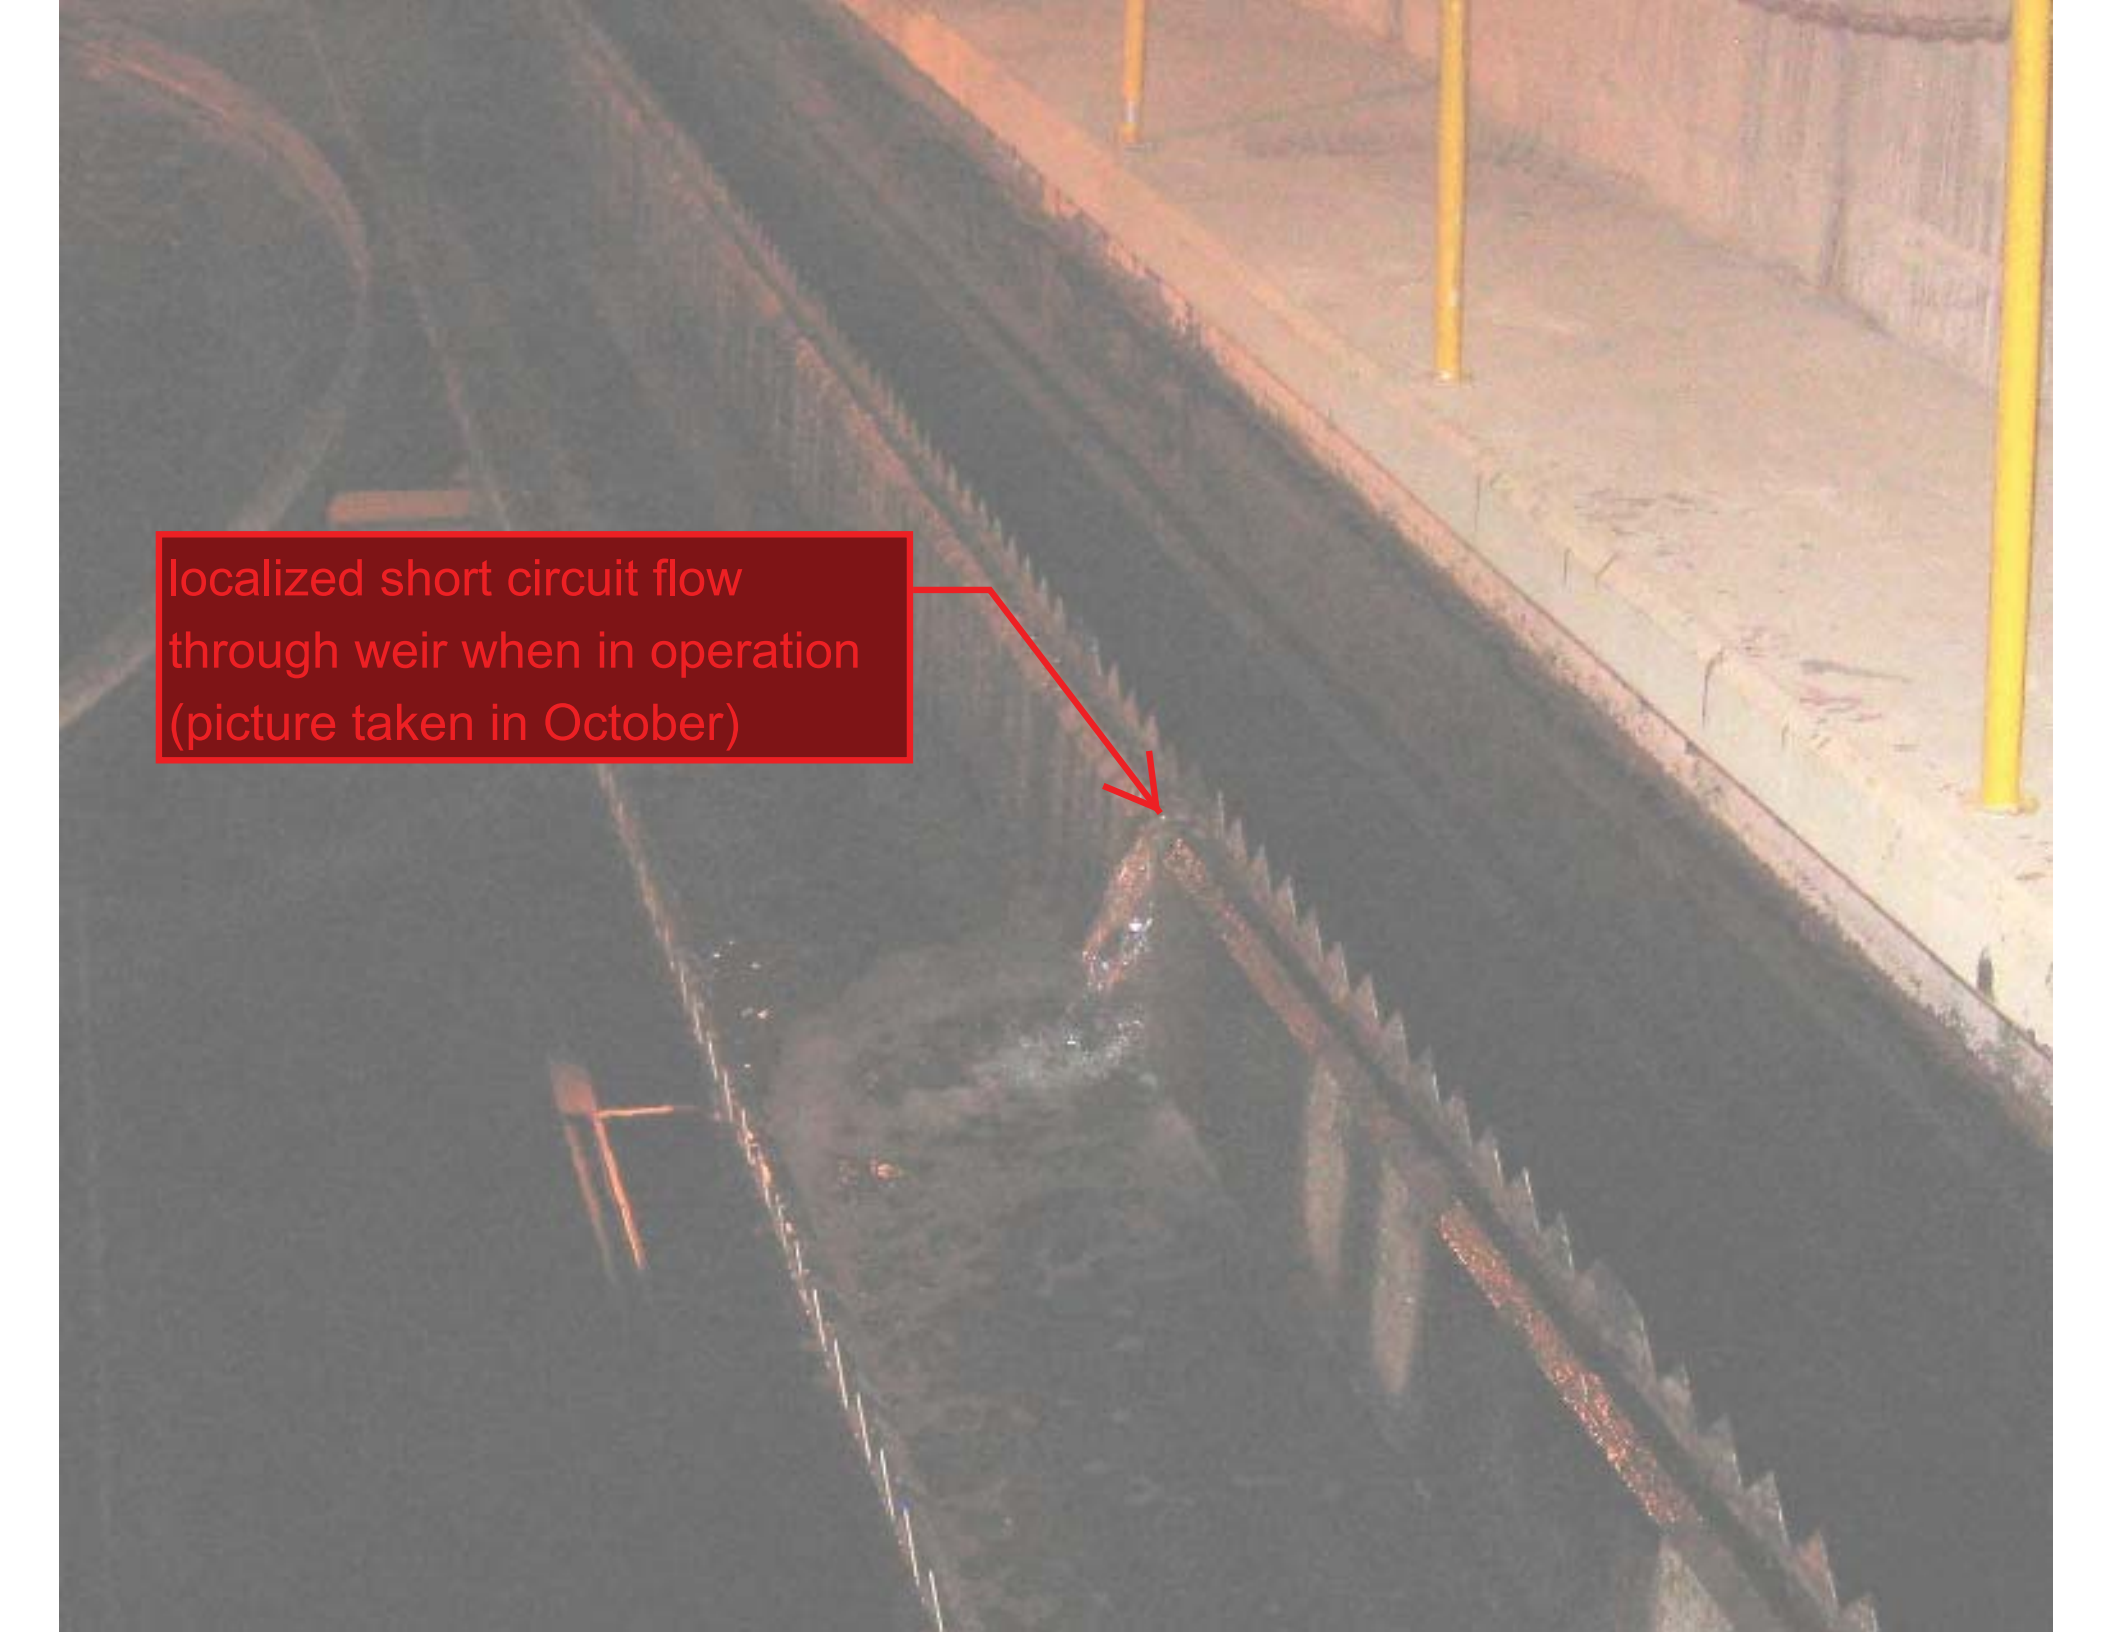
localized short circuit flow
through weir when in operation
(picture taken in October)

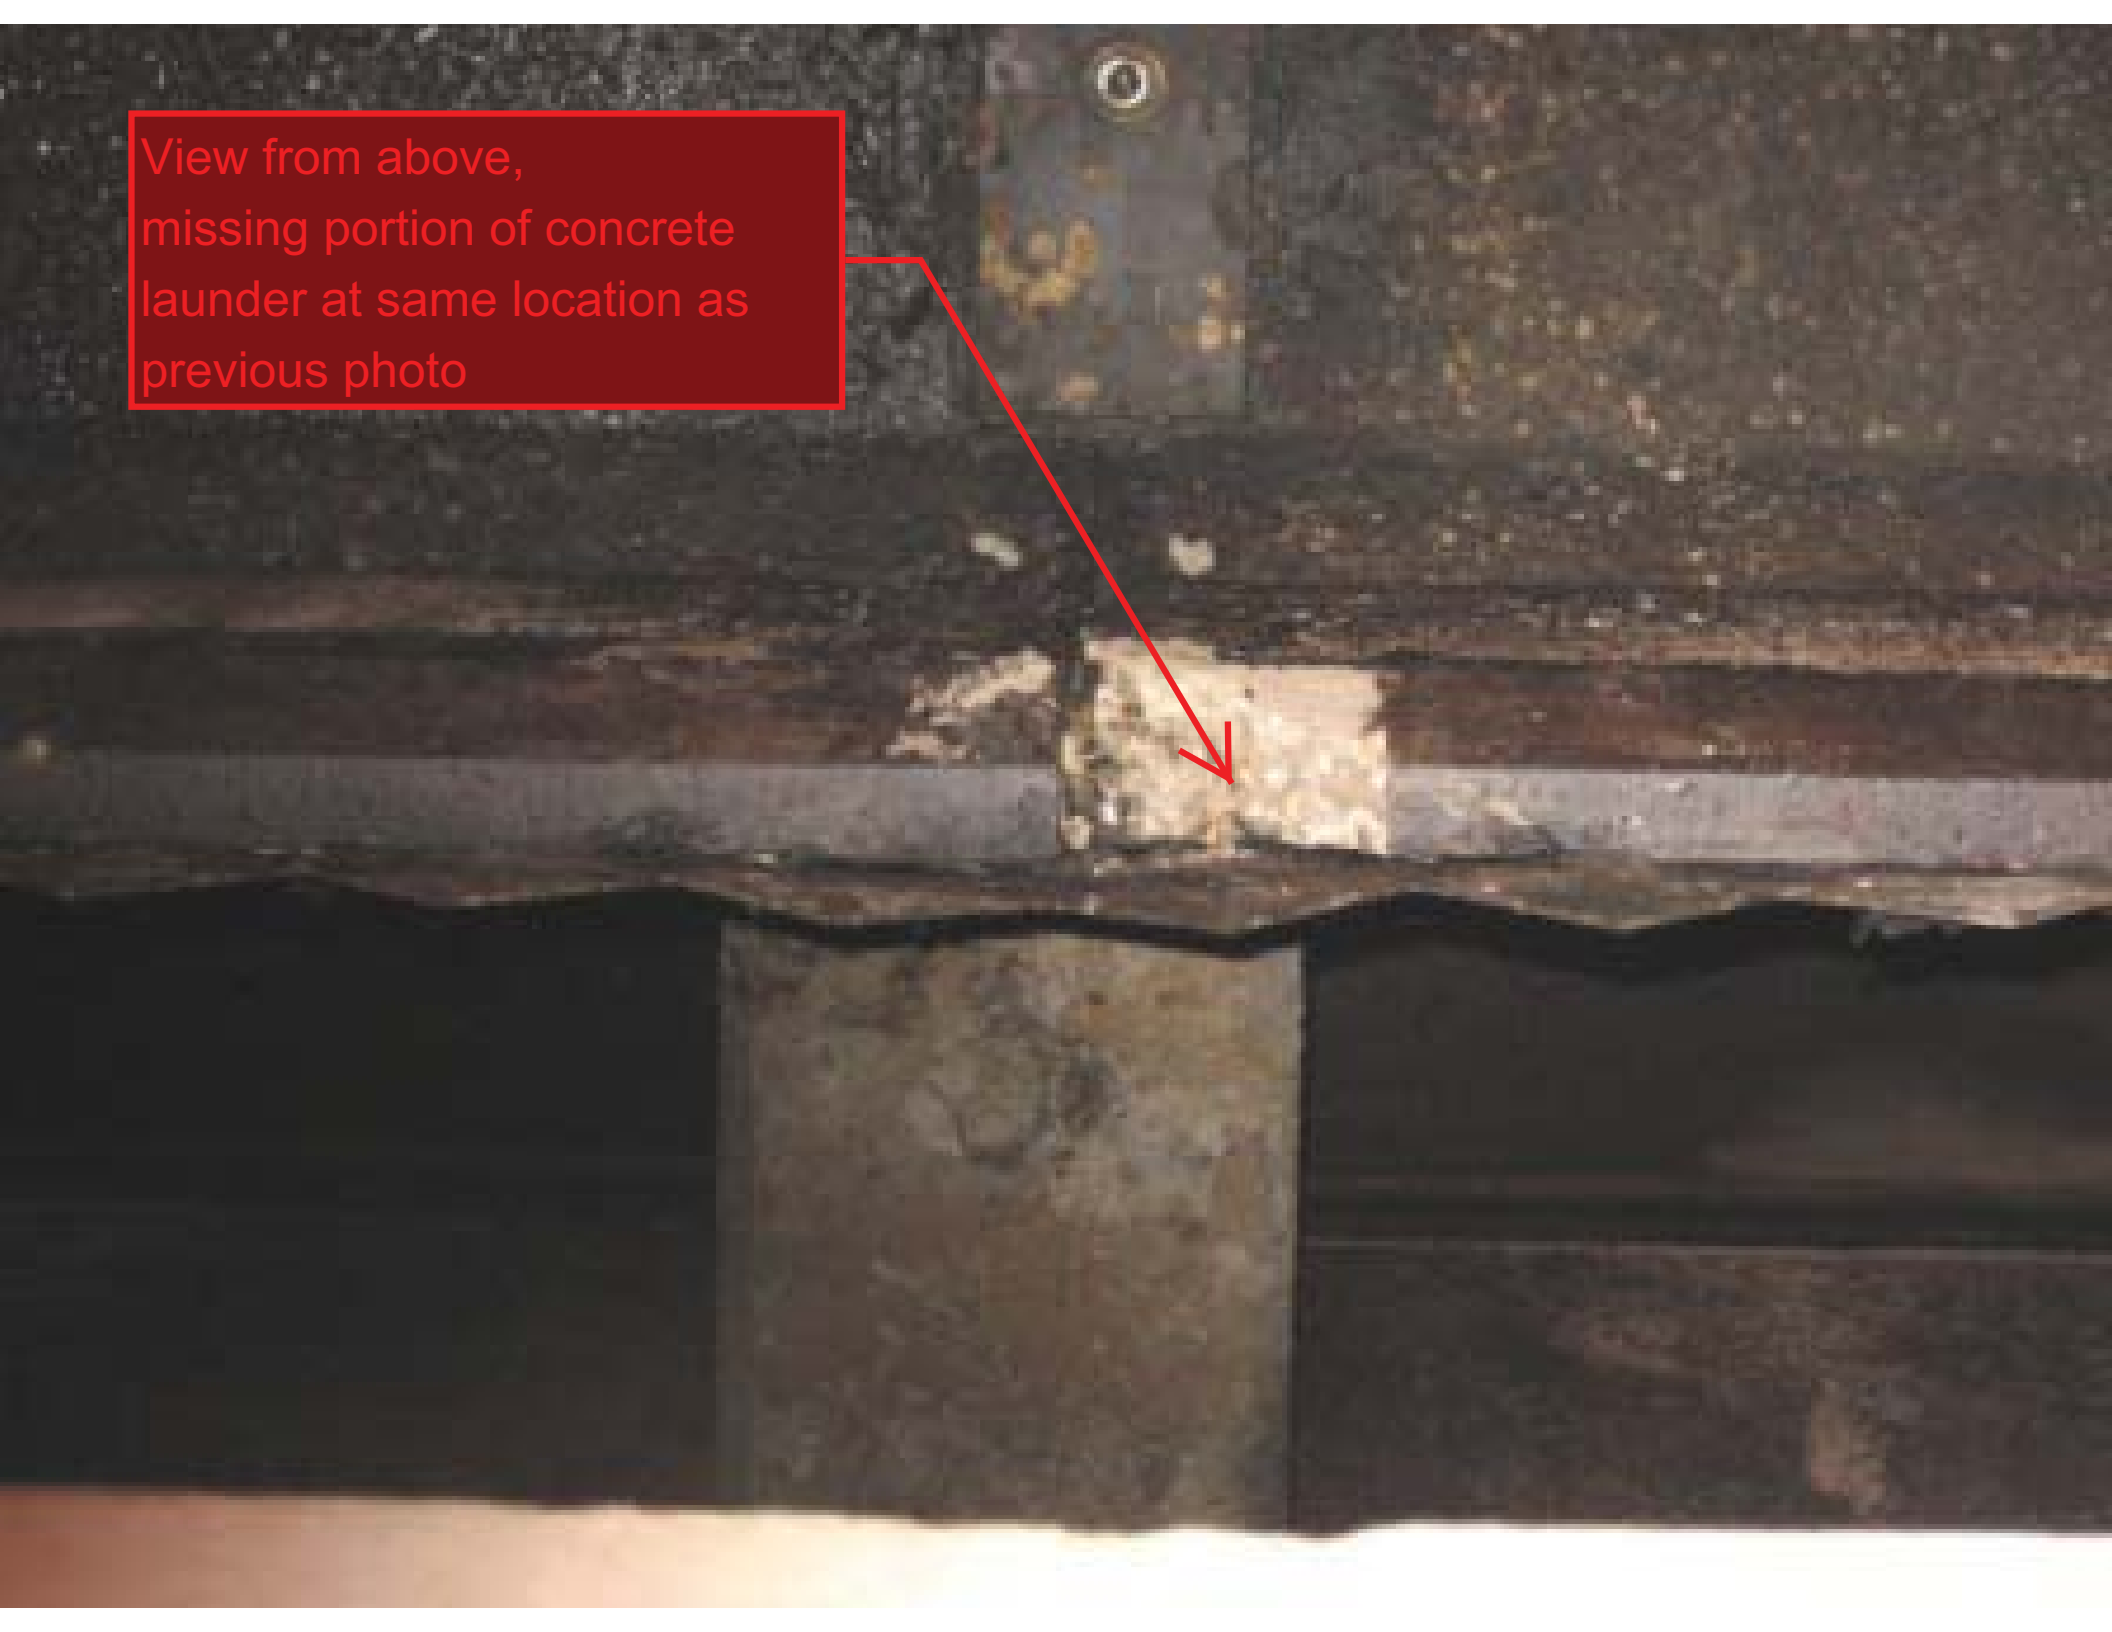
View from above,
missing portion of concrete
laundry at same location as
previous photo

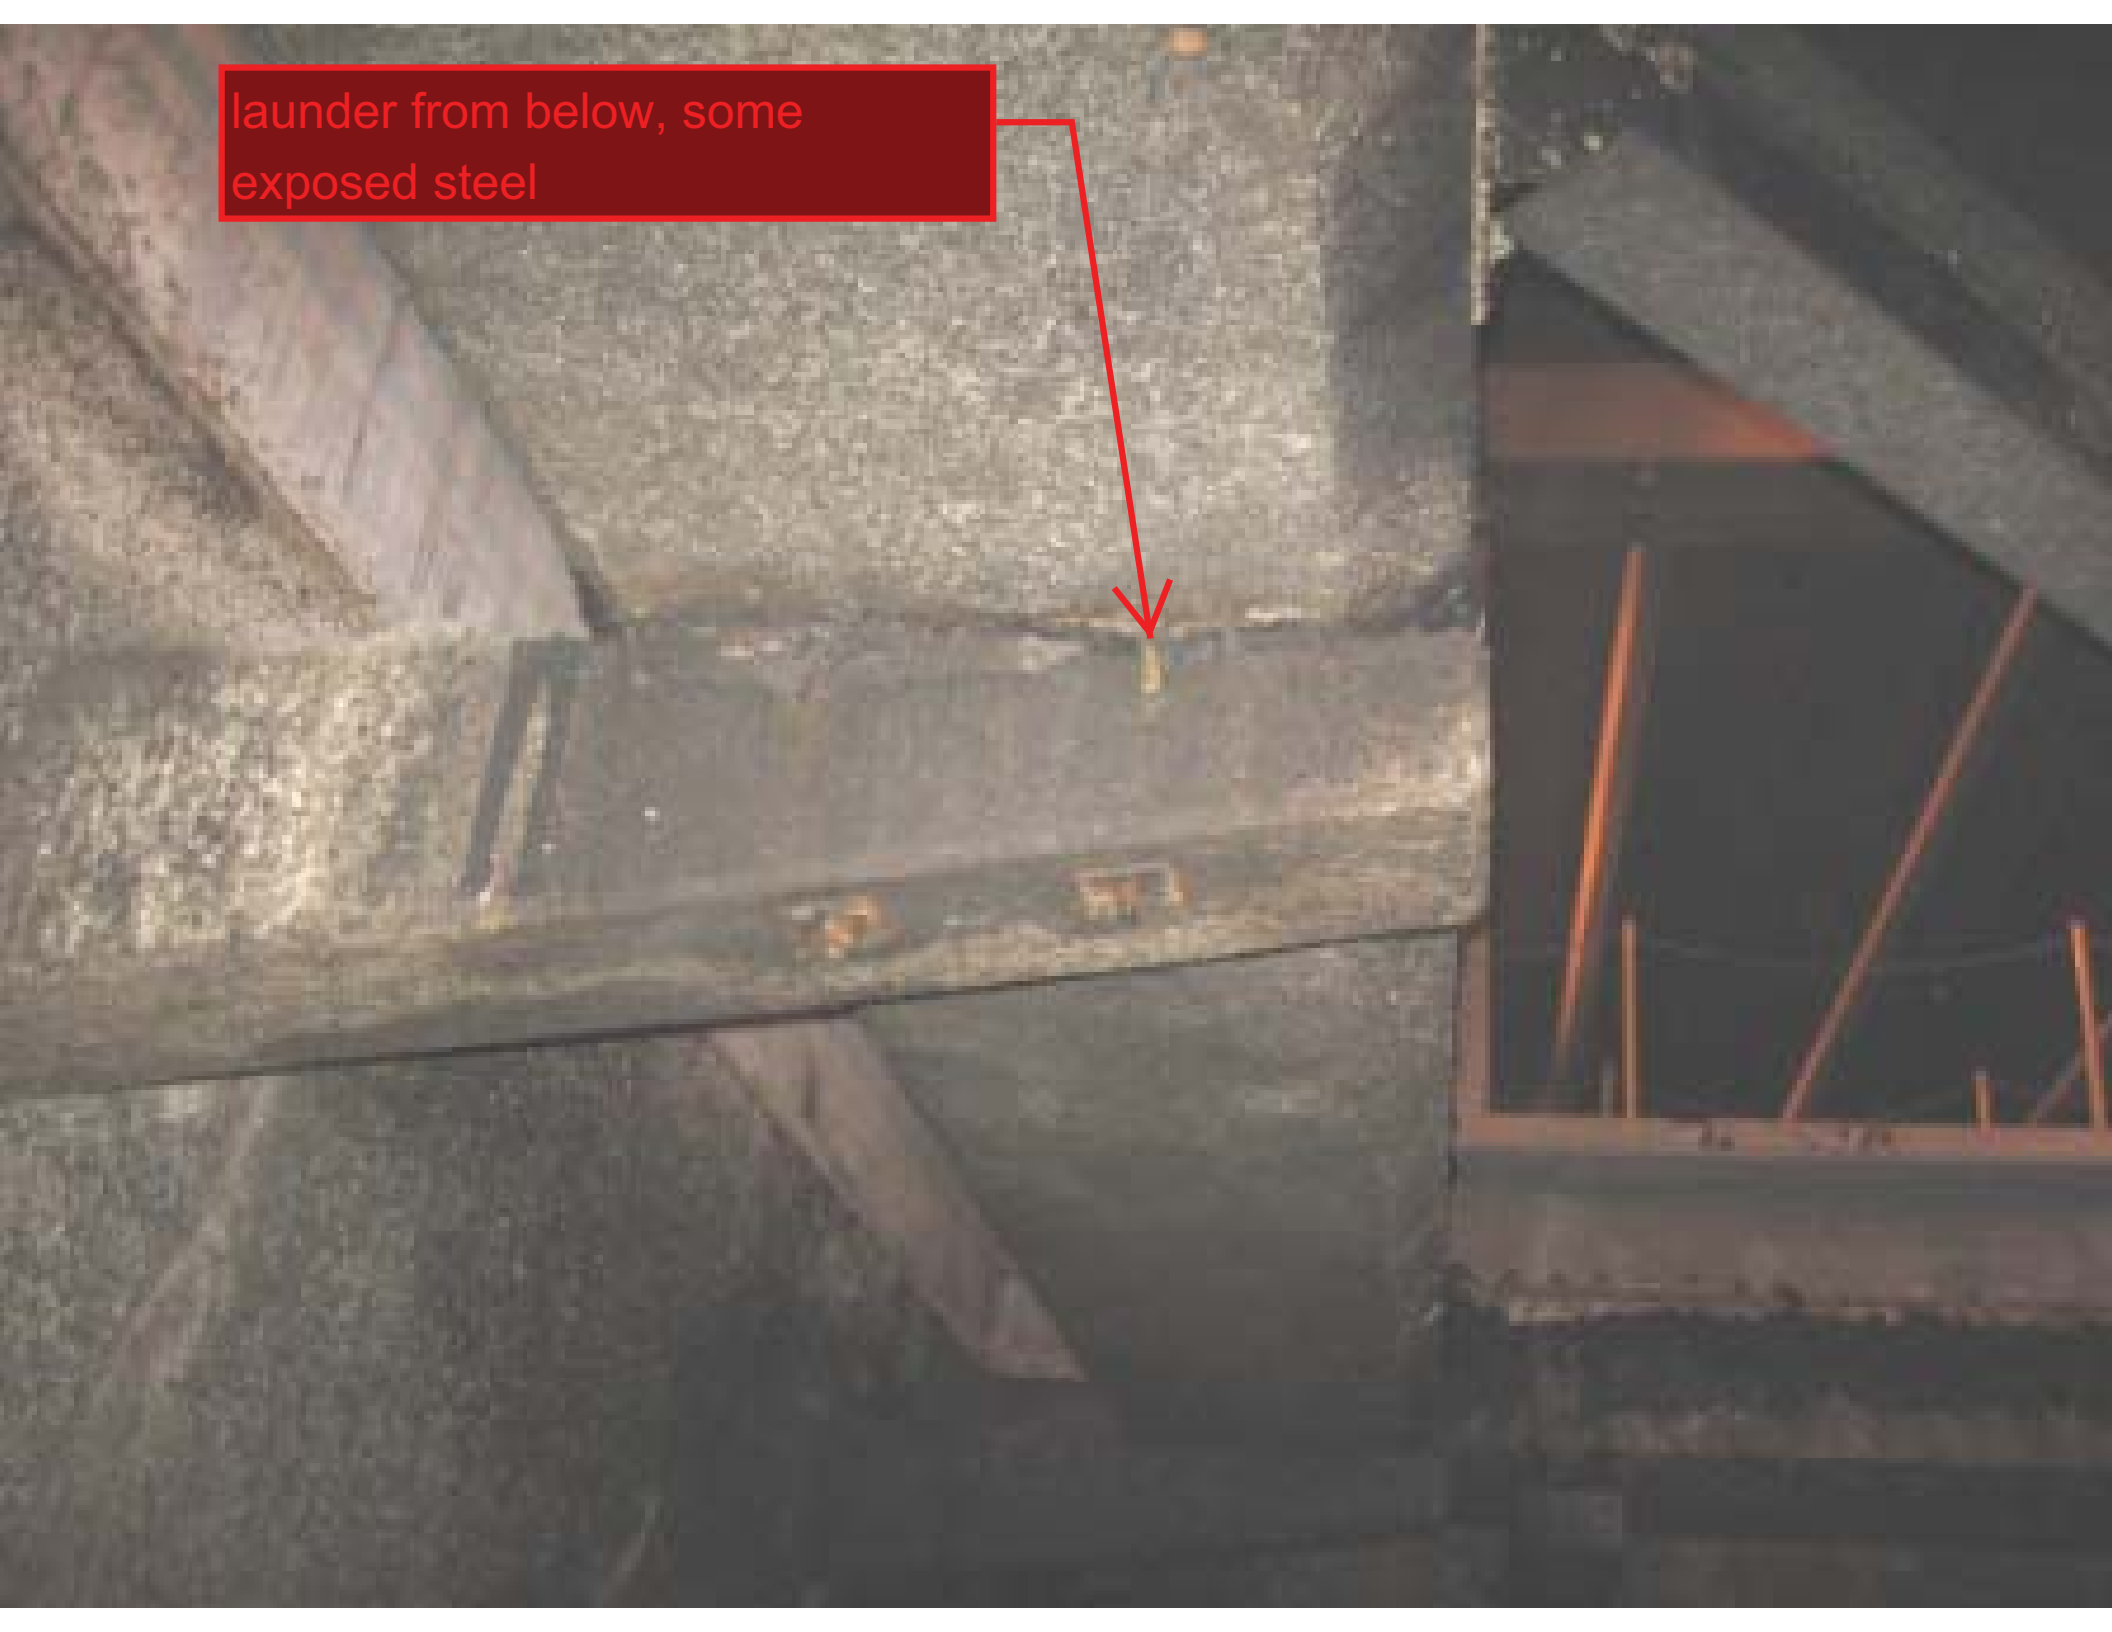
laundry from below, some
exposed steel

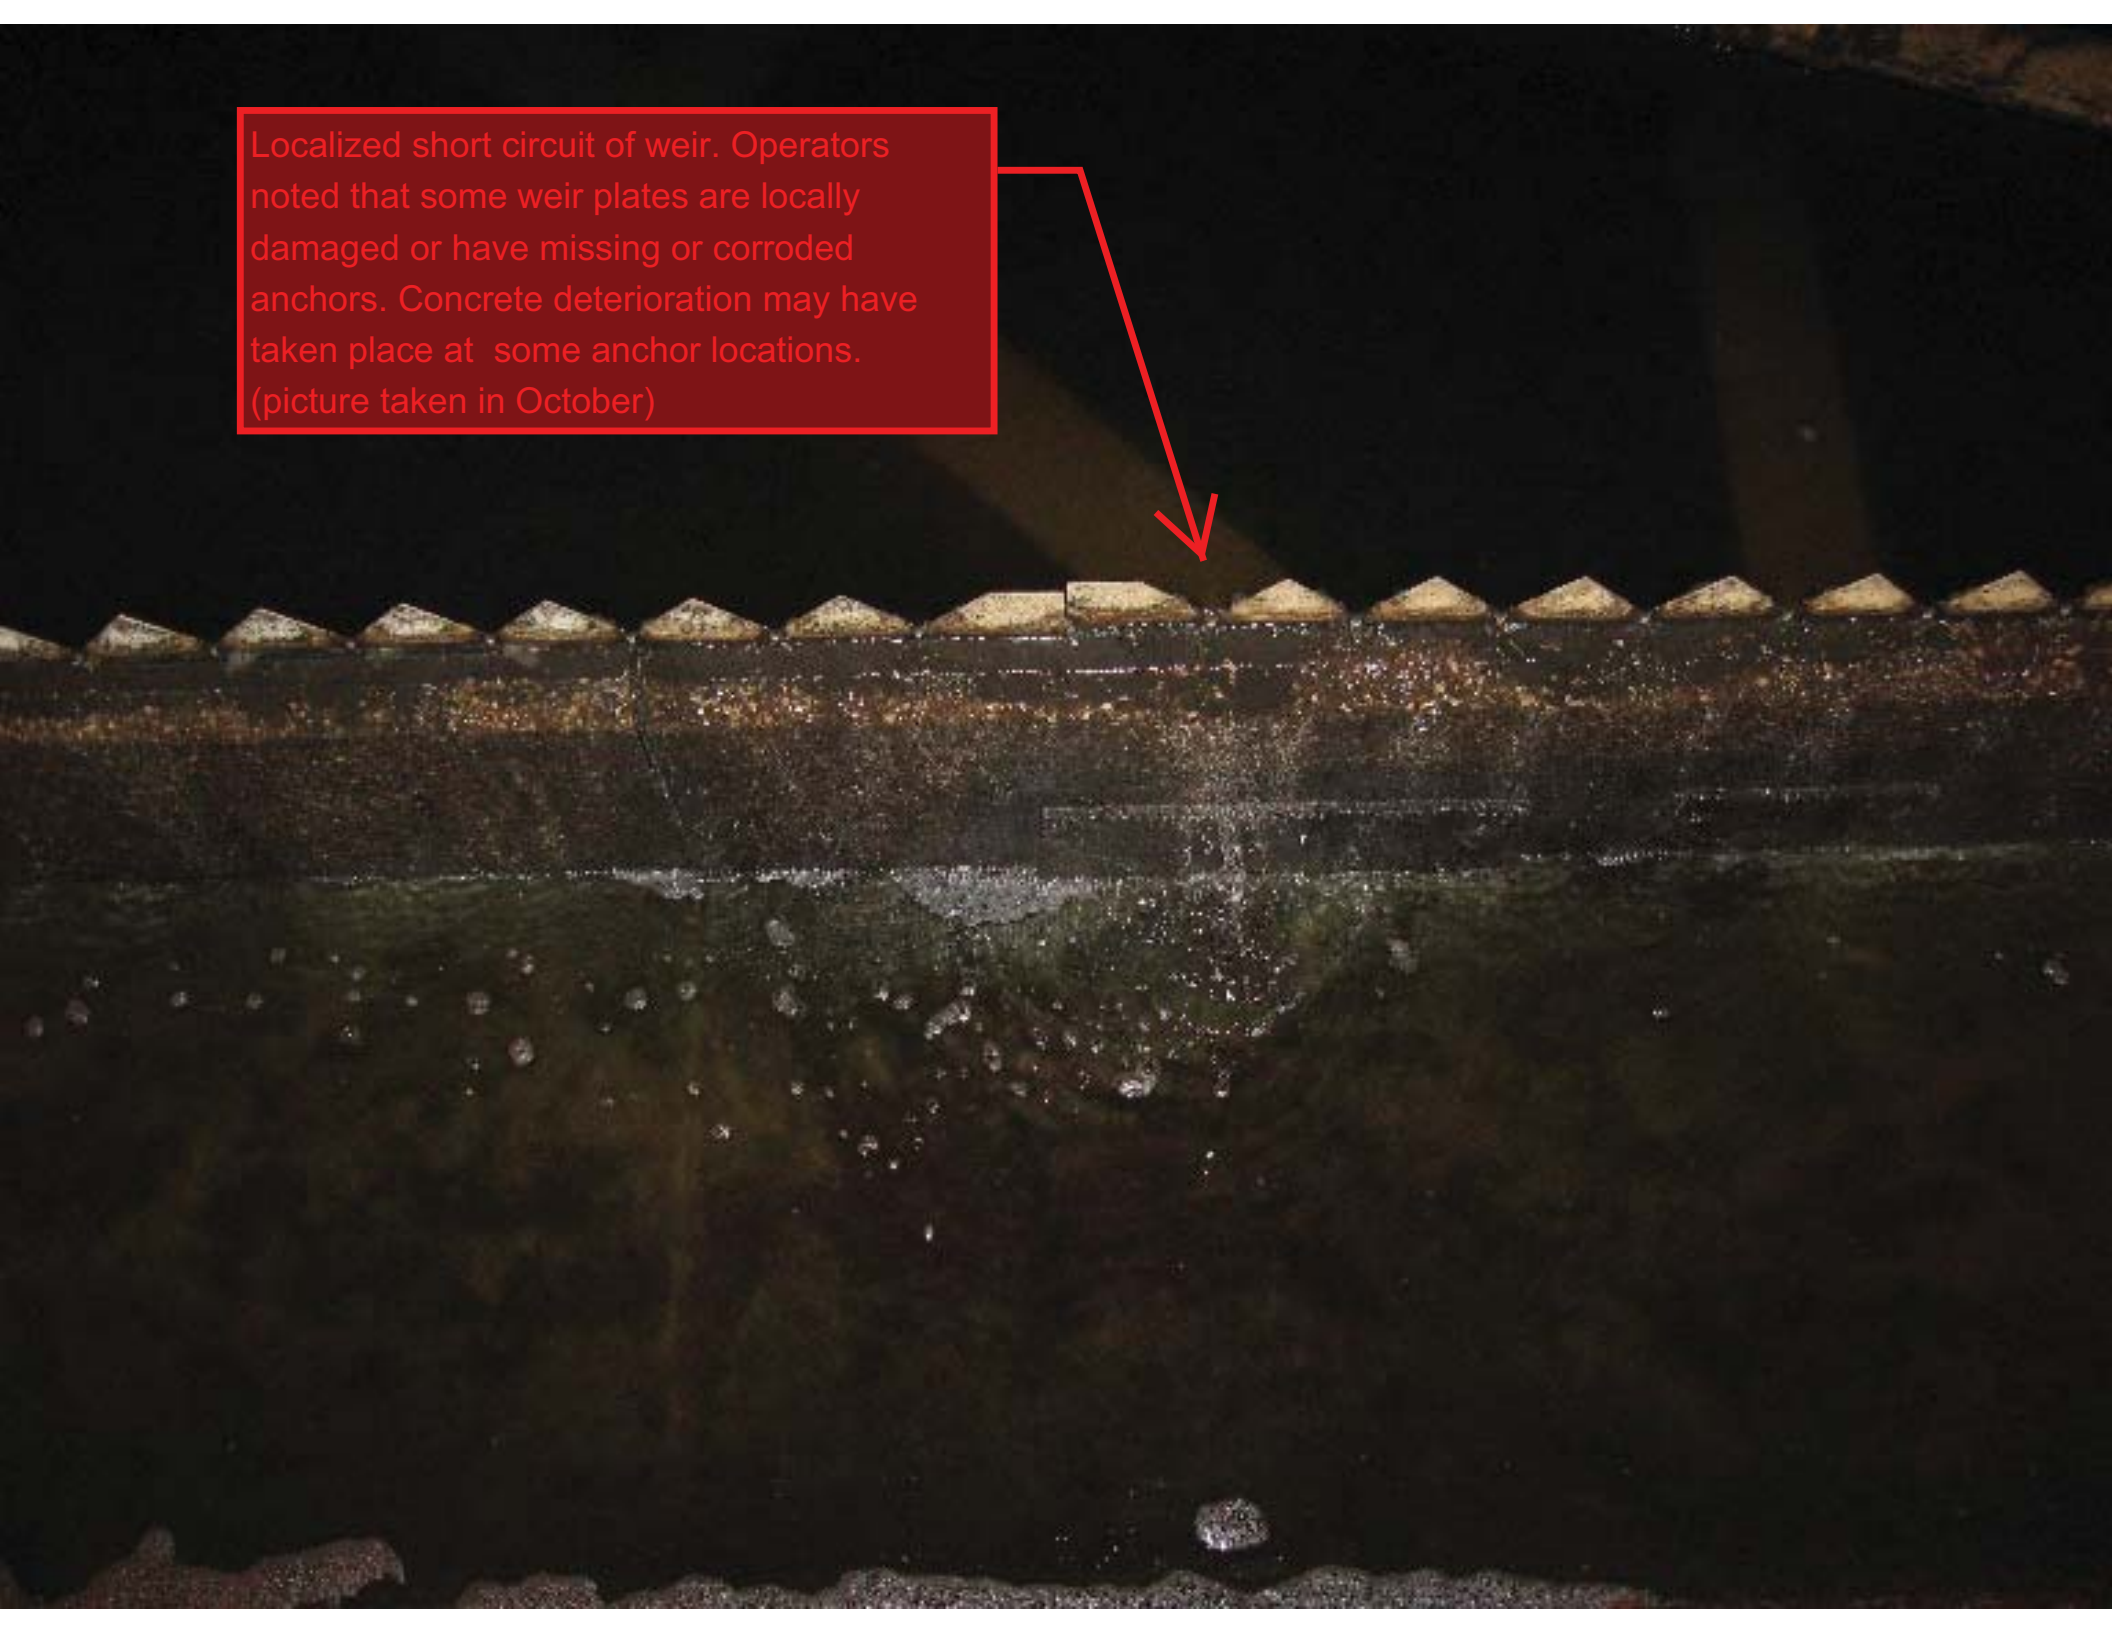
Localized short circuit of weir. Operators noted that some weir plates are locally damaged or have missing or corroded anchors. Concrete deterioration may have taken place at some anchor locations. (picture taken in October)

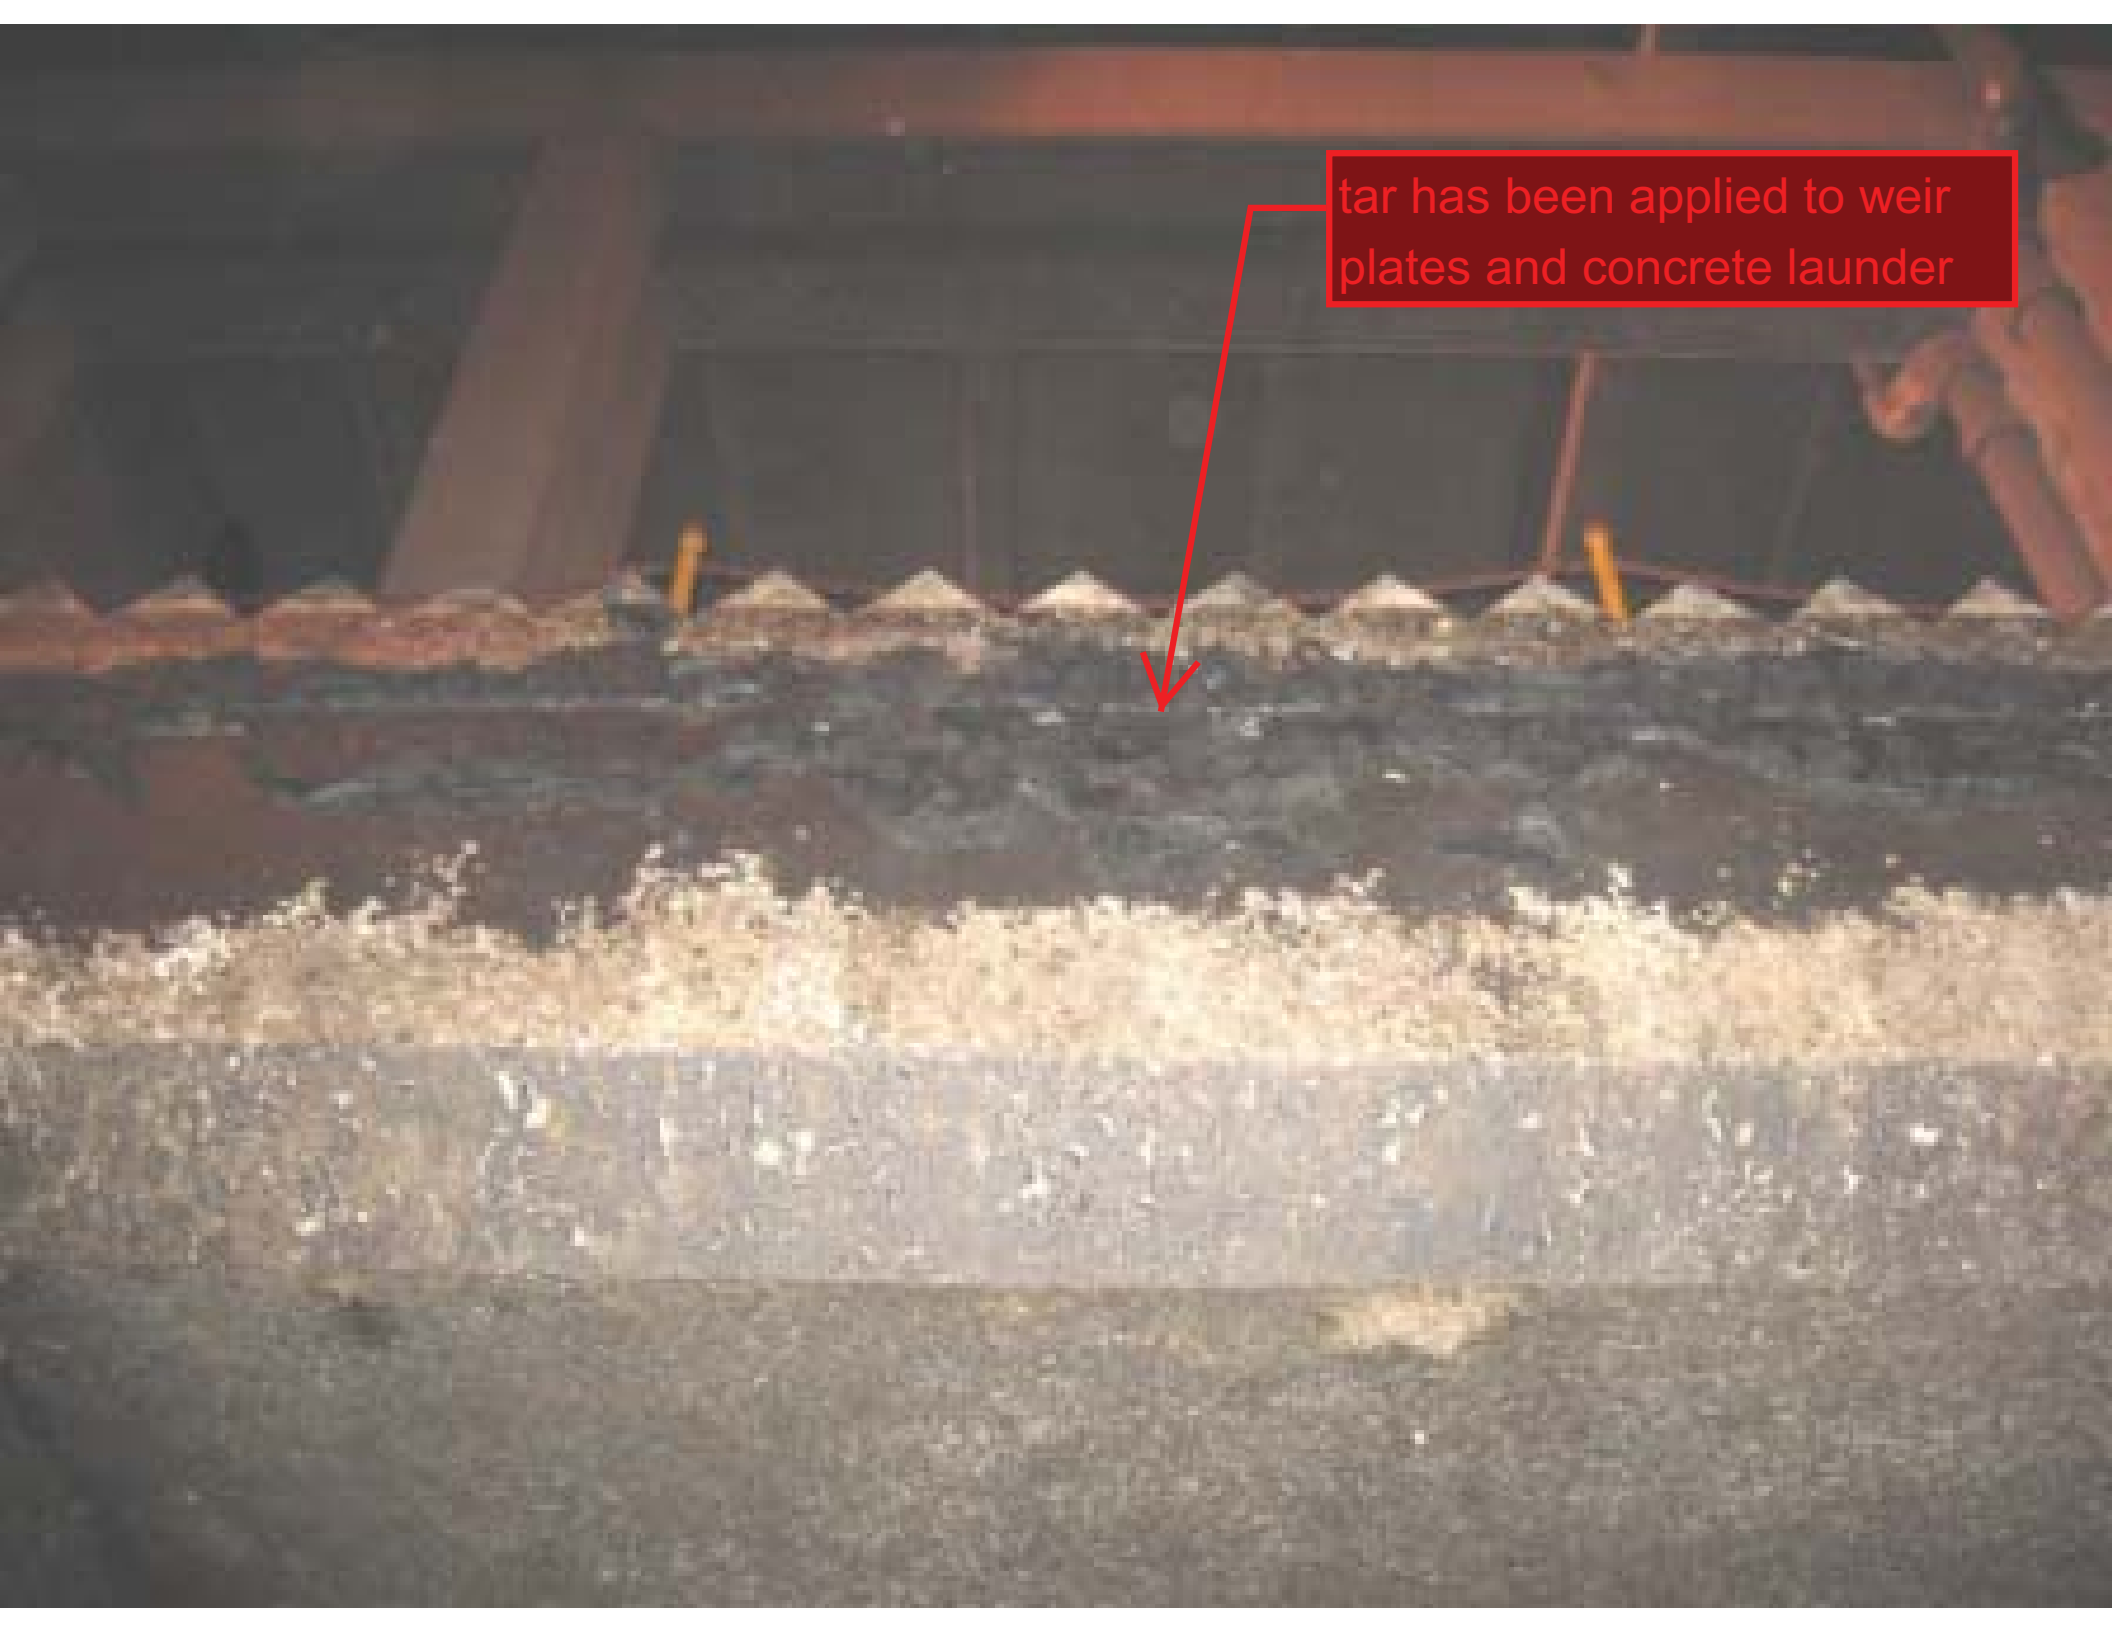
tar has been applied to weir plates and concrete launder

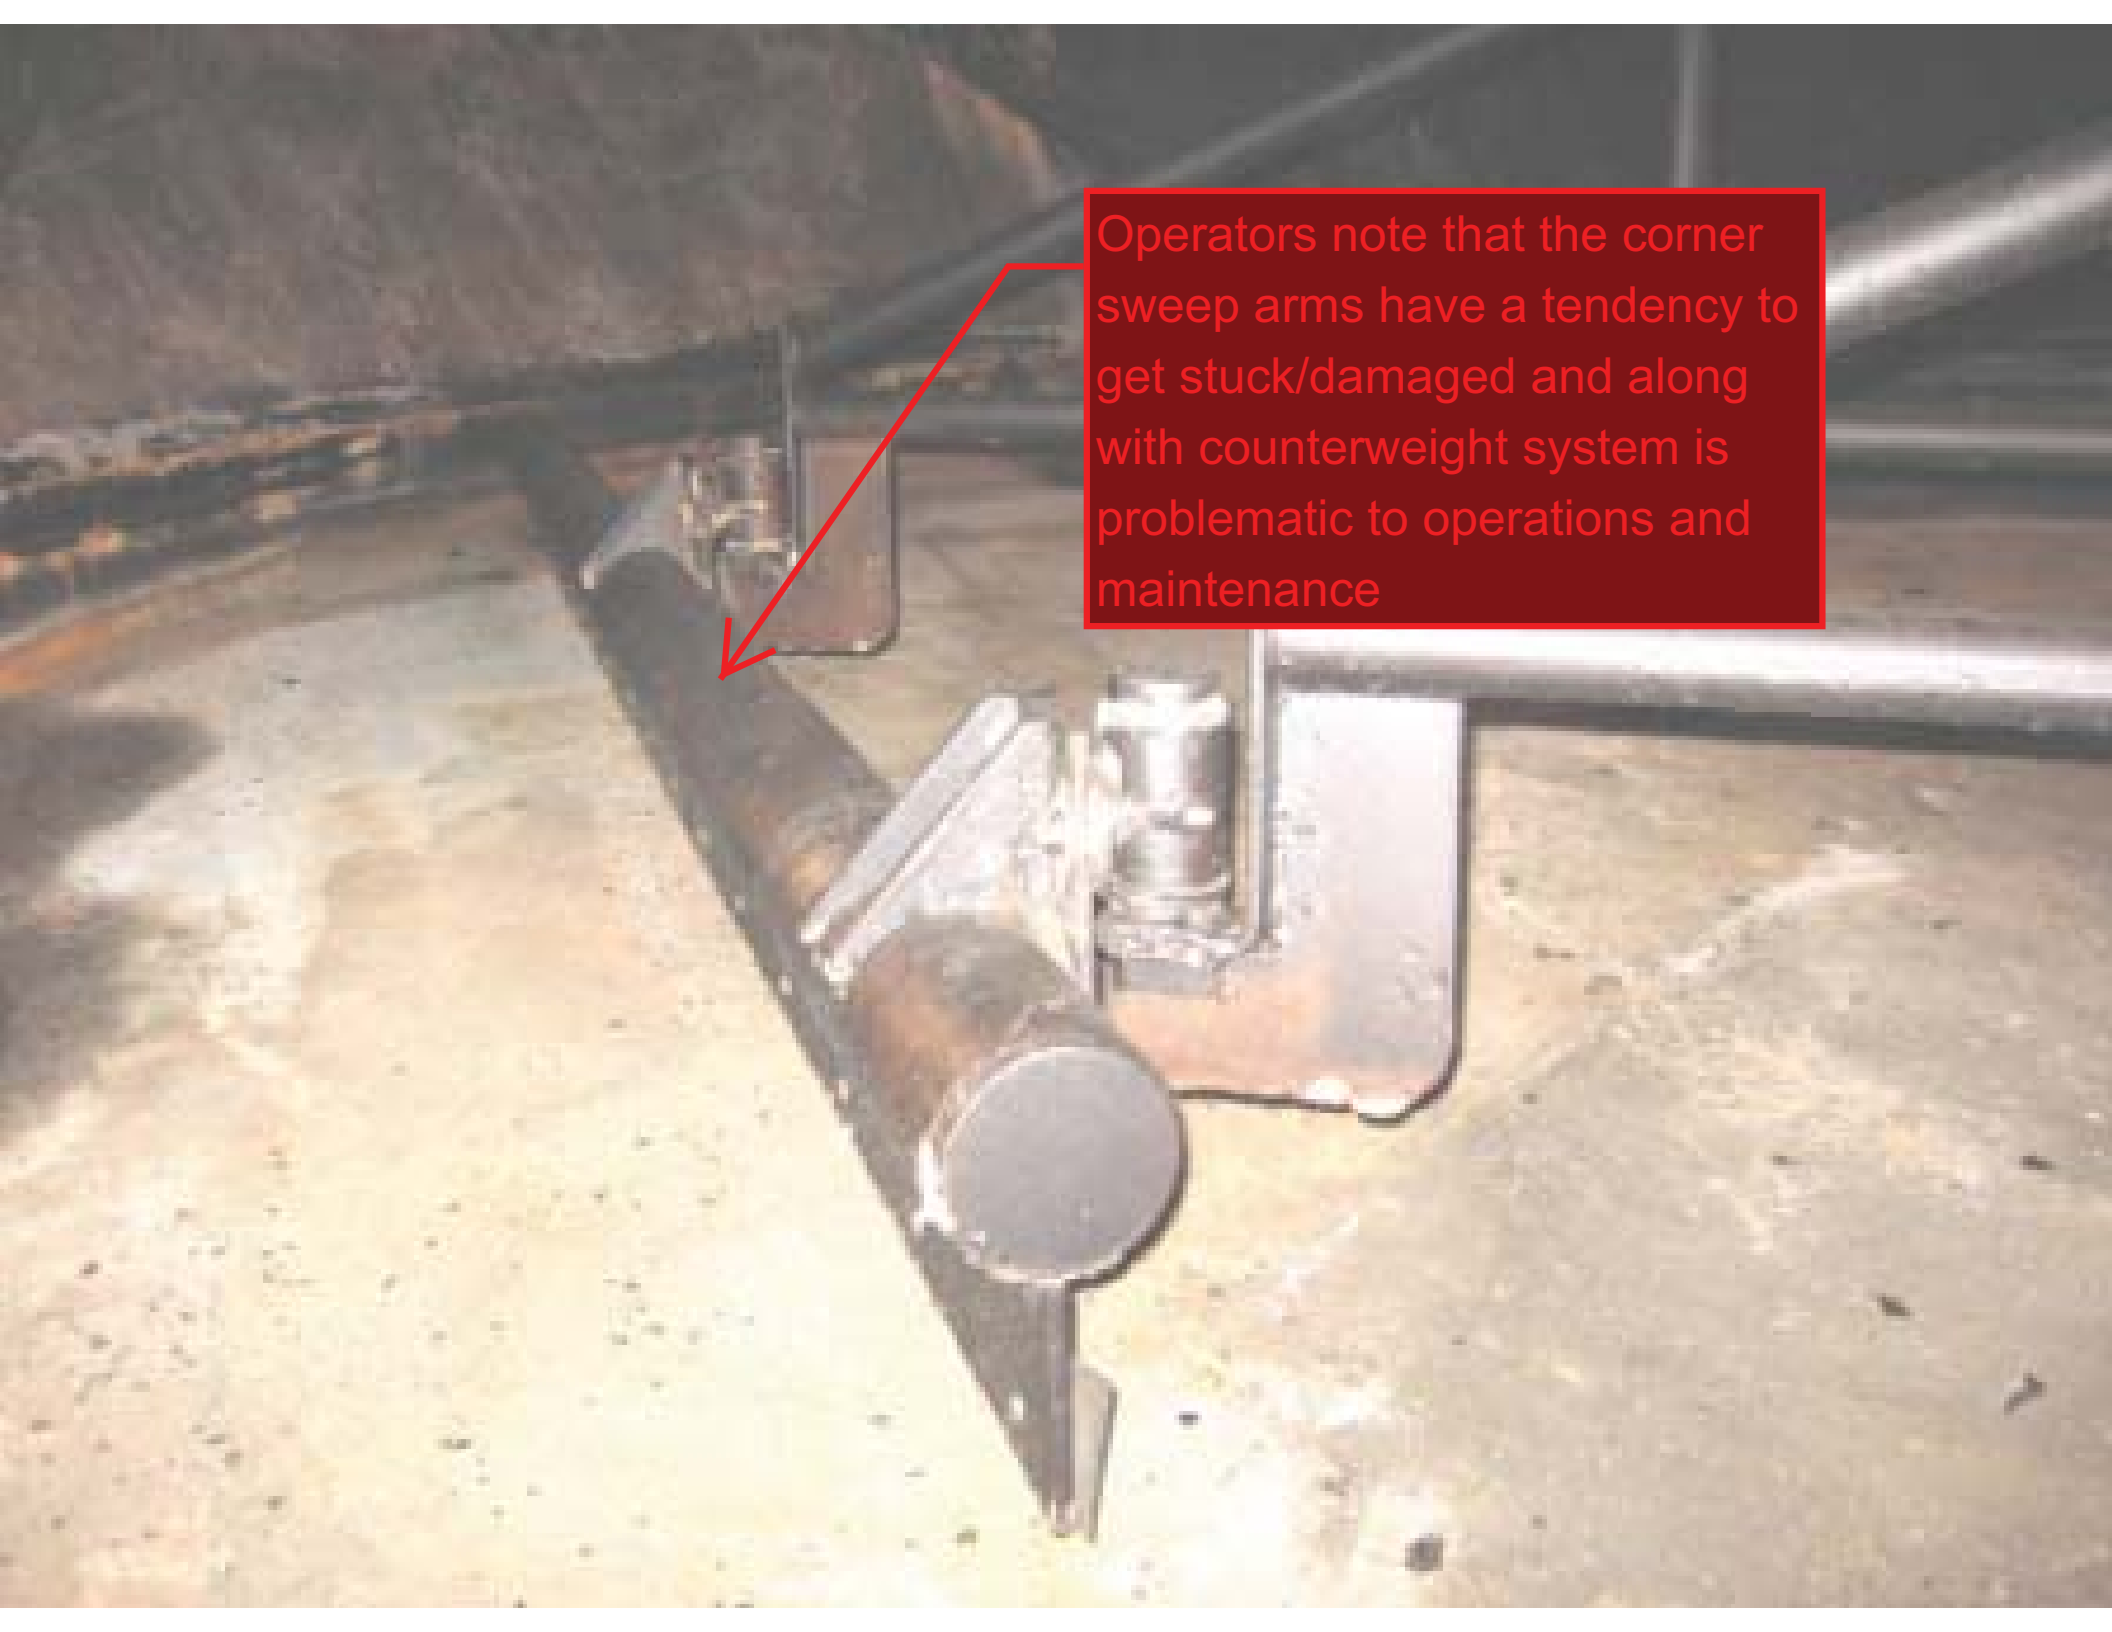
the continuous steel wear plate
for the articulating corner
sweep arm shows signs of
coating deterioration and
corrosion
