NEWPCC Secondary Clarifier #1
Examination
December 03, 2010

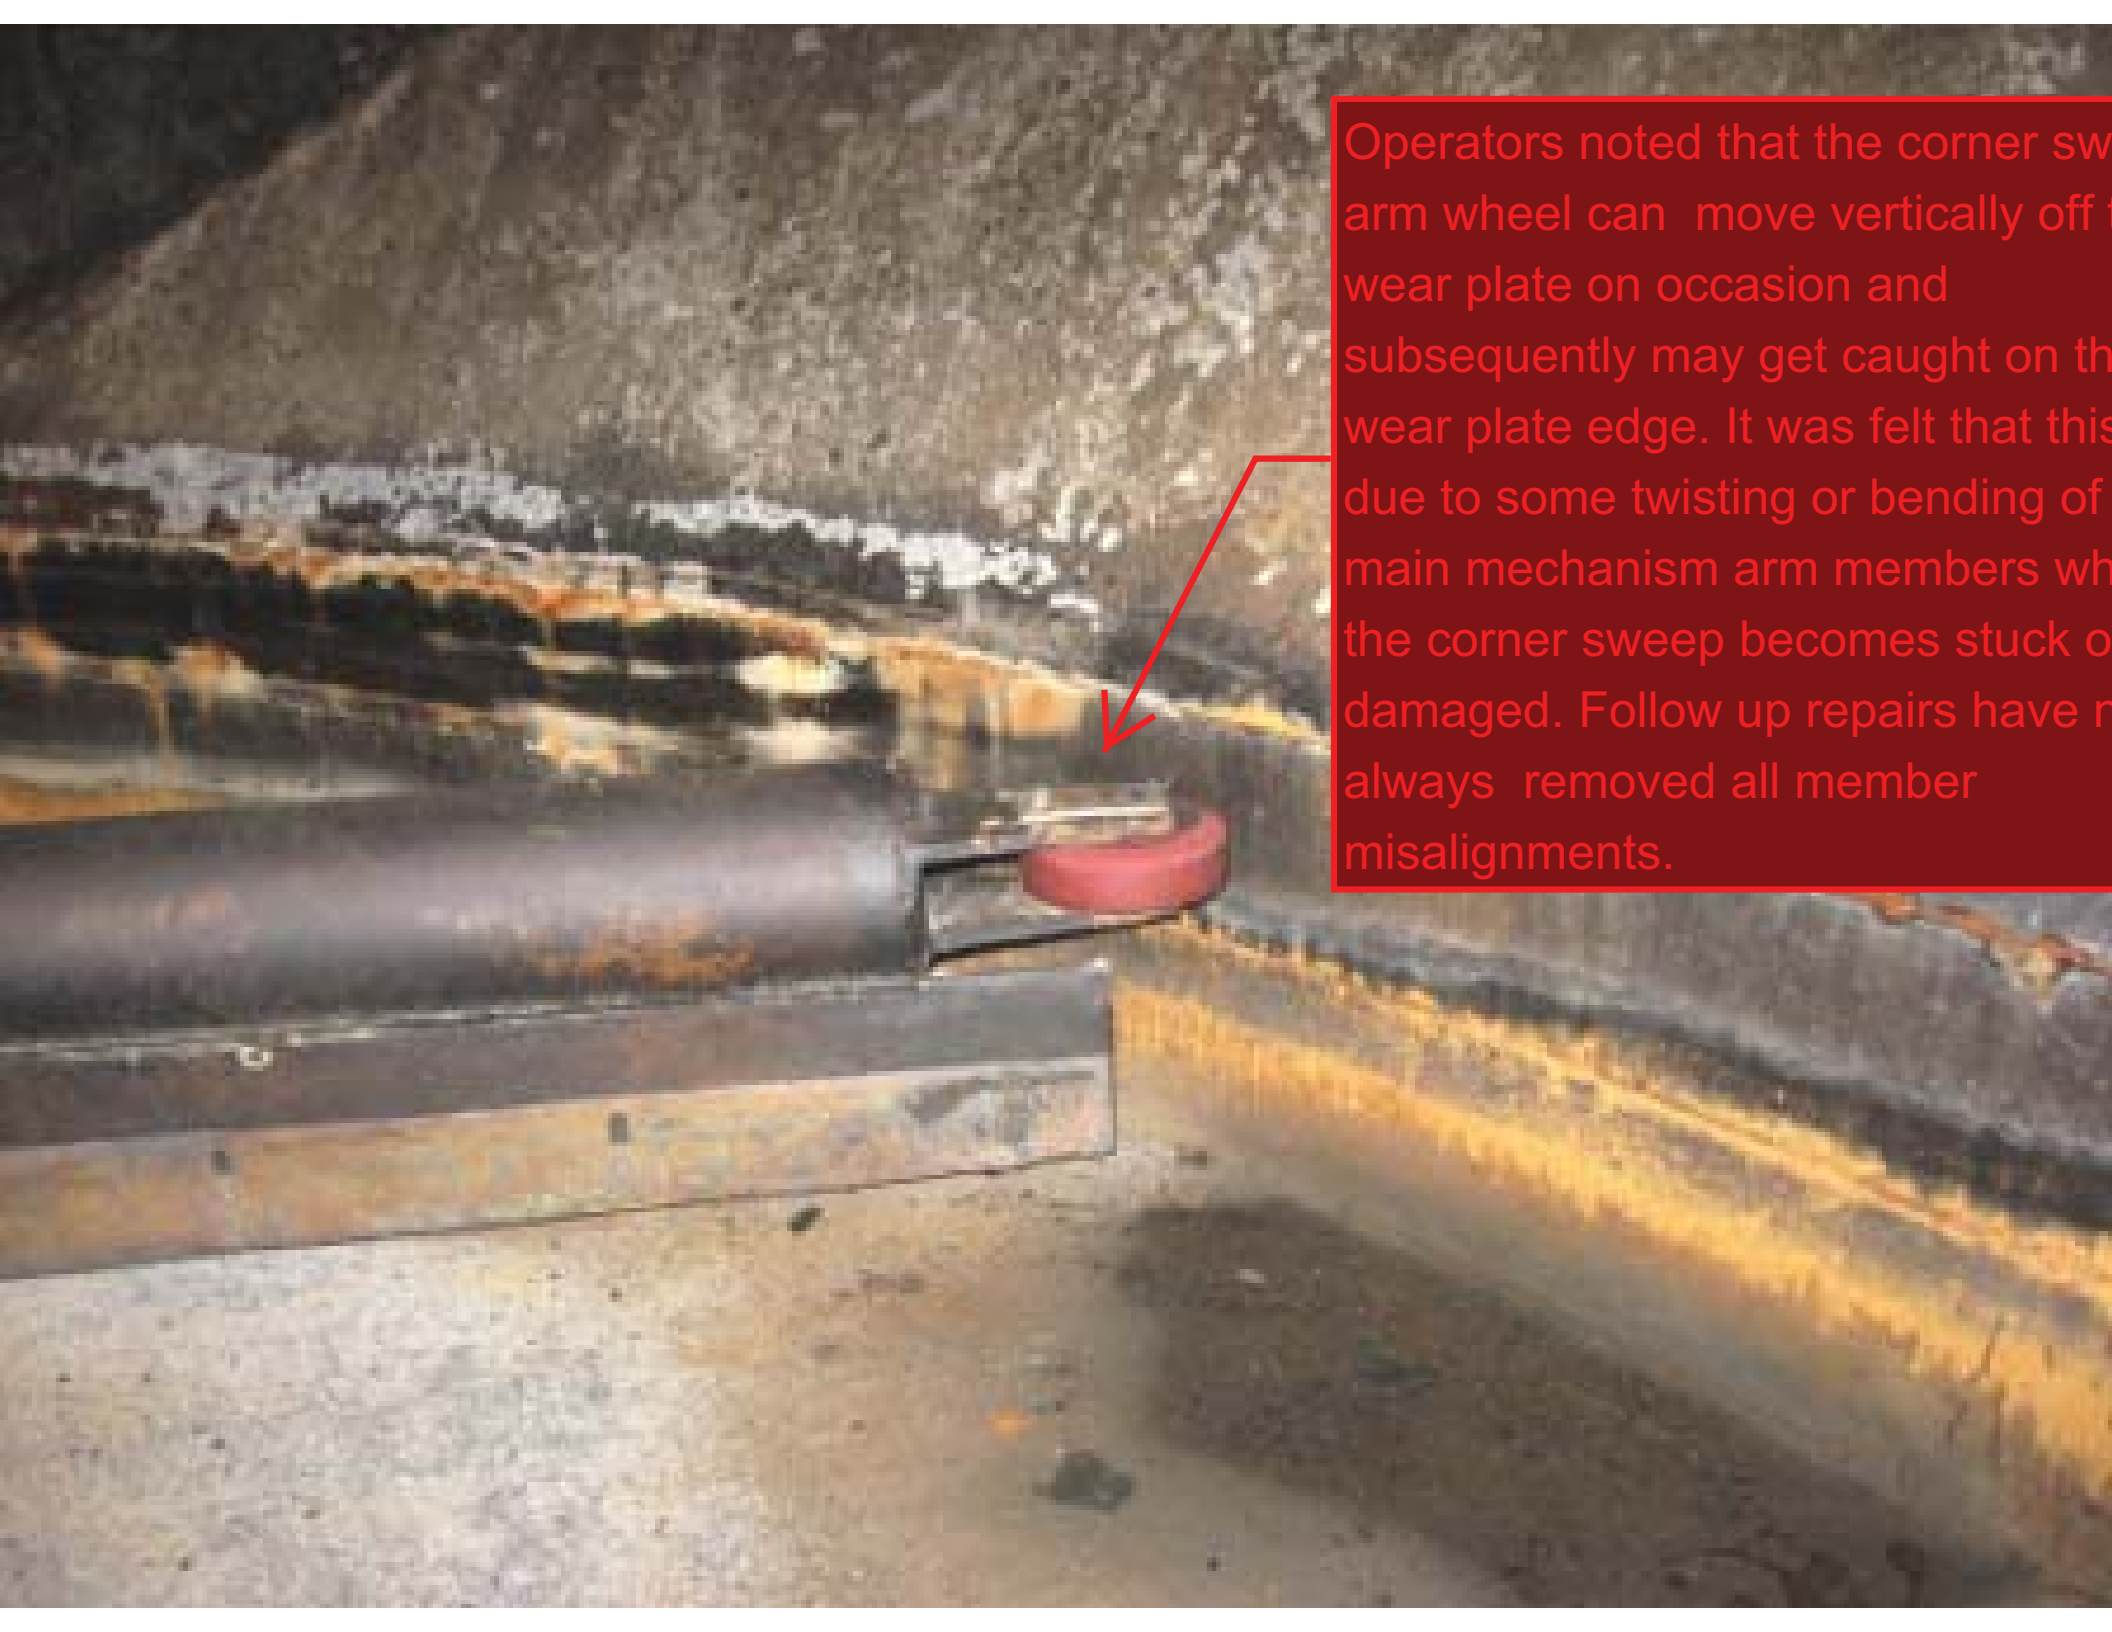
Operators note that the corner sweep arms have a tendency to get stuck/damaged and along with counterweight system is problematic to operations and maintenance

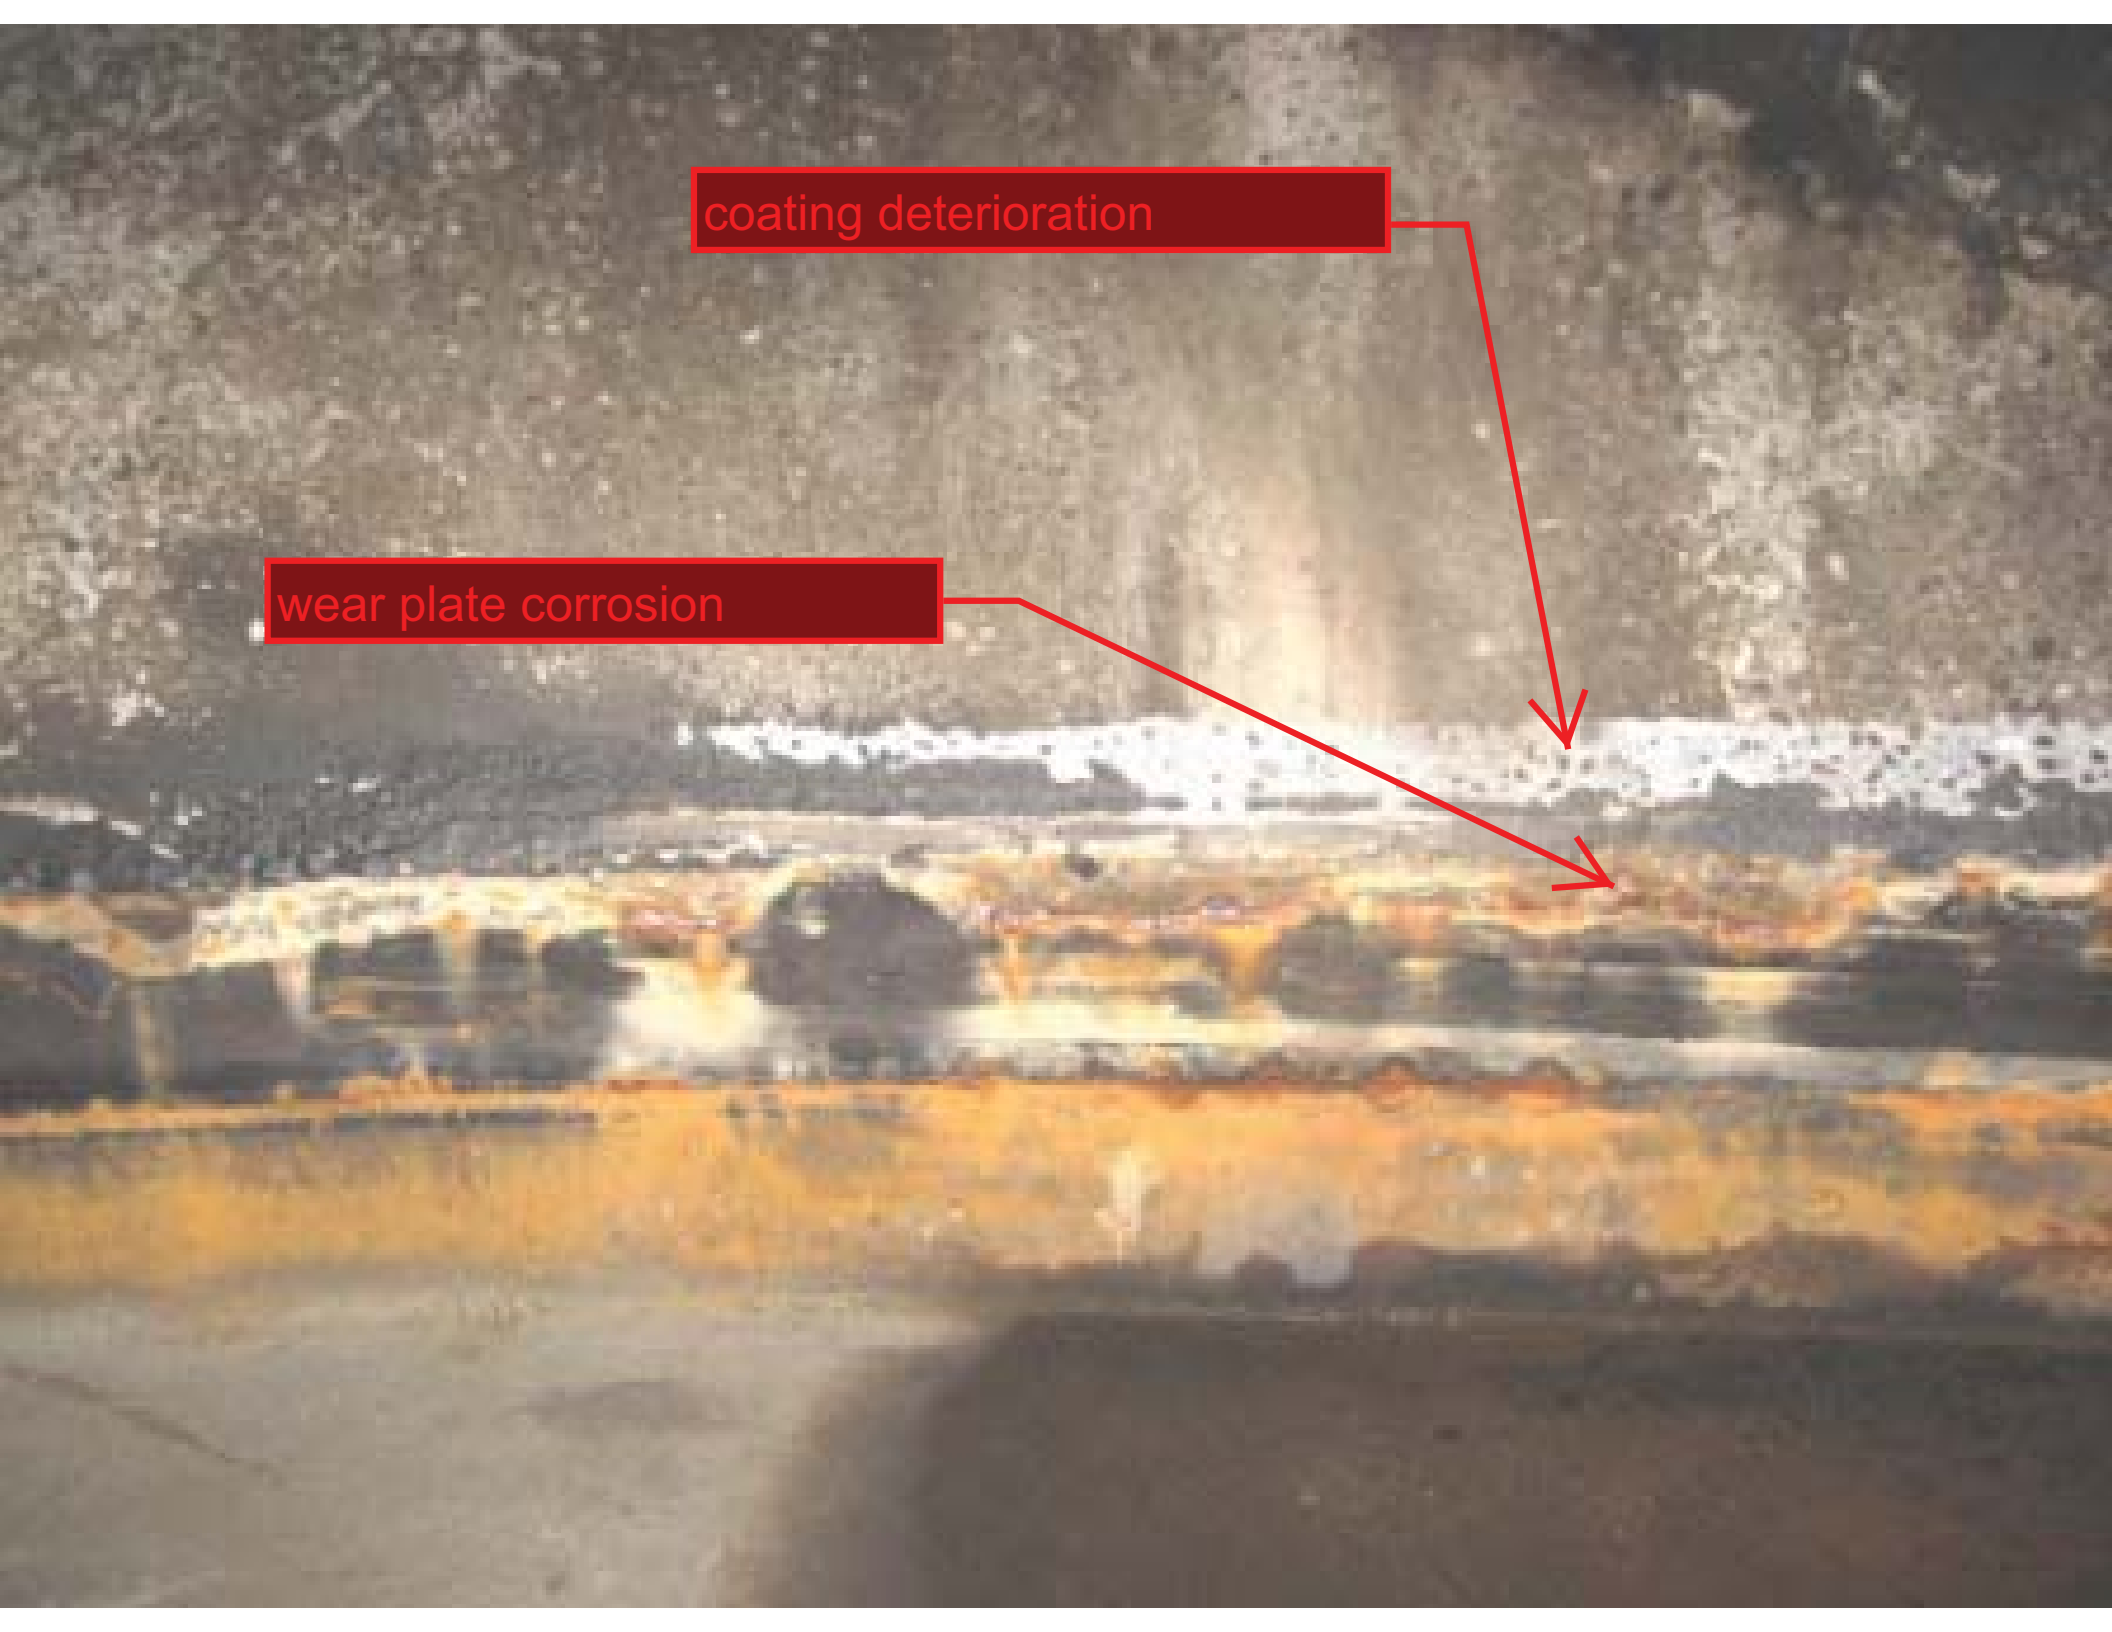
Operators noted that the corner sweep arm wheel can move vertically off the wear plate on occasion and subsequently may get caught on the wear plate edge. It was felt that this was due to some twisting or bending of the main mechanism arm members when the corner sweep becomes stuck or damaged. Follow up repairs have not always removed all member misalignments.

coating deterioration

wear plate corrosion

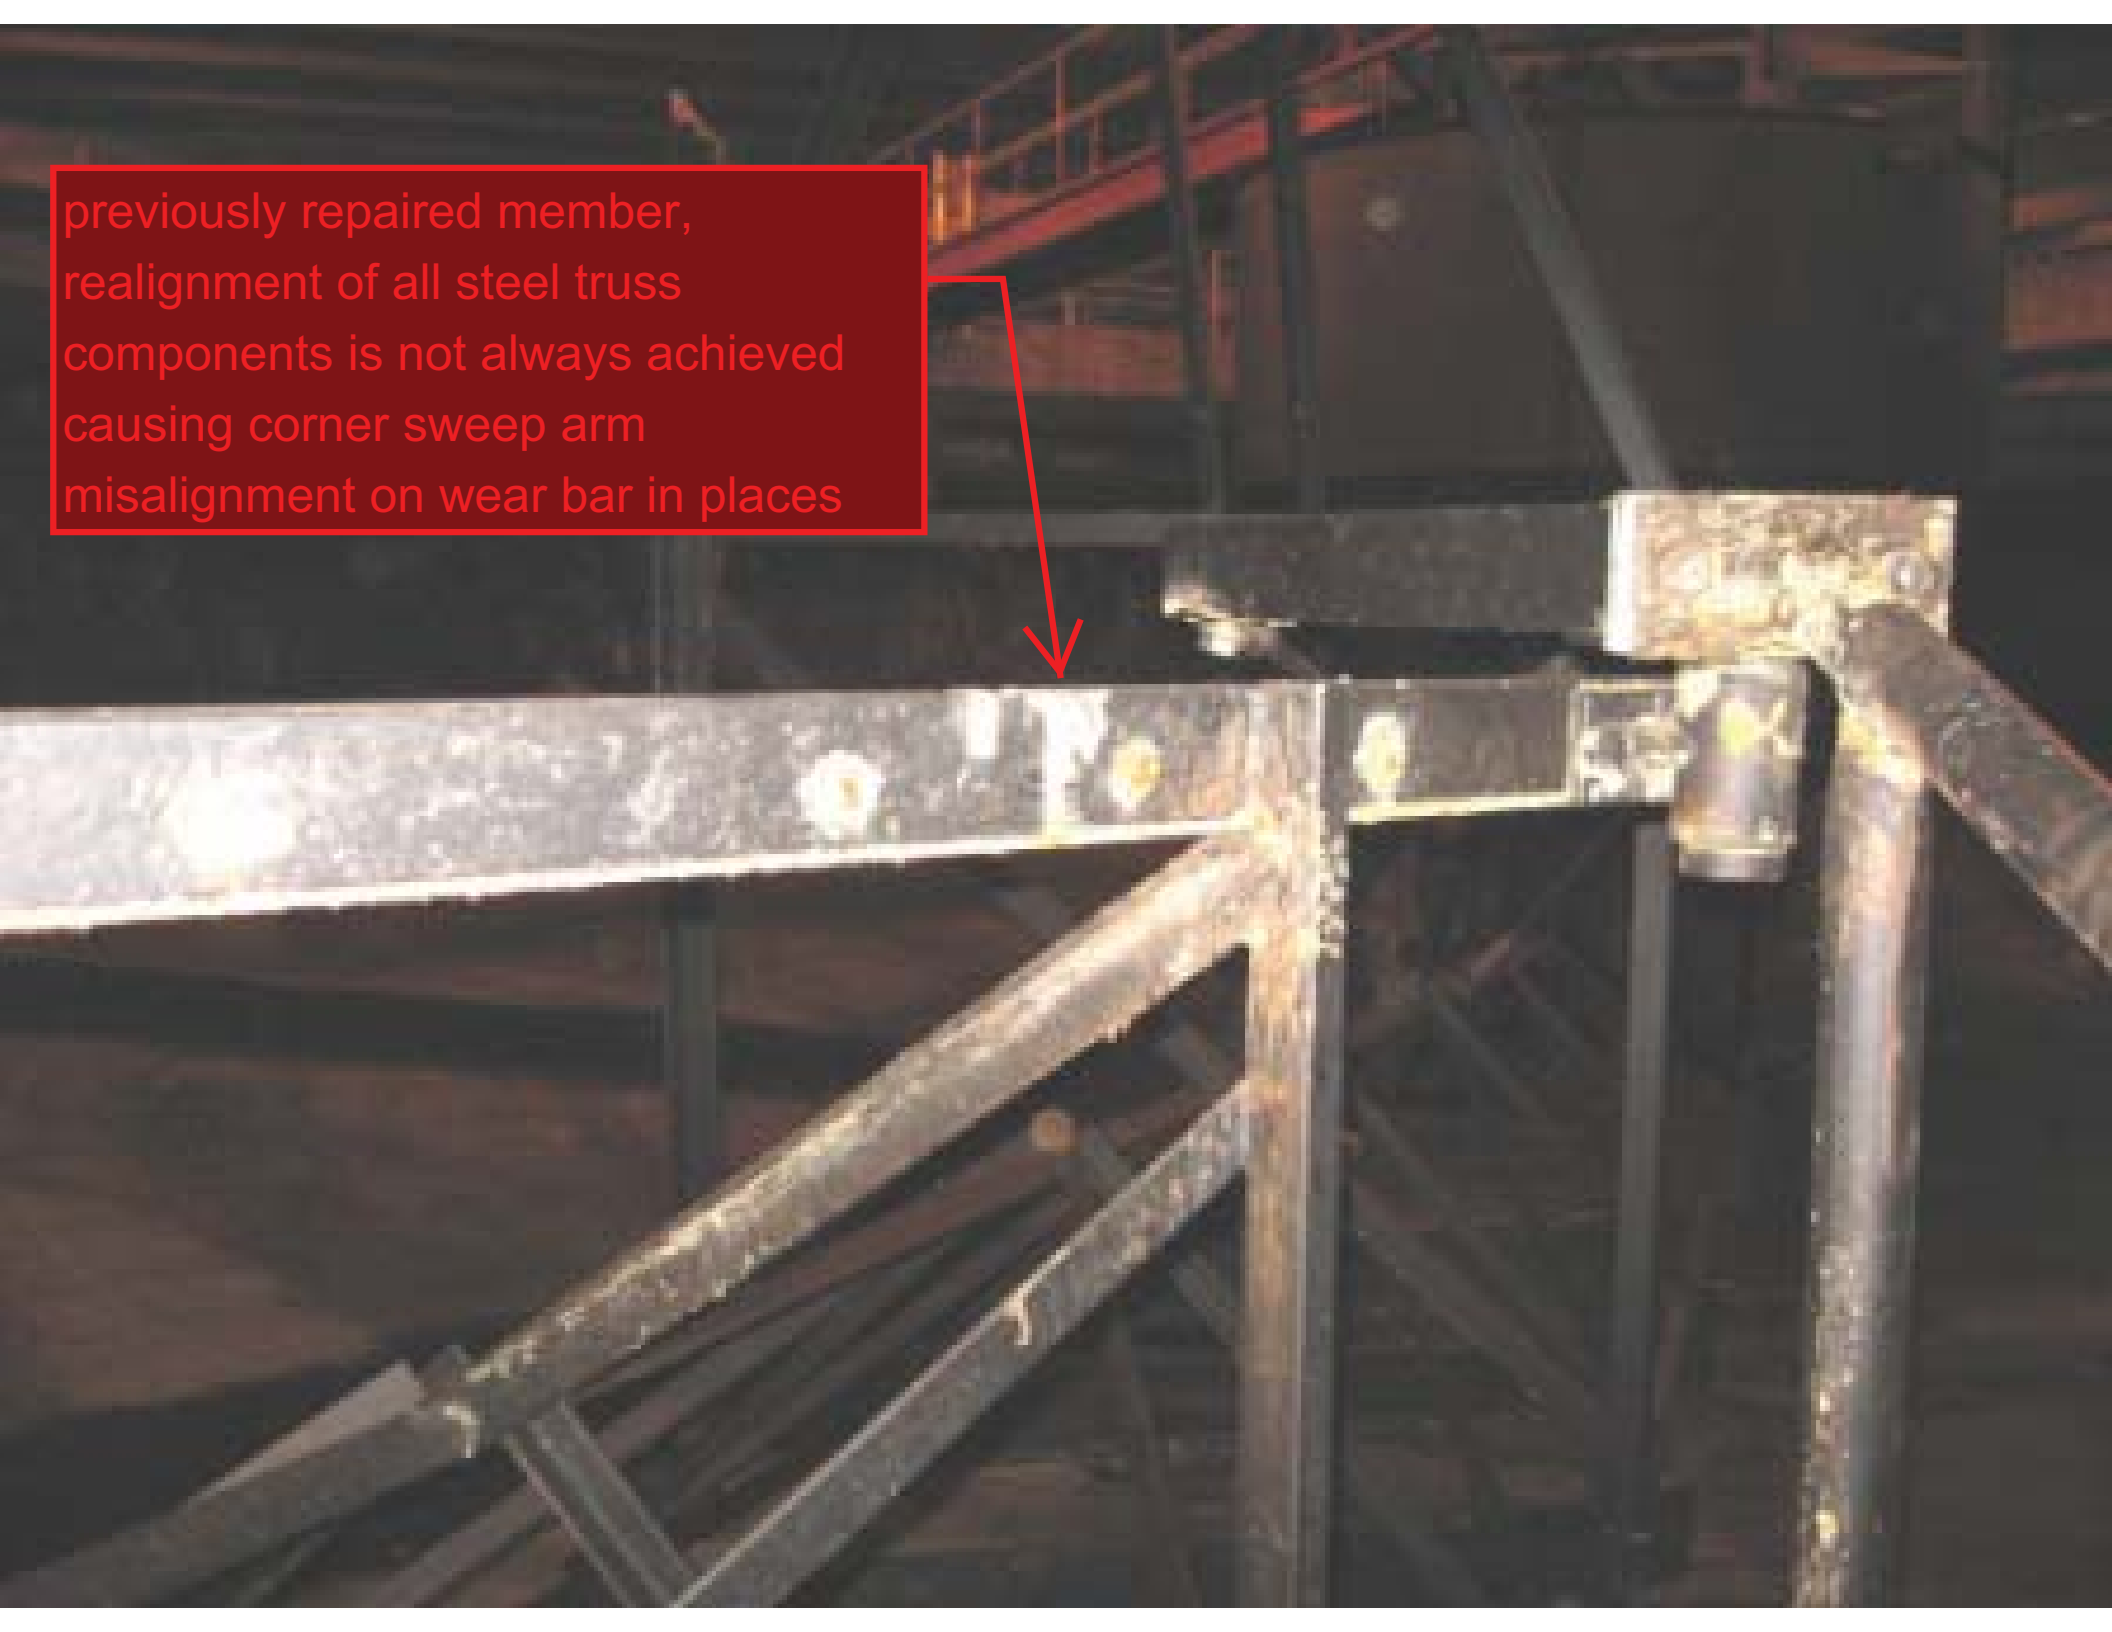
previously repaired member,
realignment of all steel truss
components is not always achieved
causing corner sweep arm
misalignment on wear bar in places

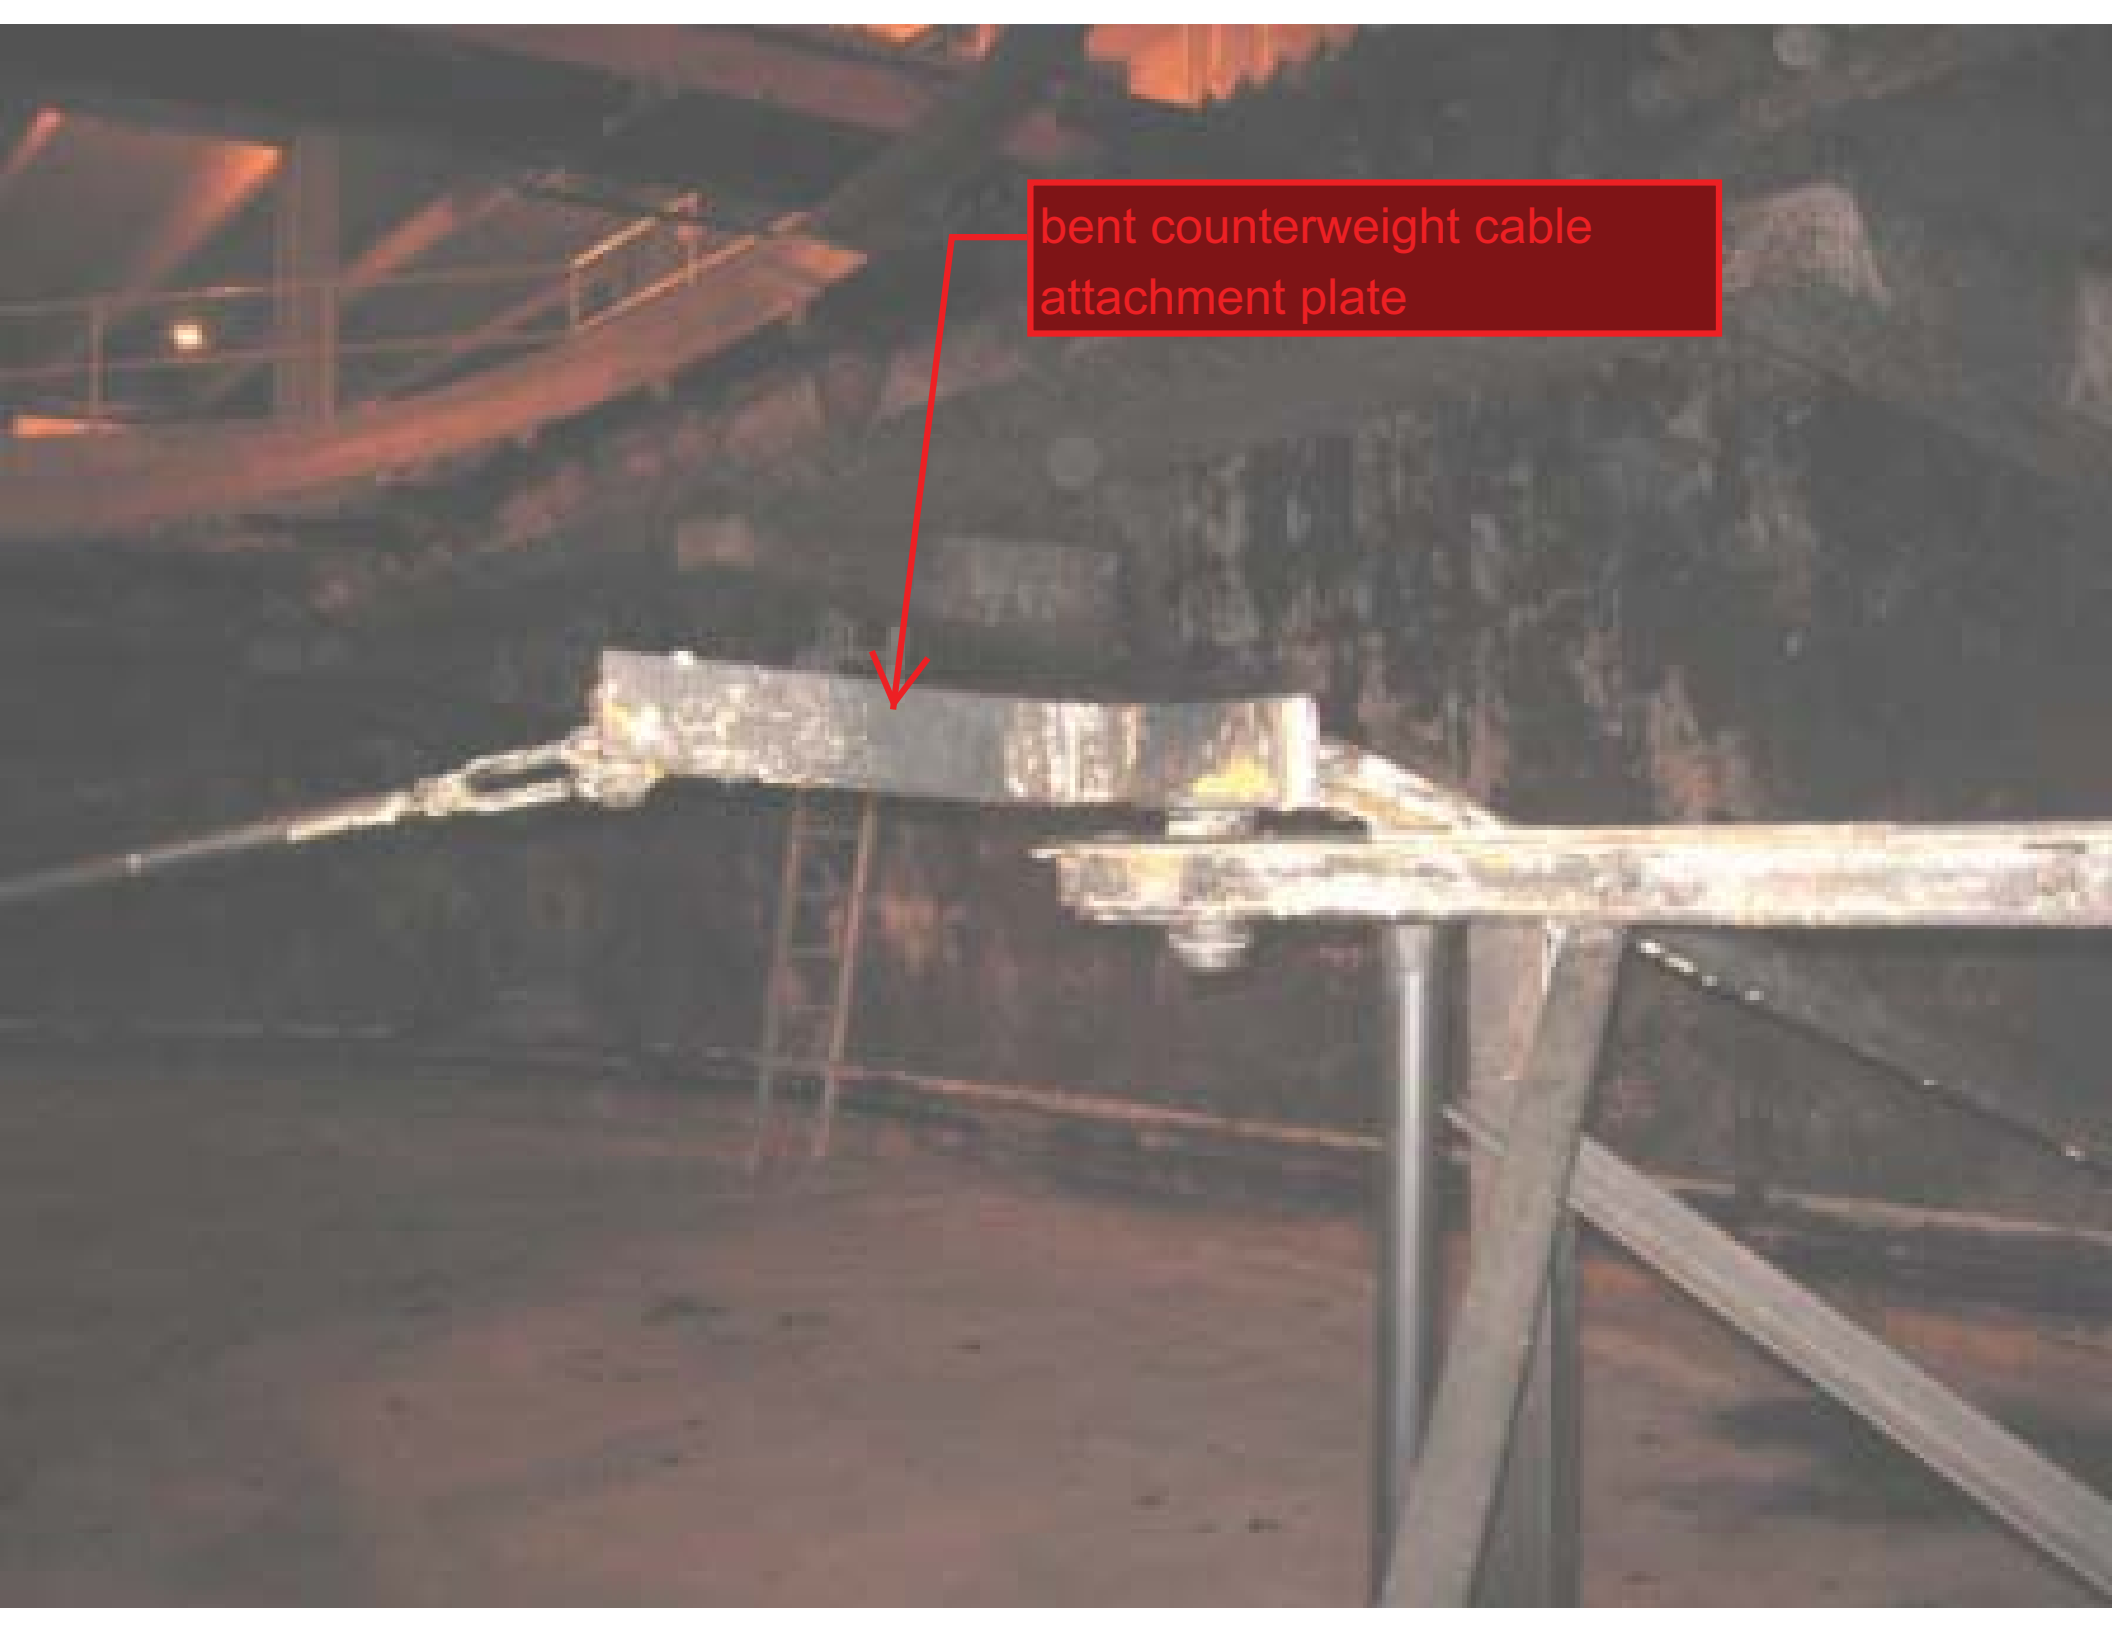
bent counterweight cable
attachment plate

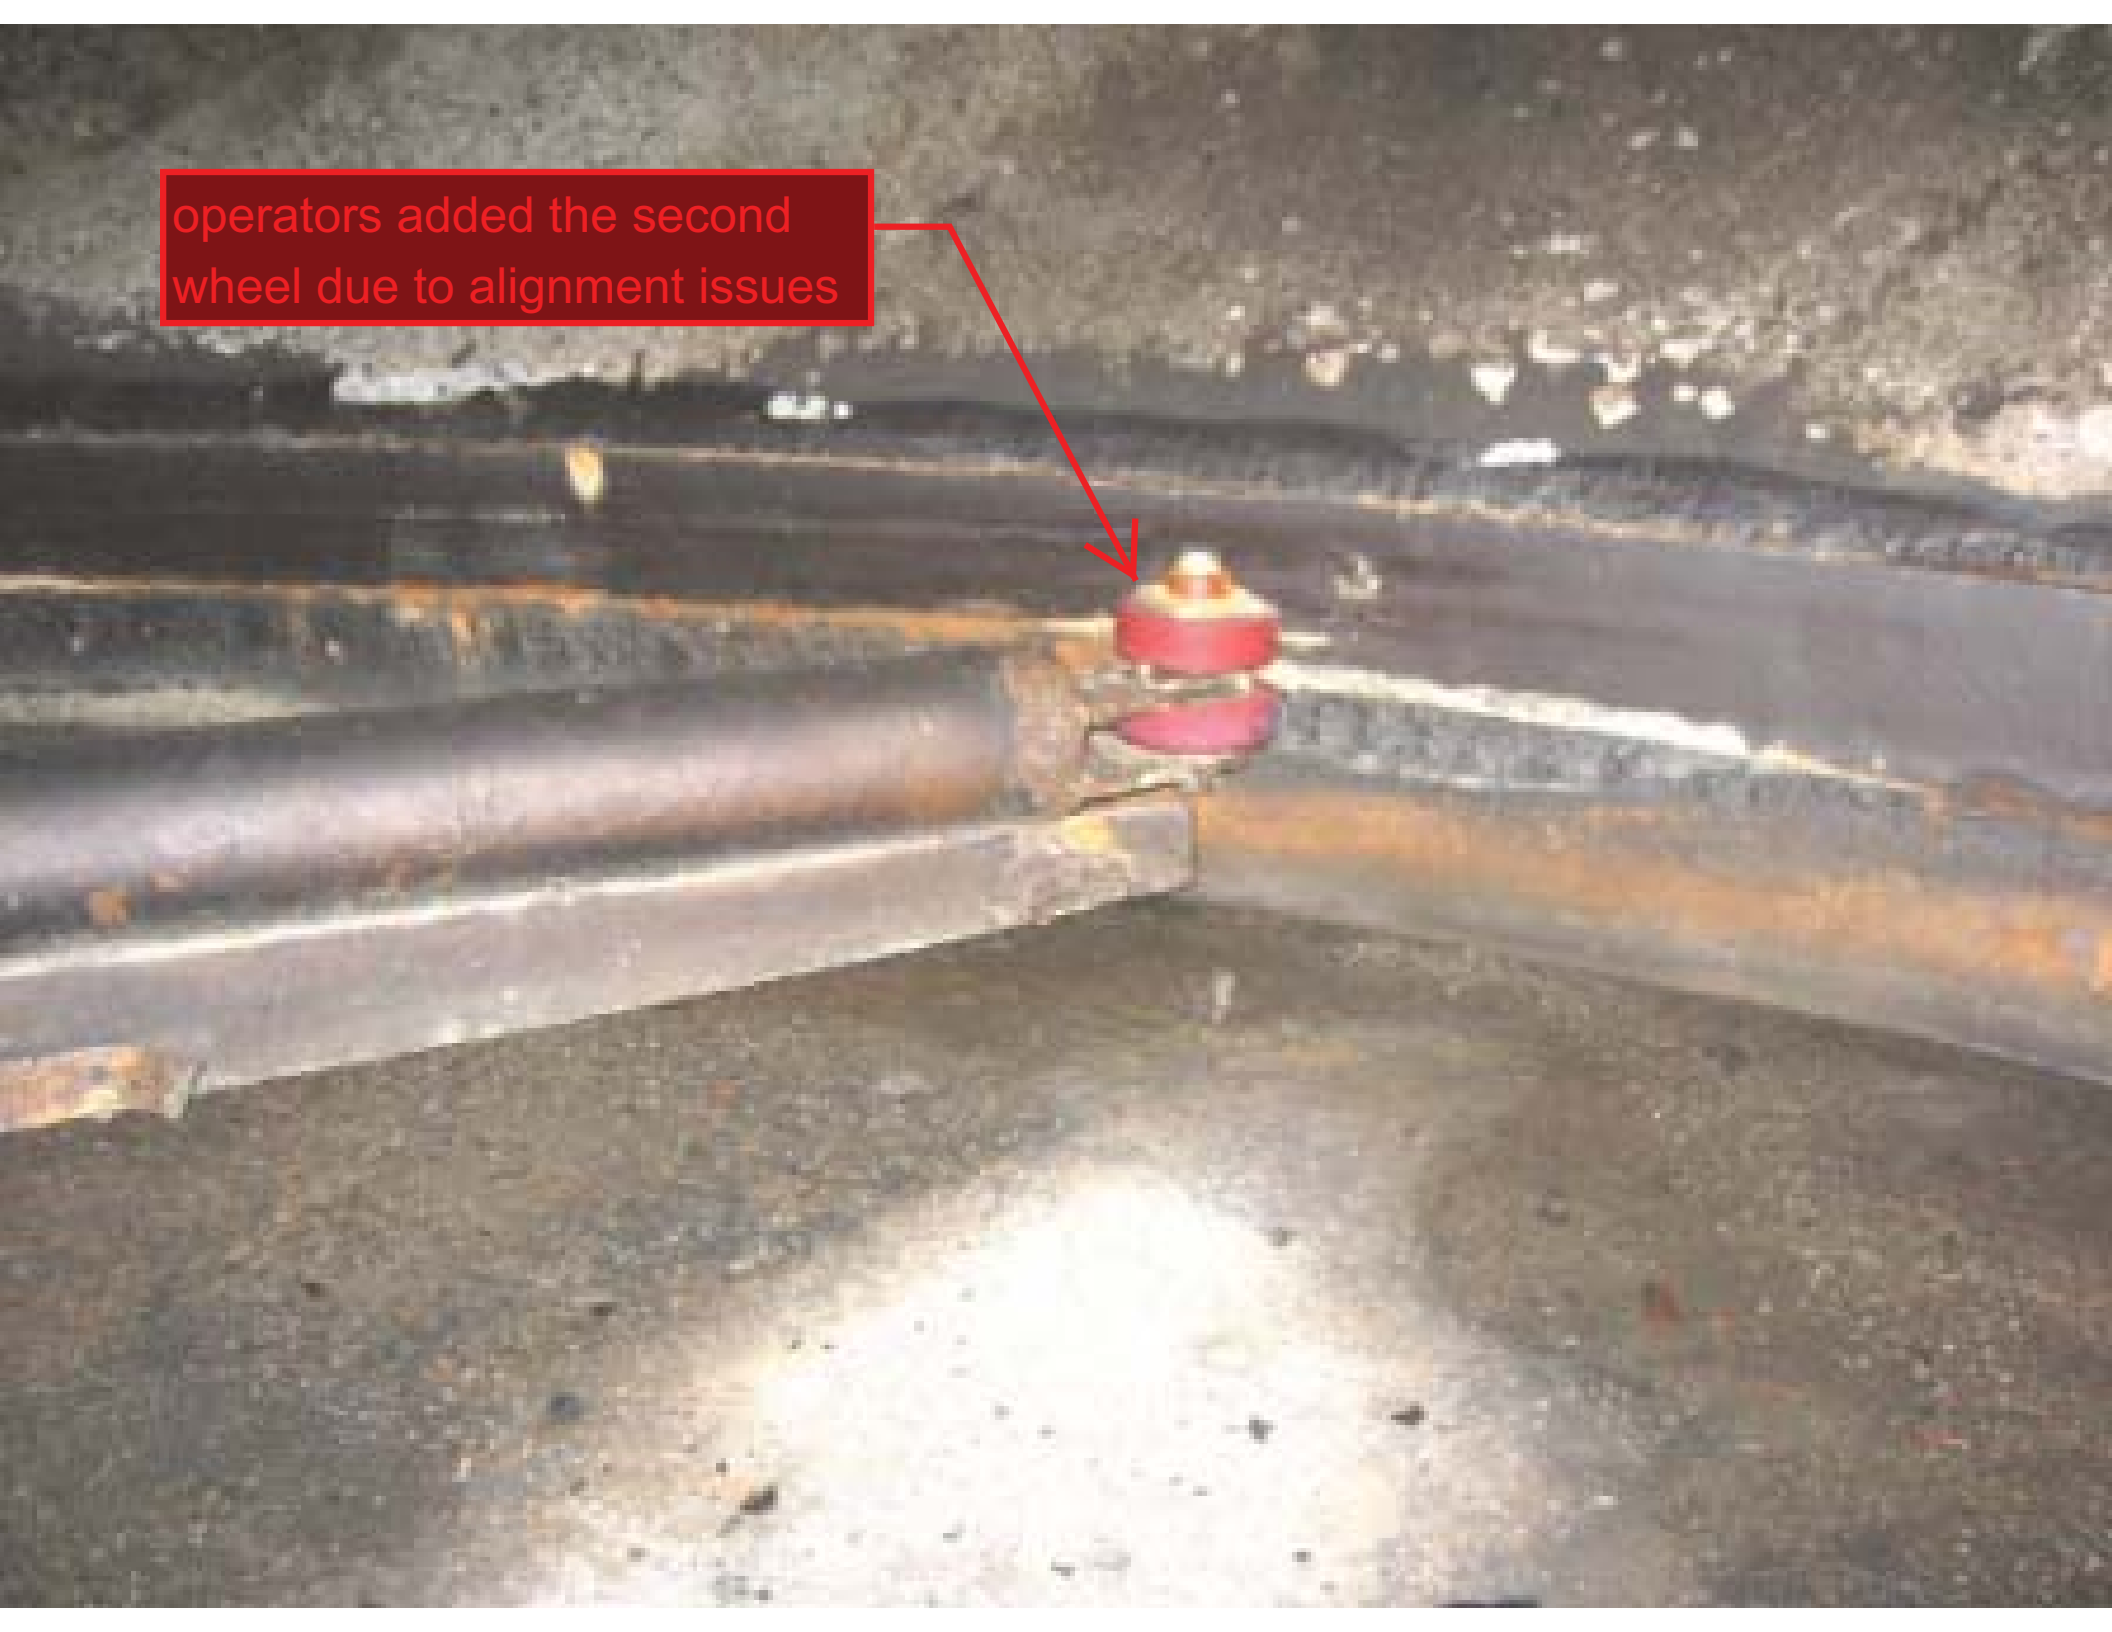
wear plate corrosion through to concrete

operators added the second wheel due to alignment issues

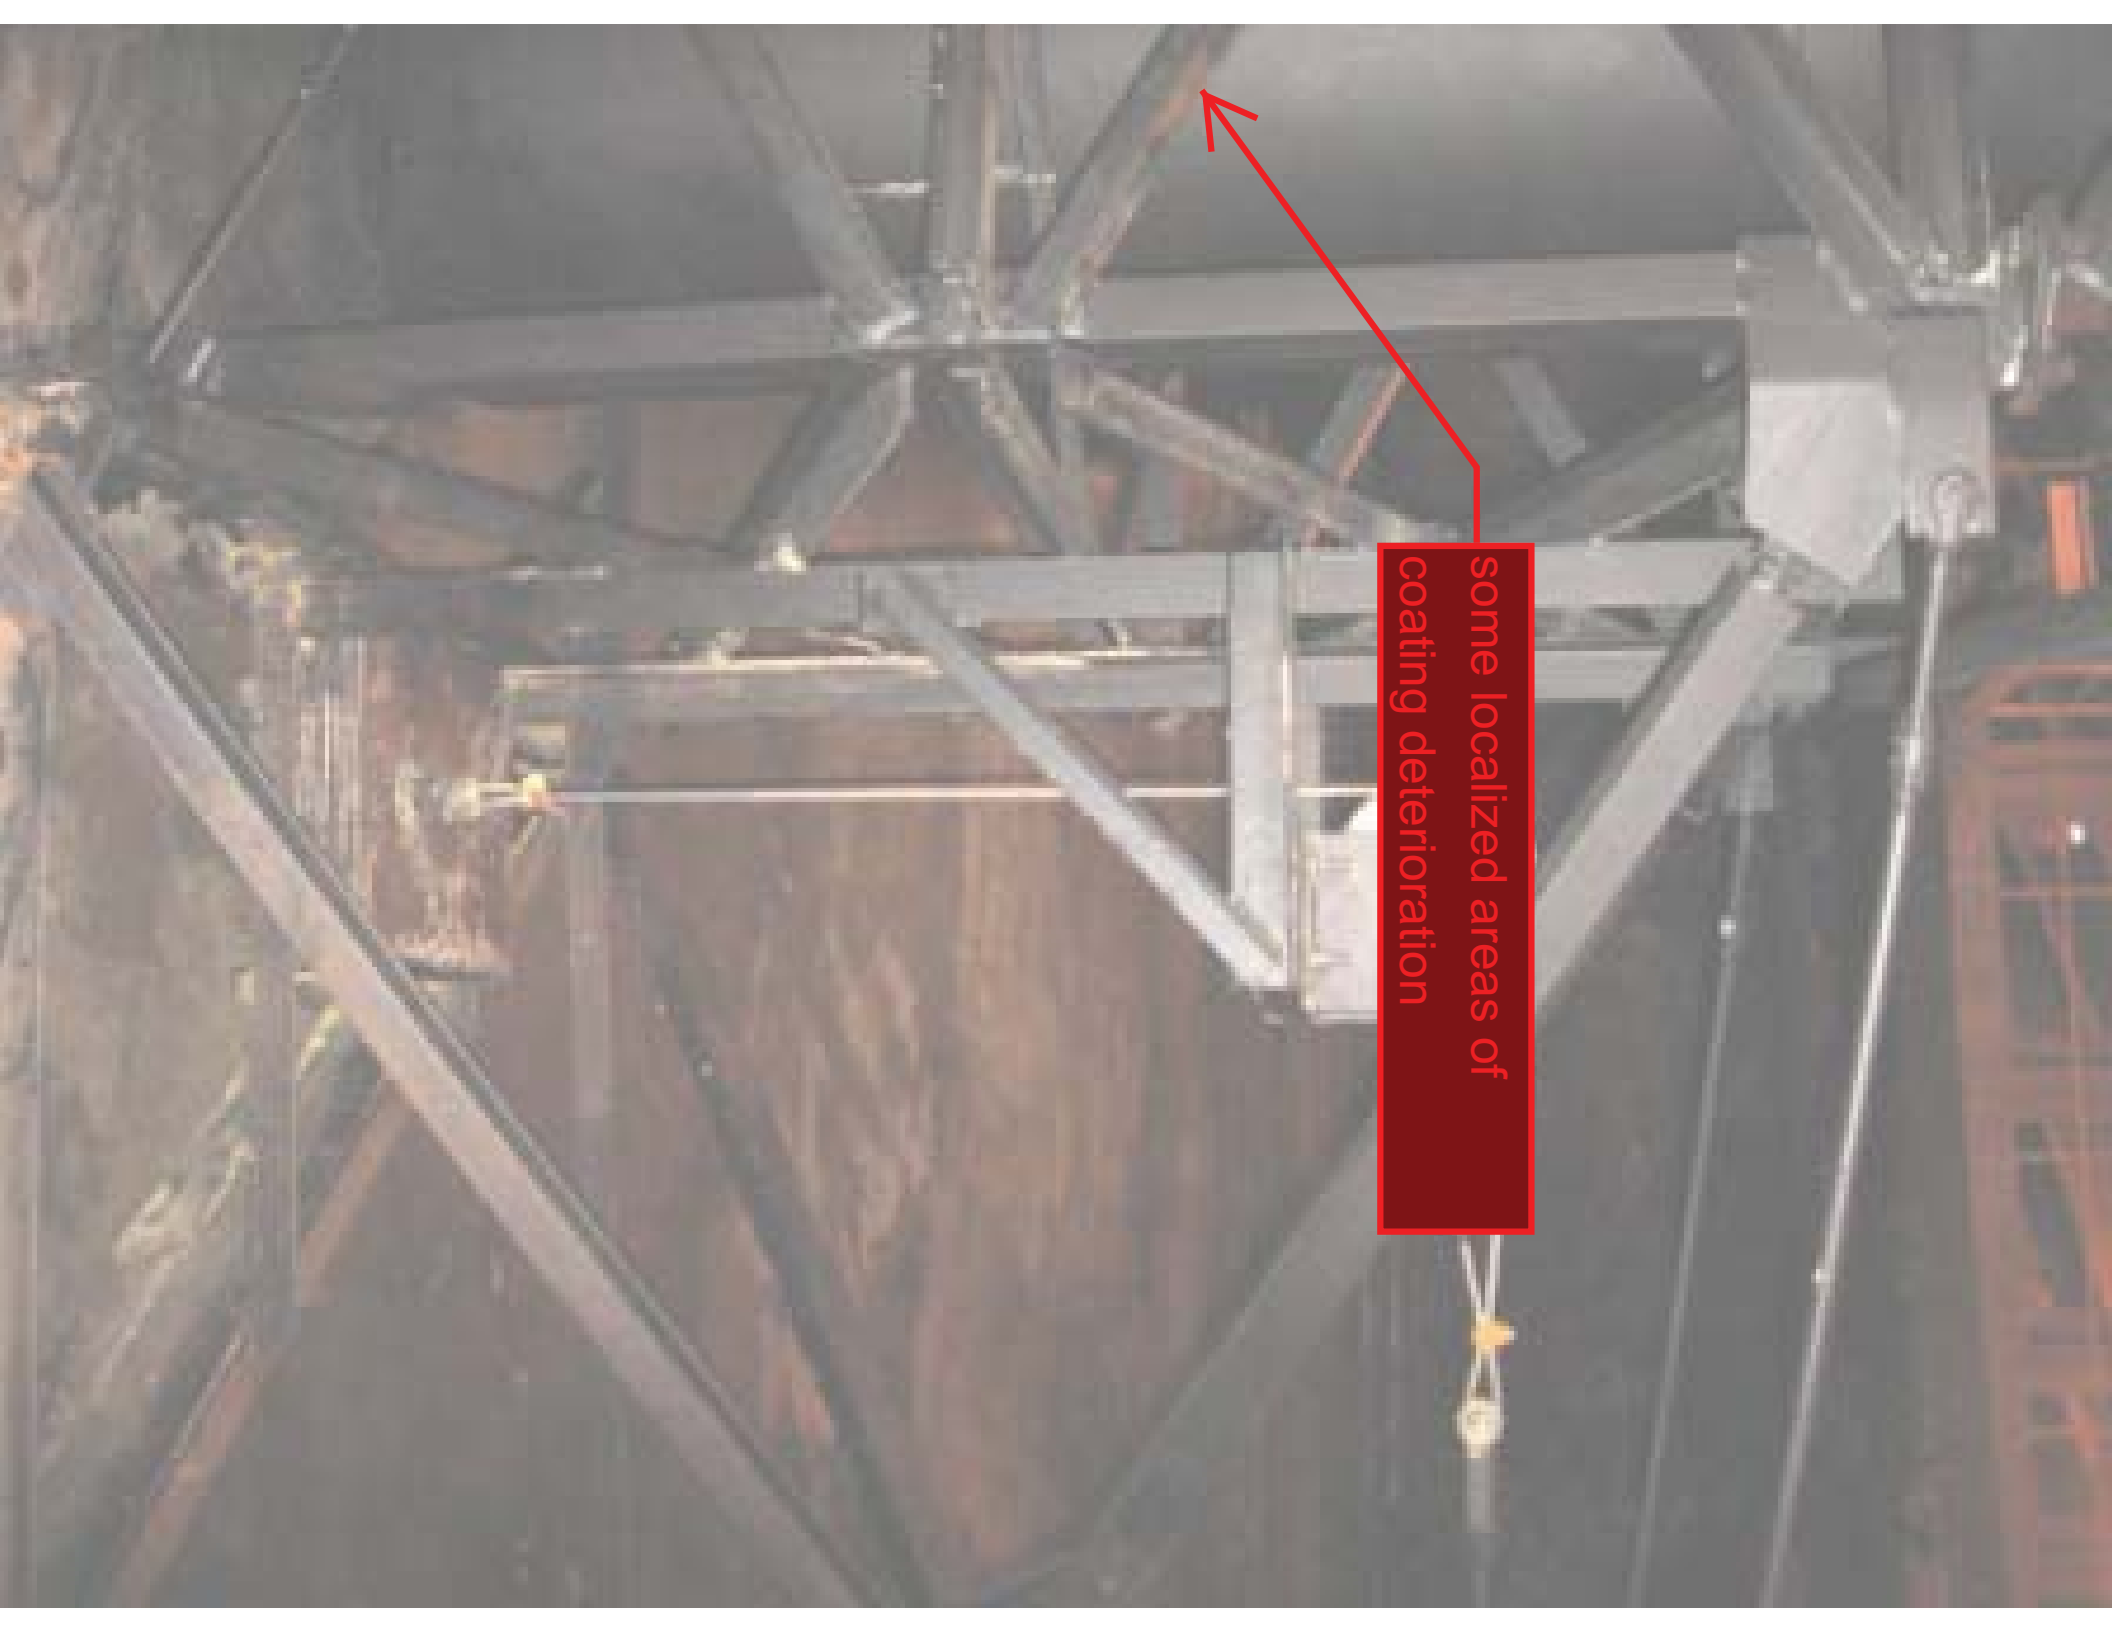
some localized areas of
coating deterioration
