NEWPCC Secondary Clarifier #1
Examination
December 03, 2010

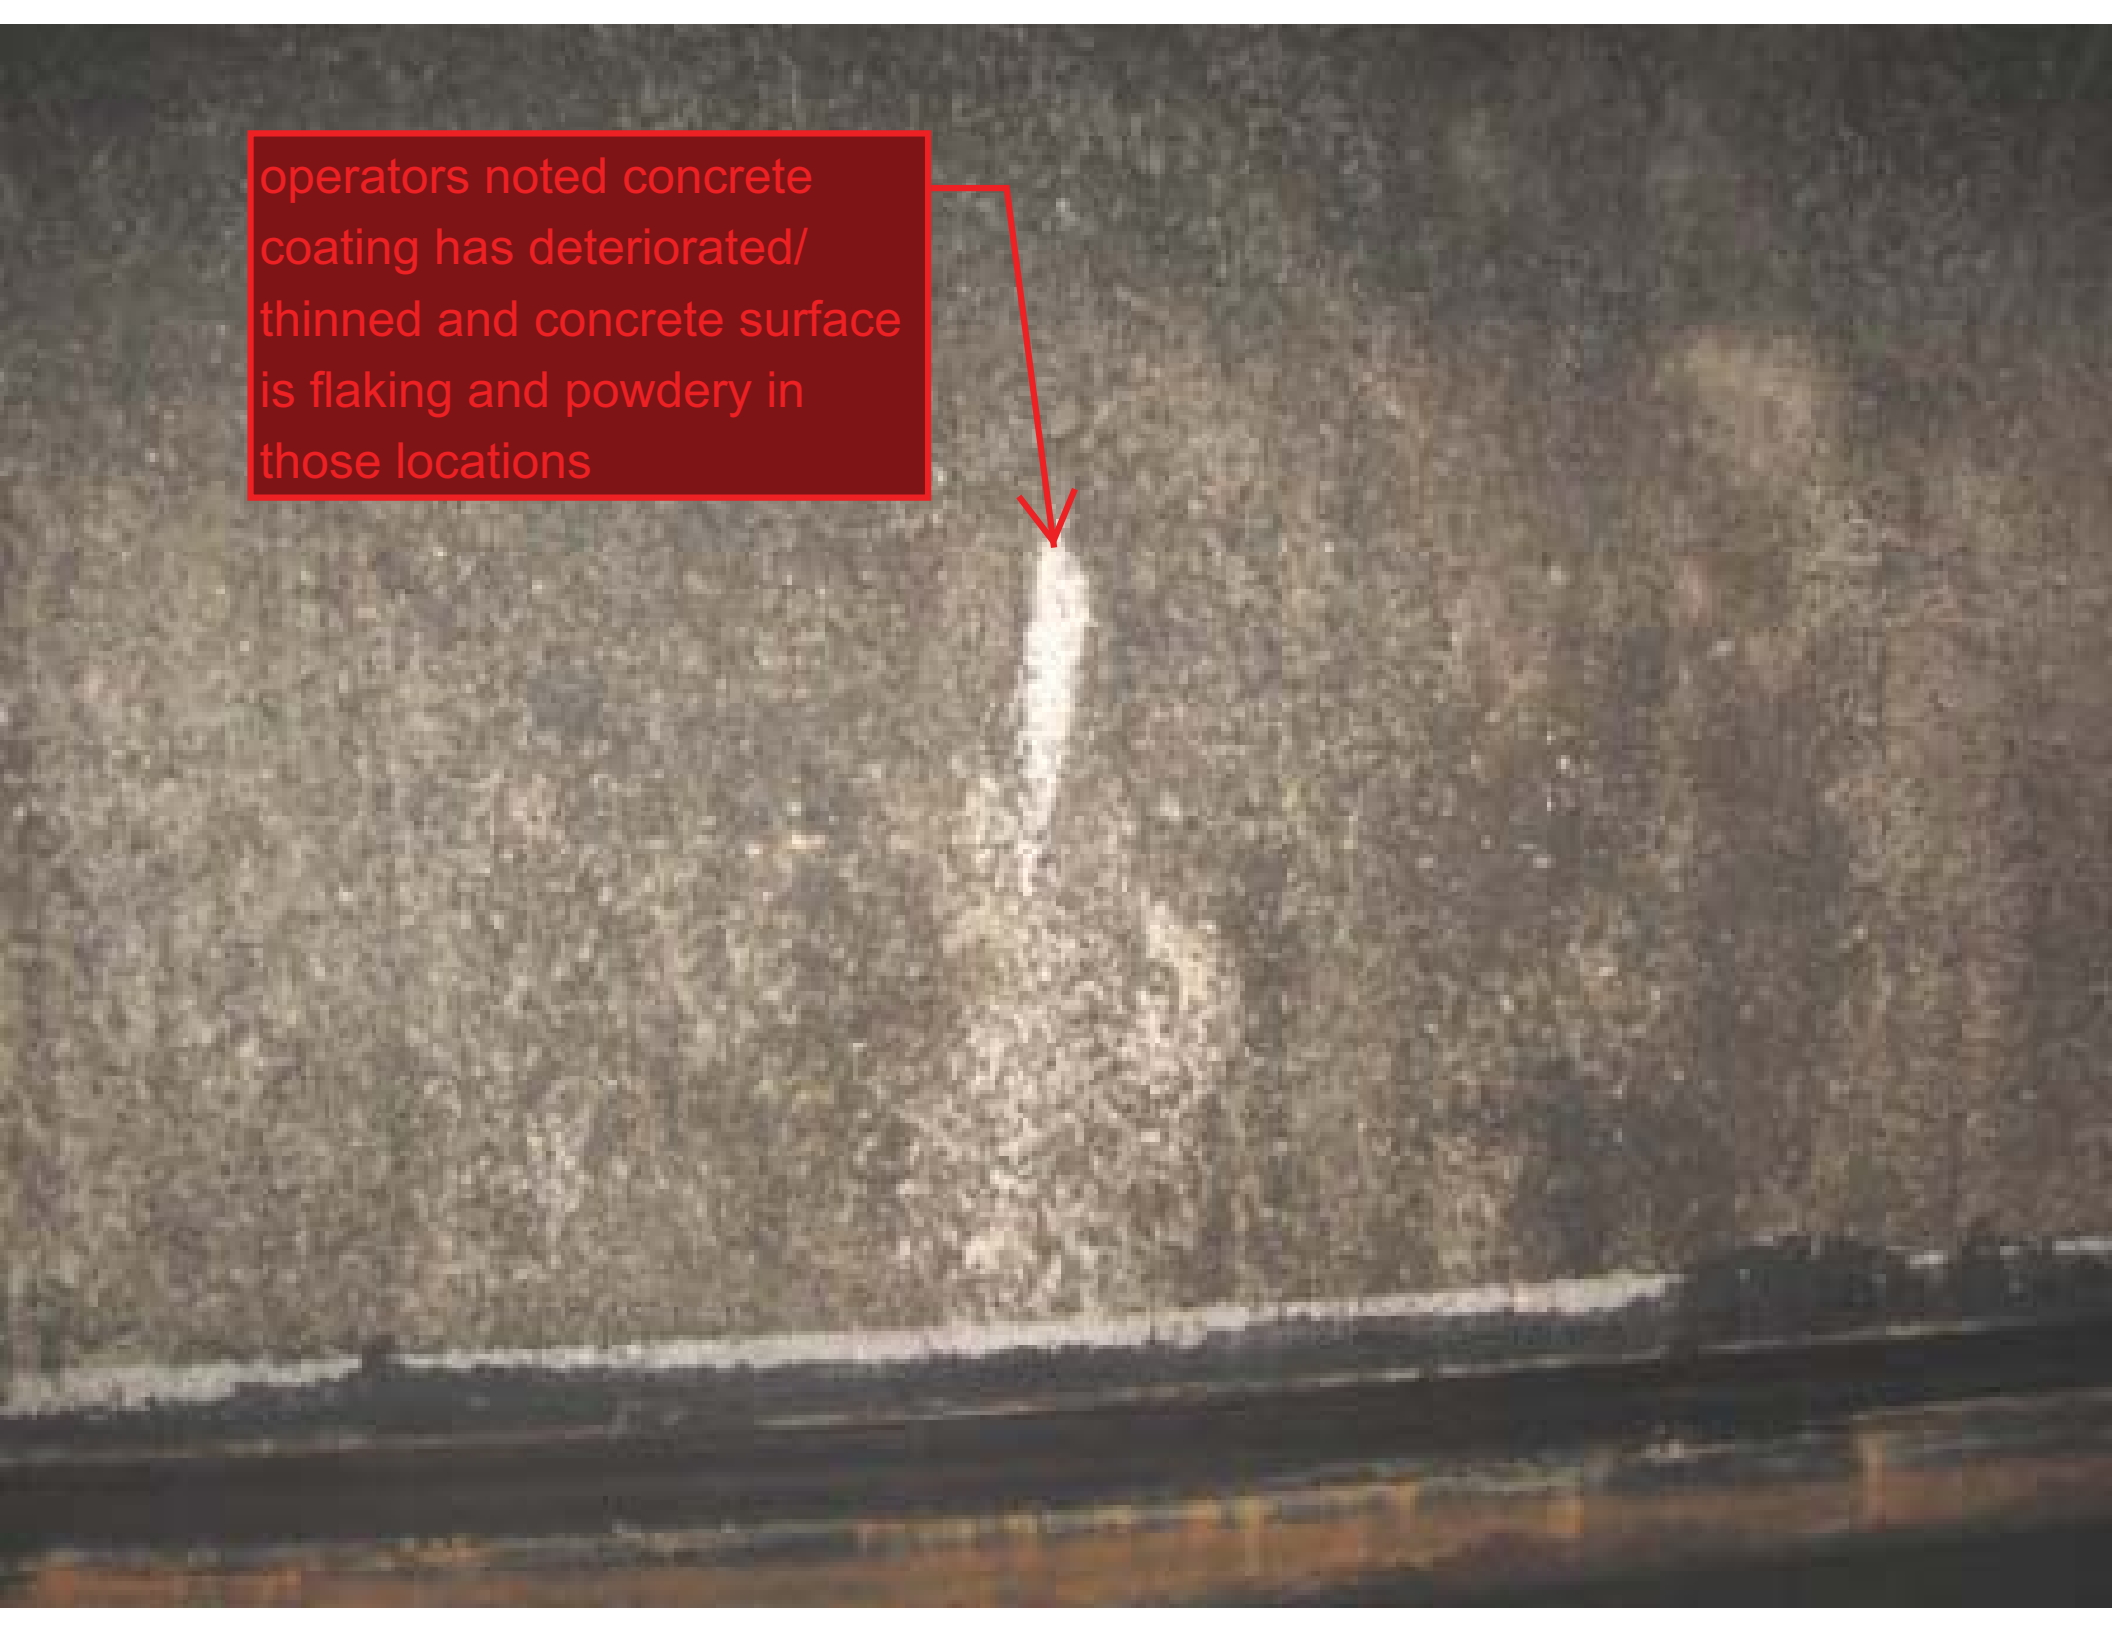
operators noted concrete coating has deteriorated/ thinned and concrete surface is flaking and powdery in those locations

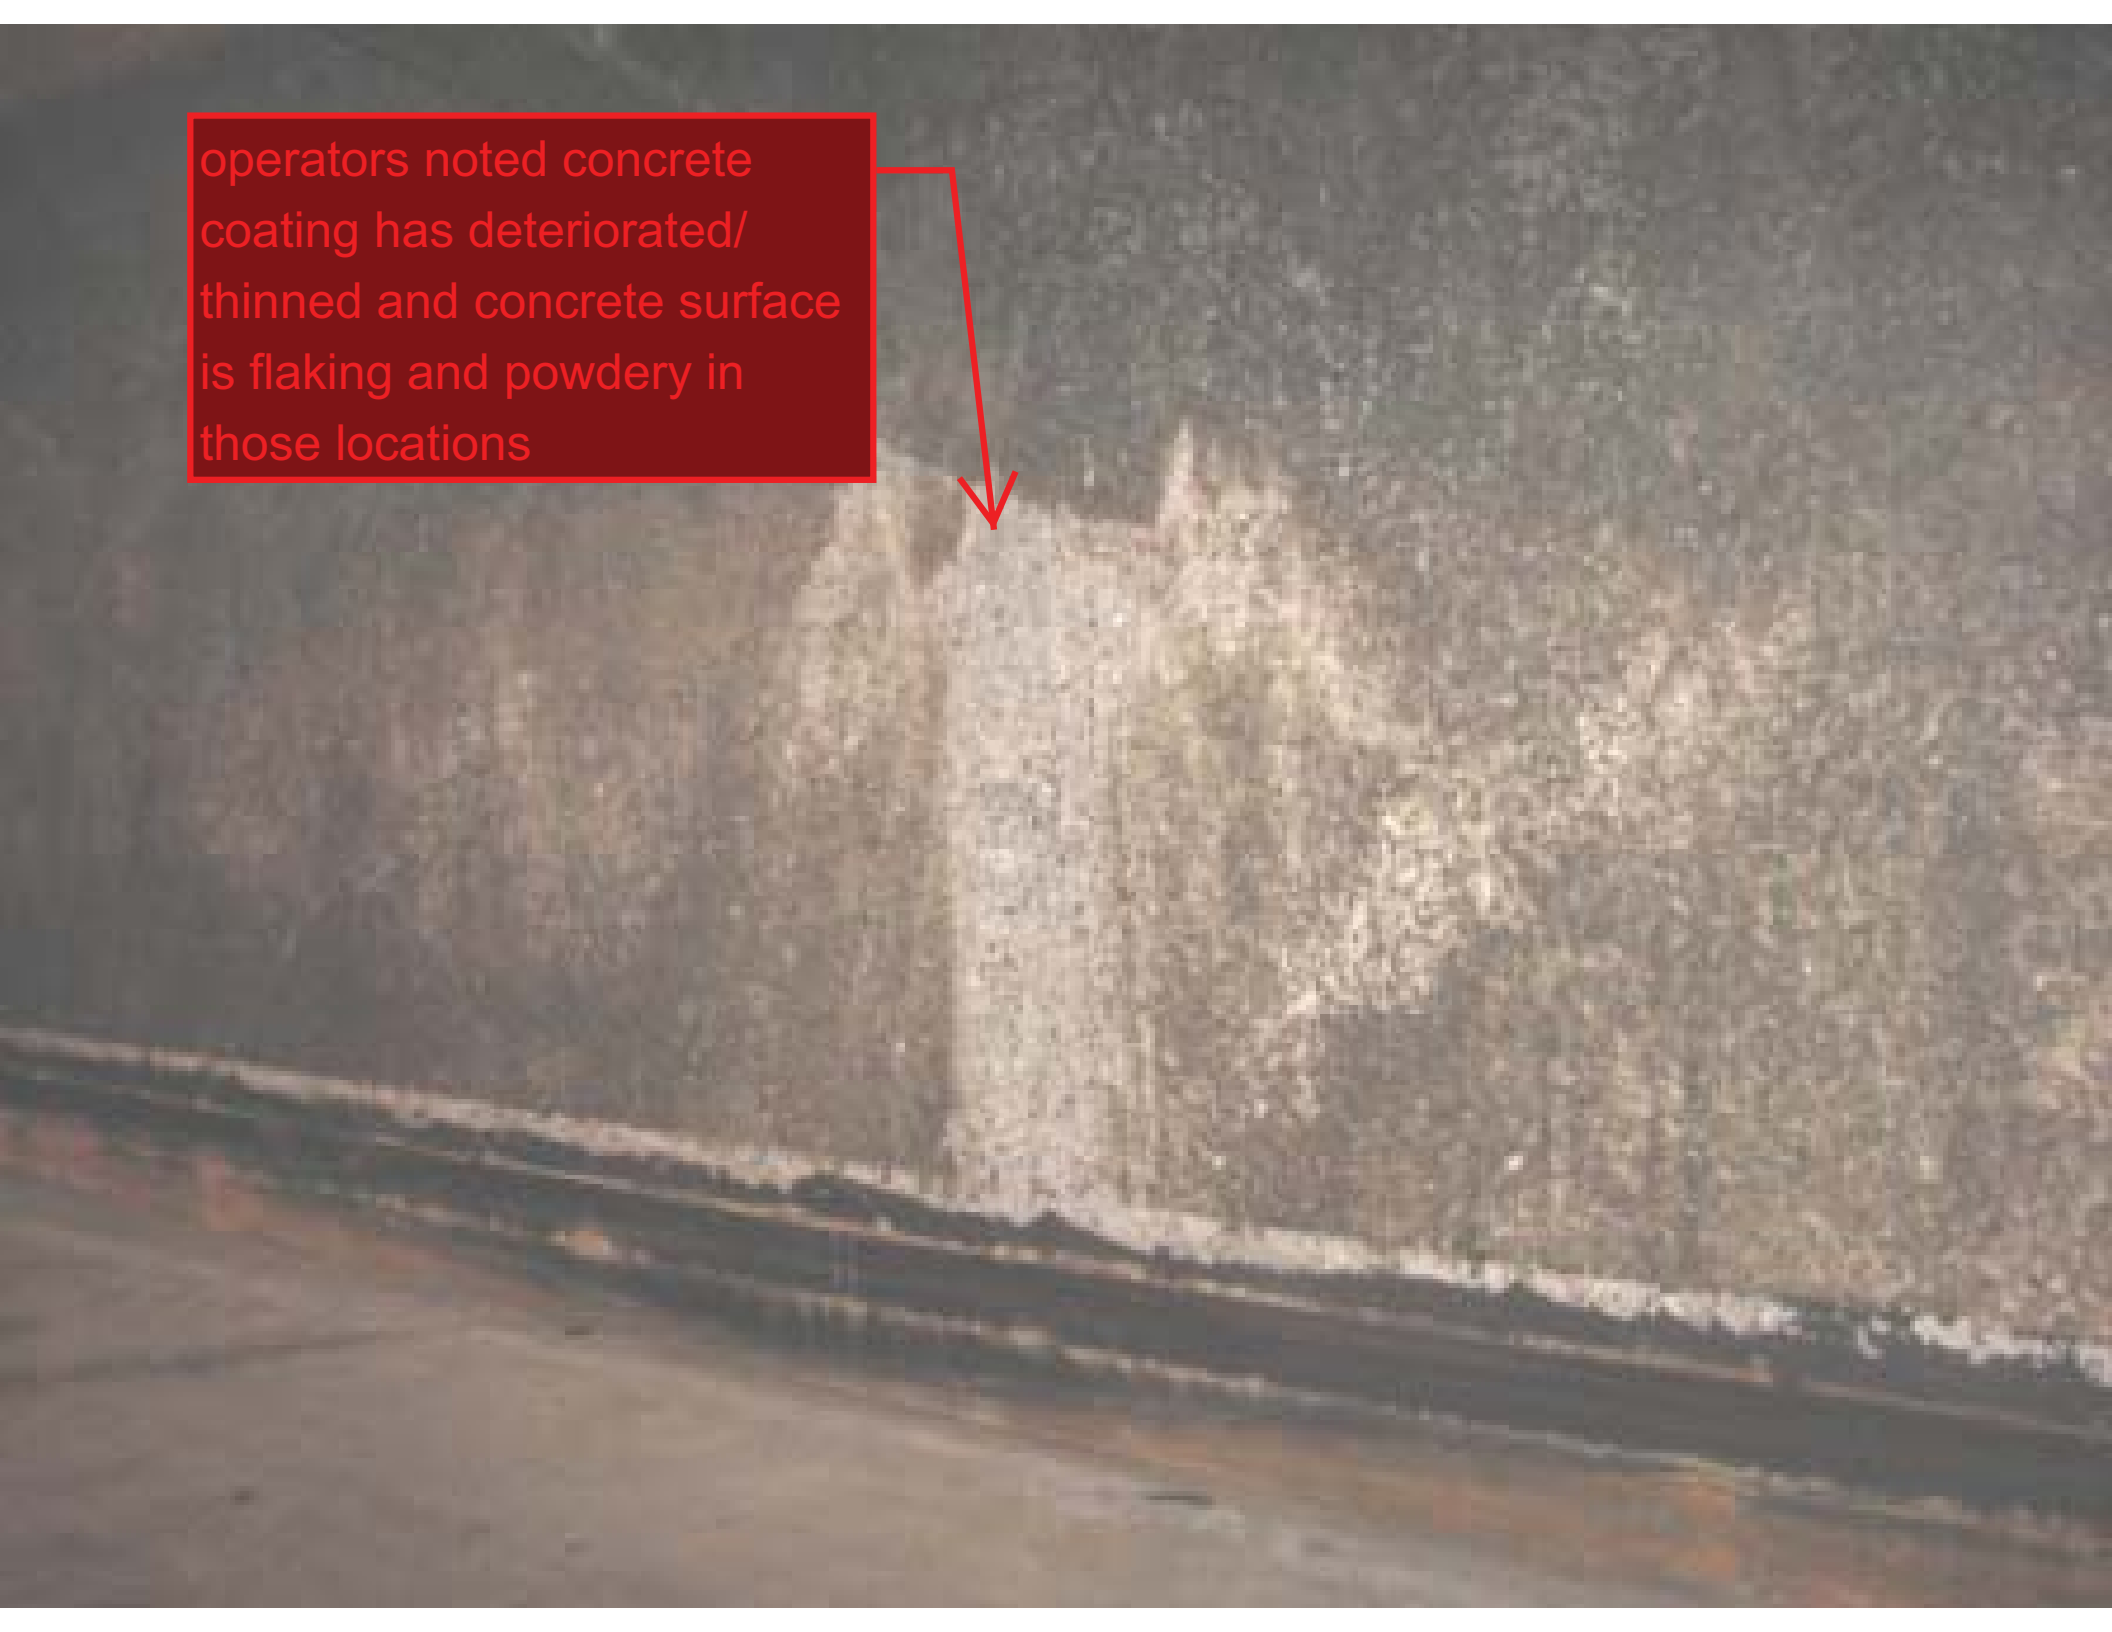
operators noted concrete coating has deteriorated/ thinned and concrete surface is flaking and powdery in those locations
