PEGUIS PAVILION
 UPGRADES AND ENTRY ADDITION
 BIDDING #913-2011

TYPICAL CONCRETE REPAIR DETAILS

scale: AS NOTED
 date: March 7, 2012
 drawn by: MS
 checked by: TKM
 project no. 2011026
 sheet no. S3.2-R1

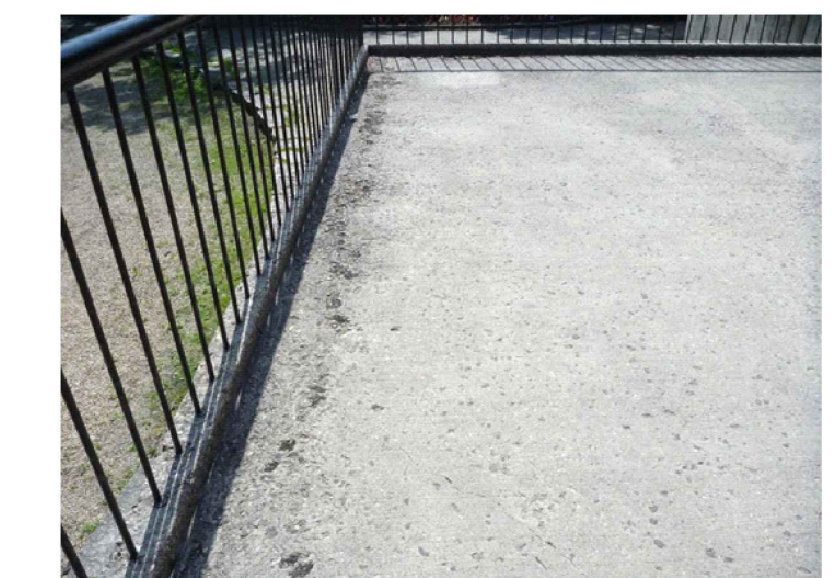
- THE SURFACE OF THE EXTERIOR BALCONY AREA EXHIBITS PITTING AND MODERATE TO SEVERE SCALING OF THE SURFACE CONSISTENT WITH FREEZE-THAW DETERIORATION. REPAIRS ARE REQUIRED TO ADDRESS THE LOSS IN SECTION, PROTECT THE TOP REINFORCING STEEL, AND PROVIDE A SMOOTH SOUND SURFACE FOR THE WATERPROOFING MEMBRANE. CHAIN DRAG SOUNDINGS HAVE IDENTIFIED APPROXIMATELY 100 SQ.FT. OF TOP SURFACE SCALING AND APPROXIMATELY 15 SQ.FT. OF TOP SURFACE DELAMINATION. REFER TO PHOTOGRAPHS #1, #2, AND #5 INCLUDED WITH THIS ADDENDUM.

PHOTO #1:
 EXTERIOR BALCONY SHOWING AREAS OF PITTING AND SCALING.

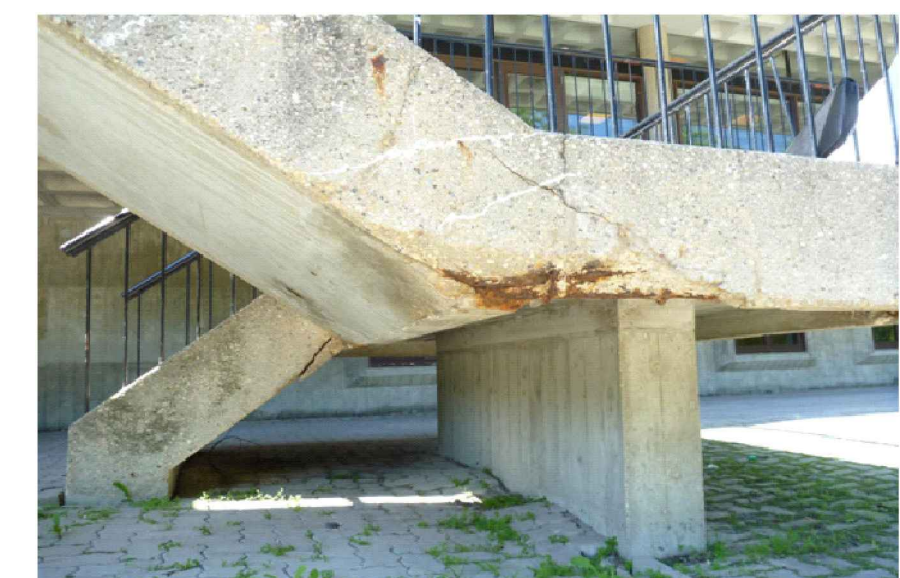
- EXTENSIVE DELAMINATION AND SPALLING OF THE CONCRETE STAIR STRINGERS WAS OBSERVED AT THE NORTH EXTERIOR STAIR. REPAIR OF THE STAIR STRINGERS IS REQUIRED. REFER TO PHOTOGRAPHS #3 AND #4 INCLUDED WITH THIS ADDENDUM.

PHOTO #4:
 CRACKING AND DELAMINATION OF STAIR STRINGER.

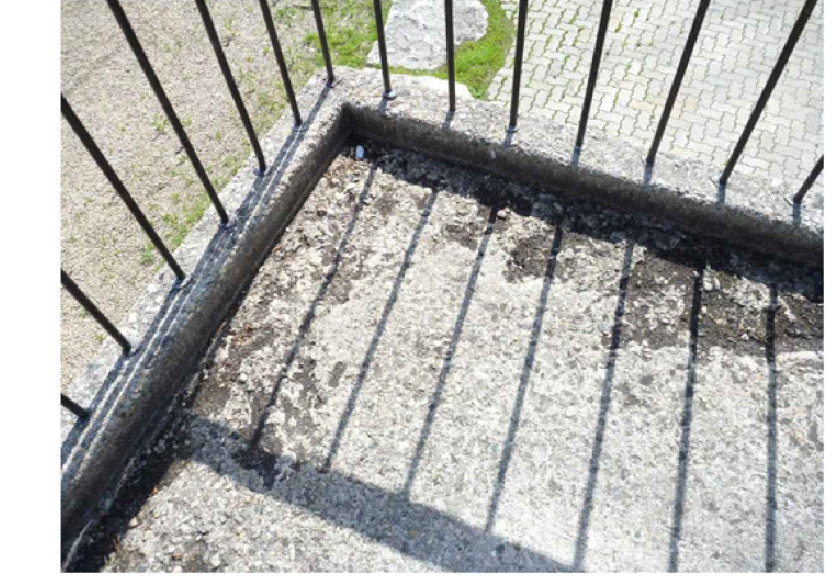
PHOTO #2:
 MODERATE TO SEVERE SCALING OF SLAB SURFACE IN NORTHEAST CORNER.

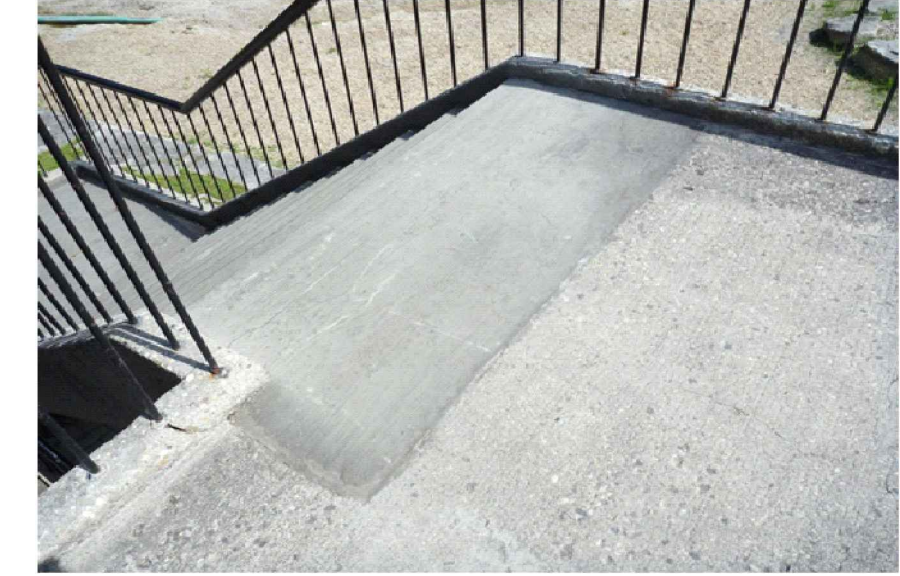
PHOTO #5:
 TOP SURFACE OF LANDING SHOWING SKIM COAT REPAIR.

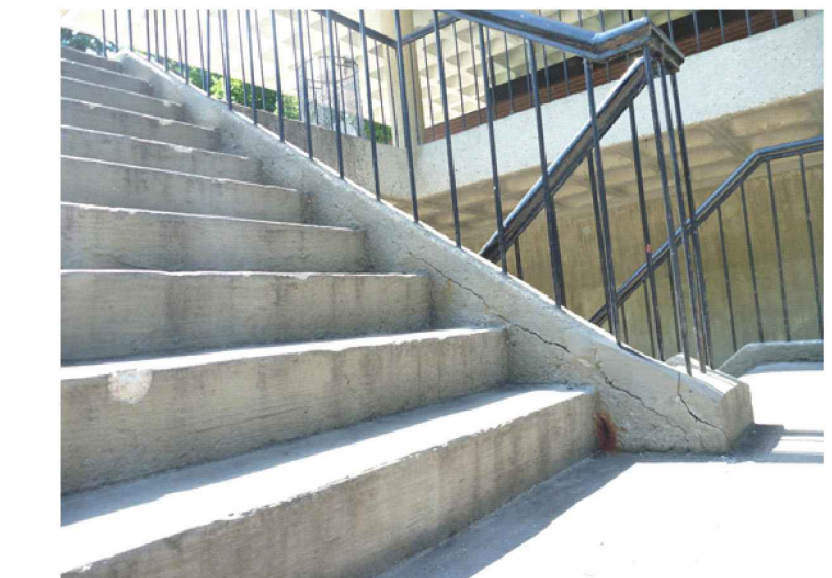
PHOTO #3:
 CRACKING AND DELAMINATION OF STAIR STRINGER.
