GEOTECHNICAL REPORT FOR

1. PULLBERRY STREET
2. RIVERBEND AVENUE

**PAVEMENT INVESTIGATION
PULBERRY STREET REHABILITATION
ST. VITAL ROAD TO MOORE AVENUE
2012 STREET RENEWAL PROGRAM**

**PAVEMENT INVESTIGATION
RIVERBEND AVENUE REHABILITATION
MINNETONKA STREET TO METZ STREET
2012 STREET RENEWAL PROGRAM**

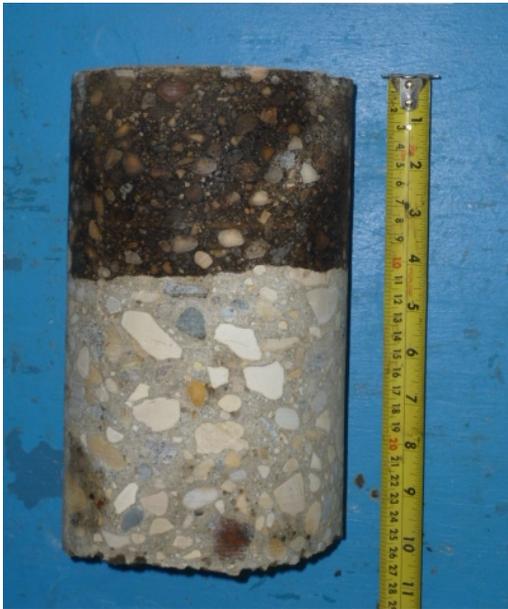
| Testhole ID | Testhole Location | Pavement Surface | | Pavement Structure Material | | Soil Description | Sample Depth (m) | Moisture Content (%) | Particle Size Analysis | | | | Atterberg Limits | | |
|---|---|---|---|---|---|---|---|---|---|---|---|---|---|---|---|
| TH1 | Pulberry Street Centre of northbound lane 8.7 m south of St. Vital Road | Asphalt | 100 | Clay Fill | 1060 | clay fill | 0.6 | 32.0 | 4.0 | 10.7 | 23.4 | 61.9 | 81 | 19 | 62 |
| | | Concrete | 140 | | | | | | | | | | | | |

Core Sample from Testhole TH1

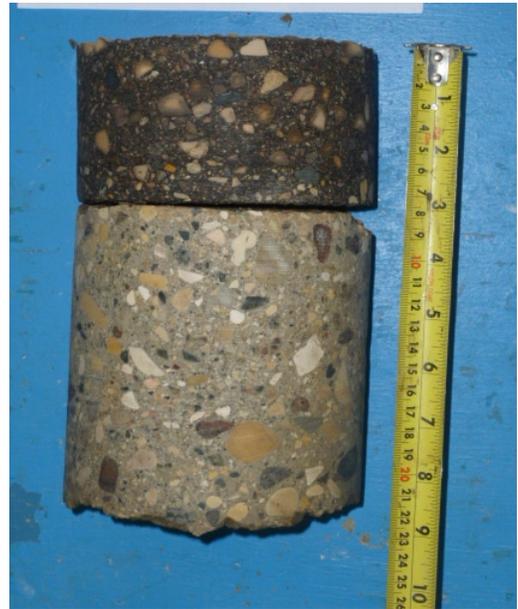
| Testhole ID | Testhole Location | Pavement Surface | | Pavement Structure Material | | Soil Description | Sample Depth (m) | Moisture Content (%) | Particle Size Analysis | | | | Atterberg Limits | | |
|---|---|---|---|---|---|---|---|---|---|---|---|---|---|---|---|
| TH2 | Pulberry Street Centre of southbound lane 12 m north of Barrington Avenue | Asphalt | 75 | Clay Fill | 655 | clay | 0.9 | 41.0 | 0.8 | 1.7 | 13.3 | 84.2 | 105 | 23 | 82 |
| | | Concrete | 145 | | | | | | | | | | | | |

Core Sample from Testhole TH2

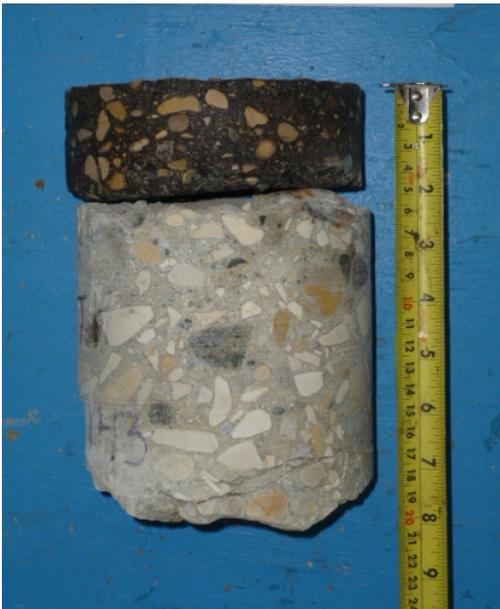
| Testhole ID | Testhole Location | Pavement Surface | | Pavement Structure Material | | Soil Description | Sample Depth (m) | Moisture Content (%) | Particle Size Analysis | | | | Atterberg Limits | | |
|---|---|---|---|---|---|---|---|---|---|---|---|---|---|---|---|
| TH3 | Pulberry Street Centre of northbound lane 35 m south of Barrington Avenue | Asphalt | 50 | Clay Fill | 1650 | — | — | — | — | — | — | — | — | — | — |
| | | Concrete | 150 | | | | | | | | | | | | |

Core Sample from Testhole TH3

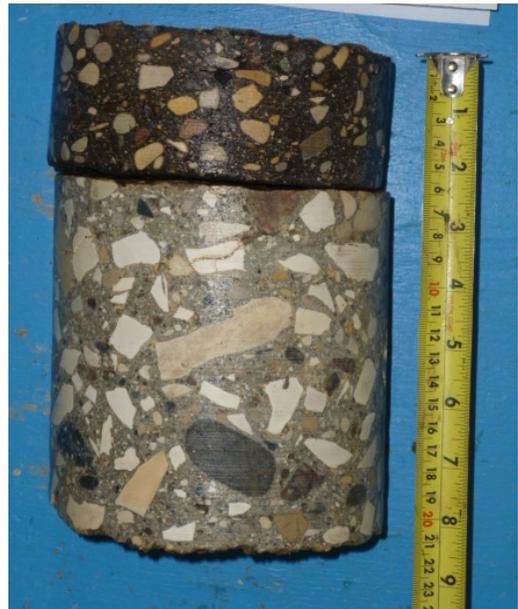
| Testhole ID | Testhole Location | Pavement Surface | | Pavement Structure Material | | Soil Description | Sample Depth (m) | Moisture Content (%) | Particle Size Analysis | | | | Atterberg Limits | | |
|---|---|---|---|---|---|---|---|---|---|---|---|---|---|---|---|
| TH4 | Pulberry Street Centre of southbound lane 4.5 m south of Woodbury Drive | Asphalt | 65 | Crushed Limestone | 100 | — | — | — | — | — | — | — | — | — | — |
| | | Concrete | 145 | Clay Fill | 790 | | | | | | | | | | |

Core Sample from Testhole TH4

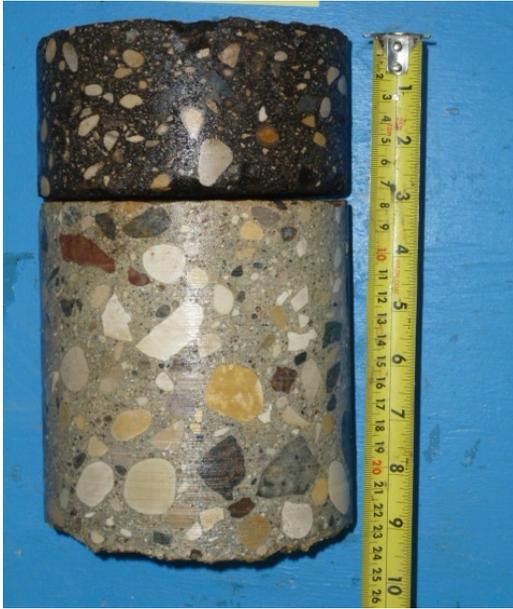
| Testhole ID | Testhole Location | Pavement Surface | | Pavement Structure Material | | Soil Description | Sample Depth (m) | Moisture Content (%) | Particle Size Analysis | | | | Atterberg Limits | | |
|---|---|---|---|---|---|---|---|---|---|---|---|---|---|---|---|
| TH5 | Pulberry Street Centre of northbound lane 6 m north of Moore Avenue | Asphalt | 75 | Clay Fill | 1165 | — | — | — | — | — | — | — | — | — | — |
| | | Concrete | 160 | | | | | | | | | | | | |

Core Sample from Testhole TH5

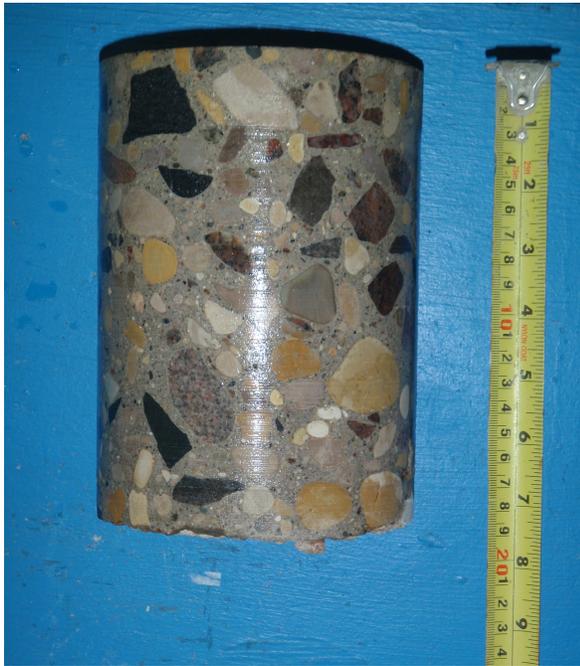
Core Sample C1

| Core ID | Core Location | Pavement Surface | | Condition of Core Sample |
|---|--|---|---|---|
| C1 | Eastbound lane 1m east of property line between 104 and 106 Riverbend Avenue 2.5 m from south curb | Concrete | 185 | Good Condition |

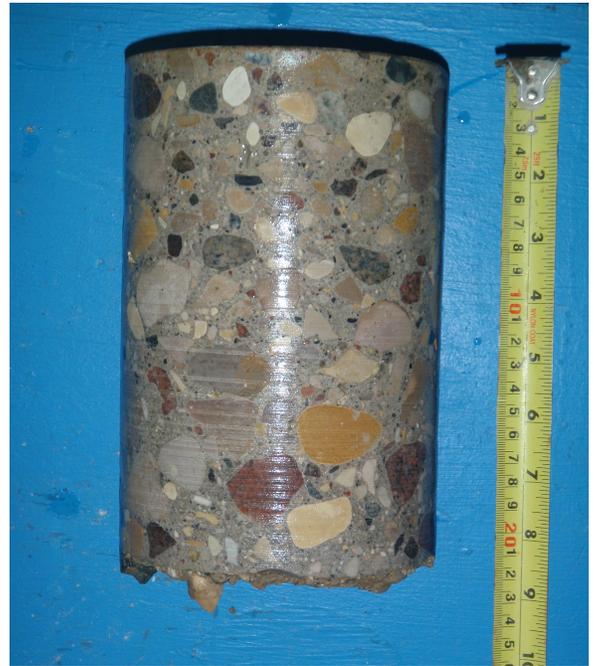
Core Sample C2

| Core ID | Core Location | Pavement Surface | | Condition of Core Sample |
|---|--|---|---|---|
| C2 | Westbound lane at property line bewtween 87 and 89 Riverbend Avenue 3.2 m from north curb | Concrete | 215 | Good Condition |

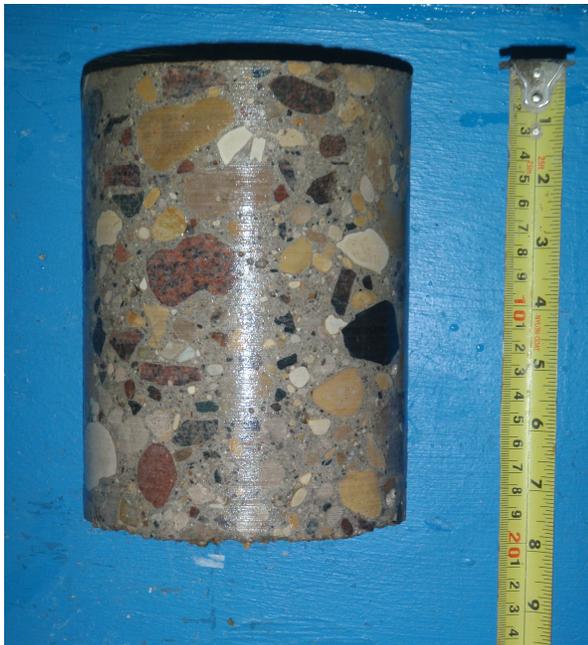
Core Sample C3

| Core ID | Core Location | Pavement Surface | | Condition of Core Sample |
|---|--|---|---|---|
| C3 | Eastbound lane 6 m west of west edge of driveway at 82 Riverbend Avenue 1.9 m from south curb | Concrete | 190 | Good Condition |
