## **APPENDIX B – AUBREY PUMPING STATION HOIST DEVICES AND LIFTING CAPACITIES REPORT**

## 1.0 LIFT STATION INFORMATION

**Station Name:** Aubrey Lift Station

**Date of Inspection:** February 17, 2010

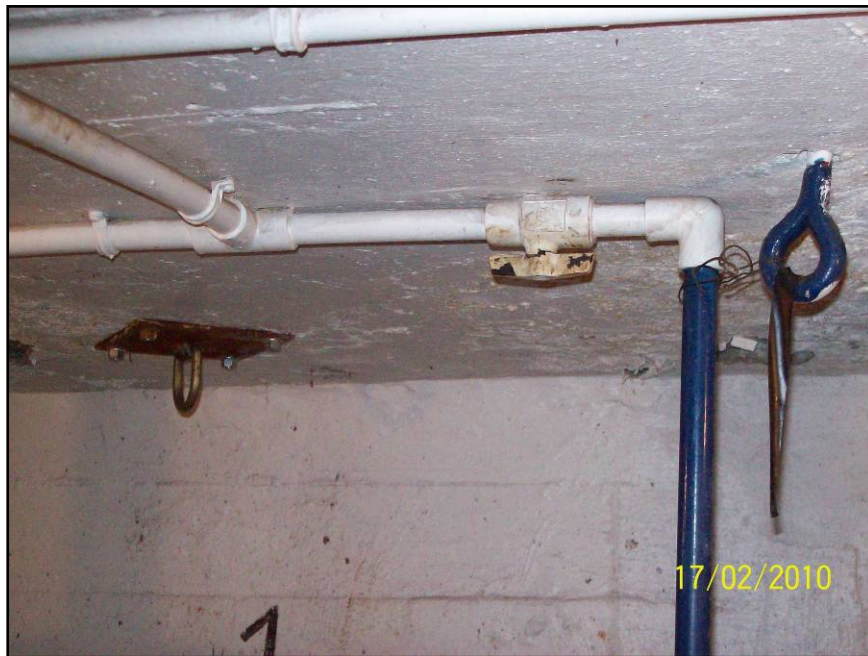
**Photograph No. 1**

Various hooks in the pump room

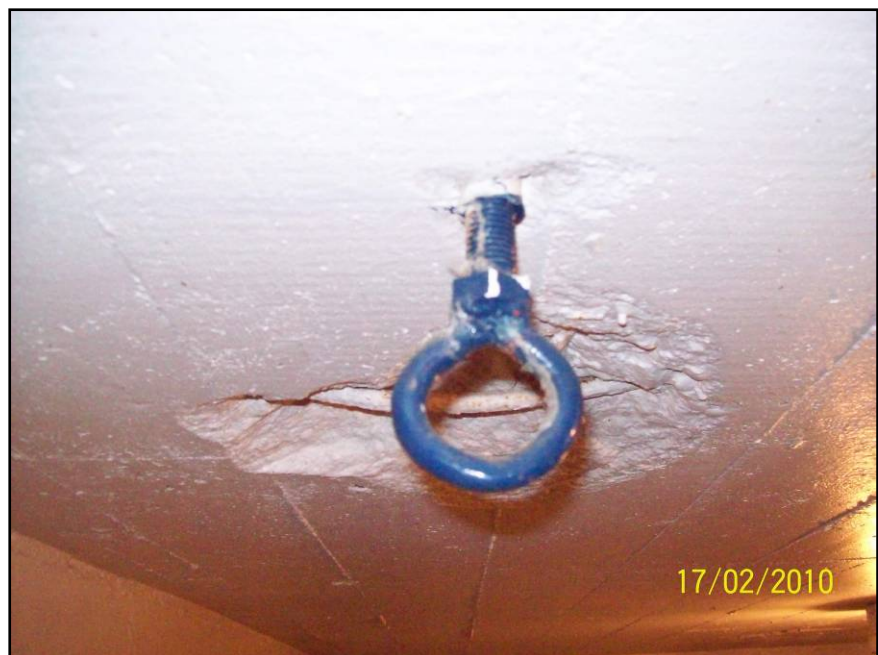
**Photograph No. 2**

Cast-in-place concrete deteriorated near one of the eye-shaped hooks

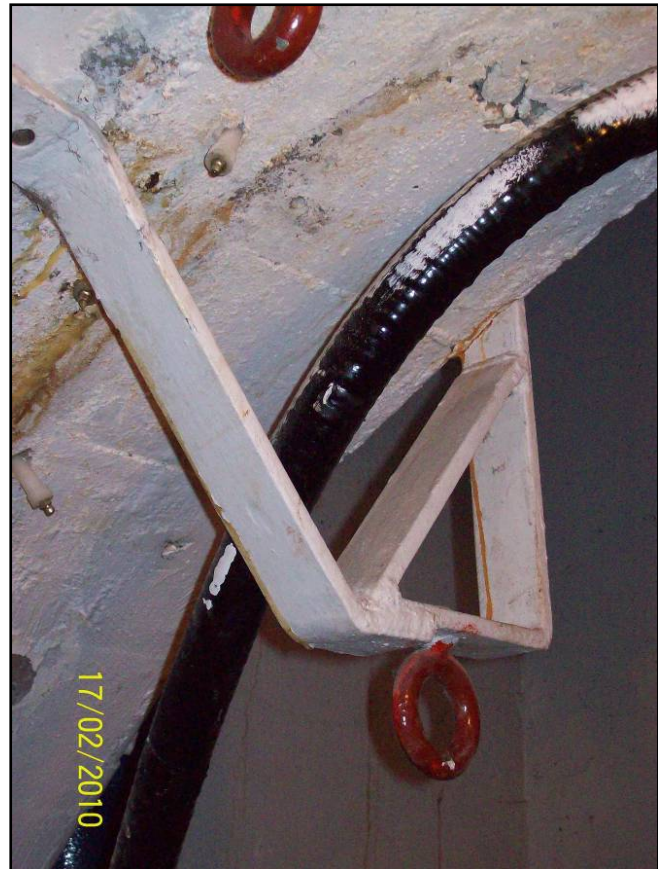
**Photograph No. 3**

The bracket hook, located in the third floor motor room, was analyzed for tensile resistance of the hook, pullout of the floor anchor bolts, shear resistance of the wall anchor bolts, and the shear resistance of the bracket. The pullout resistance was the governing factor in the hook, which was calculated to be 3.3 tons. However, due to the surface corrosion and the unconventional bracket design, a factor of safety of 3.3 was applied, to yield a **load rating of 1.0 ton.**

Motor room bracket hook

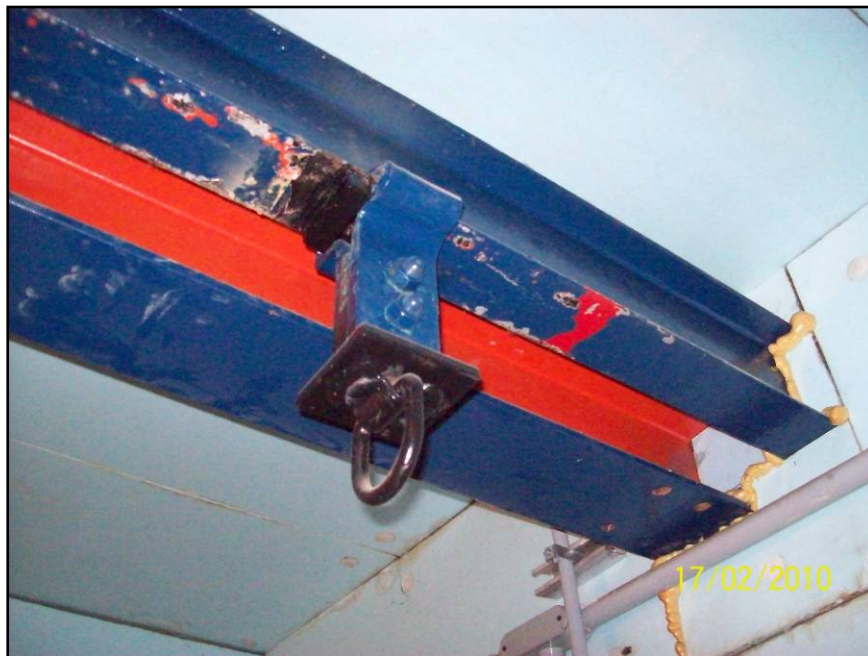
**Photograph No.4**

The main floor has two (2) steel lifting beams are beam approximately 2400mm above the top of main floor spanning approximately 3120mm. One (1) lifting beam is an S150x19 steel beam. A sliding steel beam clamp is bolted onto the bottom flange of the lifting beam. The other lifting beam is a W150x22 steel beam. Sliding steel beam clamps are bolted onto the bottom flange of the reference lifting beams. The lifting beam support connections were unable to be observed due to wall insulation.

Both beams on the main floor were analyzed for bending resistance. Bending resistance in the S-beam was determined to be 3.0 tons, and the W-Beam was determined to be 4.8 tons. This capacity was reduced by factors of 3.0 and 3.2 respectively, due to unknown wall connections to yield a **load rating of 1.0 tons for the S150x19 beam and 1.5 tons for the W150x22 beam.**

Side by side lifting beams on the main floor
