**Harbour View Recreation Complex
1867 Springfield Road, Winnipeg, MB
Water Mitigation Study – Interim Final Report**

August 27, 2012

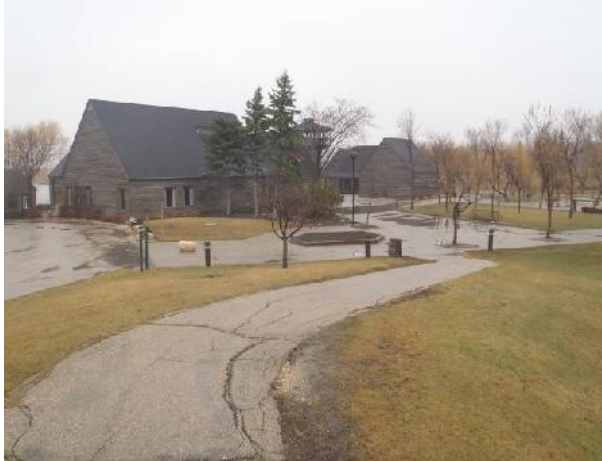
View of the Harbour View Facility from the Southwest

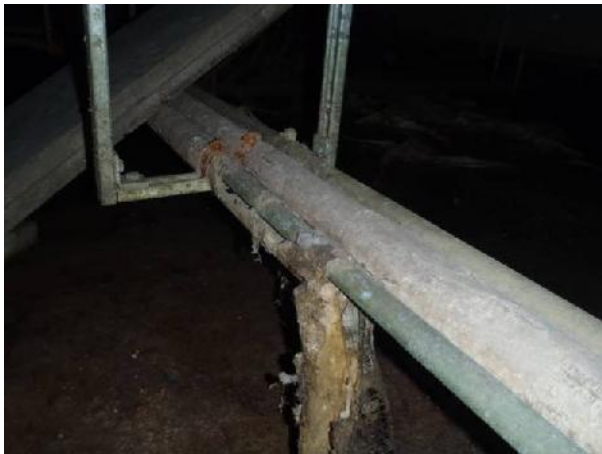
Missing insulation around the pipe

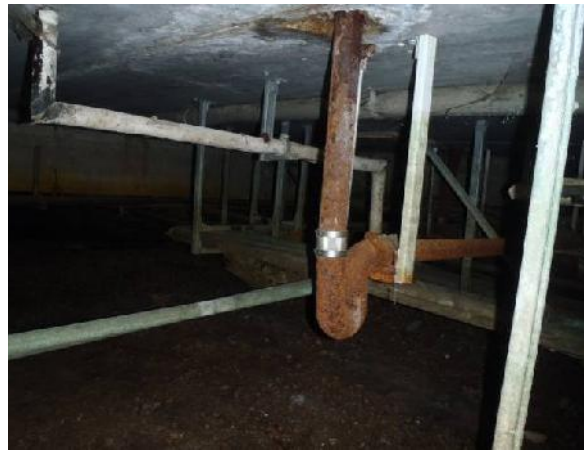
Rust on pipes and pipe hangers in the crawlspace

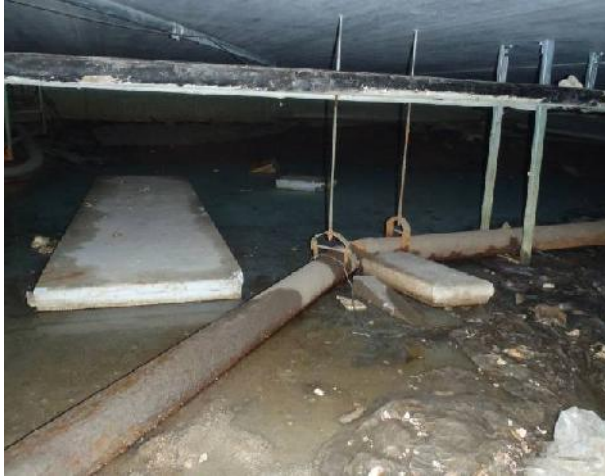
Loose rigid insulation floating on the water under the kitchen area

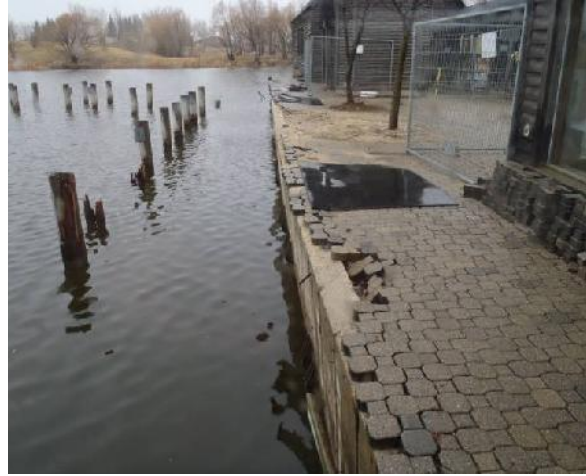
View of retaining wall along water's edge

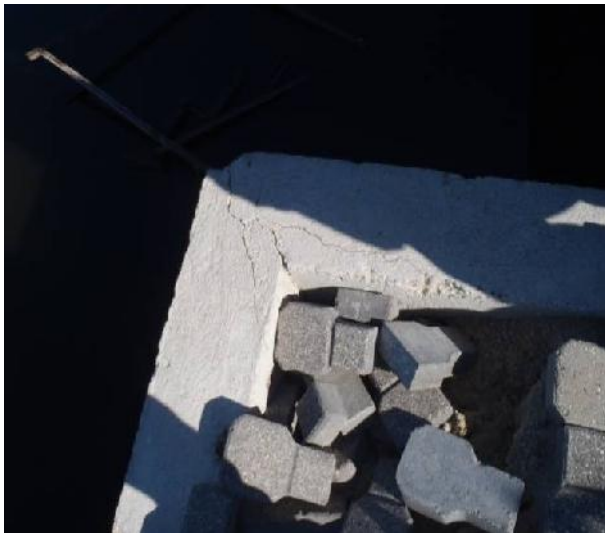
Crack at corner of retaining wall

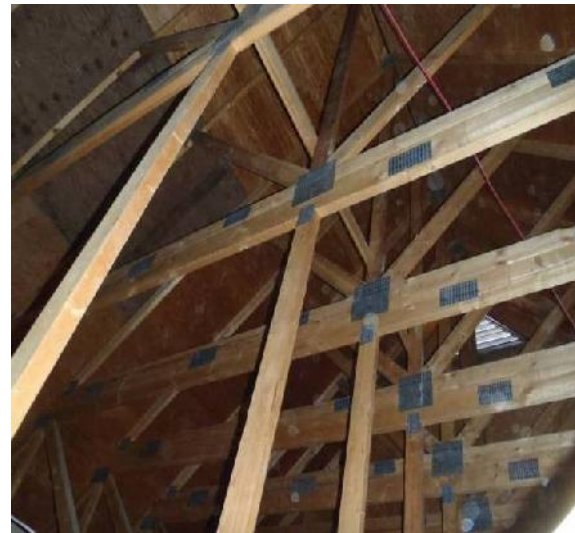
General view of roof trusses

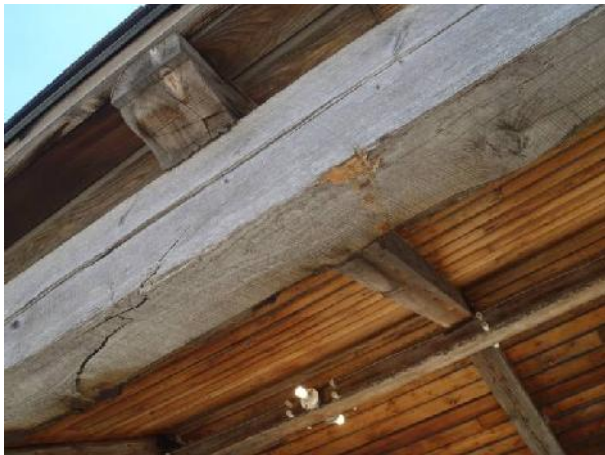
Crack in the Canopy beam

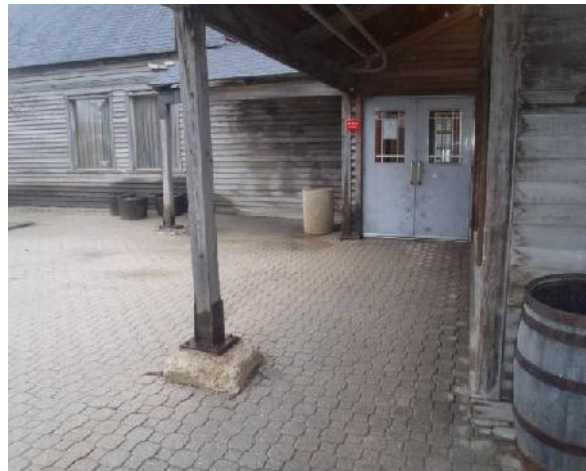
Deterioration in canopy pile cap

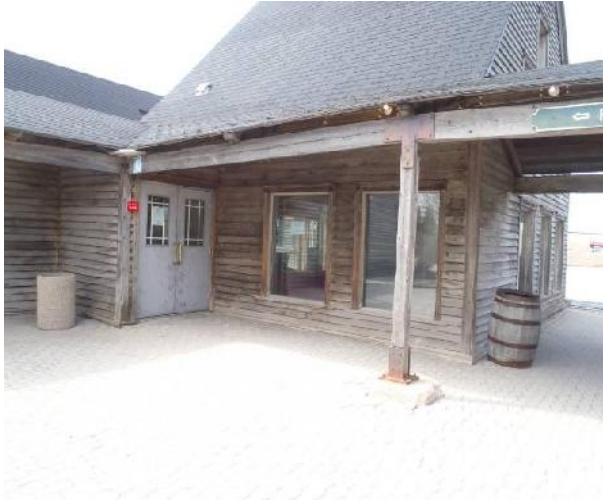
Heaving of canopy column

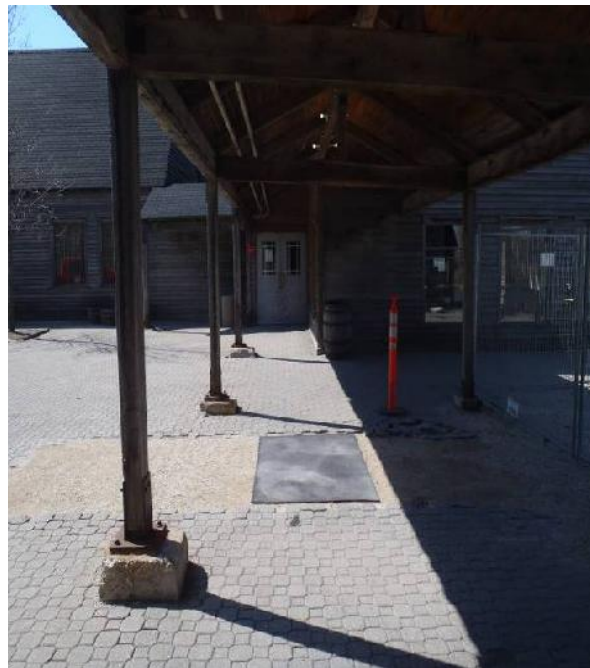
Areas of paving stones needing replacement

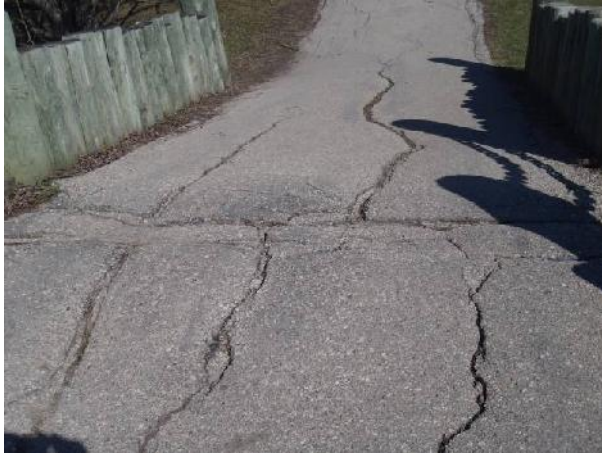
Pathway to Clubhouse from south parking lot area

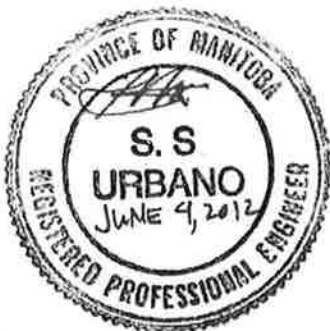
This report has been prepared by GENIVAR for the benefit of the client to whom it is addressed. The information and data contained herein represent GENIVAR's best professional judgment in light of the knowledge and information available to GENIVAR at the time of preparation. Except as required by law, this report and the information and data contained herein are to be treated as confidential and may be used and relied upon only by the client, its officers and employees. GENIVAR denies any liability whatsoever to other parties who may obtain access to this report for any injury, loss or damage suffered by such parties arising from their use of, or reliance upon, this report or any of its contents without the express written consent of GENIVAR and the client.

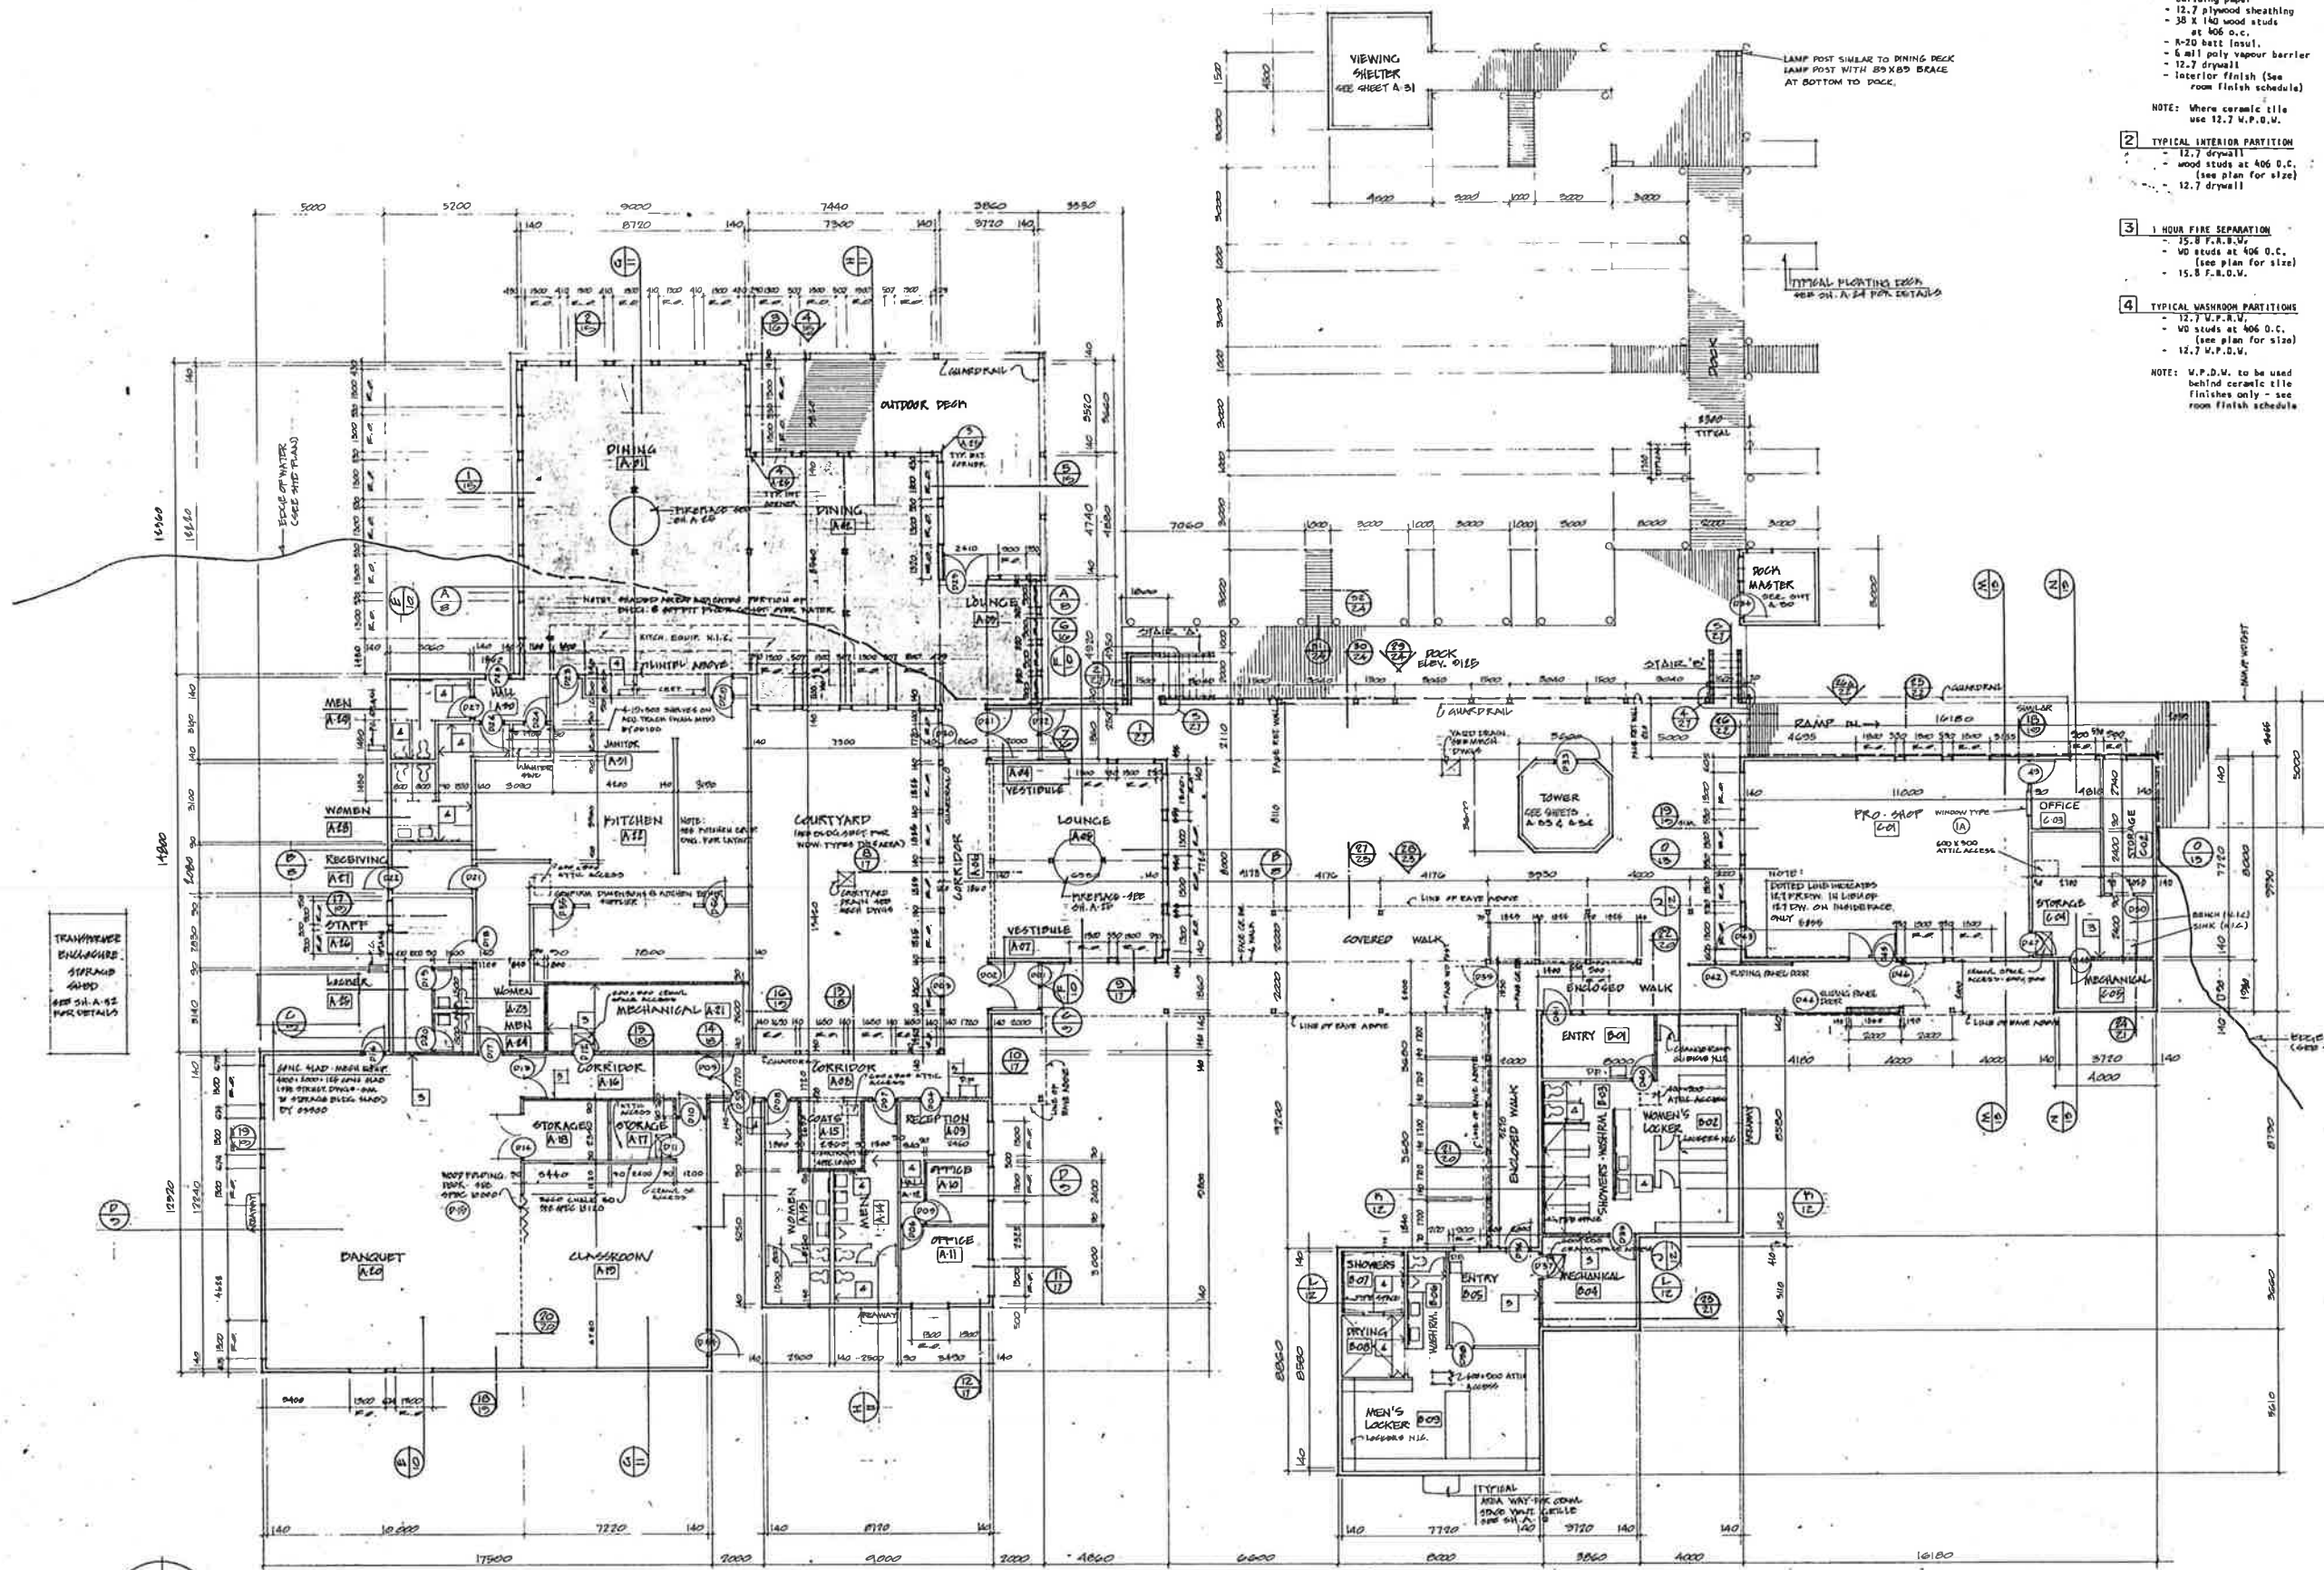
FLOOR PLAN
 SCALE: 1" = 10'
 NOTE: SEE SH. A-14 FOR ENLARGED FLOOR PLAN PLUG 'D' (LAWYER ROOM)
 SEE SH. A-14 FOR WASHROOM ELEVATIONS
 SEE SH. A-25 FOR WINDOW ELEVATIONS & TYPES

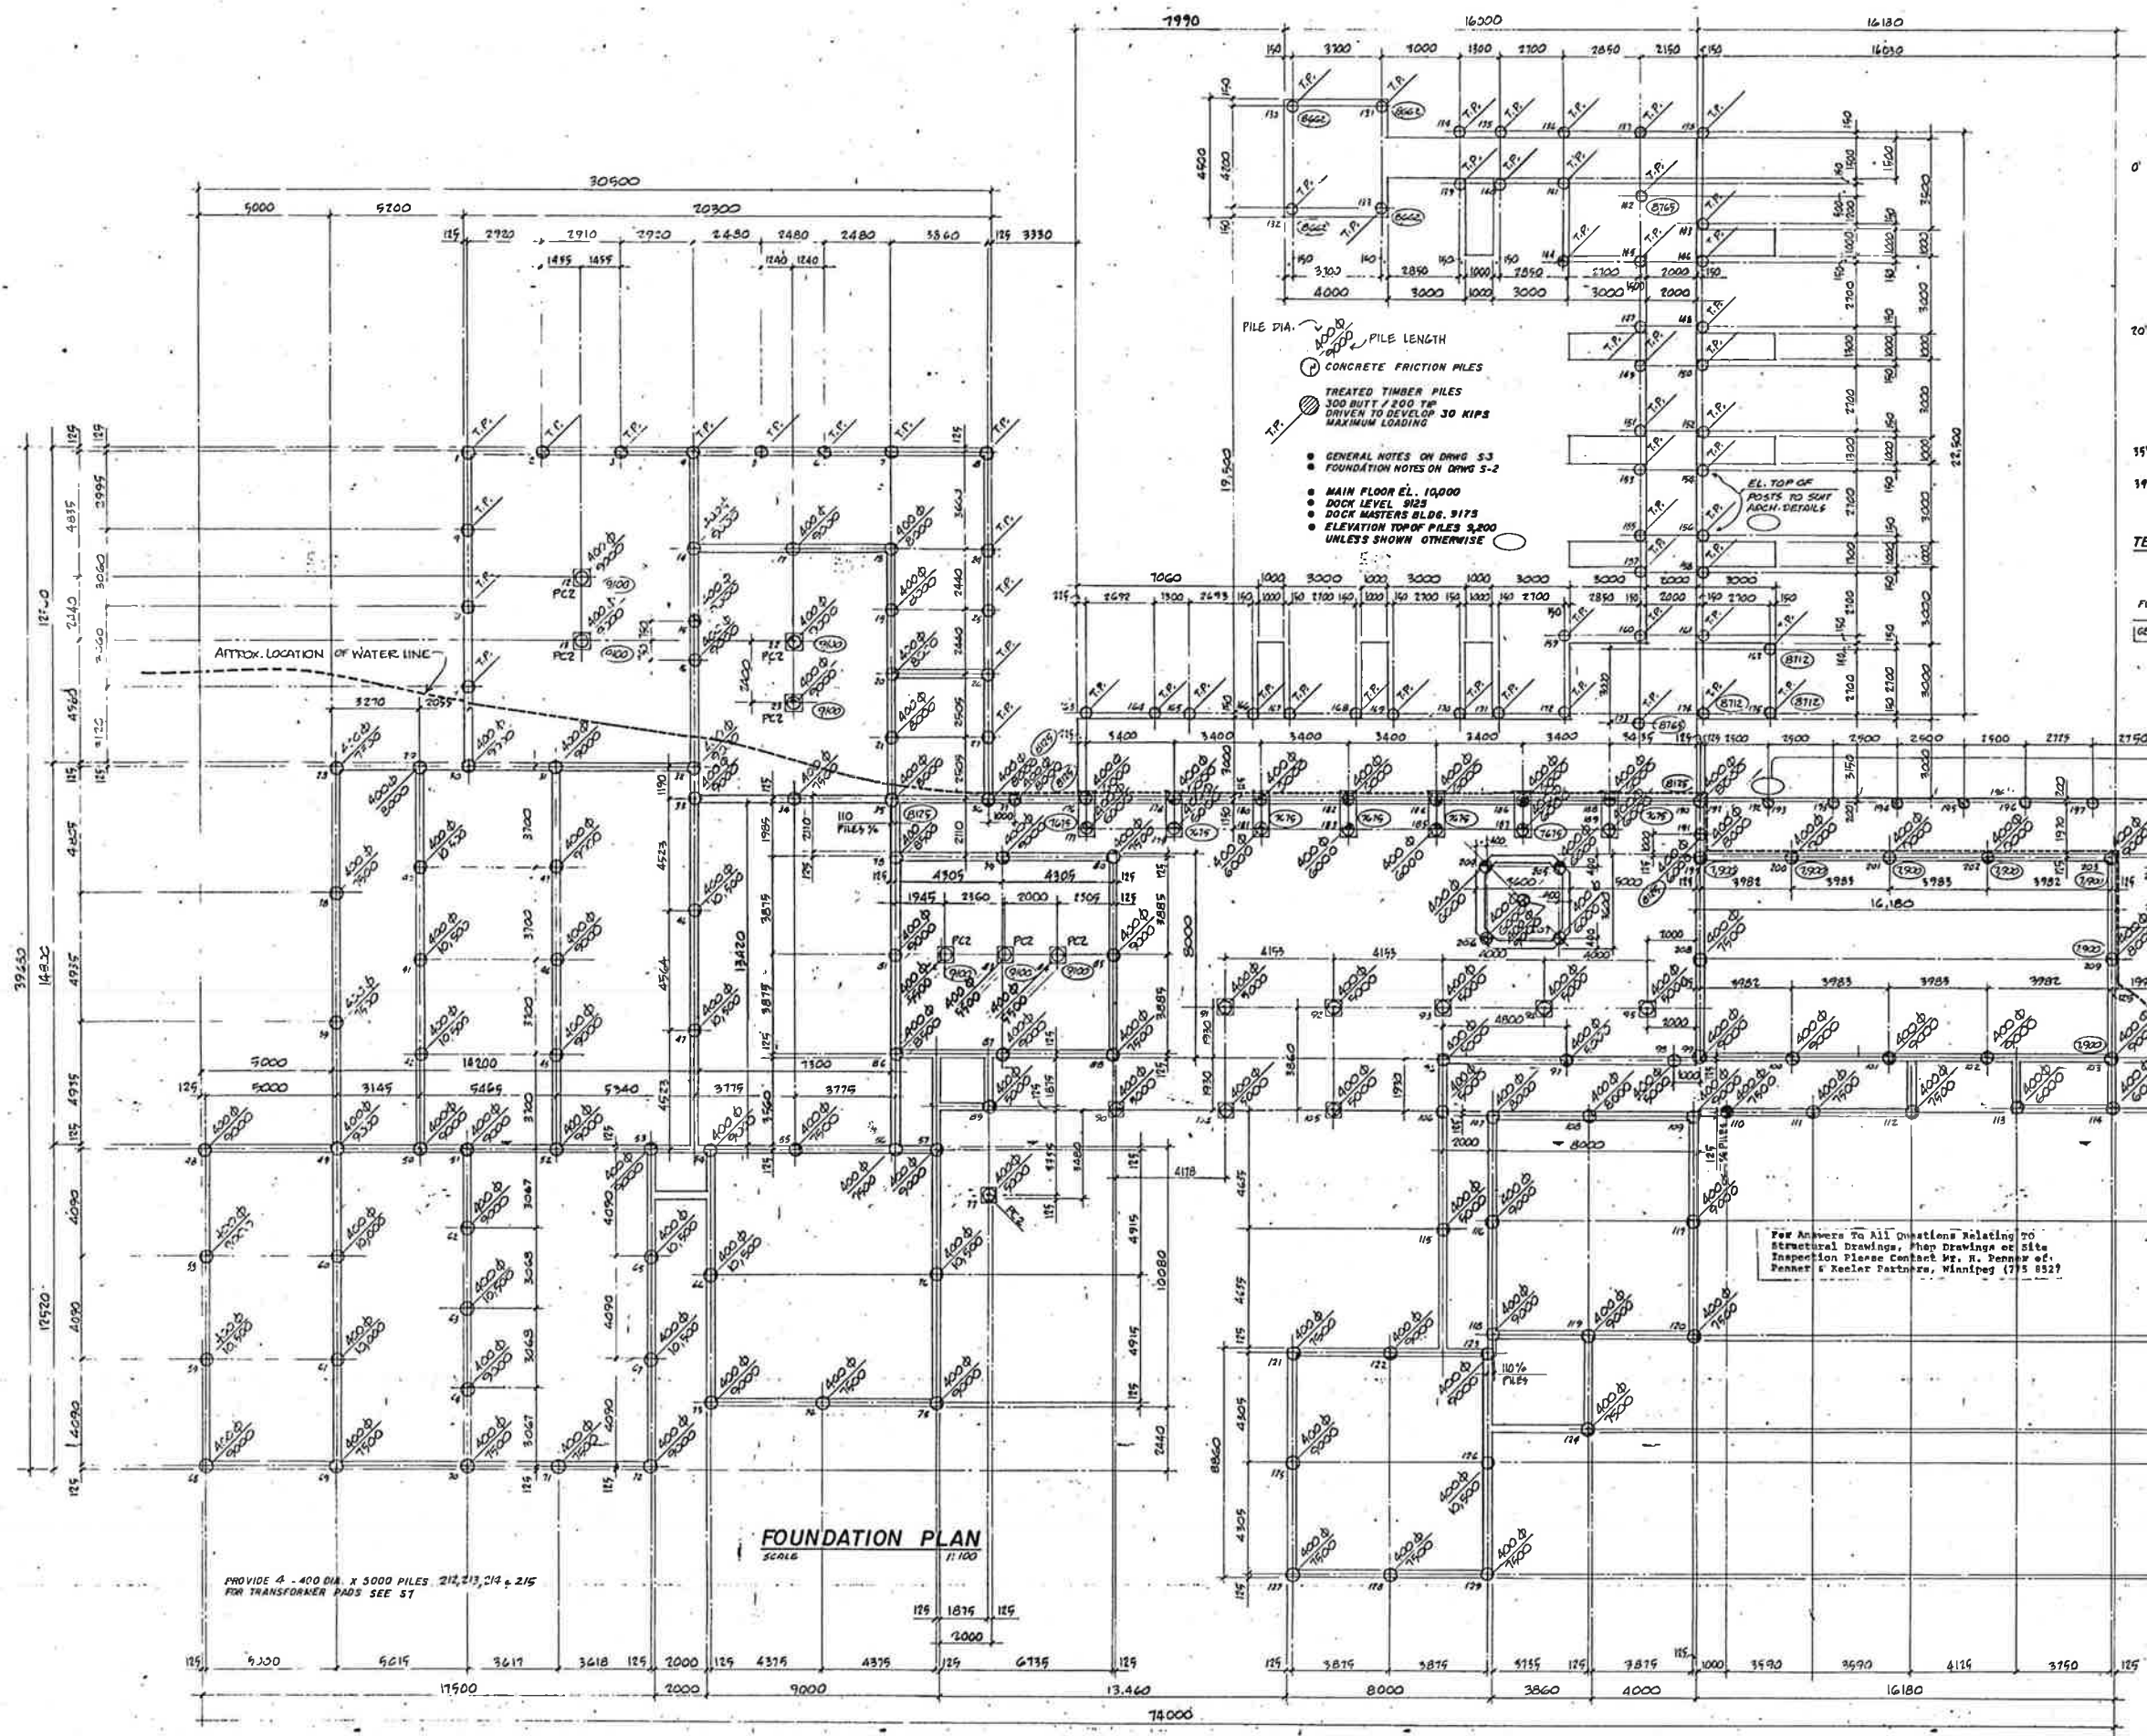
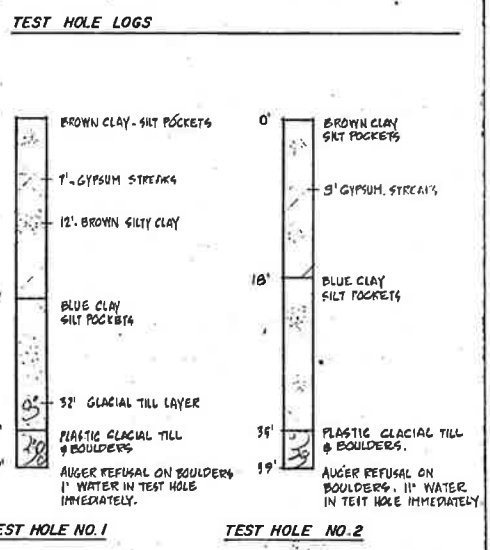
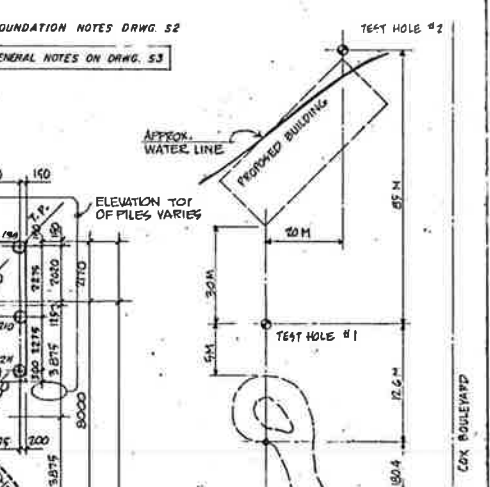
TEST HOLE #1
TEST HOLE #2

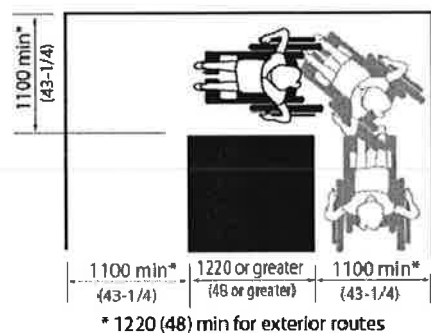
Recommended Minimum Access Widths (Refer also to 4.3.17 for widths of public sidewalks)

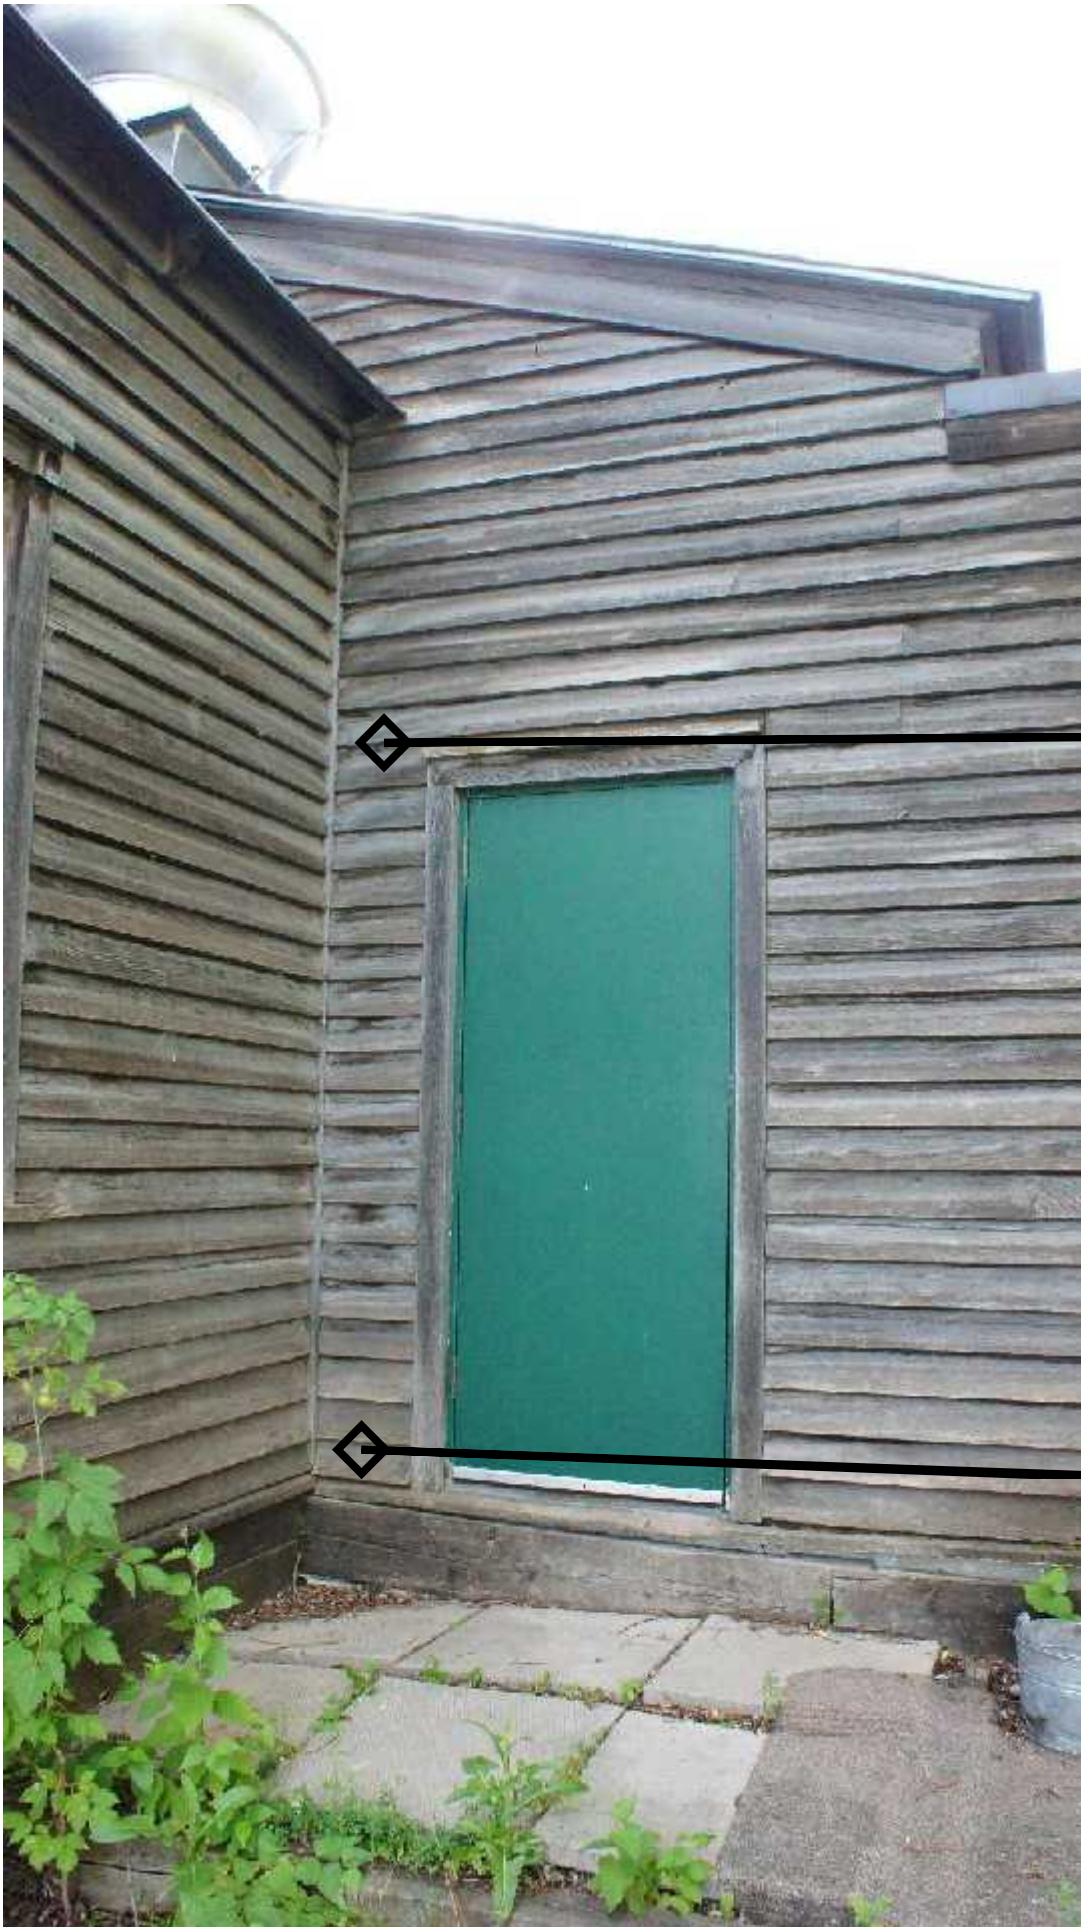
There are 76 identified locations in total.
