SEWPCC Upgrading/Expansion Conceptual Design Report

SECTION 20 - Administration Building

20.0 Administration Building

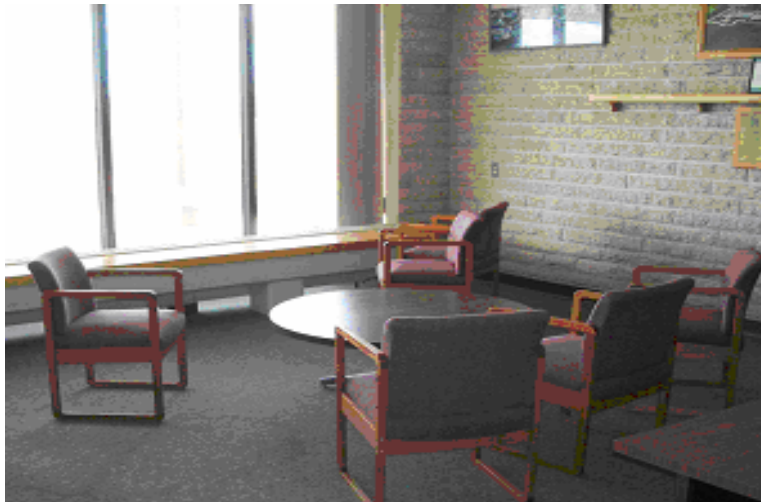
The existing entry reception room offers an opportunity to provide educational information to the visiting public about the treatment plant. Based on review of the room and discussions with the City personnel, Stantec recommends that the City provide a display model of the SEWPCC in this room. A rectangular table should be provided for the model display, replacing the existing small round table. Several of the existing chairs would be displaced. Stantec also recommends

Figure 20.3: Front Entry Reception Room Window View

that several photographs or drawings of the treatment plant be mounted on the two walls opposite from the windows and the entry doorway. These could include diagrams of the treatment process of cross-sectional elevation drawings or schematics. A model of the existing plant currently exists in storage. That model might serve as a base for the expanded plant model.

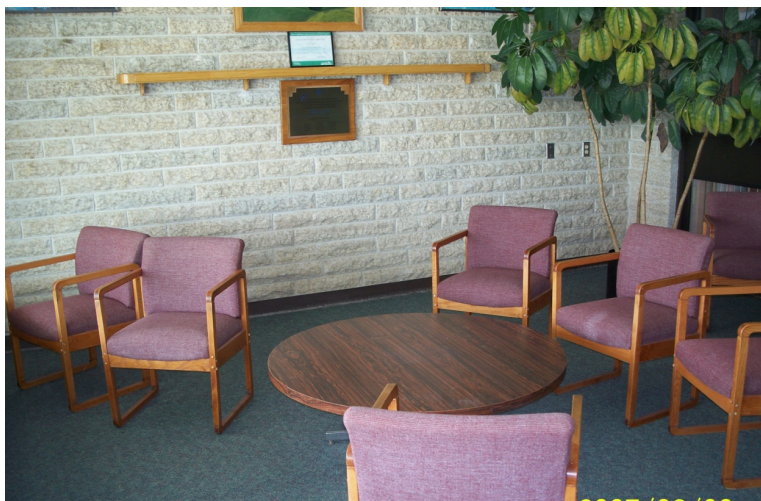
Figure 20.4: Front Entry Reception Room Interior Wall View

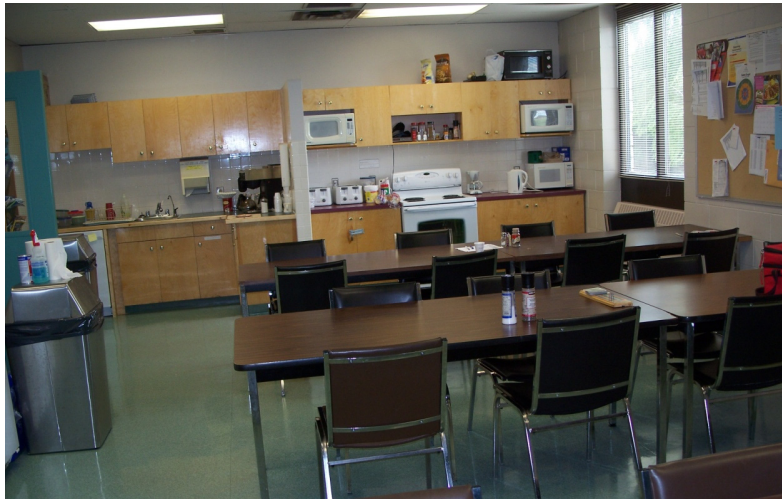
This room meets its intended functions well, and serves an important functional space for communication among staff personnel and for periodic rest breaks. Stantec recommends that the City upgrade the ceiling and wall treatment with light-colored paint or covering, except for the southern tile-covered wall which is currently satisfactory. Consideration should be given to installing wiring and a ceiling-mounted projector for classroom purposes.

Figure 20.7: Lunch Room / Classroom – Looking at the South Wall

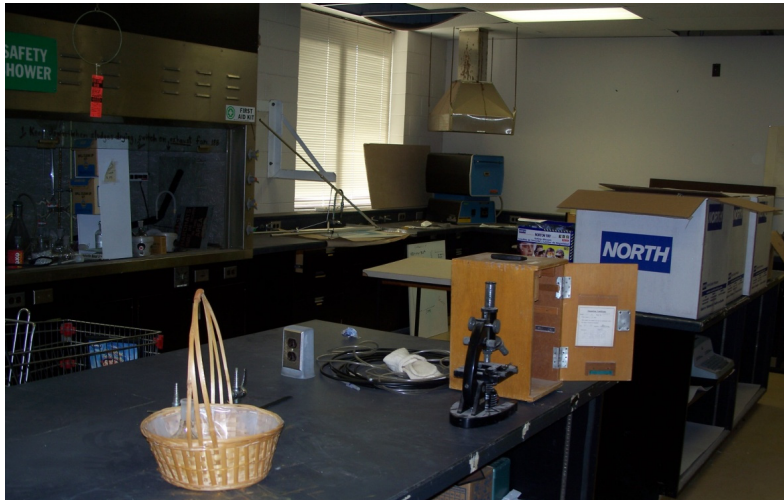
The former analytical laboratory room which is on the main floor of the Administration Building is no longer used for any significant laboratory functions. The room is 9.70 m (31 feet 10 inches) long by 5.74 m (18 feet 10 inches) wide; inside clear dimensions. The room area is 55.7 m² (599 ft²). Photos showing the existing laboratory room are provided on Figures 20.10, 20.11, and 20.12. The space provided by the existing room far exceeds that currently needed for operable laboratory equipment. The room is presently used largely for storage of miscellaneous items. The existing lab room has a fume hood, gas lines, sinks, water, and counters in place. There is a muffle furnace in place, but the exact operational condition is unknown.

Figure 20.10: Laboratory Room View Toward Fume Hood

- A fume hood will not be needed in the future.
- The planned plant upgrade currently being designed will involve several items of fixed online instruments for pH, D.O., and sludge density.
- The upgraded plant multi-source operational testing should include D.O., ORP, pH, conductivity, UV Transmissivity, SVI, MLVSS, and MLSS.
- Portable instruments should include D.O., ORP, pH, conductivity.
- Equipment should be maintained on site somewhere at the SEWPCC for:
 - MLSS and MLVSS (filter apparatus, scale, and drying oven/muffle furnace – rehabilitated or new).
 - SVI (settling cone).

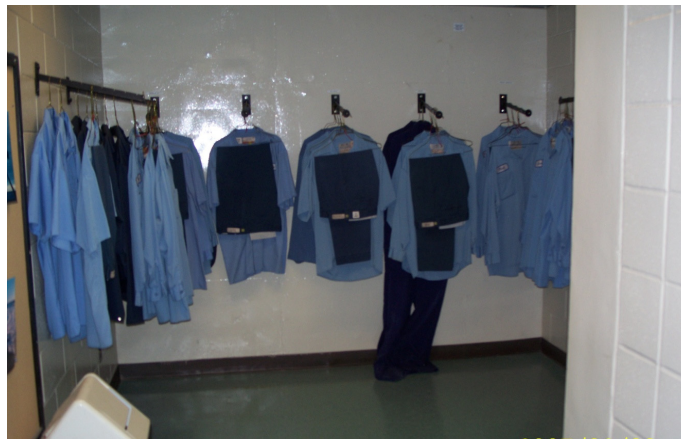
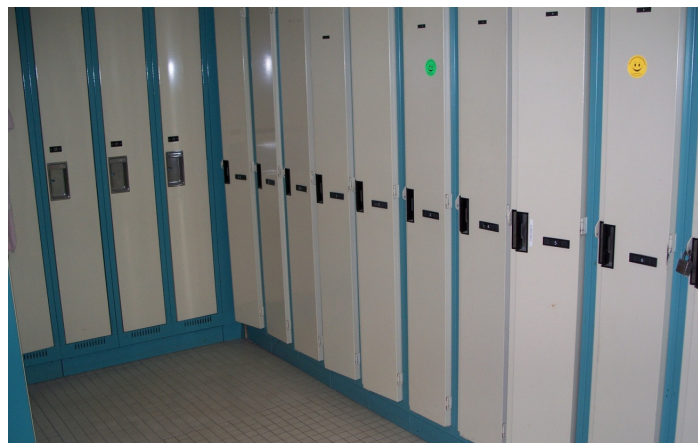
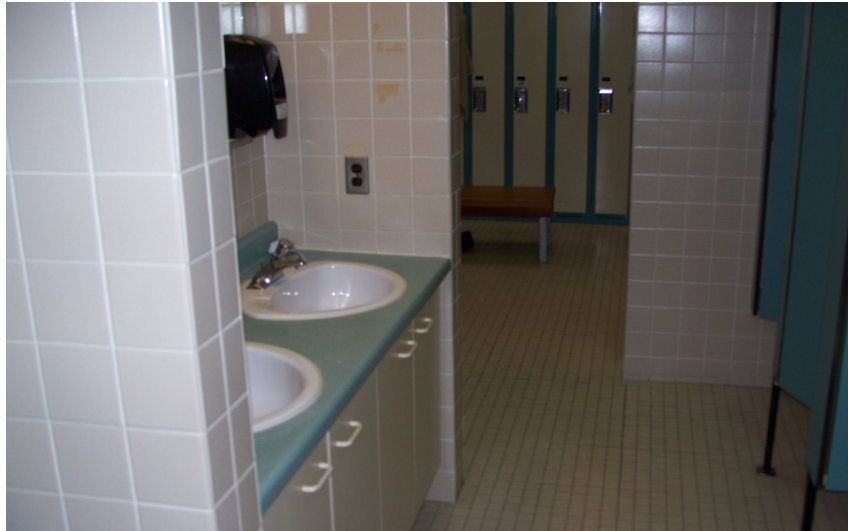
Figure 20.13: Men's Locker Room - Clothing Hangers

Figure 20.14: Men's Locker Room - Lockers

Figure 20.15: Men's Locker Room - Sinks

Stantec examined the existing locker rooms to assess whether the required additional shower stalls and other fixtures could be added into the existing men's locker room space by rearranging items. Stantec has concluded that this is not feasible. The existing men's shower room is already crowded.

To avoid having two Men's Locker Rooms, Stantec recommends that the City implement Alternative 2. To minimize construction costs, it is recommended that the existing shower, sink and toilet locations be maintained. Some of the fixtures would be modified slightly, but no plumbing construction would be required in the basement floor concrete, with the exception of new urinals. This will result in one Men's Locker Room space which has two sets of showers, toilets and sinks. While this is not an ideal layout concept, it is felt that the lower construction cost justifies the approach.

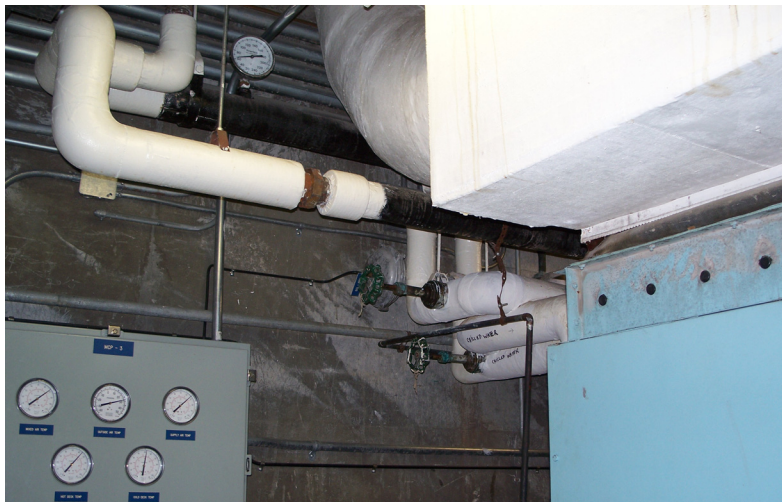
plant boilers located in the Service Building, and boost it through the heat exchangers that serve the Administration Building. The heat exchanger unit draws cool air in and heats that air using the hot water heat source. The heat exchange unit and related piping is insulated. A view of the heat exchanger is provided in Figure 20.19.

Figure 20.19: Air Handling Heat Exchanger and Piping

The review of the Administration area did not reveal a need for upgrade or expansion of the pumps, heat exchanger or heating or cooling systems; nor for replacement of piping in this area. Heat exchanger and pipe insulating materials that potentially consist of asbestos containing materials are addressed in Section 22. To the extent possible, any disturbance to this material should be avoided or minimized.

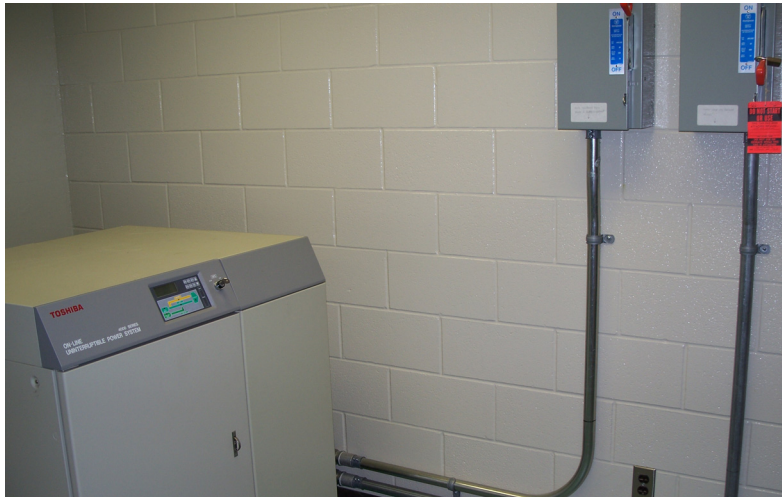
A Toshiba 4000 Series uninterruptible Power Source (UPS) device is located in the computer room which is in the southeast corner of the new Administration Building, on the Main Floor level, and is shown in Figure 20.20. During the site tour on August 6, 2008, that UPS unit was not working, and had not been working for several months. Information conveyed during the August 20, 2008 presentation and review meeting indicated that the City is in the process of addressing that deficiency.

Figure 20.20: UPS - Not working as of August 2008

- Install a visitor advisory signal system – plant-wide buzzer or similar.
- Coordinate security, smoke/fire alarm systems, and coordinate with Risk and Criticality review actions.
- Repair or replace the UPS.

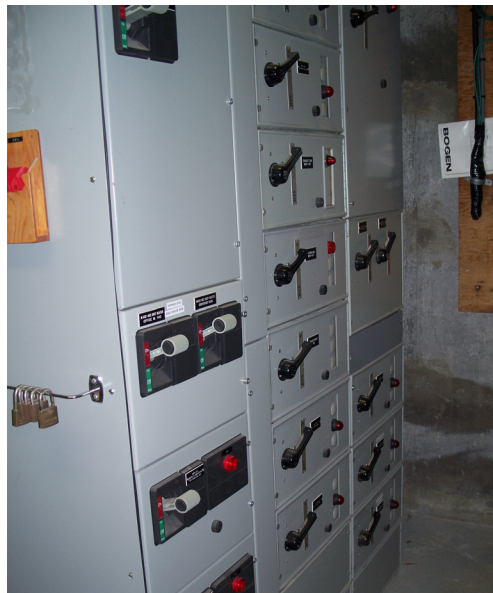
This Electrical Room and MCC-1M have some limited space for additional circuits, but not for any additional major equipment or transformers. Because the major equipment that will be added in the plant upgrade/expansion will be served through MCCs local to each equipment area, it is not anticipated that there will be a need to add significant circuits, loads, or panels in the Administration Building to MCC-1M or other stacks. If as the plant design develops it becomes necessary to add further MCC, transformer, or panel devices, these could be added by converting some of the non-critical rooms which are near this Electrical Room, such as the adjacent Storage Room, the nearby Storage Room in the new building section, and possibly a nearby room which is used as a Cot Room.

Figure 20.21: MCC-1M in the Admin Building Electrical Room

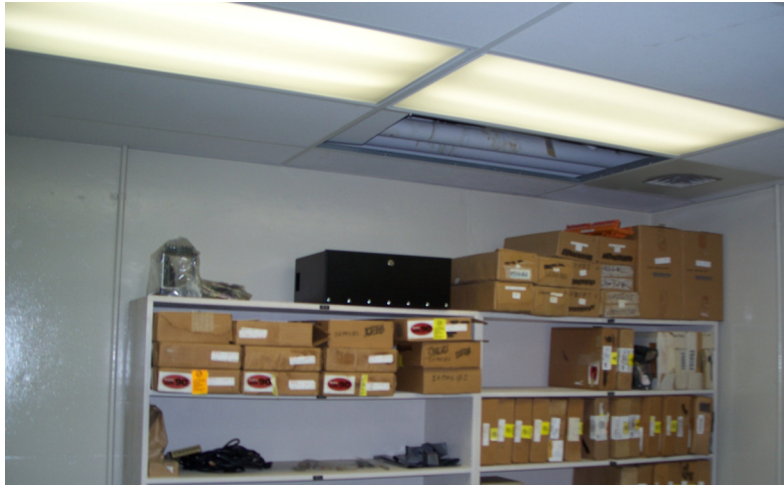
The August 6, 2008 site visit indicated that there have been several leaks in the building in the past. In the past a leak dropped water from the ceiling in the computer parts storage room onto several boxes of computer and telecommunication equipment parts. That leak was subsequently repaired, although the root cause of the leak was not conveyed during this review. The leak location is shown in Figure 20.23.

Figure 20.23: Computer Supplies Storage - Past Ceiling Leak

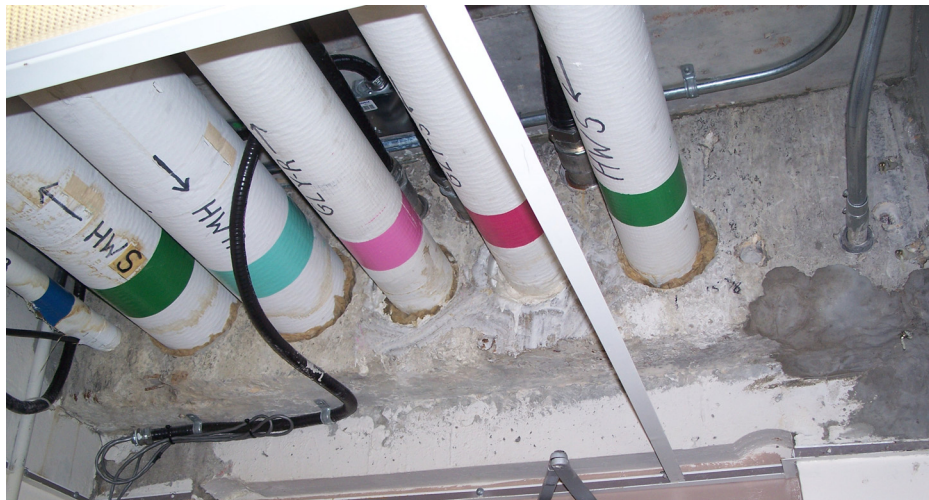
Water has in the past leaked through the wall where plant piping penetrates the lintel over the doorway entering the link corridor, shown in Figure 20.24. This leak into the interior of the Administration Building has been repaired by injecting polymer material.

Figure 20.24: Leak Site at Corridor Portal

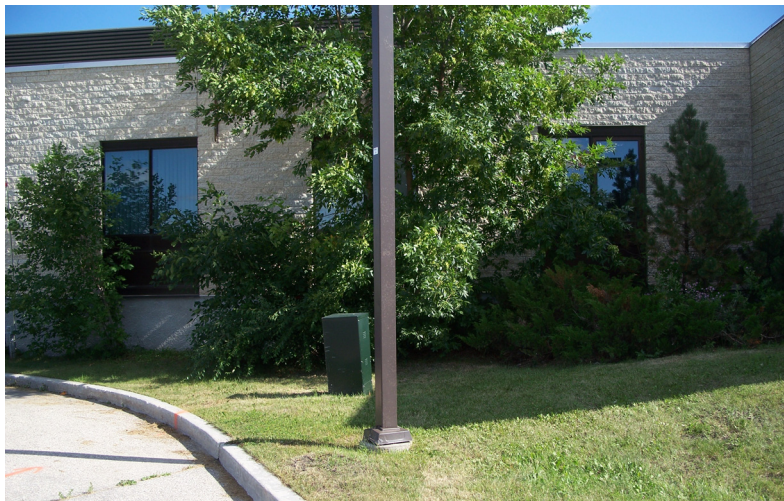
Figure 20.25 shows the north side of the building, looking at the new addition section. This view indicates that there are ornamental trees and shrubs growing immediately against the building exterior wall surface.

Figure 20.25: Exterior - North Side of New Addition

Trees and shrubs located near a building can sometimes contribute to a windbreak effect, saving building heat loss in the winter. However, having trees and shrubs with leaves against the surface of the building increases the risk of trapping moisture on the exterior wall surface. This could promote mildew and possibly micro-scale frost fracturing, which could lead to crumbling. This is particularly applicable for the north-facing building walls that receive no direct sunlight. It is preferable to have a clear space between the trees/shrubs and the wall surface, of about 0.5 m to 1.0 m in width. This clear space can be maintained by periodic trimming. It is

recommended that the City trim and remove selected trees and shrubs away from the face of the building.
