SEWPCC Upgrading/Expansion Conceptual Design Report

SECTION 22 - Asbestos Abatement

22.0 Asbestos Abatement

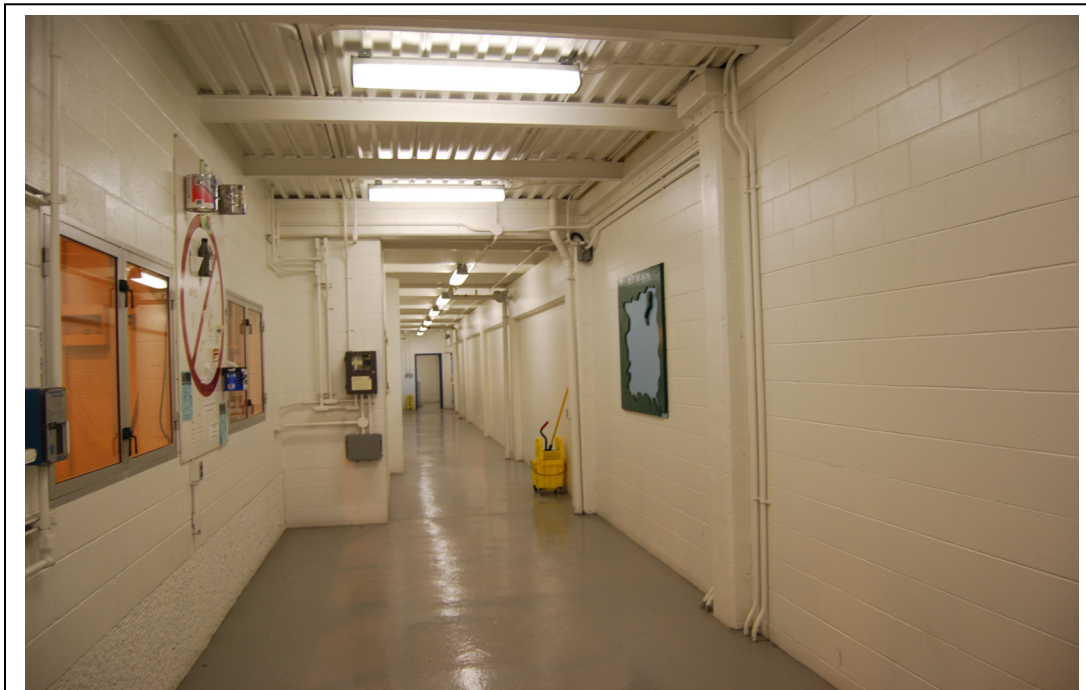
Figure 22.2: Hallway west of Screen Room facing south. Area ID #6.

No ACM's were noted in the HMIS Report to be located in the vicinity of this area.

Not Applicable.

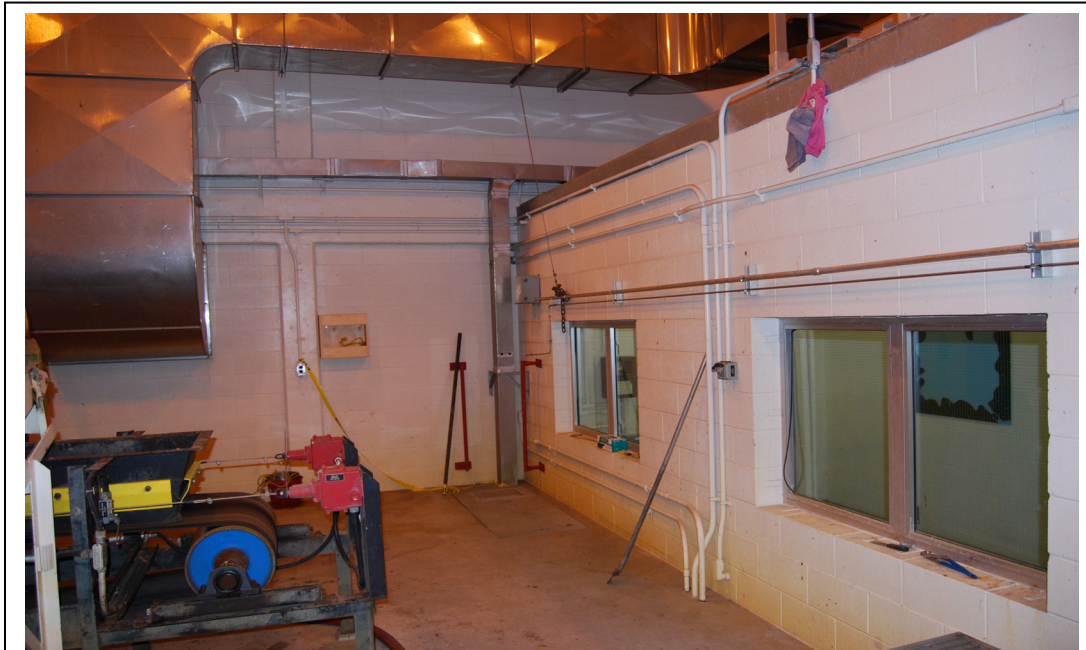
Figure 22.3: Screen Room southwest corner. Area ID #7.

One ACM was noted in the HMIS Report to be located in the vicinity of this area.

Not Applicable.

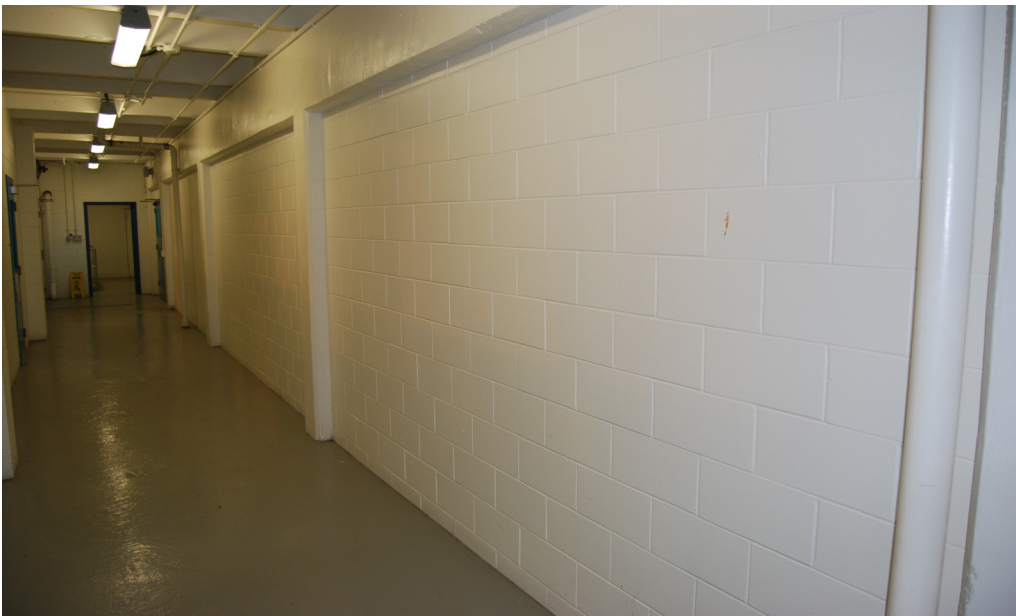
Figure 22.4: Hallway west of Grit Room facing south. Area ID #8.

Three ACM's were noted in the HMIS Report to be located in the vicinity of this area.

Not Applicable.

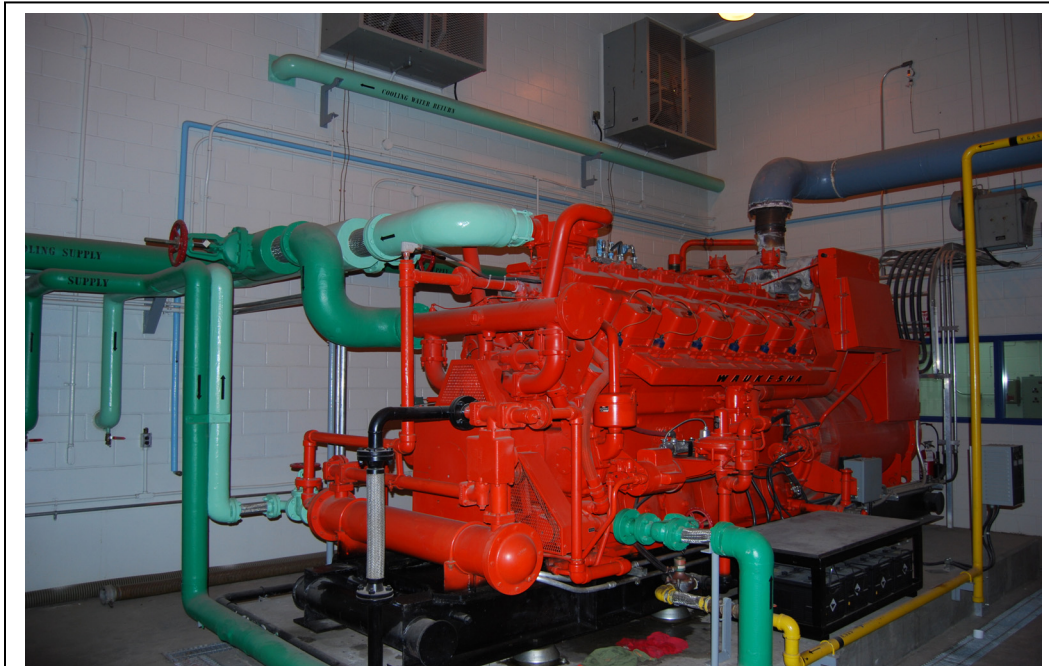
Figure 22.5: Standby power building generator. Area ID #9.

Two ACM's were noted in the HMIS Report to be located in the vicinity of this area.

It is estimated that asbestos abatement and inspection costs will be approximately \$1,500, excluding re-insulating the system.

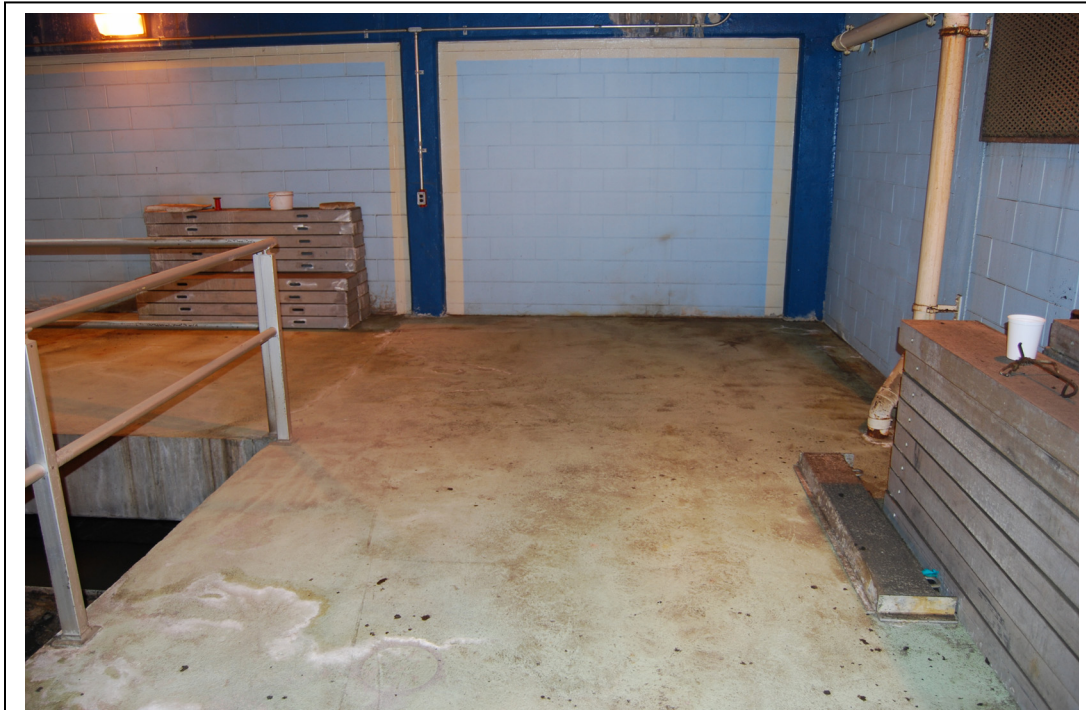
Figure 22.6: Grit Room southeast corner. Area ID #10.

No ACM's were noted in the HMIS Report to be located in the vicinity of this area.

Not Applicable.

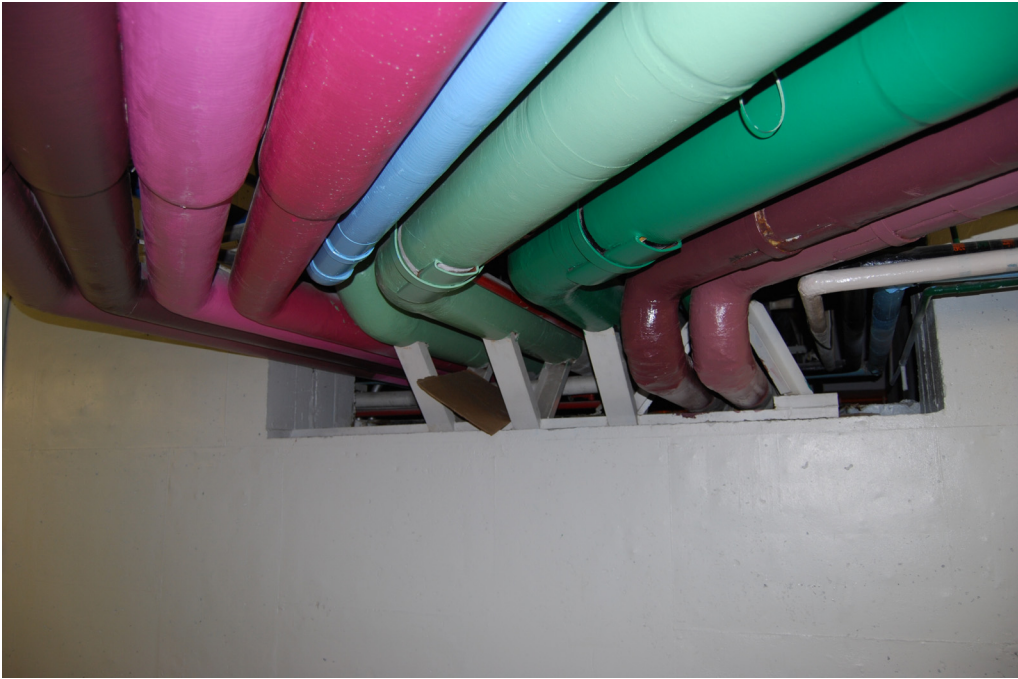
Figure 22.7: Gallery No. 3 at pipe chase to Boiler Room facing northeast. Area ID #11.

Two ACM's were noted in the HMIS Report to be located in the vicinity of this area.

It is estimated that asbestos abatement and inspection costs will be approximately \$1,500. Re-insulation of the high and low pressure steam piping is not required as the piping is no longer required.

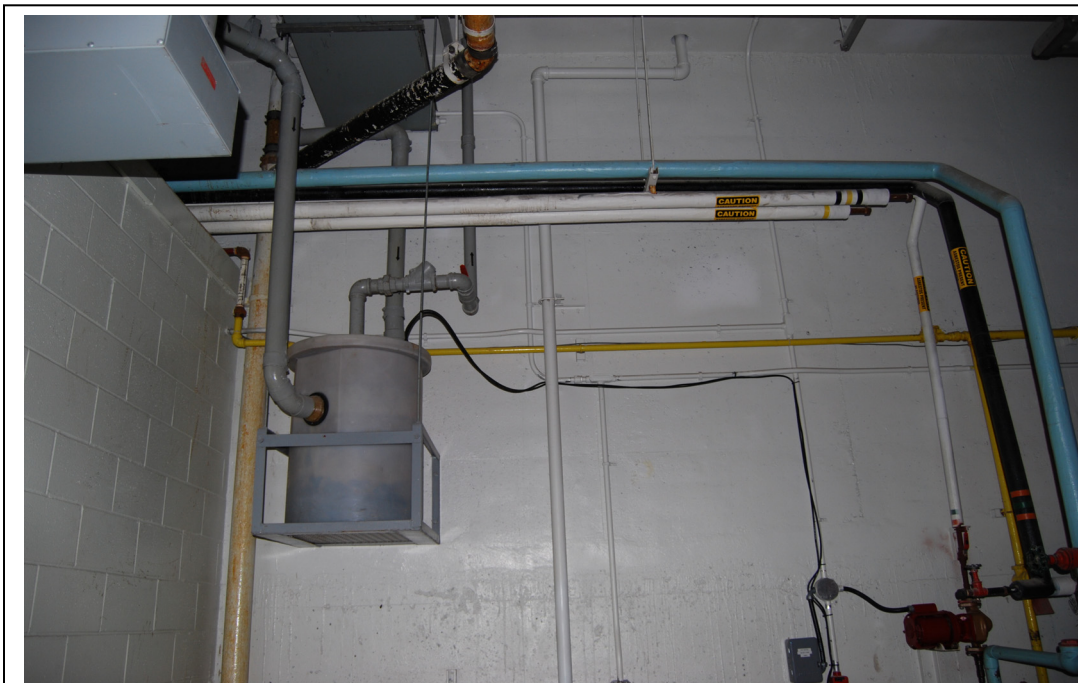
Figure 22.8: Boiler Room facing north. Area ID #11.

Eight ACM's were noted in the HMIS Report to be located in the vicinity of this area.

It is estimated that asbestos abatement and inspection costs for the removal of the boiler system will be approximately \$20,000. Asbestos abatement and inspection costs will be approximately \$15,000 extra if the abatement is to include associate heat pump areas, excluding re-insulating the system. As noted previously, the high and low pressure steam piping does not need to be re-insulated.

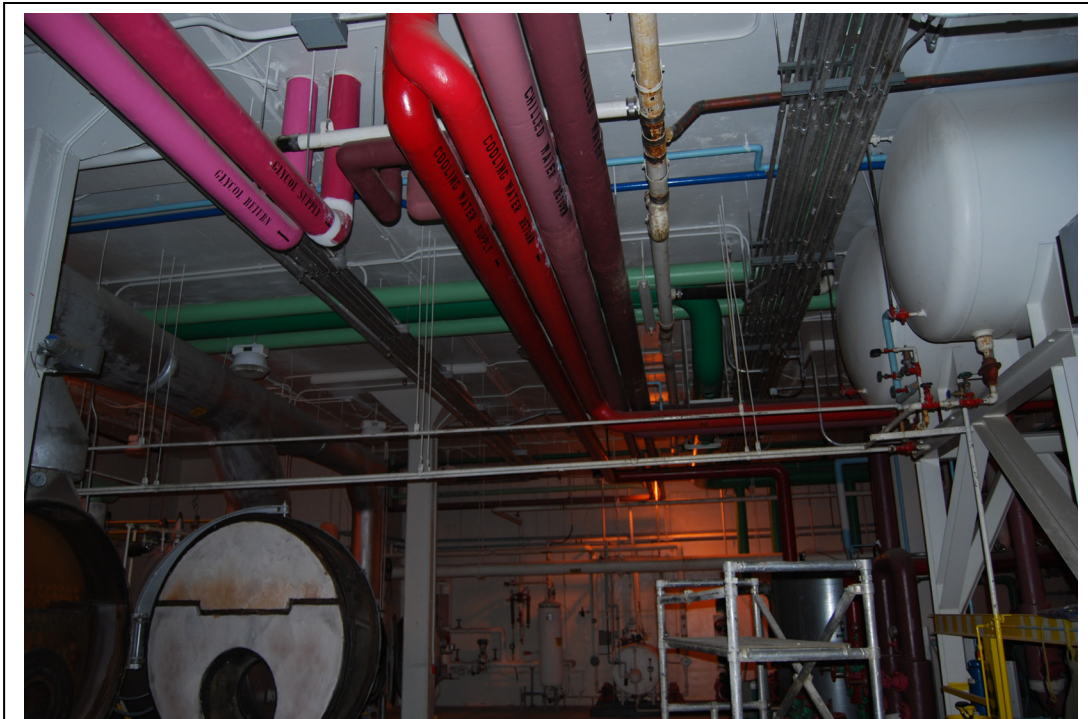
Figure 22.9: Boiler Room facing south. Area ID #11.

Eight ACM's were noted in the HMIS Report to be located in the vicinity of this area.

It is estimated that asbestos abatement and inspection costs for the removal of the boiler system will be approximately \$20,000. Asbestos abatement and inspection costs will be approximately \$15,000 extra if the abatement is to include the associated heat pump areas, excluding re-insulating the system. As noted previously, the high and low pressure steam piping does not need to be re-insulated.

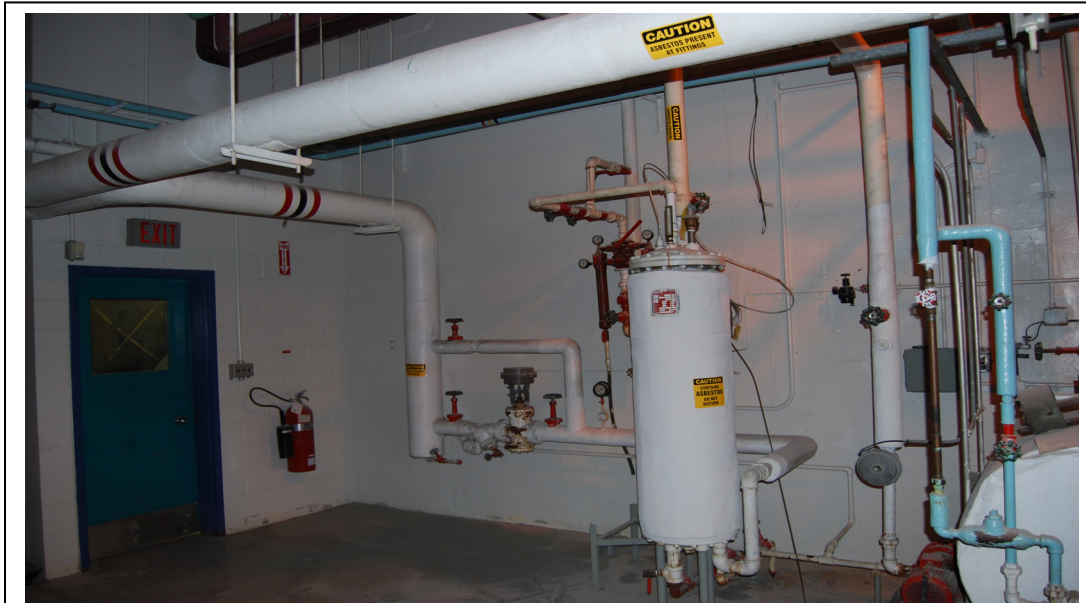
Figure 22.10: Boiler Room southeast corner. Area ID #11.

Eight ACM's were noted in the HMIS Report to be located in the vicinity of this area.

It is estimated that asbestos abatement and inspection costs for the removal of the boiler system will be approximately \$20,000. Asbestos abatement and inspection costs will be approximately \$15,000 extra if the abatement is to include the associated heat pump areas, excluding re-insulating the system. As noted previously, the high and low pressure steam piping does not need to be re-insulated.

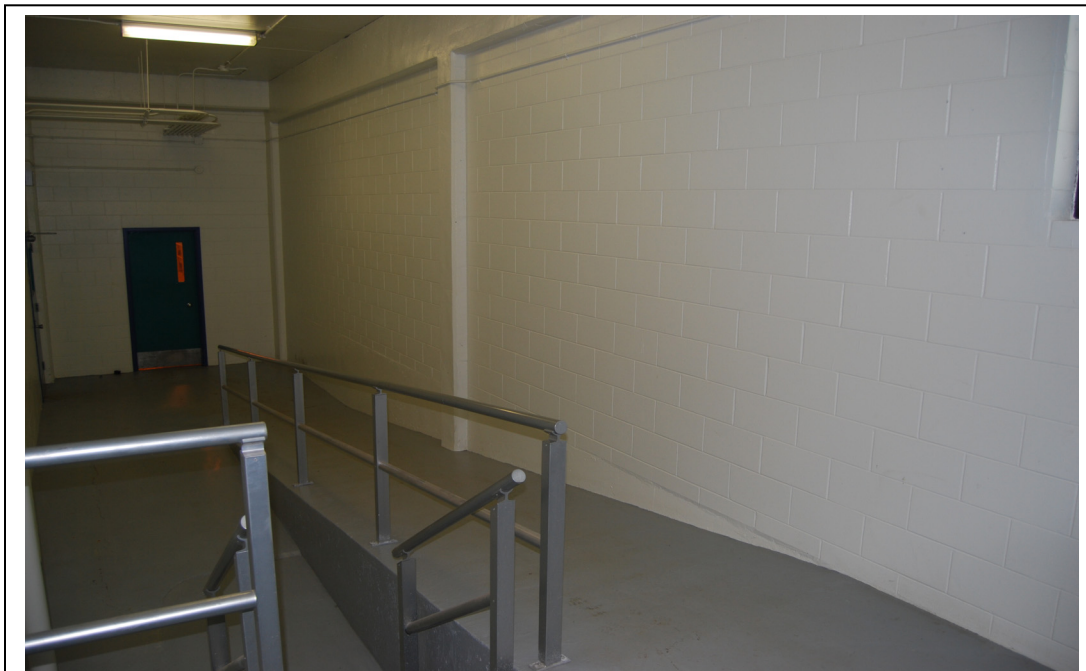
**Figure 22.11: Hallway from Grit Room to PST facing west.
Area ID #12.**

One ACM was noted in the HMIS Report to be located in the vicinity of this area.

Not Applicable.

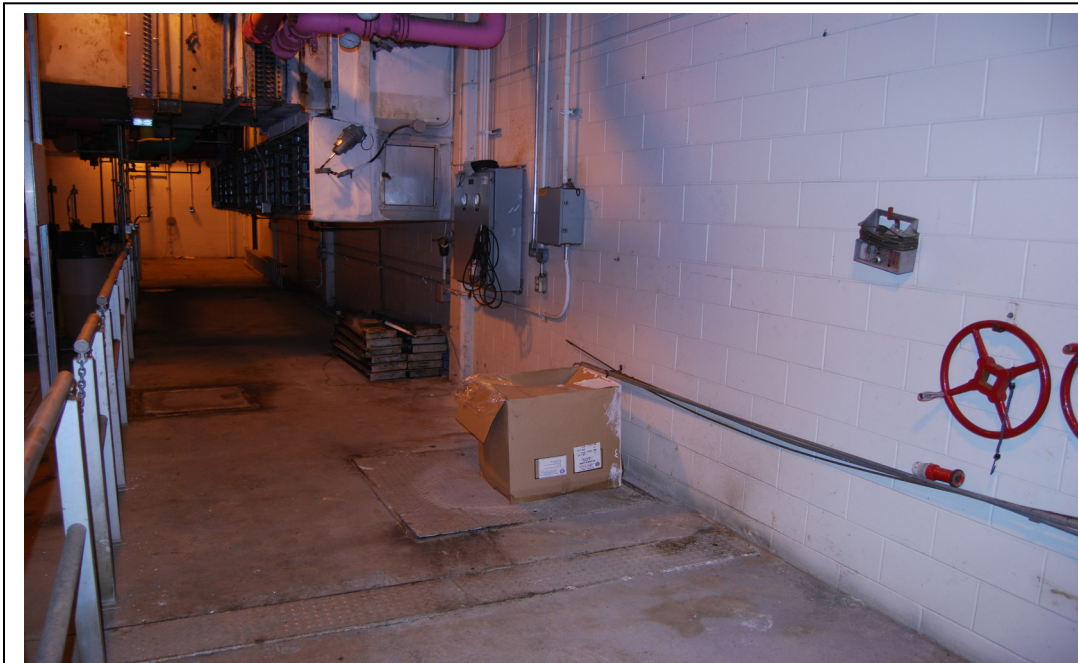
Figure 22.12: Influent end of PST No. 2 & 3 facing north. Area ID #13.

Positive air pressure may pose a problem during this abatement procedure.

It is estimated that asbestos abatement and inspection costs will be approximately \$35,000 excluding re-insulating the system after relocation.

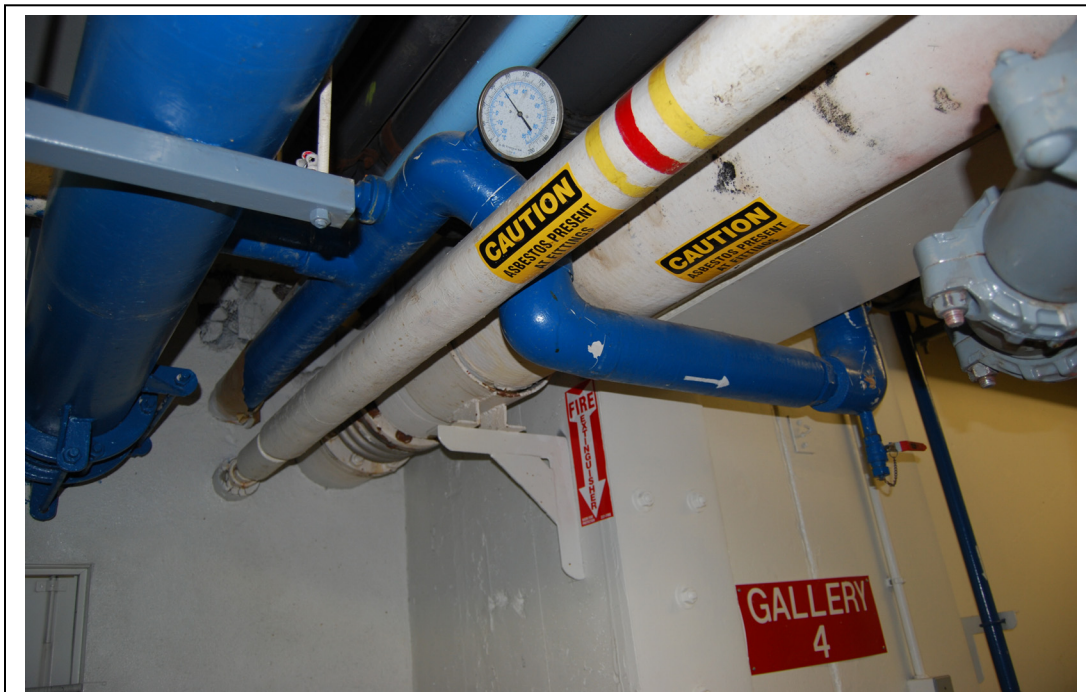
Figure 22.13: Gallery No.3 at entrance to Gallery No. 4 facing east. Area ID #14.

Two ACM's were noted in the HMIS Report to be located in the vicinity of this area.

It is estimated that asbestos abatement and inspection costs will be approximately \$3,000. As noted previously, the high and low pressure steam piping does not need to be re-insulated.

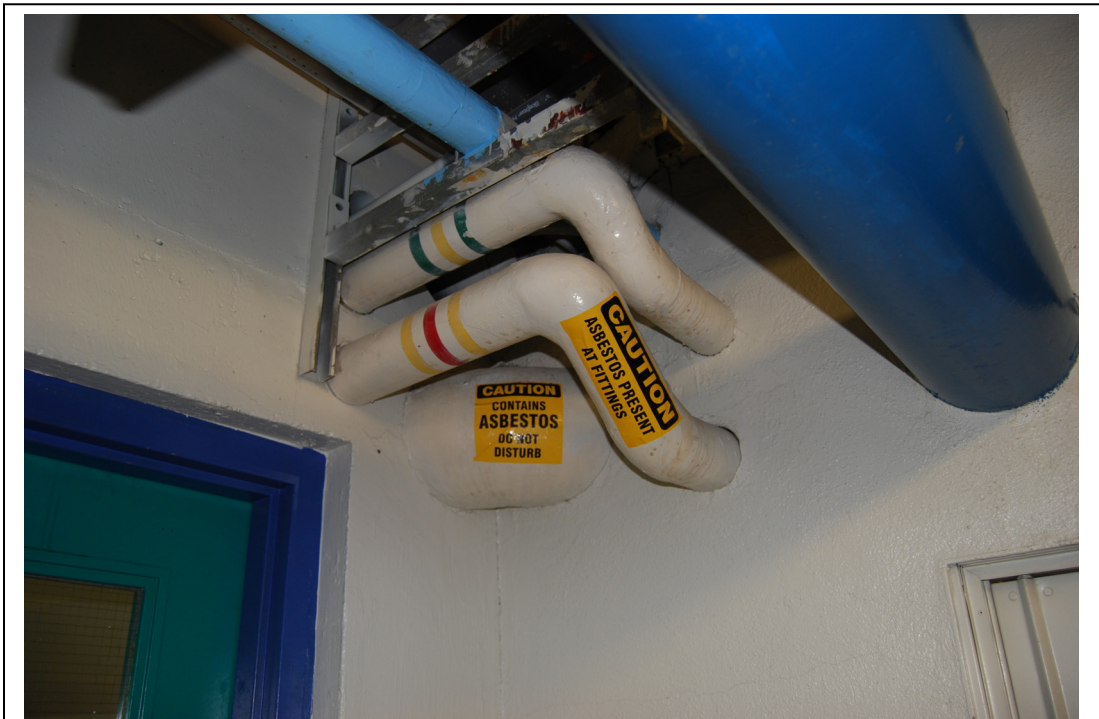
Figure 22.14: Gallery No. 3 east of entrance to Gallery No. 4 facing west. Area ID #14.

Two ACM's were noted in the HMIS Report to be located in the vicinity of this area.

It is estimated that asbestos abatement and inspection costs will be approximately \$2,000. As noted previously, the high and low pressure steam piping does not need to be re-insulated.

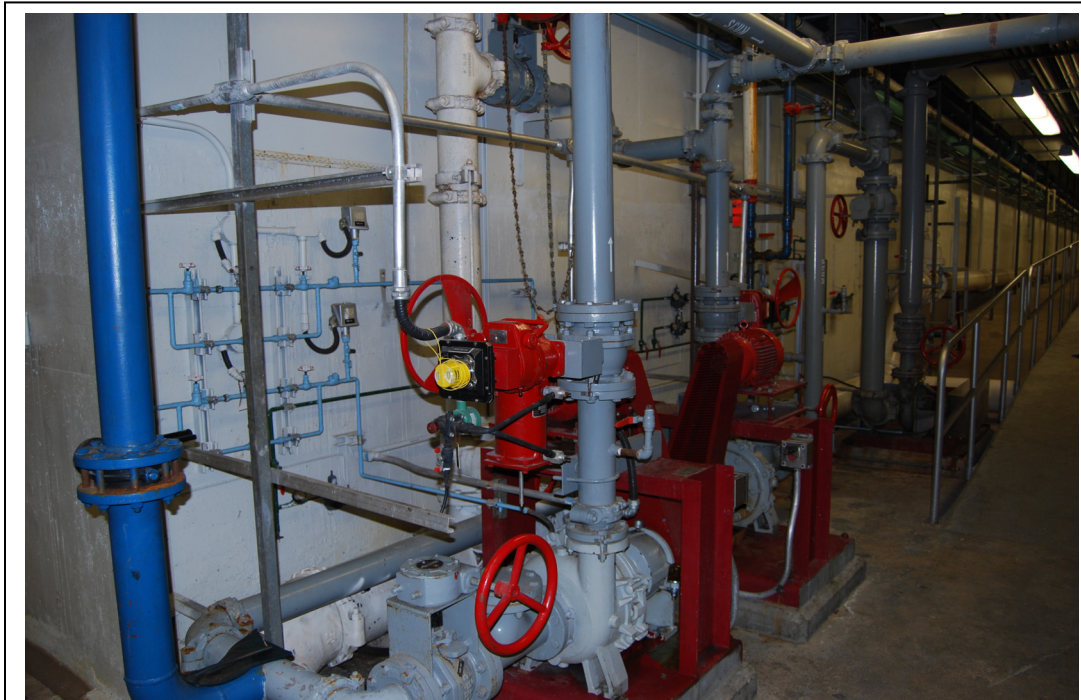
Figure 22.15: Gallery No. 3 at the Scum Pumping System for PST No. 1 & 2. Area ID #14.

Two ACM's were noted in the HMIS Report to be located in the vicinity of this area.

It is estimated that asbestos abatement and inspection costs will be approximately \$1,500, excluding re-insulating the system. As noted previously, the high and low pressure steam piping does not need to be re-insulated.

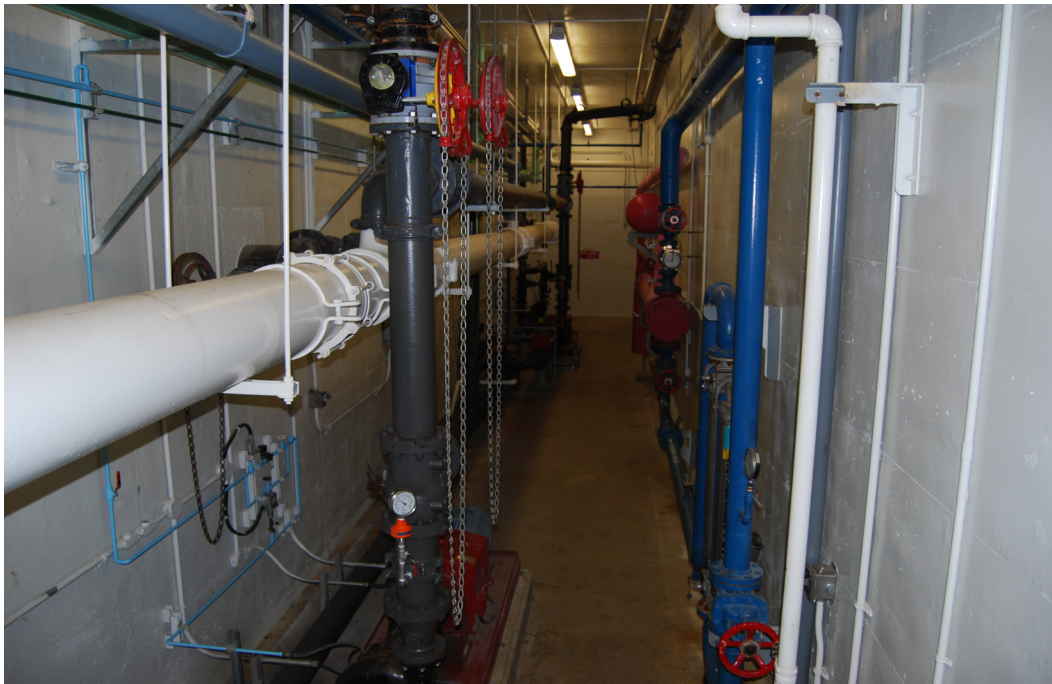
Figure 22.16: Gallery No. 4 (influent end of PST No. 1 & 2) facing north. Area ID #15.

No ACM's were noted in the HMIS Report to be located in the vicinity of this area.

Not Applicable.

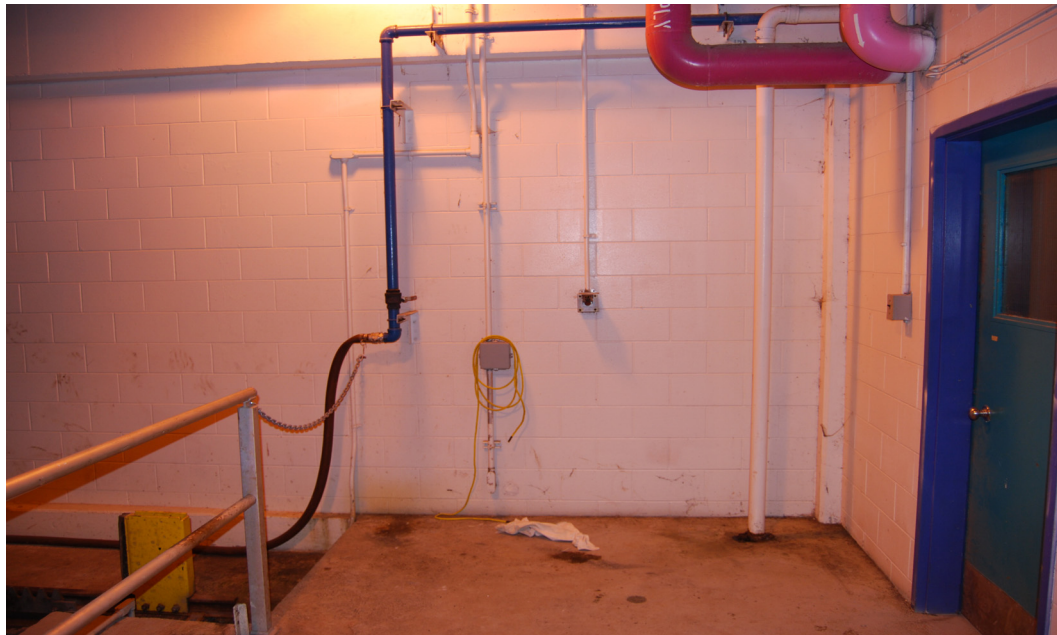
**Figure 22.17: Influent end of PST No. 2 & 3 facing north wall.
Area ID #16.**

It is estimated that asbestos abatement and inspection costs will be approximately \$35,000, excluding re-insulating the system after relocation. Positive air pressure may pose a problem during this abatement procedure.

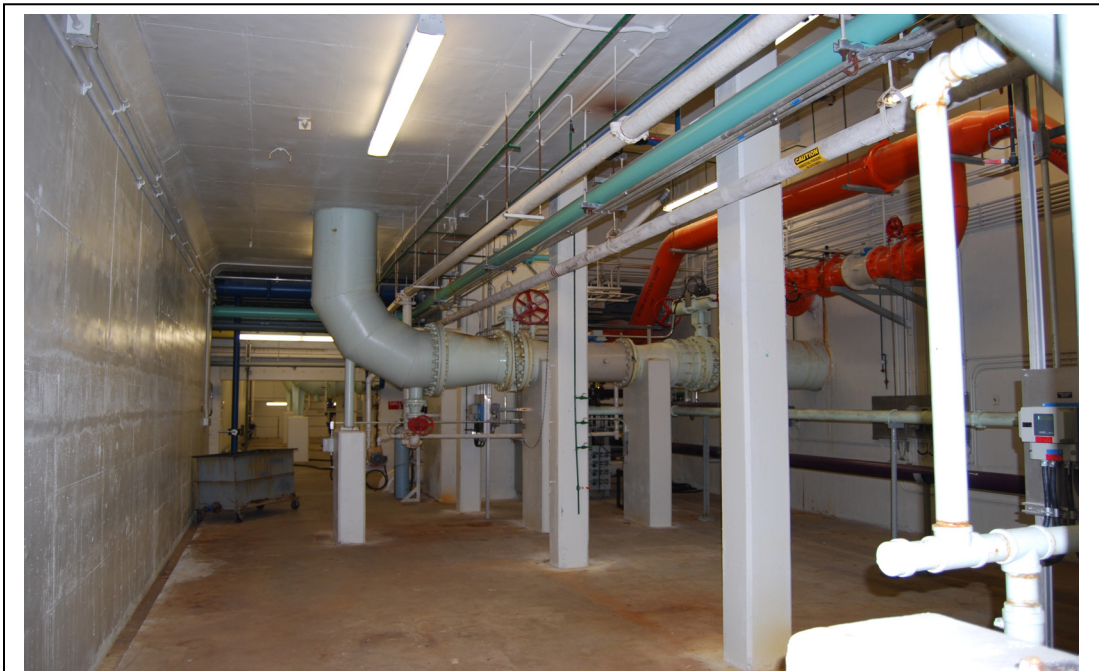
Figure 22.18: Gallery No. 5 (PST No. 1 & 2 effluent end) facing south. Area ID #17.

One ACM was noted in the HMIS Report to be located in the vicinity of this area.

It is estimated that asbestos abatement and inspection costs will be approximately \$1,500, excluding re-insulating the system.

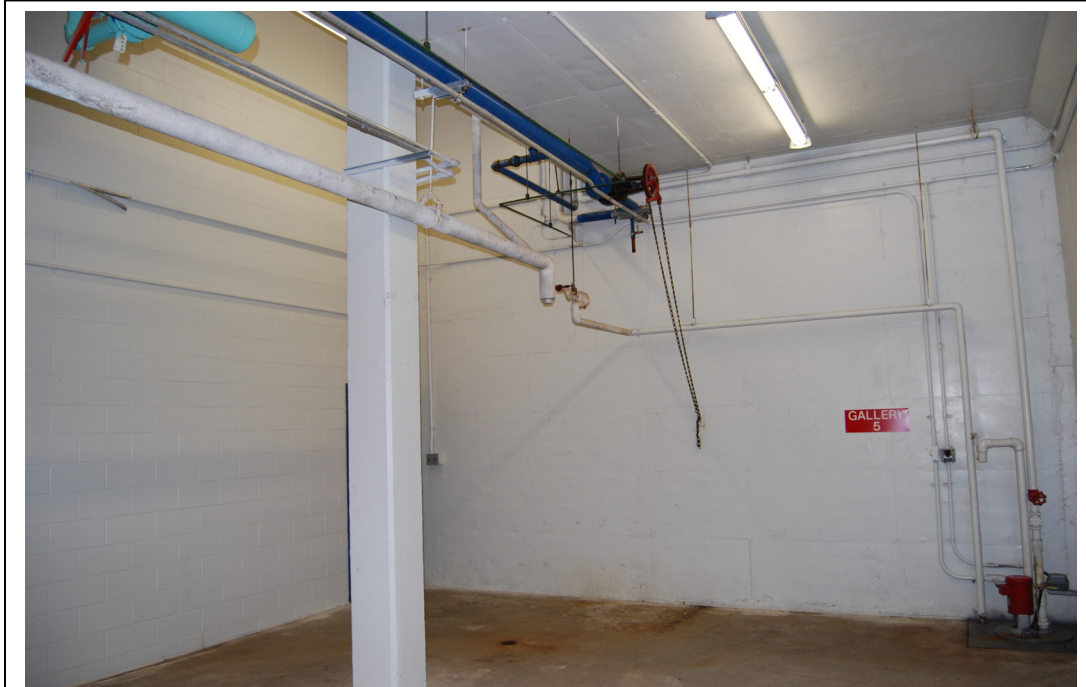
Figure 22.19: Gallery No. 5 facing north. Area ID #17.

One ACM was noted in the HMIS Report to be located in the vicinity of this area.

It is estimated that asbestos abatement and inspection costs will be approximately \$1,500. As noted previously, the high and low pressure steam piping does not need to be re-insulated.

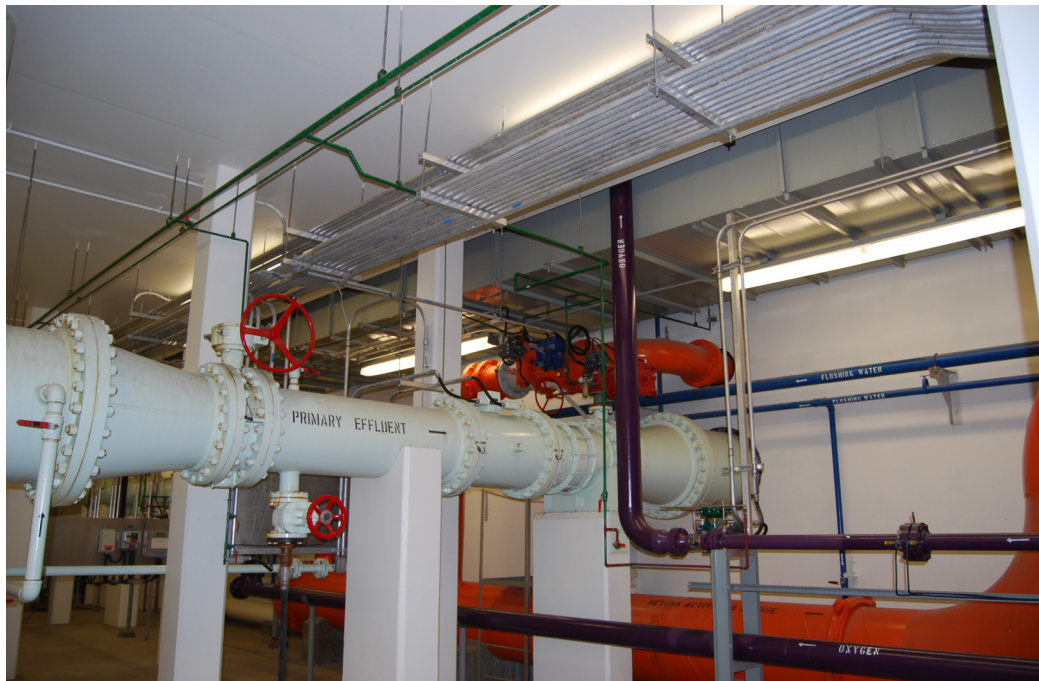
Figure 22.20: Gallery No. 5 (PST No. 3 effluent end) facing south. Area ID #17.

One ACM was noted in the HMIS Report to be located in the vicinity of this area.

It is estimated that asbestos abatement and inspection costs will be approximately \$1,500. As noted previously, the high and low pressure steam piping does not need to be re-insulated.

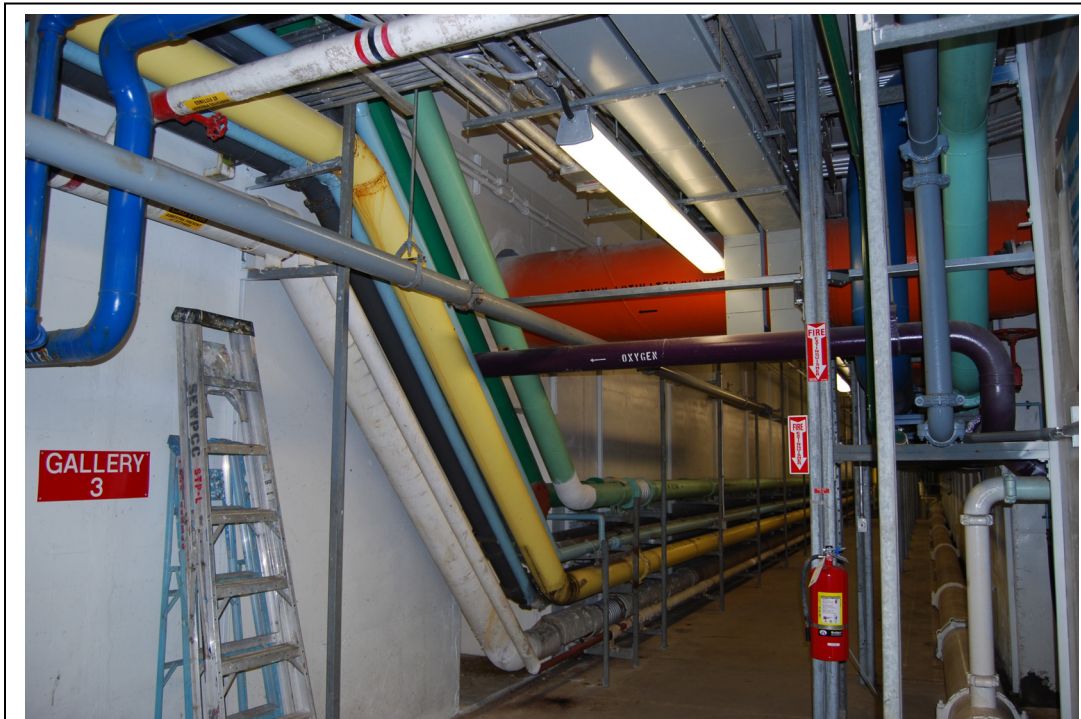
Figure 22.21: Gallery No. 3 at entrance to Gallery No. 5. Area ID #17.

Two ACM's were noted in the HMIS Report to be located in the vicinity of this area.

It is estimated that asbestos abatement and inspection costs will be approximately \$1,500. As noted previously, the high and low pressure steam piping does not need to be re-insulated.

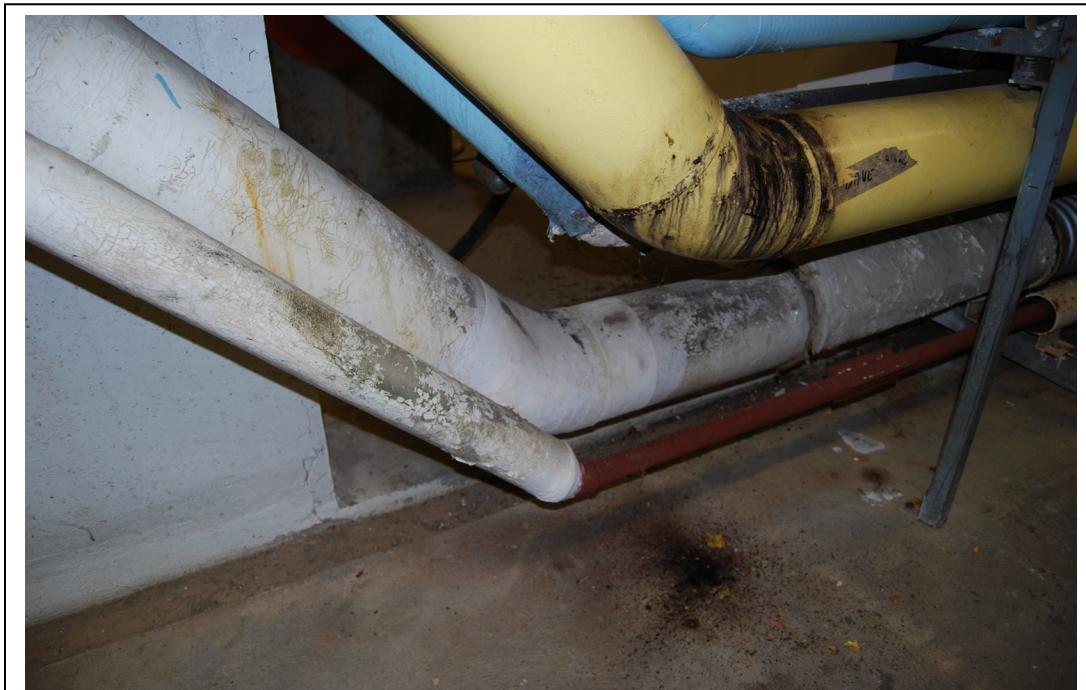
Figure 22.22: Gallery No. 3 at entrance to Gallery No. 5. Area ID #17.

Two ACM's were noted in the HMIS Report to be located in the vicinity of this area.

Note: *This run of piping appears to be in poor/damaged condition and should be included in any abatement program being completed.*

It is estimated that asbestos abatement and inspection costs will be approximately \$1,500. As noted previously, the high and low pressure steam piping does not need to be re-insulated.

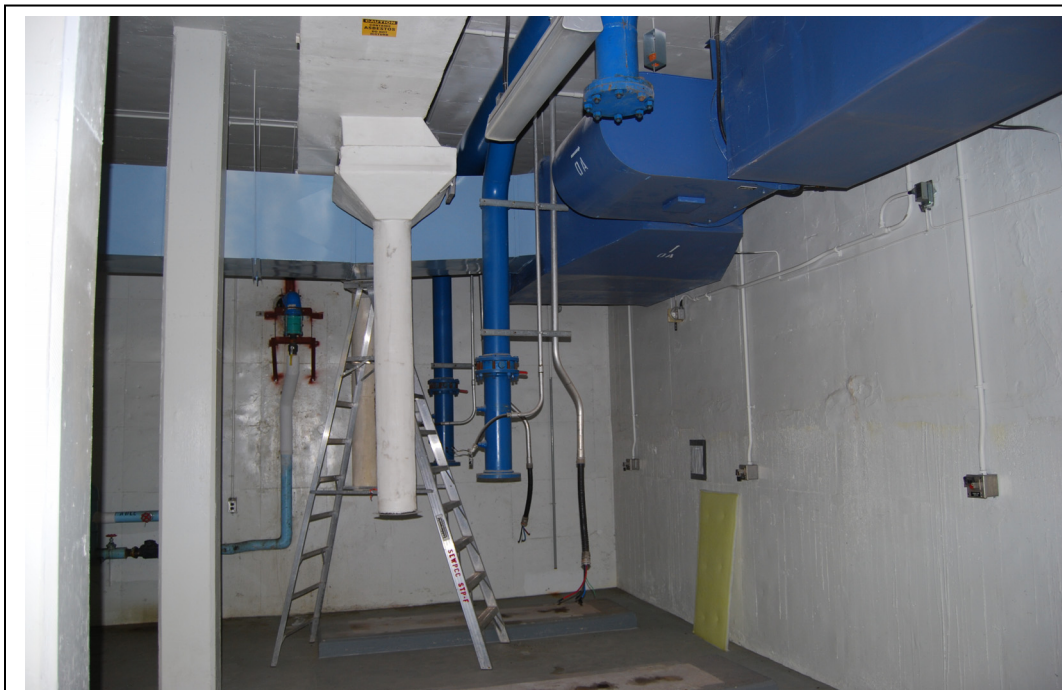
Figure 22.23: Water Service / Compressor Room facing east. Area ID #19.

One ACM was noted in the HMIS Report to be located in the vicinity of this area.

It is estimated that asbestos abatement and inspection costs will be approximately \$2,000, excluding re-insulating the system.

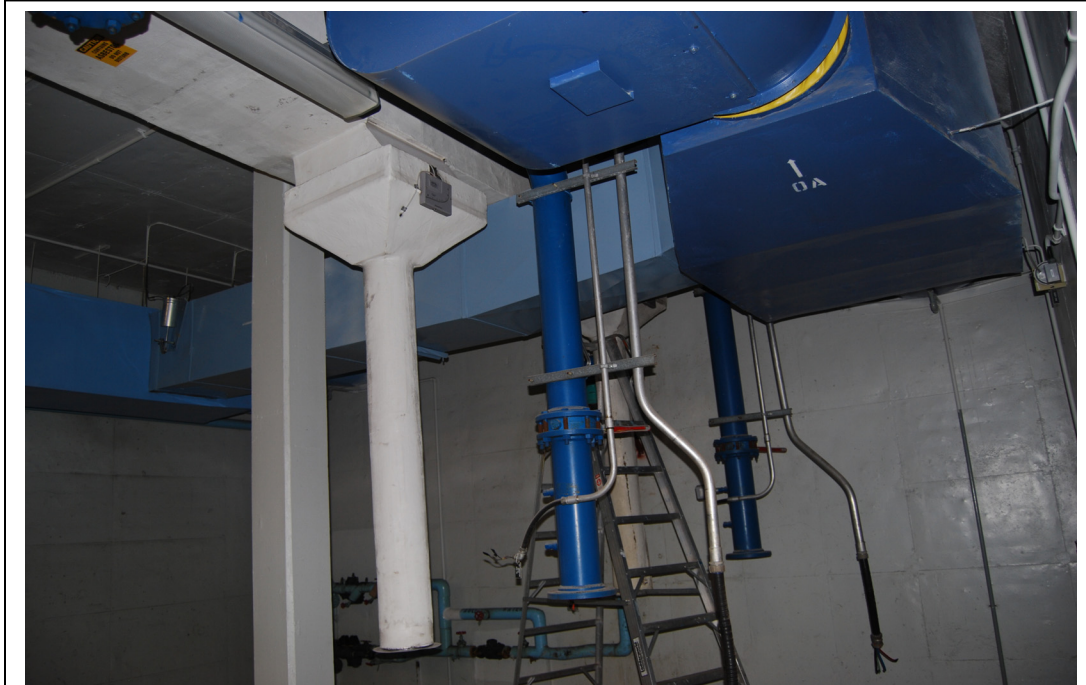
Figure 22.24: Water Service / Compressor Room facing east. Area ID #19.

One ACM was noted in the HMIS Report to be located in the vicinity of this area.

It is estimated that asbestos abatement and inspection costs will be approximately \$2,000, excluding re-insulating the system.

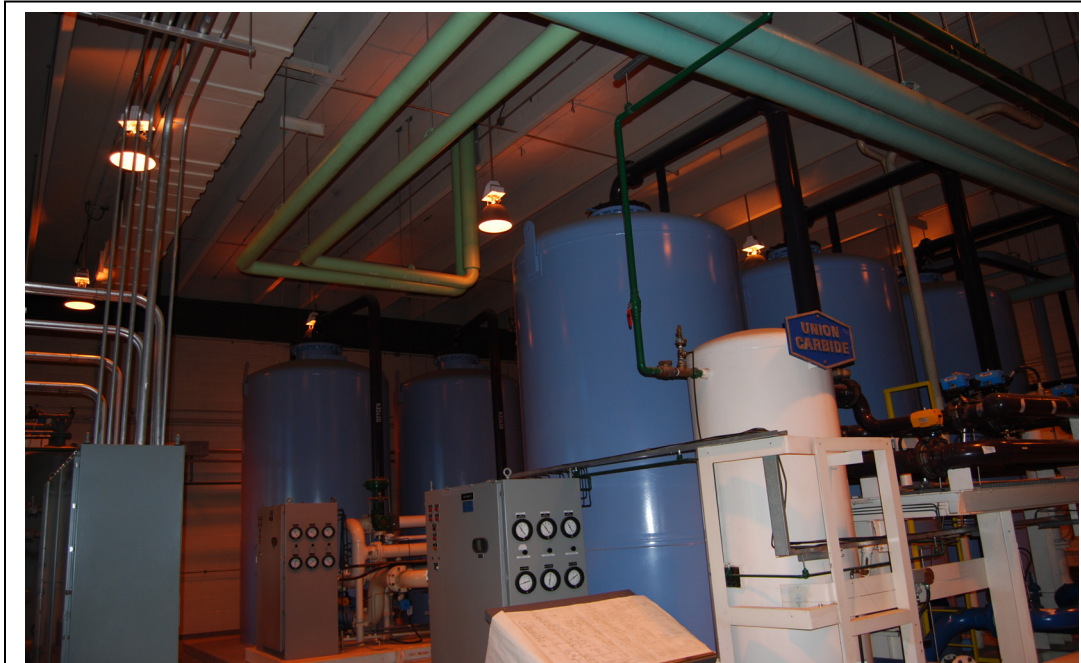
Figure 22.25: PSA / UNOX Equipment Room facing east. Area ID #20.

One ACM was noted in the HMIS Report to be located in the vicinity of this work.

If confirmed as an ACM, it is estimated that asbestos abatement and inspection costs will be approximately \$50,000, excluding re-insulating the system after abatement. Although this room is having all equipment removed, abatement may not be applicable for this modification process if extreme care is taken during demolition. However encapsulation of the ACM may have to be completed prior to the modifications. This can often be as costly as abatement with the ACM concerns remaining.

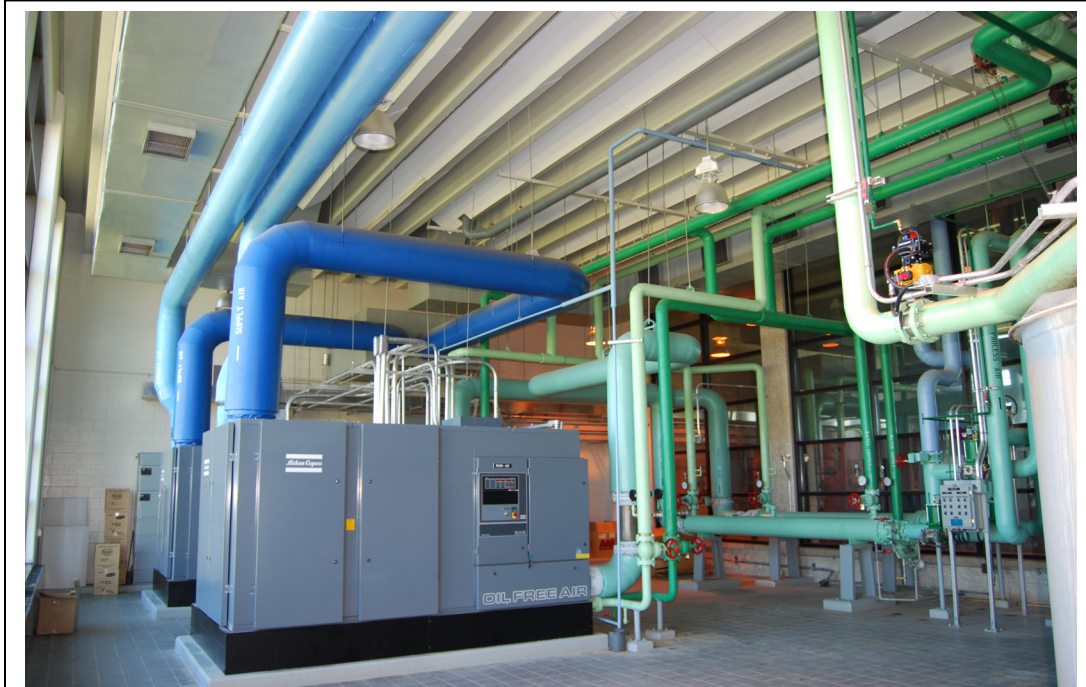
Figure 22.26: PSA Compressor Room facing east. Area ID #21.

Not Applicable.

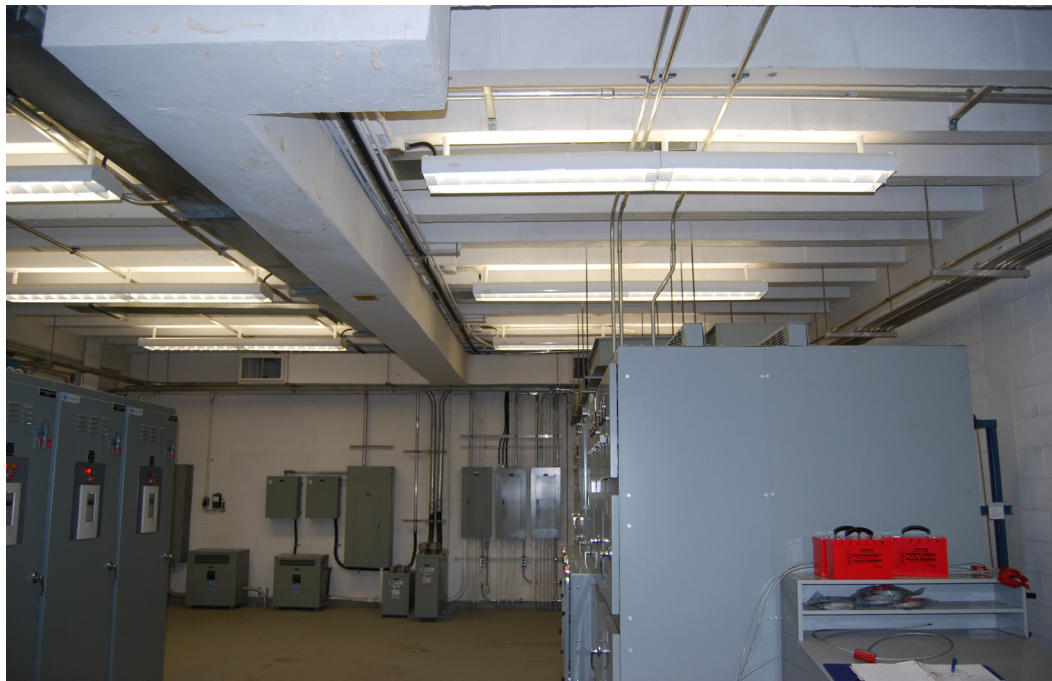
**Figure 22.27: Electrical room east of Secondary Clarifier No. 1 facing north.
Area ID #23.**

One ACM was noted in the HMIS Report to be located in the vicinity of this work.

It is estimated that asbestos abatement and inspection costs will be approximately \$25,000, excluding re-insulating the system after abatement.

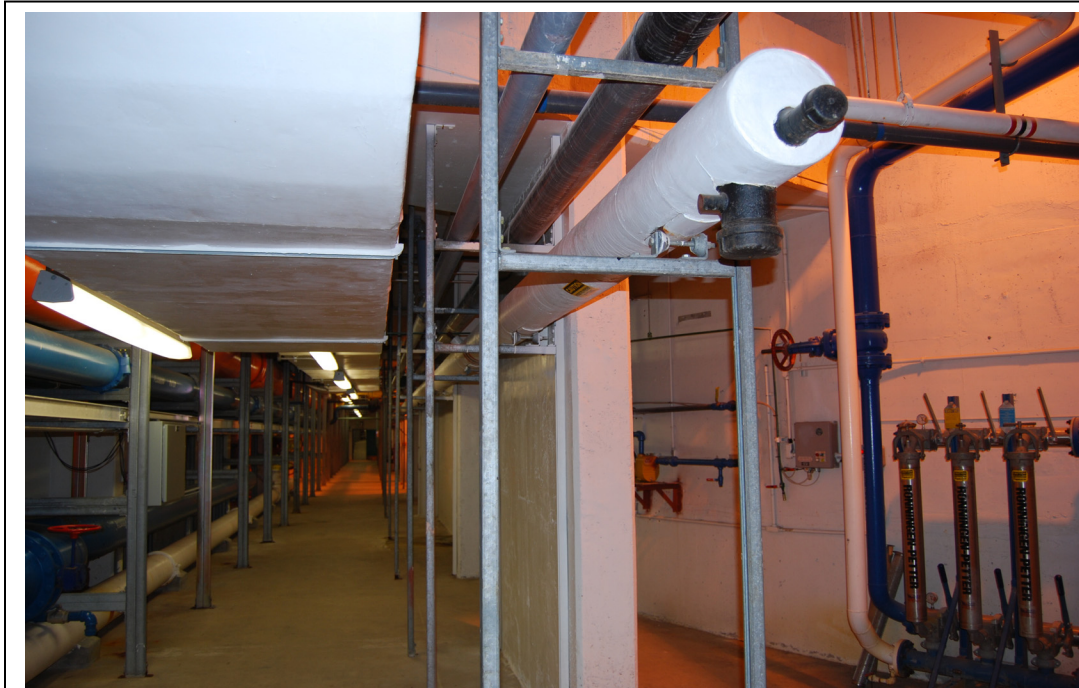
Figure 22.28: Gallery No. 3 facing east at end of Secondary Clarifier No. 1 & 2. Area ID #24/25.

One ACM was noted in the HMIS Report to be located in the vicinity of this area.

It is estimated that asbestos abatement and inspection costs will be approximately \$1,000. As noted previously, the high pressure steam piping does not require re-insulating.

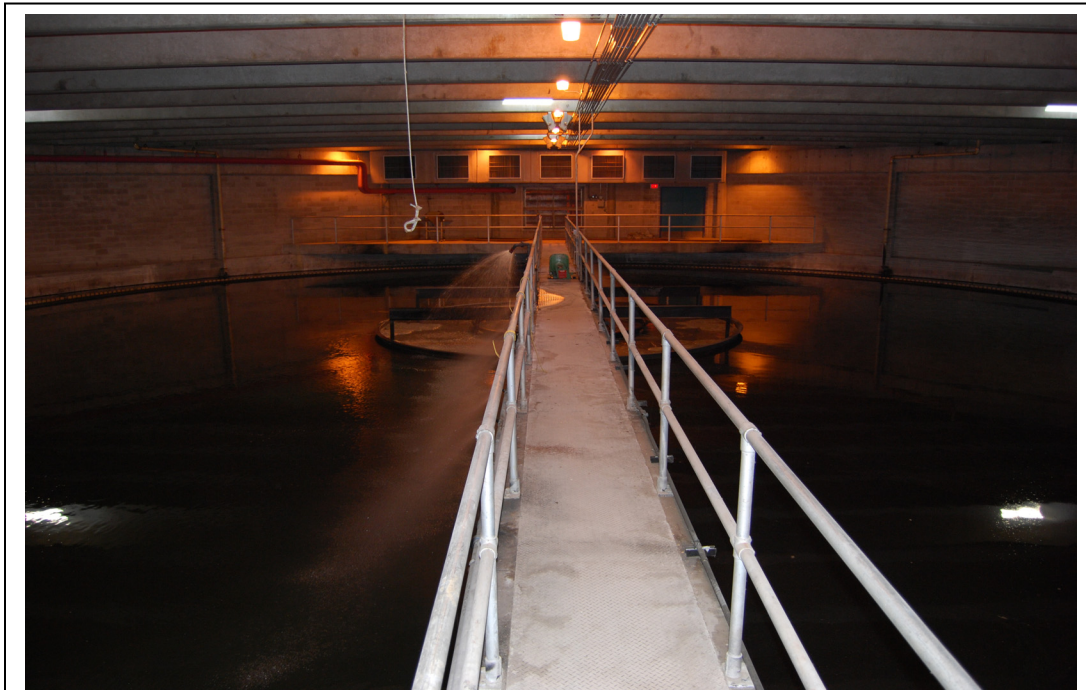
Figure 22.29: Secondary Clarifier No. 1 facing north. Area ID #26.

One ACM was noted in the HMIS Report to be located in the vicinity.

Not Applicable.
