SEWPCC Upgrading/Expansion Conceptual Design Report

SECTION 22 - Asbestos Abatement

22.0 Asbestos Abatement

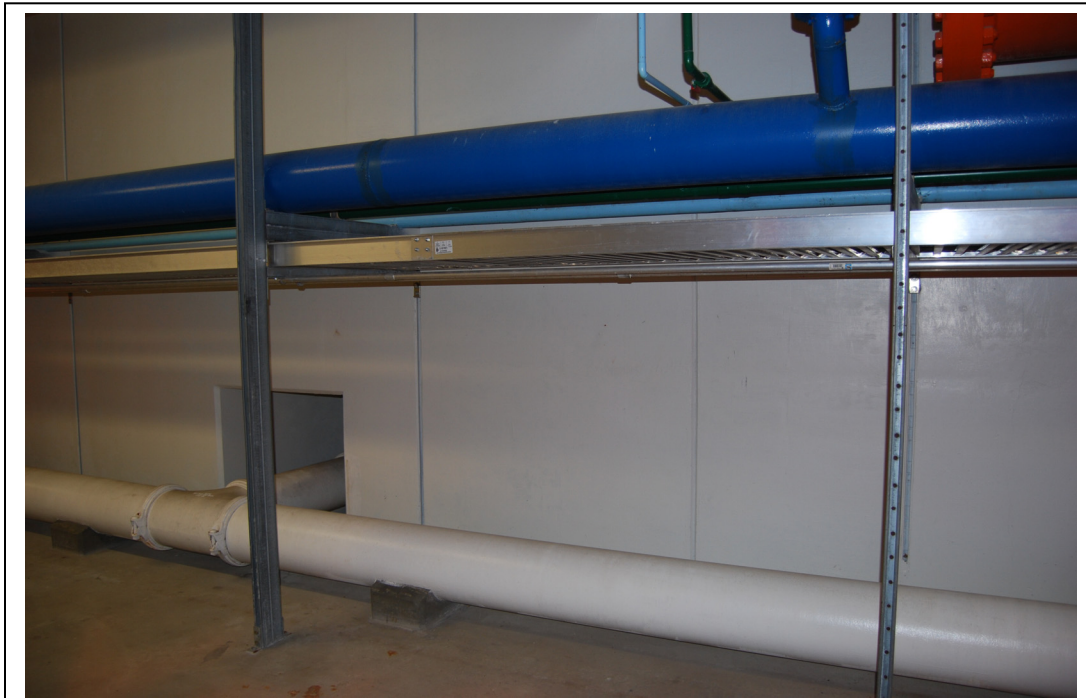
Figure 22.30: Gallery No. 3 facing north at Secondary Clarifier No. 3. Area ID #27.

Two ACM's were noted in the HMIS Report to be located in the vicinity of this area.

It is estimated that asbestos abatement and inspection costs will be approximately \$1,500. As noted previously, the high and low pressure steam piping does not need to be re-insulated.

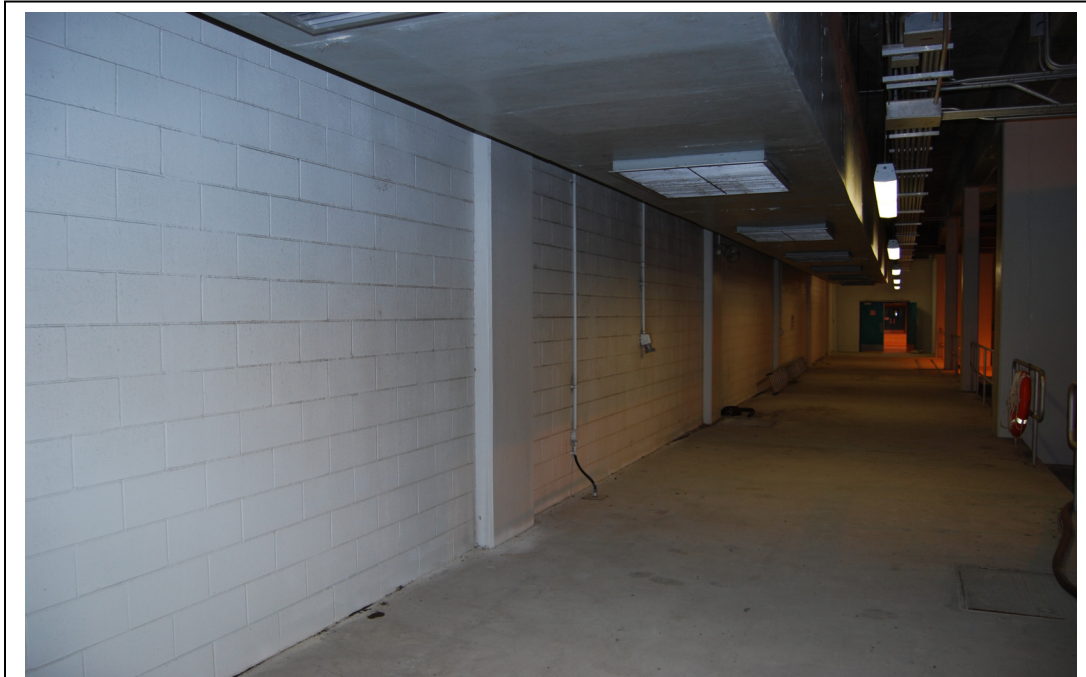
Figure 22.31: Secondary Clarifier No. 3 main floor facing north. Area ID #28.

One ACM was noted in the HMIS Report to be located in the vicinity of this area.

Not Applicable.

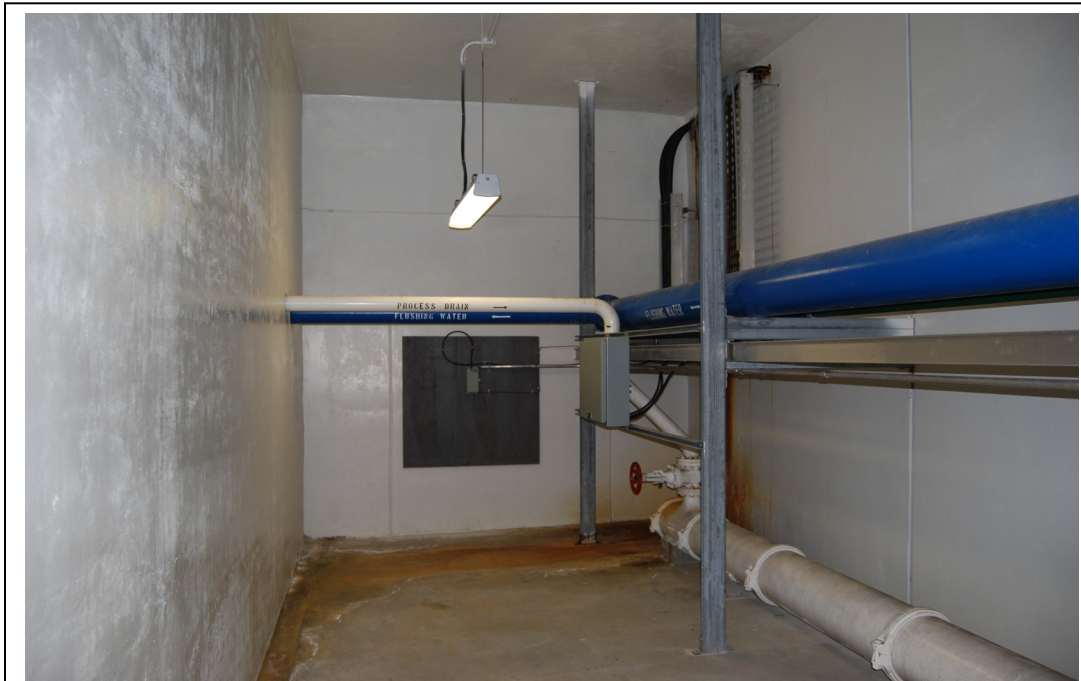
Figure 22.32: Gallery No. 3 facing west at end of Secondary Clarifier No. 3. Area ID #29.
