Crosier Kilgour & Partners Ltd.

September 13, 2013

Our File No. 2013-0861

**Re: 5 Rue Des Meurons.
King George Pool Investigation**

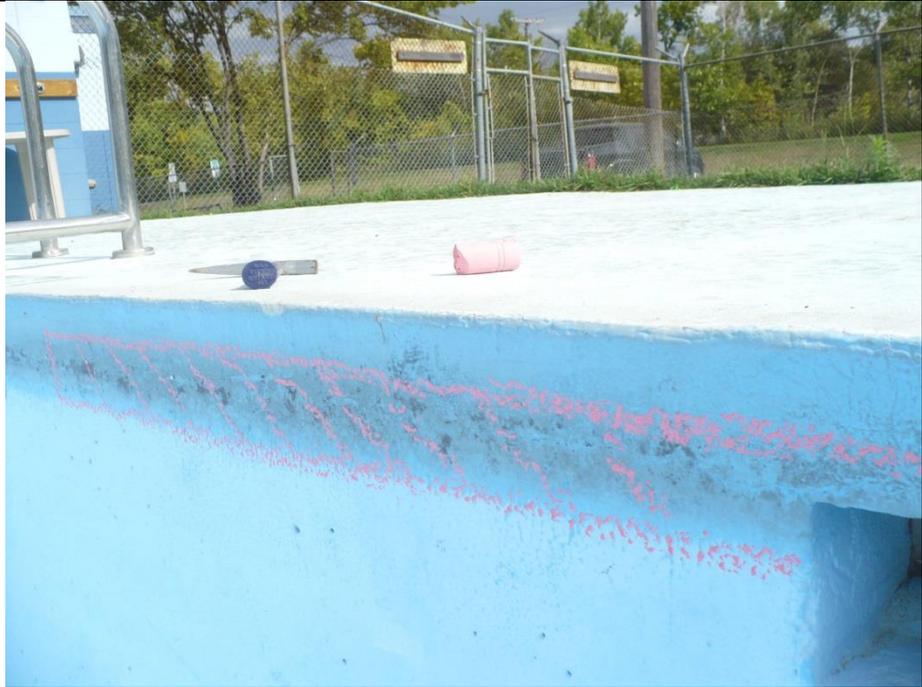
- The walls of the pool showed no signs of delamination or deterioration.
- The “Pour Joint” between the pool deck and the top of the pool wall has separated around the pool perimeter, and has been hand patched with a cementitious repair material. The repair material is de-bonded around most of the perimeter of the pool, and appears to be a yearly maintenance item when the pool is re-commissioned and painted for use (Refer to Photograph #1) each summer. The concrete itself appears to be sound, which would suggest that a system of stitching the two surfaces back together with dowels and epoxy may be a logical repair method. Holes are drilled at regular intervals intersecting the deck and wall and steel reinforcing dowels are epoxy grouted into the drill holes.

The continuous “pour joint” at the deck slab/pool wall interface appears to be a failed cold joint, versus a delamination plane. Thus, it does not appear that removal and replacement is warranted. Rather, we would dowel the sections together and inject the gap with structural grade epoxy to re-connect the two concrete

Photograph #1:
Repair area between pool
wall and deck slab cold
joint.

sections. The separation or joint is sealed on both sides with epoxy paste and injection ports are placed on the exterior crack at regular intervals.

Once the surface seal has cured, liquid epoxy resin is injected into the ports and allowed to travel from port to port indicating that the entire gap is filled and the two surfaces are bonded together. After the epoxy injection resin is cured the exterior seal would be removed by grinding to the original concrete surface. The approximate costs for this style of repair including access would be \$85.00 per lineal foot.

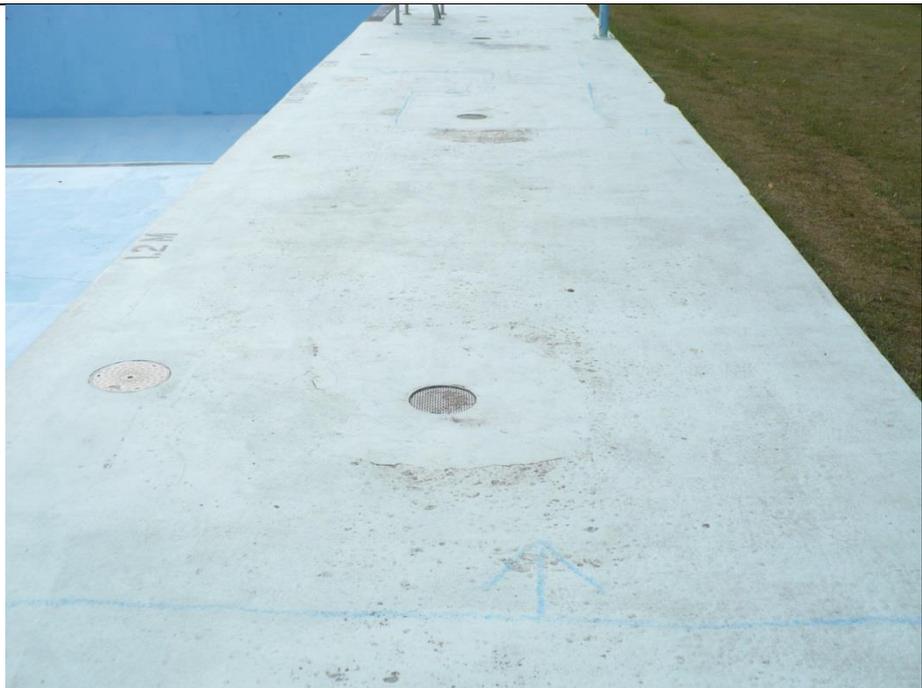
- The pool deck has 16 areas of delamination. One area on the north deck by the male change room. One area on the east deck. Six areas on the south deck and 8 areas on the west deck (Note: one area of repair totals 200 square feet on the west side (Refer to photograph #2). The chain/hammer sounding survey was difficult to establish depths and or types of repair required due to the existing deck coating. Some repairs maybe de-bonded membrane coating while others maybe concrete and membrane repairs (Refer to photograph #3). In total approx. 250 square feet of repair is required with an approximate cost of \$70.00 per square foot. (Includes concrete and membrane repairs.)

Photograph #2:
Large area of repair on west
pool apron deck.

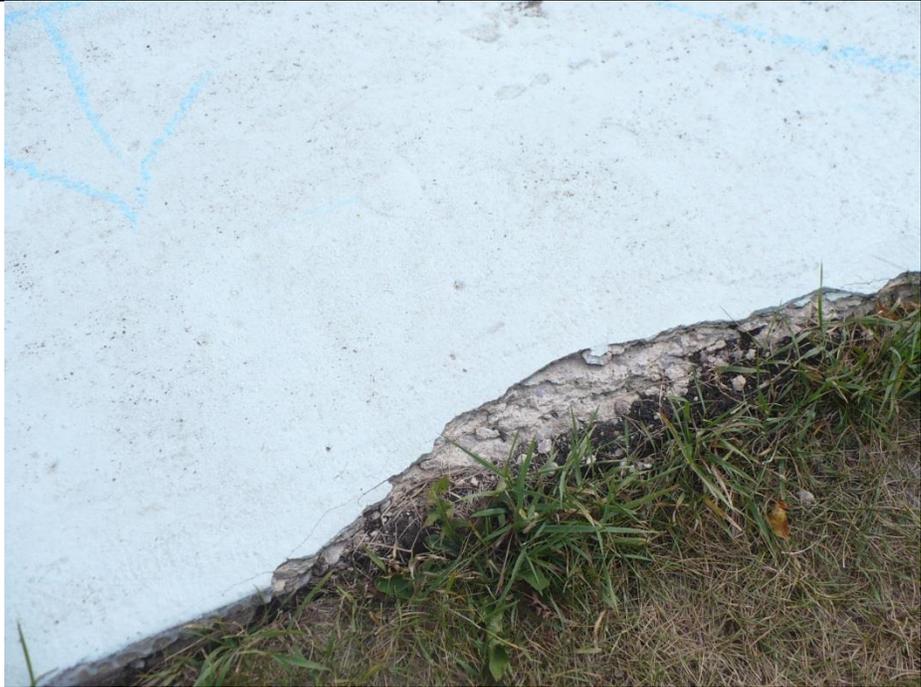
Photograph #3:
Freeze thaw damage on
pool apron deck

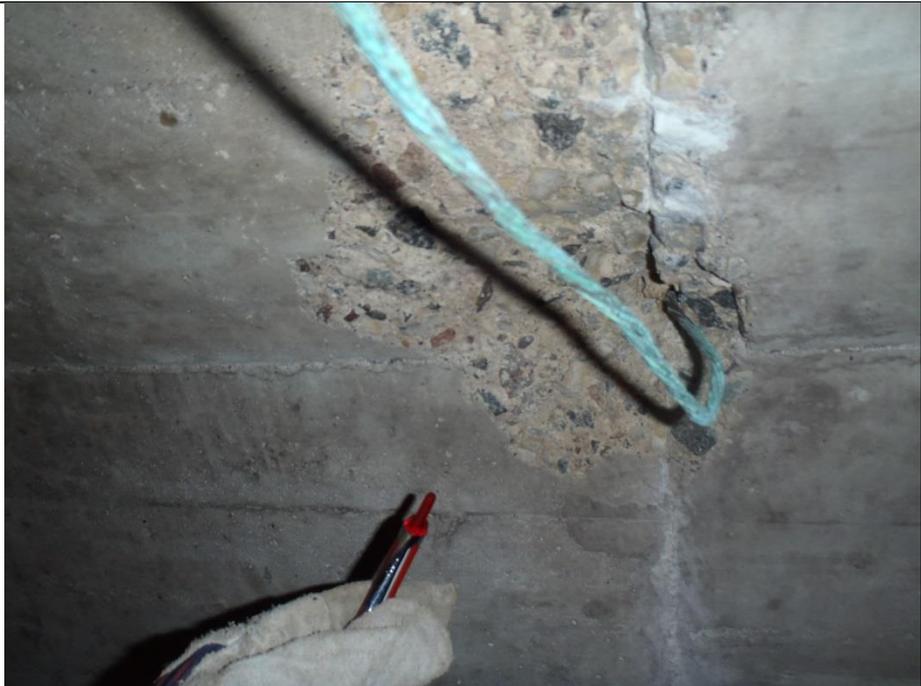
- The pool mechanical tunnel walls, ceiling and floor are in generally good condition. No significant evidence of differential movement is indicated.
- The concrete deck soffit was observed to have minimal to no signs of concrete deterioration and minor evidence of delamination (due to penetrations for grounding wires) and cracking. (Refer to Photographs #4 and #5).

Photograph #4:
Ceiling spall around ground
wire penetration.

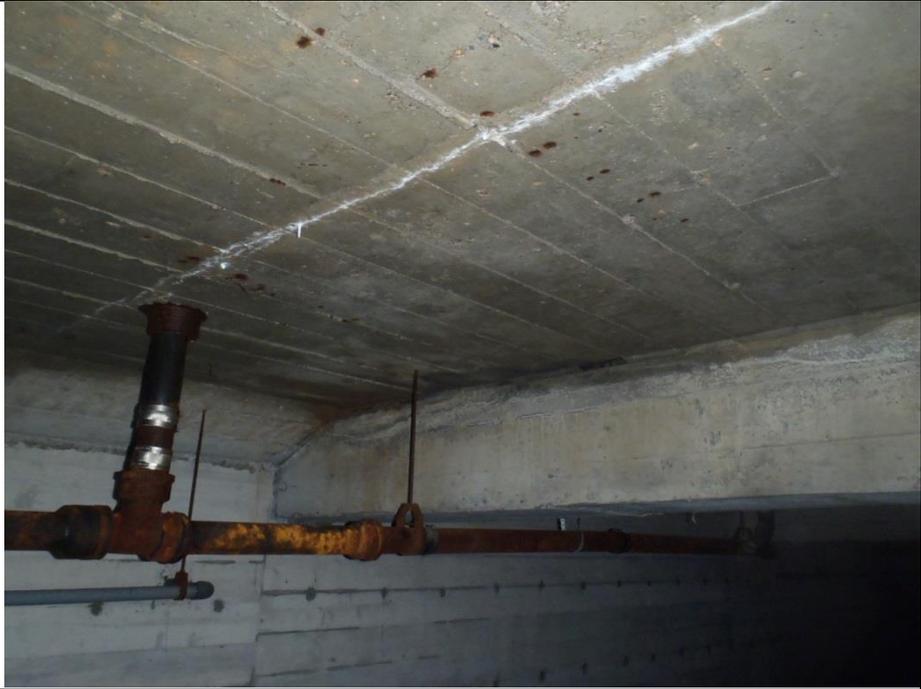
Photograph #5:
Soffit crack under pool deck
showing evidence of
leakage.

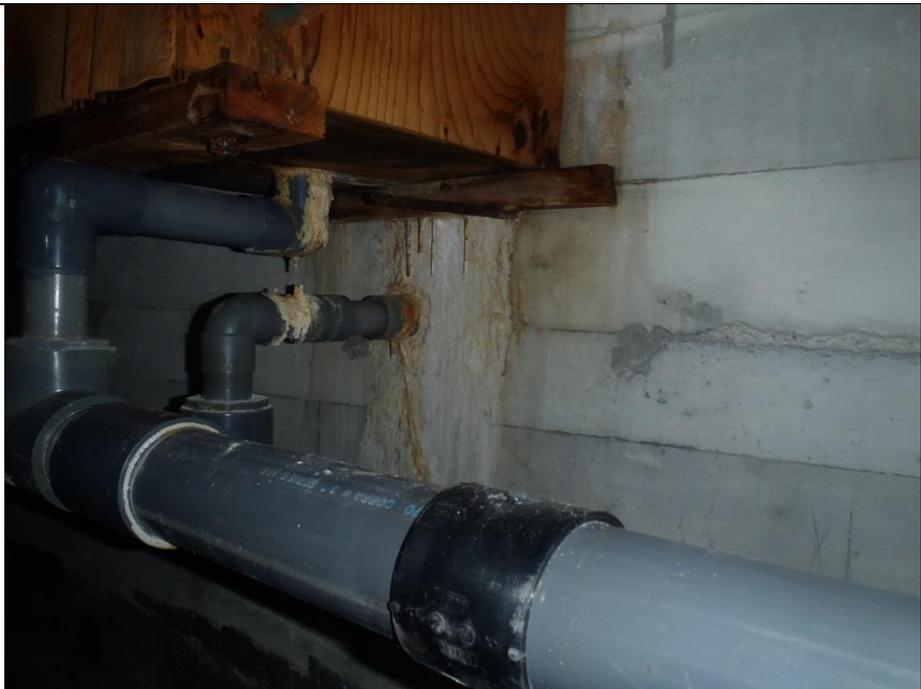
- The inside tunnel wall was also observed to be in generally good condition, however it was typical to observe evidence of water leakage known as efflorescence at most locations where a concrete block-out contains a pool scupper or a pool jet line, and at locations of pipe intrusions into the concrete wall (Refer to photograph #6).

Photograph #6:
Efflorescence from scupper
and pipe penetrations.

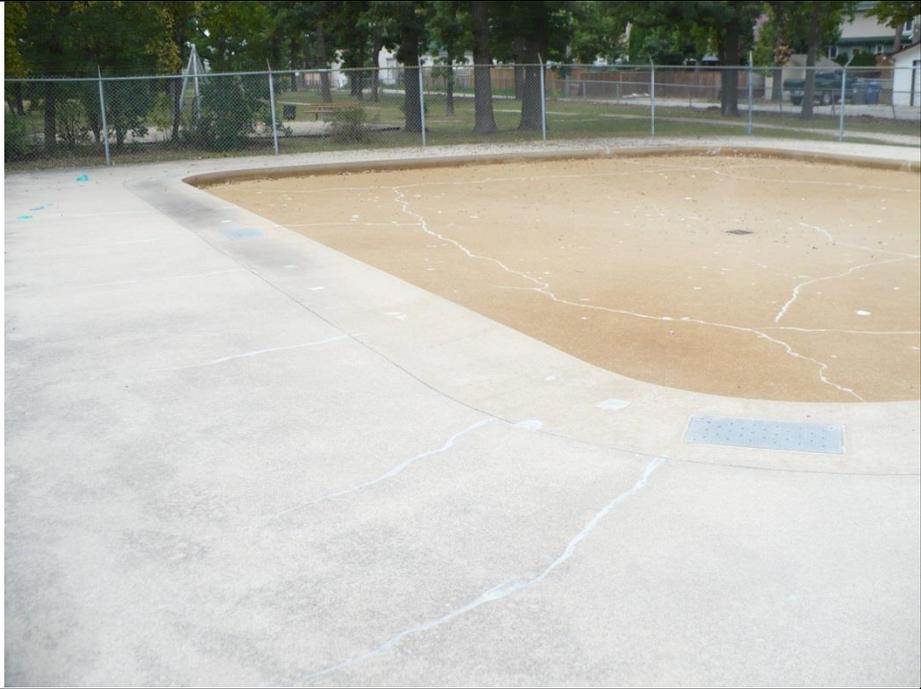
- Regarding the wading pool basin and apron deck, the system is a slab on grade construction system. The overall condition was quite good considering again the age of the facility and the fact that the concrete is a grade supported system. Cracking was evident throughout but not serious, and had been sealed with caulking to prevent additional intrusion of moisture (Refer to photographs #7 and #8). No evidence of significant differential movement was observed indicating that the integral weeping tile system is likely retained operational status.

Photograph #7:
Wading pool and deck;
sealed cracks were generally
intact indicating no
significant differential
movement.

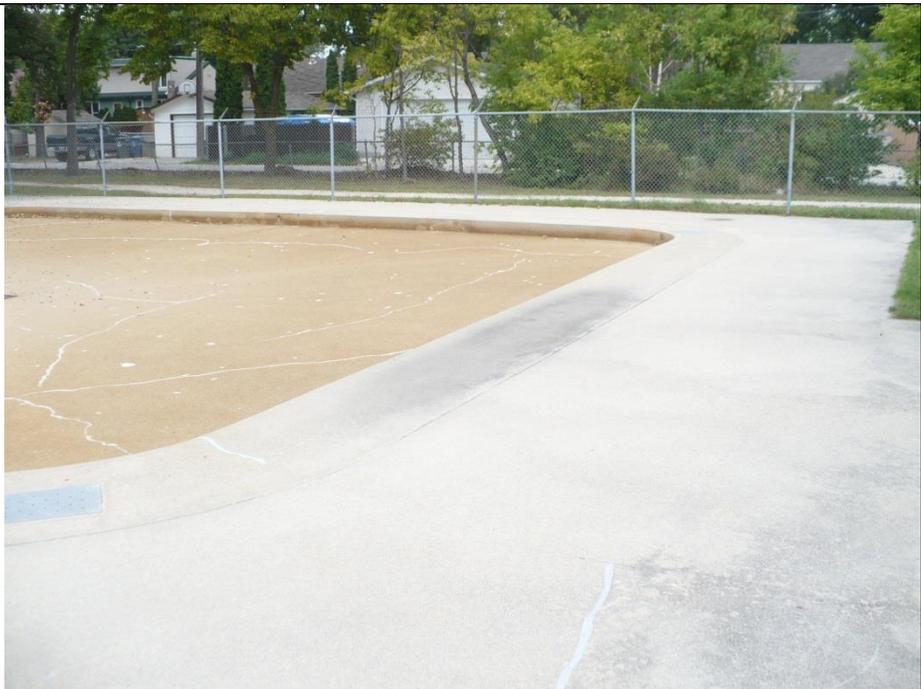
Photograph #8:
Wading pool and deck,
again, no significant
evidence of differential
movement was observed.
