## **2013 City of Winnipeg Regional and Local Street Renewals – Portage Avenue Package (I3-C-03)**

**RE: Pavement Structure Investigation Report for  
2013 City of Winnipeg Regional and Local Street Renewals – Portage Ave Package**

TREK Geotechnical Inc. is pleased to submit our Report for the pavement structure investigation on Portage Avenue from St. John's Ambulance Way to Sherburn Avenue.

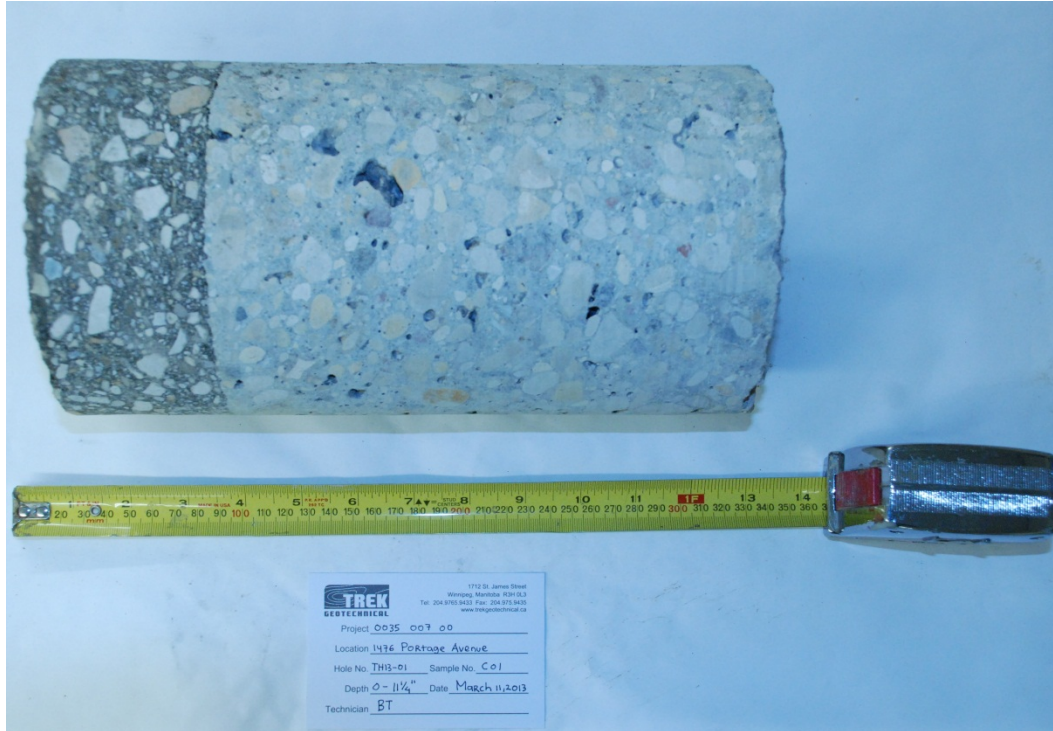
Photo 1: Asphalt and Concrete Core Sample from Test Hole TH13-01

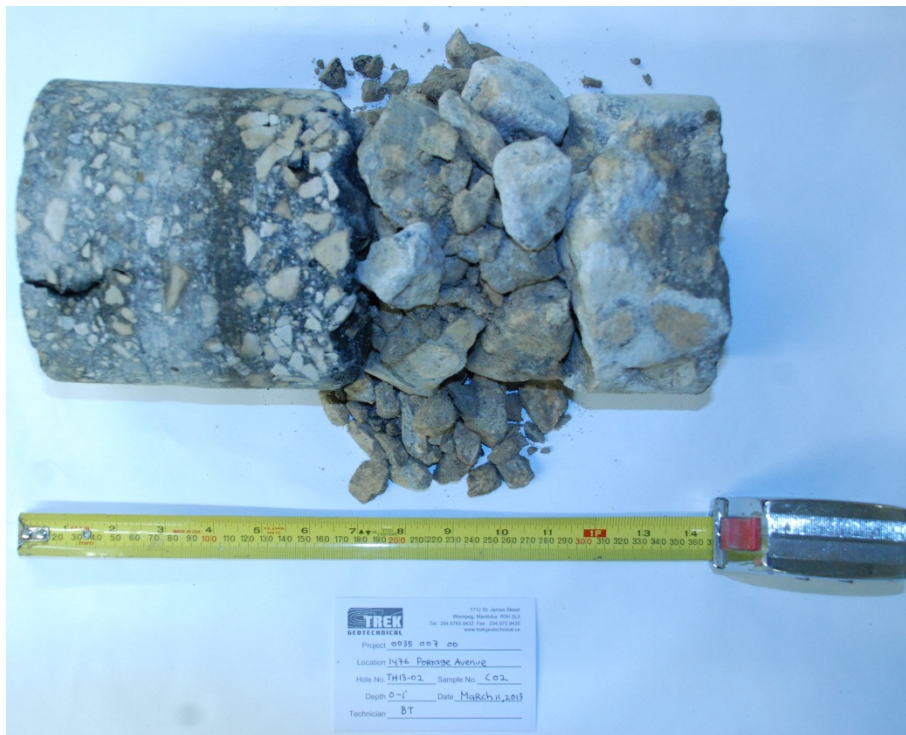
Photo 2: Asphalt and Concrete Core Sample from Test Hole TH13-02

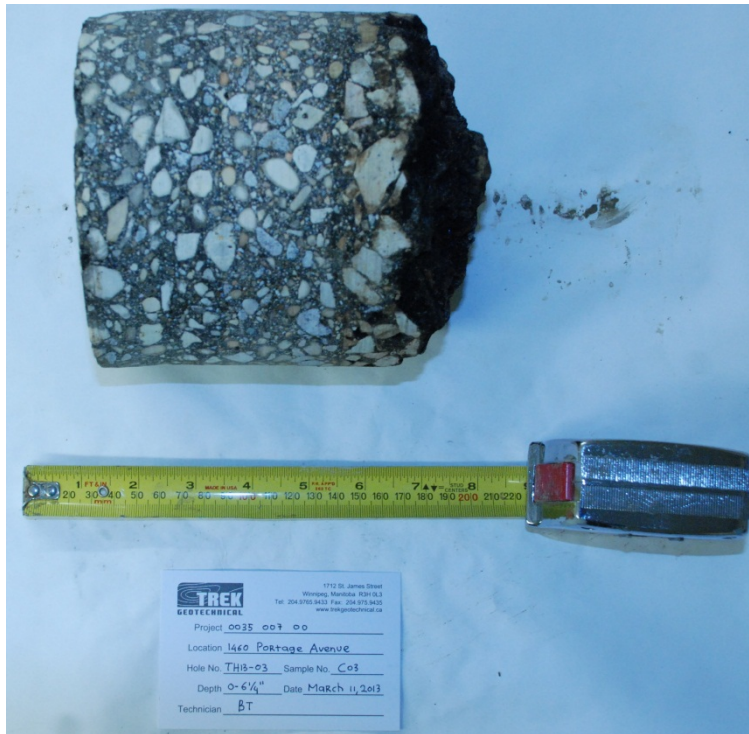
Photo 3: Asphalt Core sample from Test Hole TH13-03

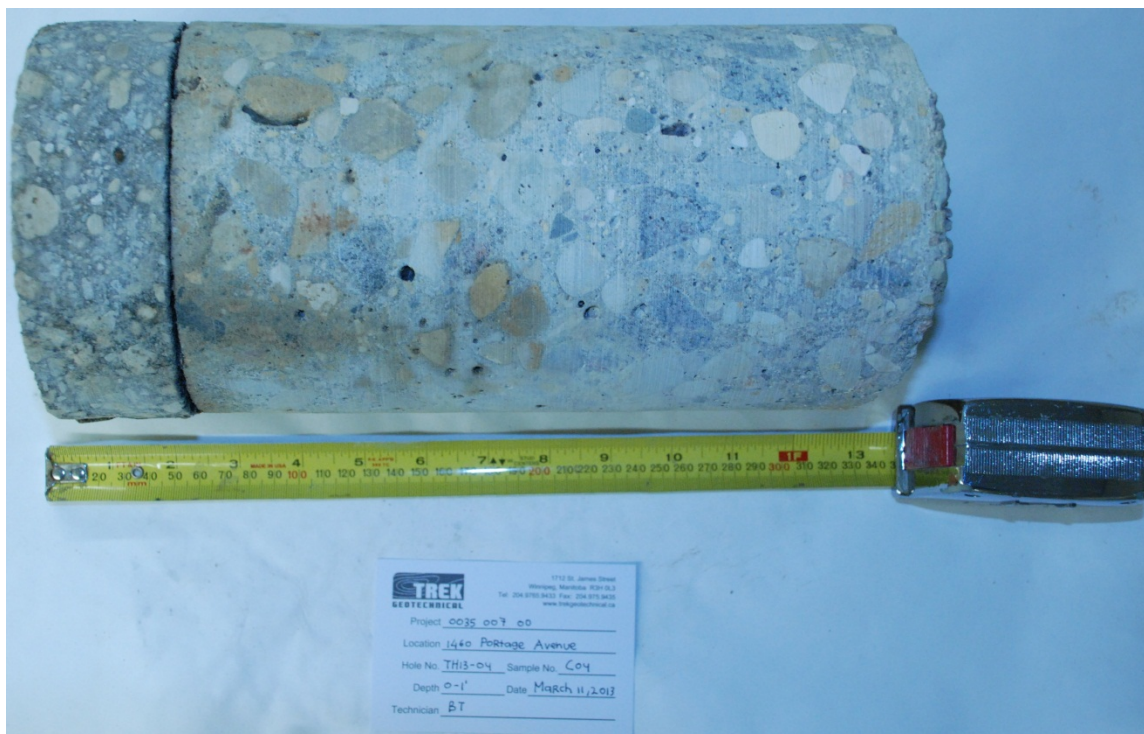
Photo 4: Asphalt and Concrete Core sample from Test Hole TH13-04

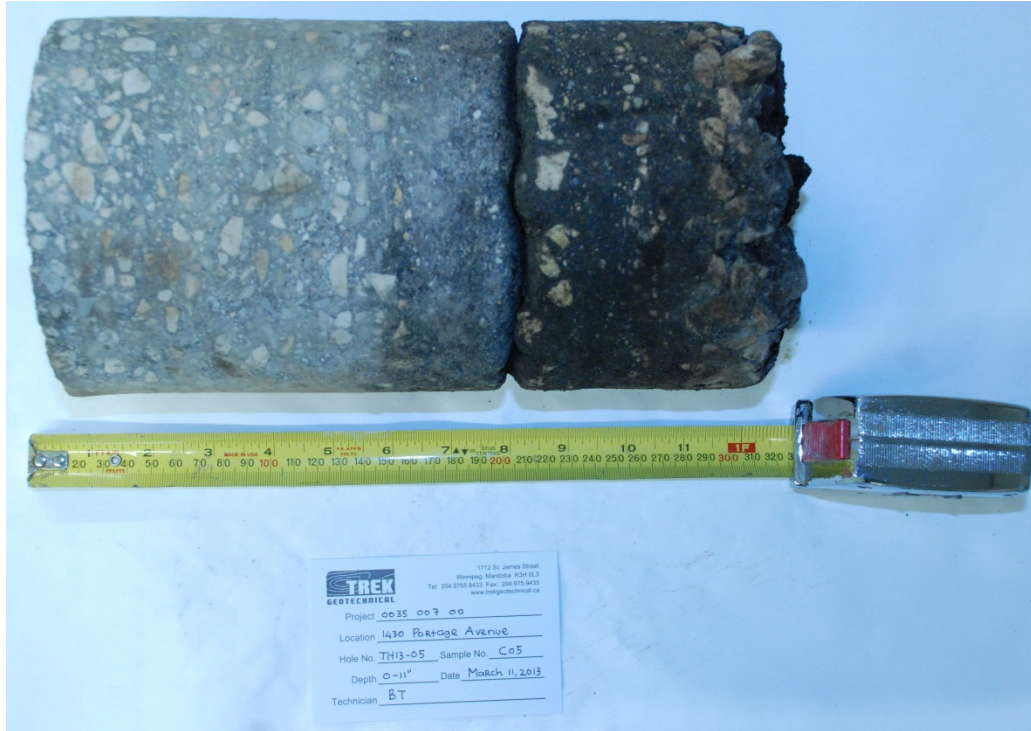
Photo 5: Asphalt Core sample from Test Hole TH13-05

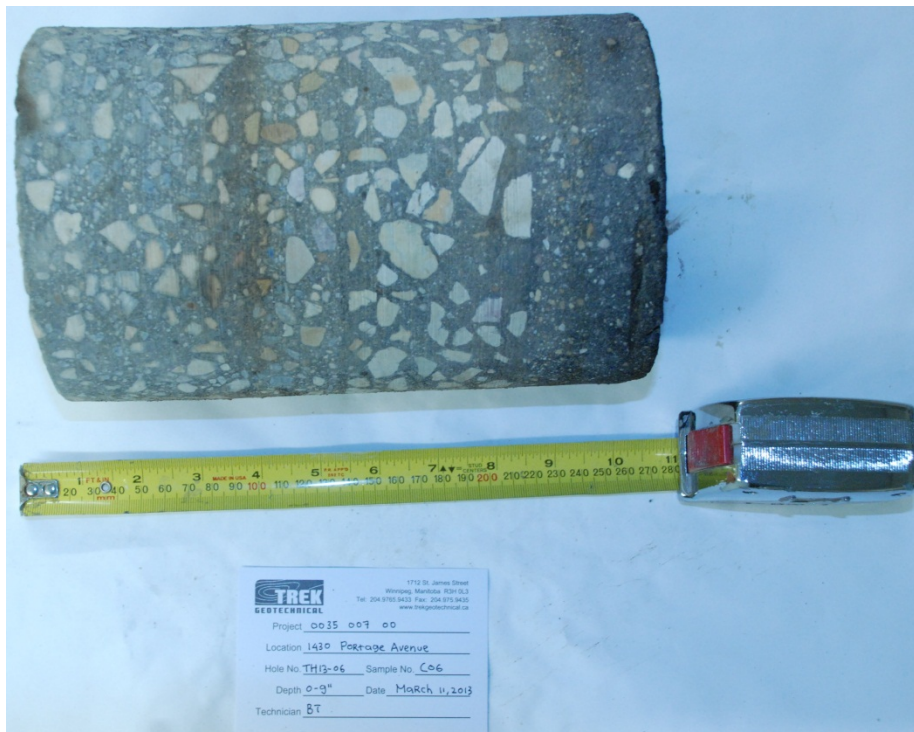
Photo 6: Asphalt Core sample from Test Hole TH13-06

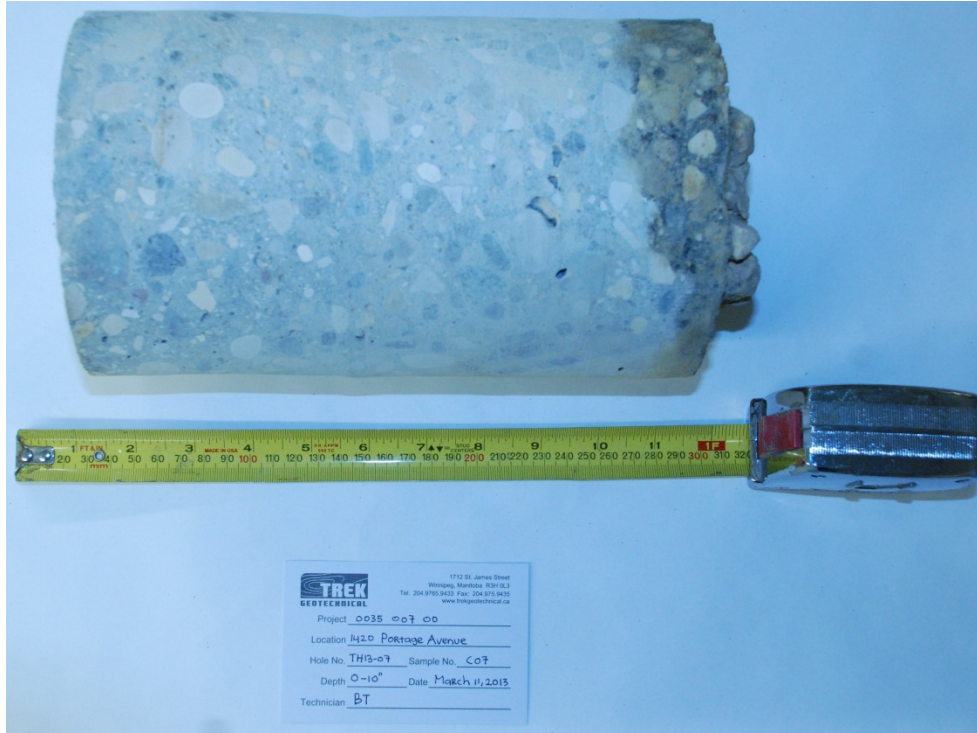
Photo 7: Concrete core sample from Test Hole TH13-07

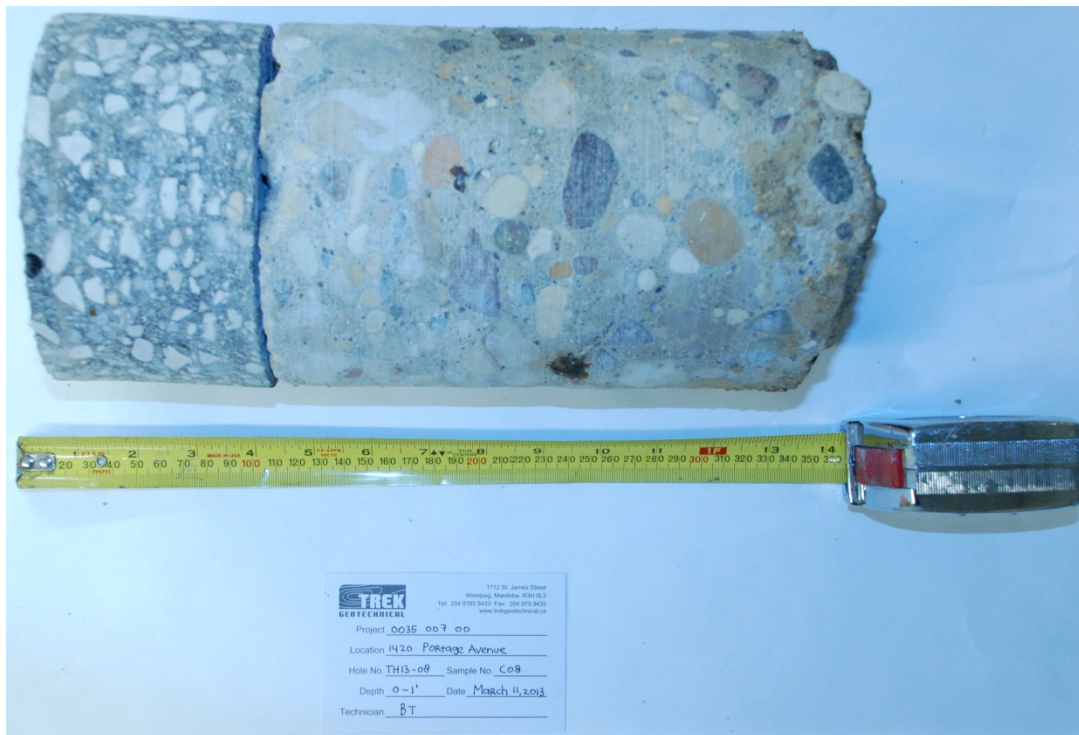
Photo 8: Asphalt and Concrete Core Sample from Test Hole TH13-08

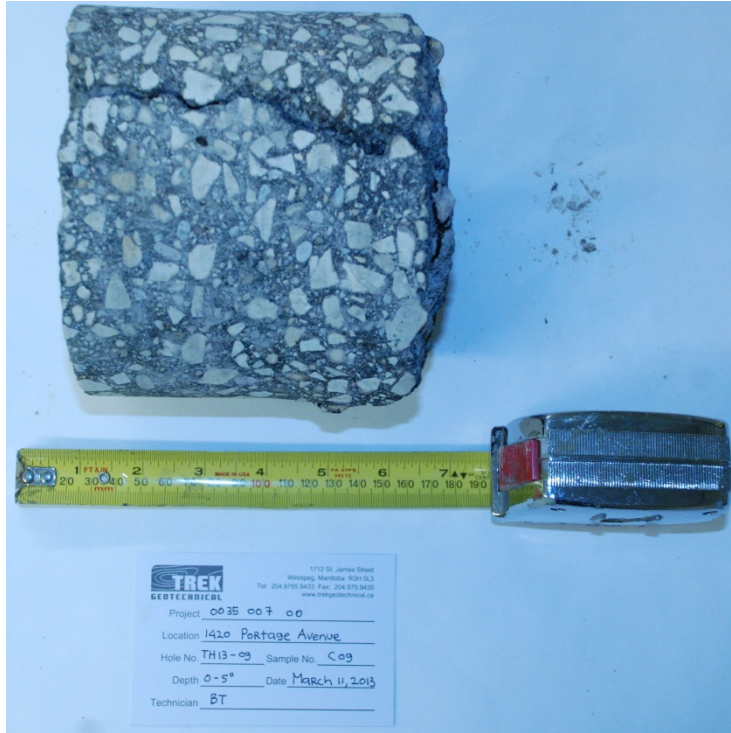
Photo 9: Asphalt Core Sample from Test Hole TH13-09

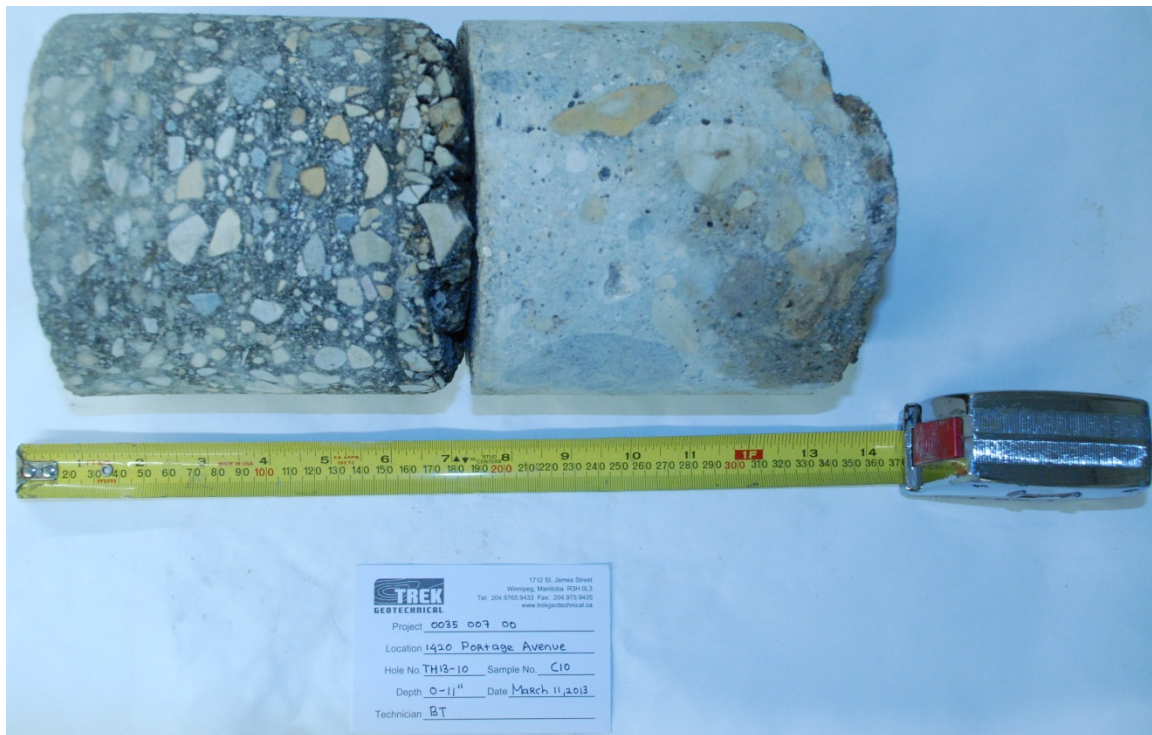
Photo 10: Asphalt and Concrete Core Sample from Test Hole TH13-10

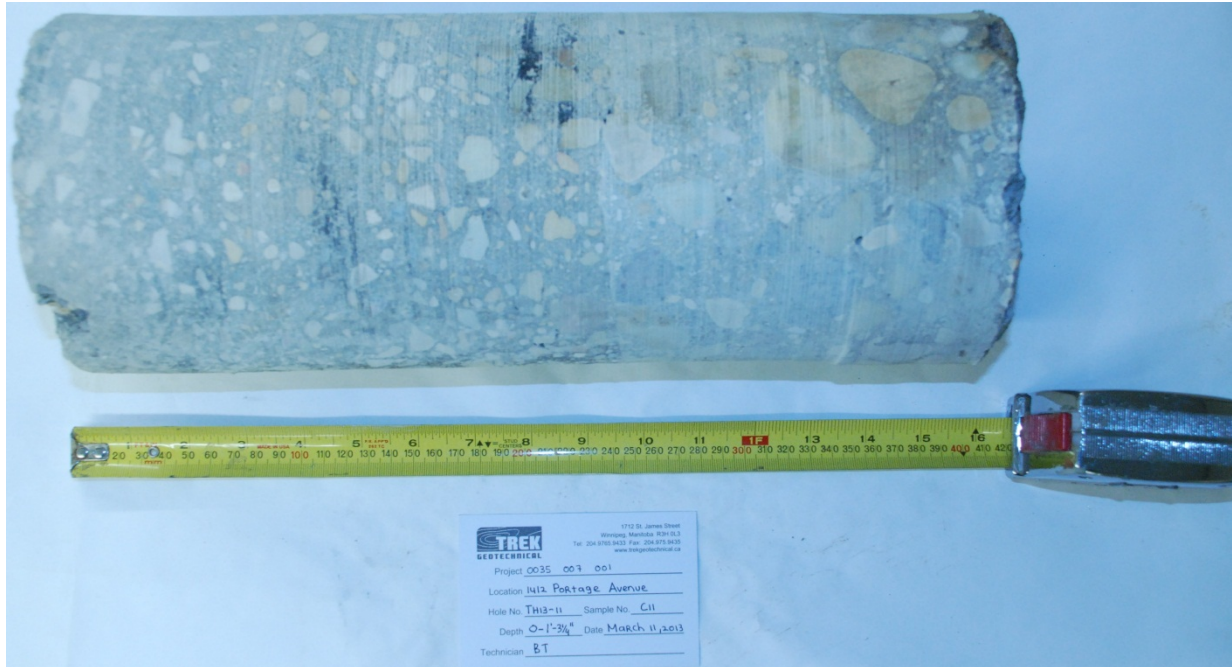
Photo 11: Asphalt and Concrete Core Sample from Test Hole TH13-11

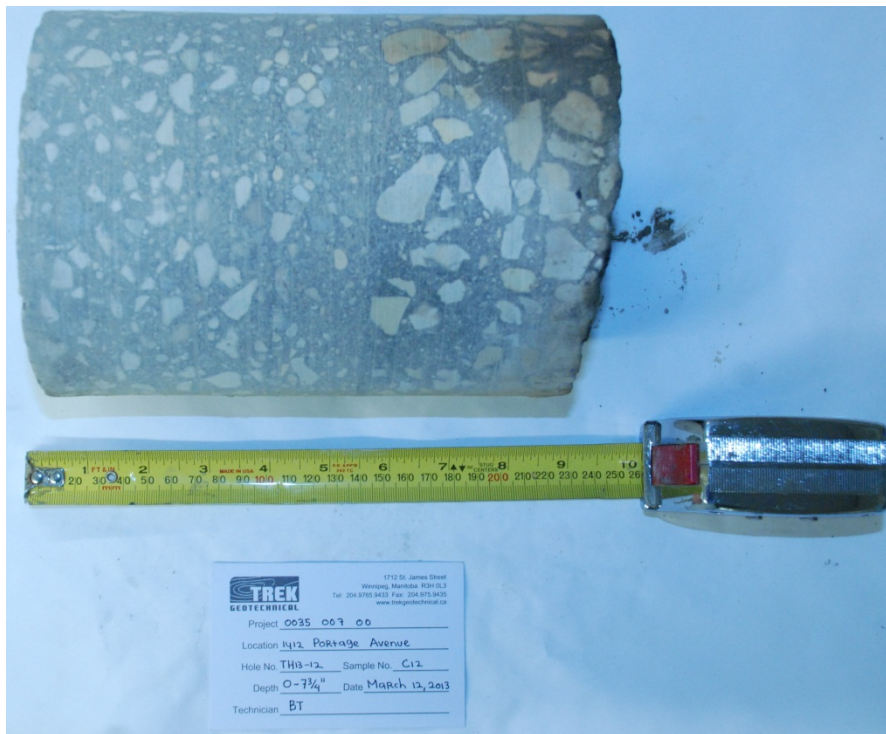
Photo 12: Asphalt Core Sample from Test Hole TH13-12

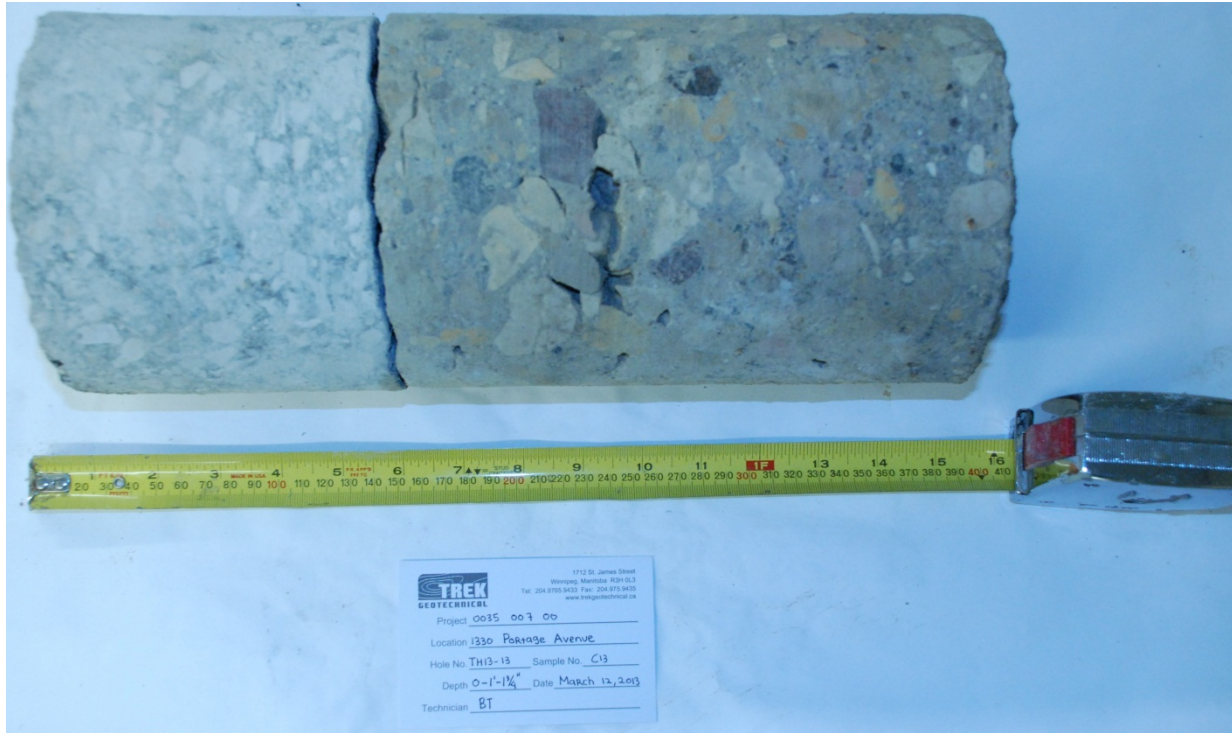
Photo 13: Asphalt and Concrete Core Sample from Test Hole TH13-13

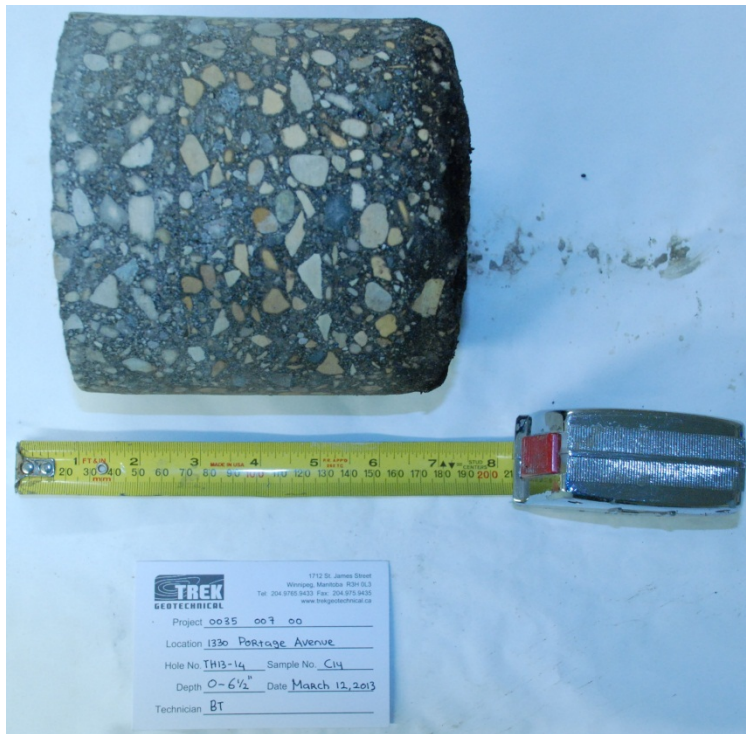
Photo 14: Asphalt Core Sample from Test Hole TH13-14

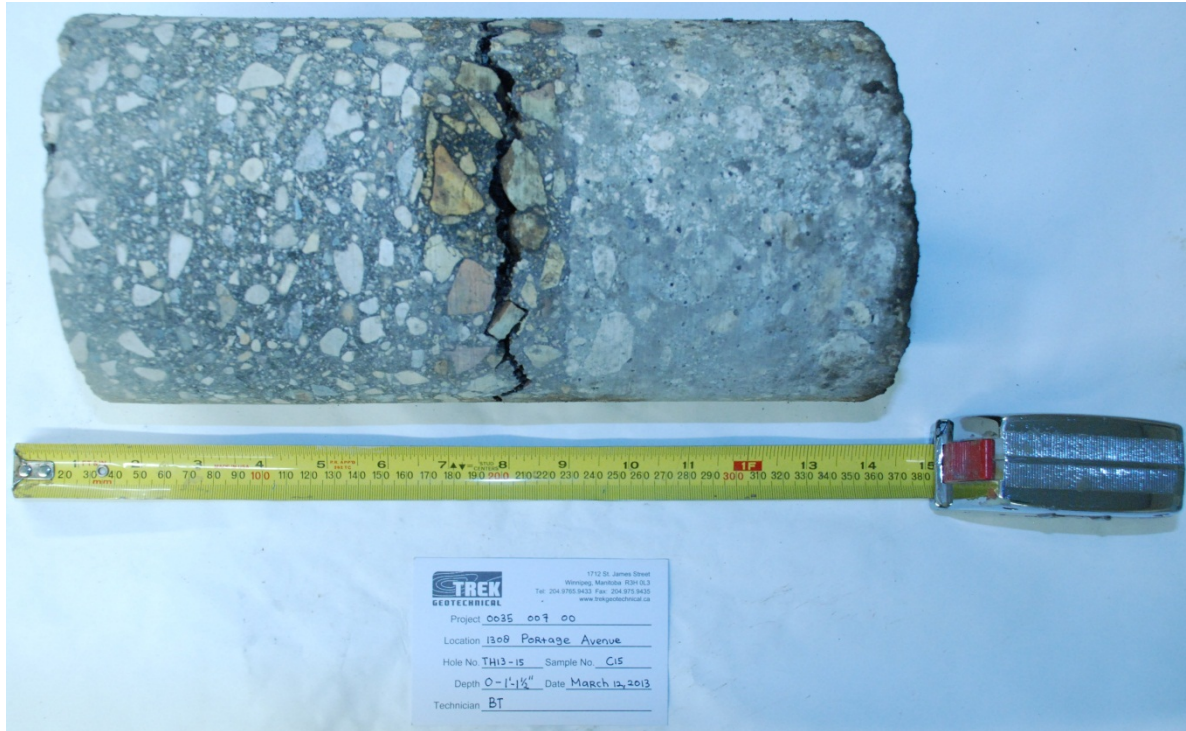
Photo 15: Asphalt and Concrete Core Sample from Test Hole TH13-15

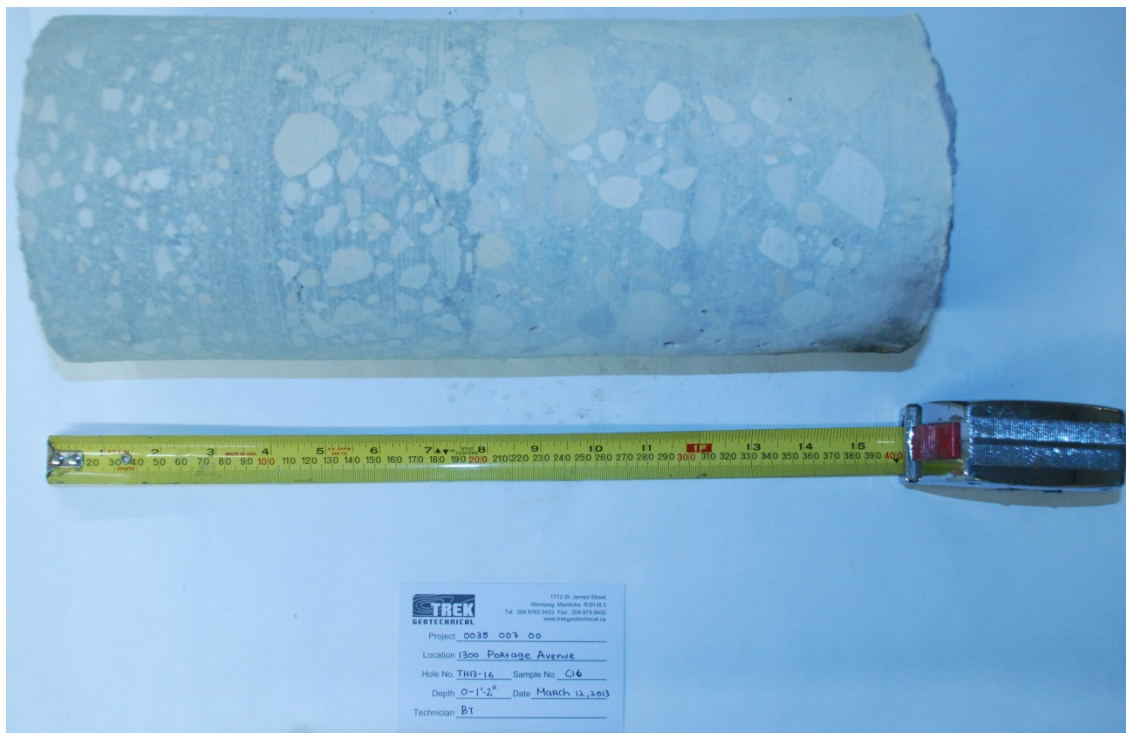
Photo 16: Asphalt and Concrete Core Sample from Test Hole TH13-16

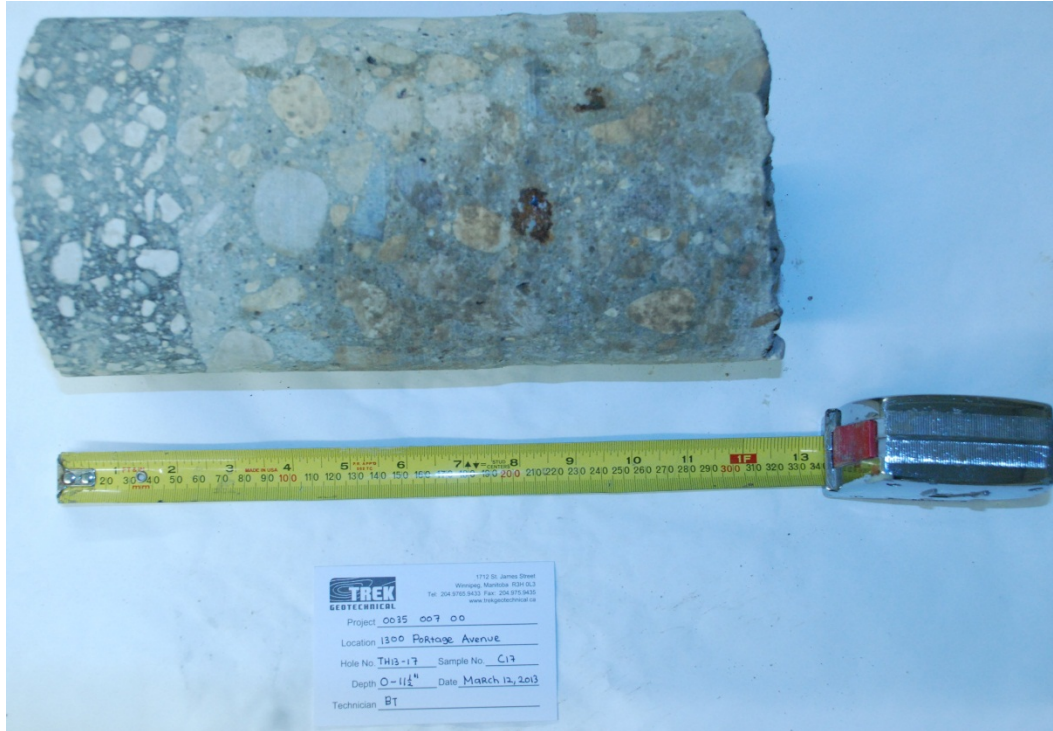
Photo 17: Asphalt and Concrete Core Sample from Test Hole TH13-17

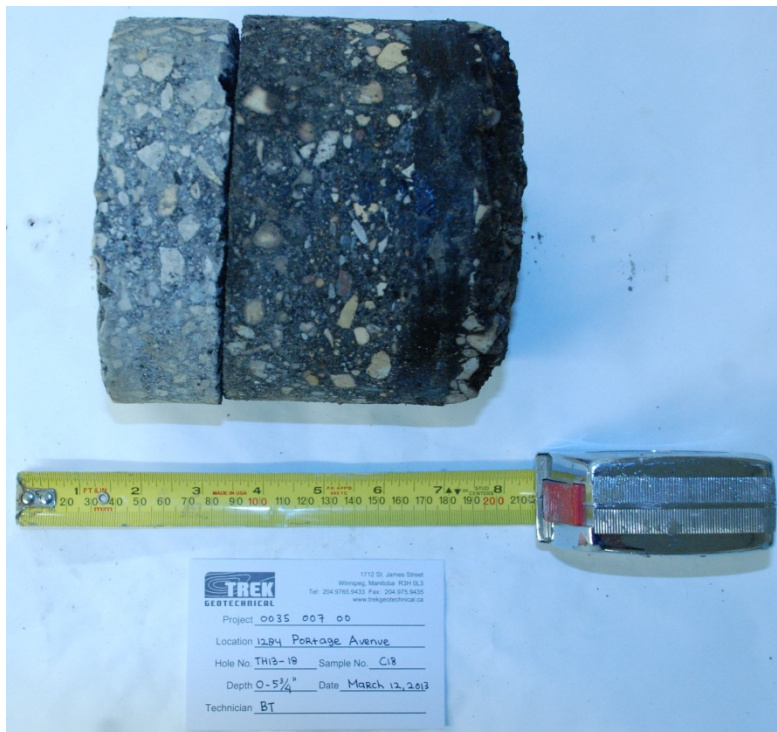
Photo 18: Asphalt Core Sample from Test Hole TH13-18

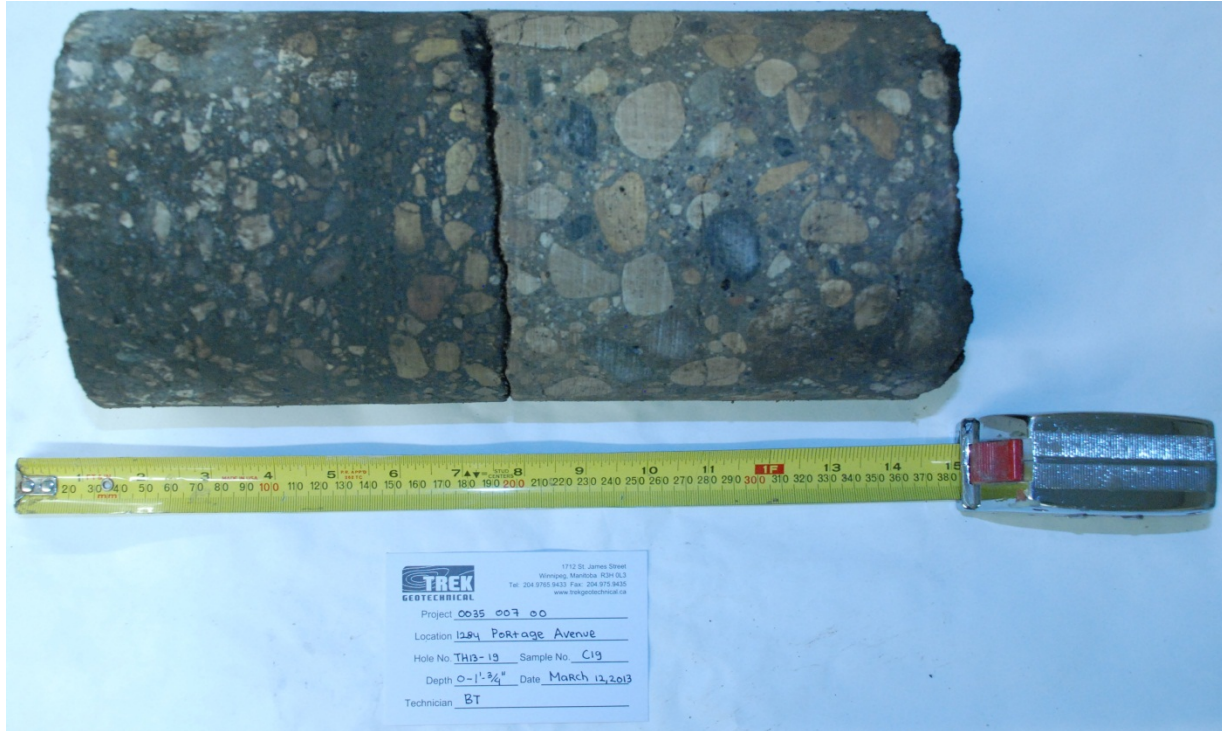
Photo 19: Asphalt and Concrete Core Sample from Test Hole TH13-19

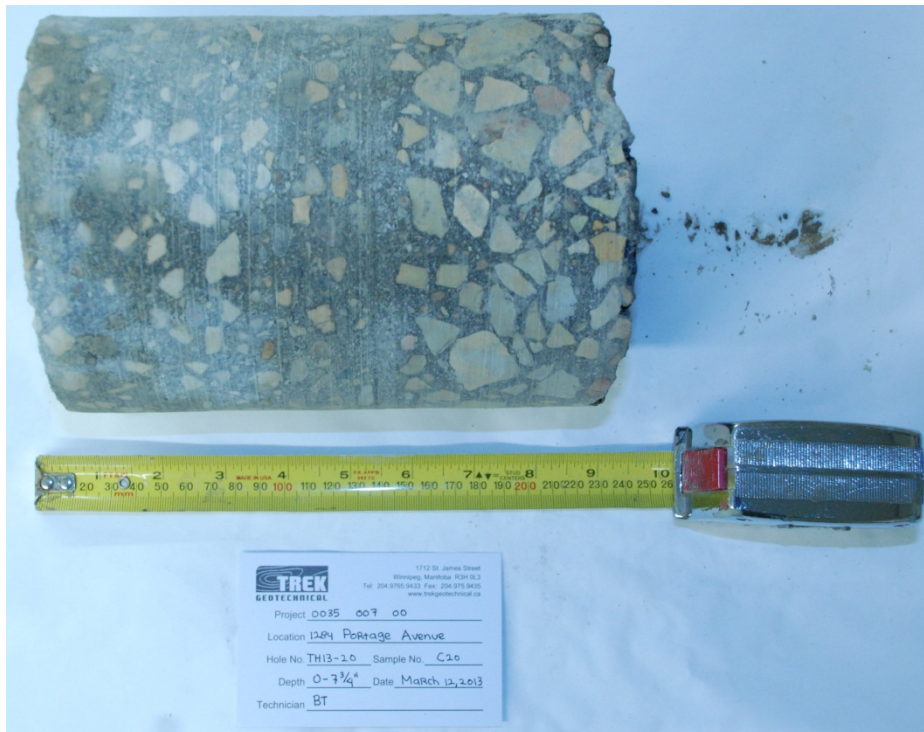
Photo 20: Asphalt Core Sample from Test Hole TH13-20

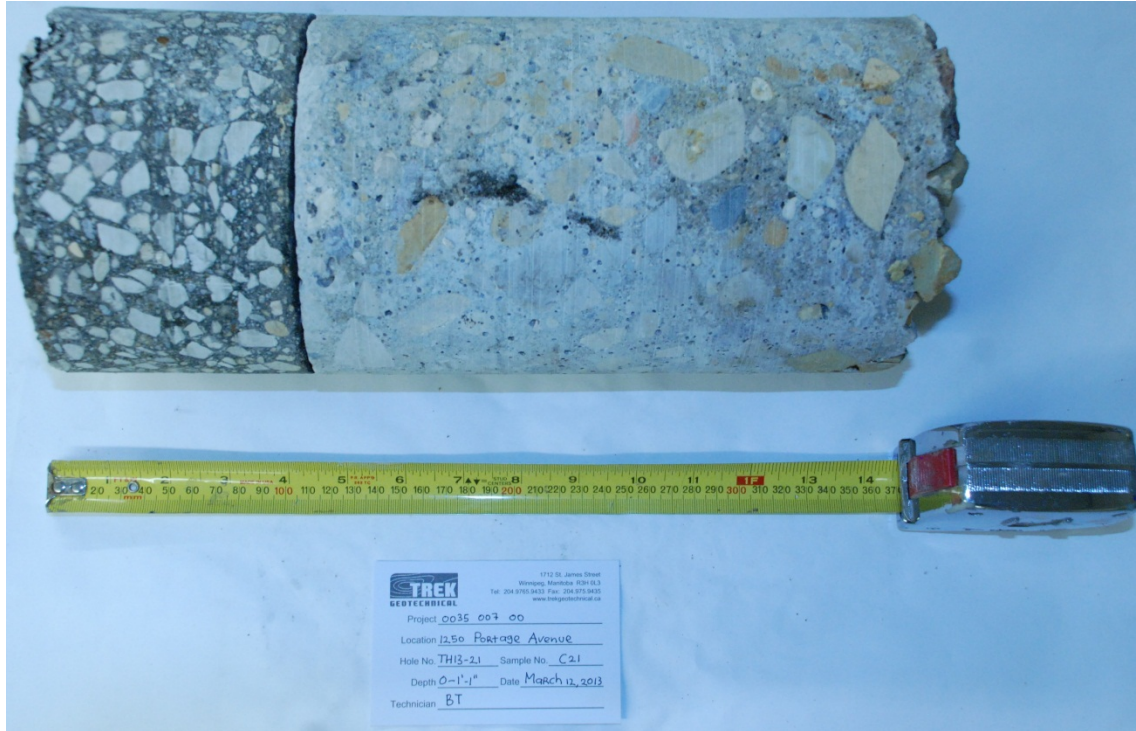
Photo 21: Asphalt and Concrete Core Sample from Test Hole TH13-21

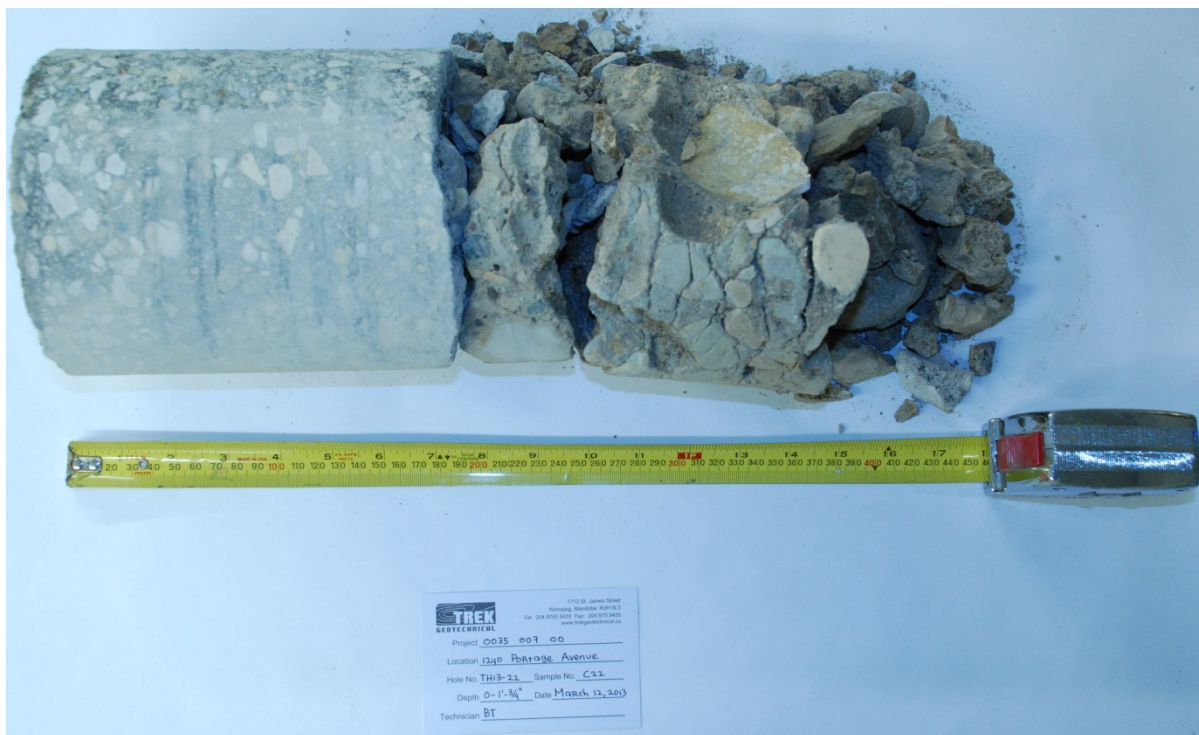
Photo 22: Asphalt and Concrete Core Sample from Test Hole TH13-22

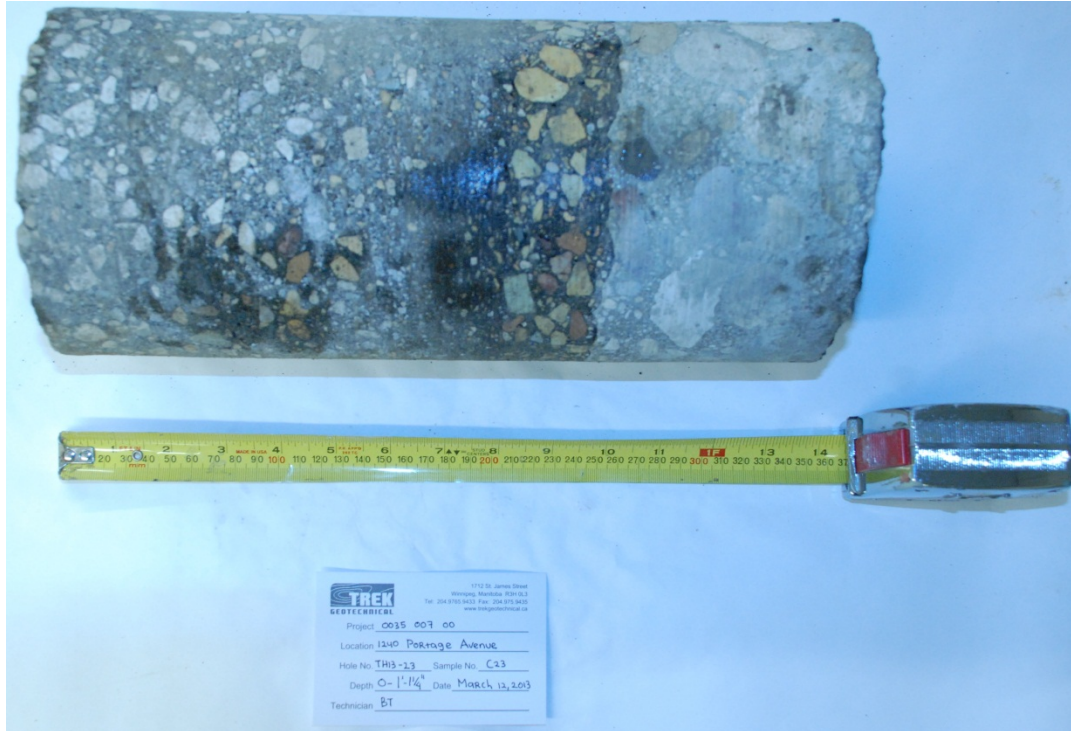
Photo 23: Asphalt and Concrete Core Sample from Test Hole TH13-23

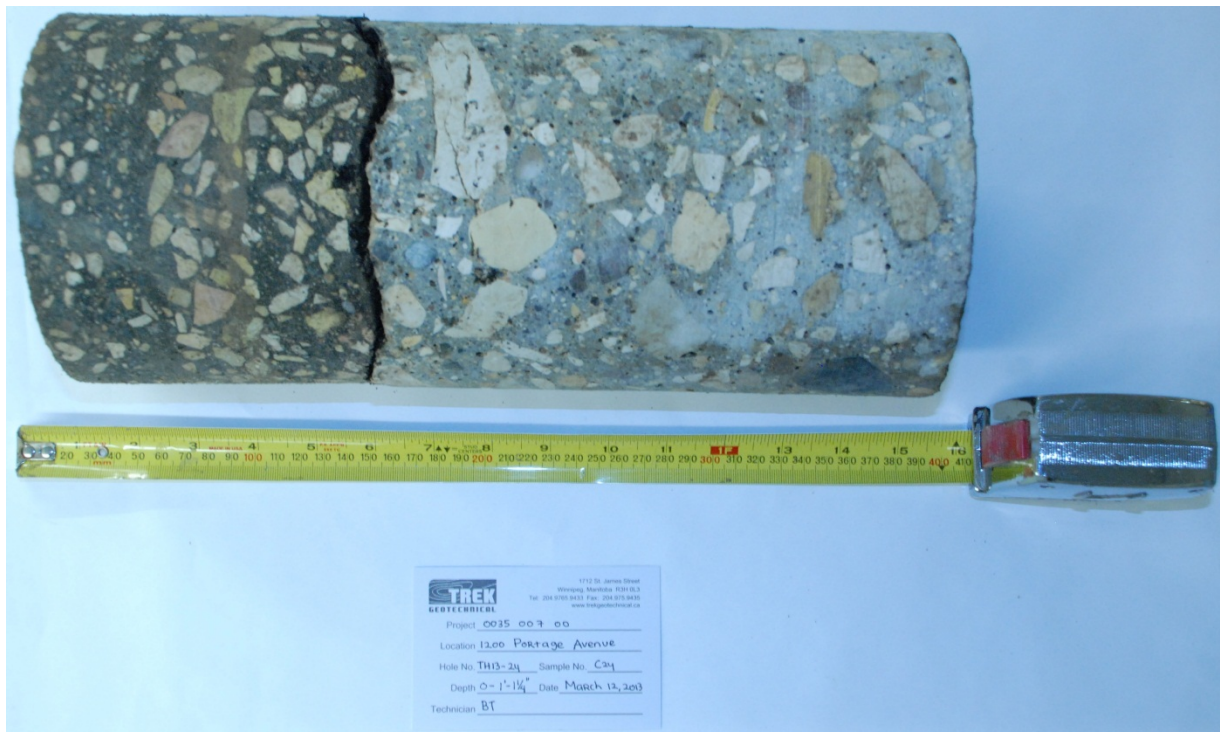
Photo 24: Asphalt and Concrete Core Sample from Test Hole TH13-24

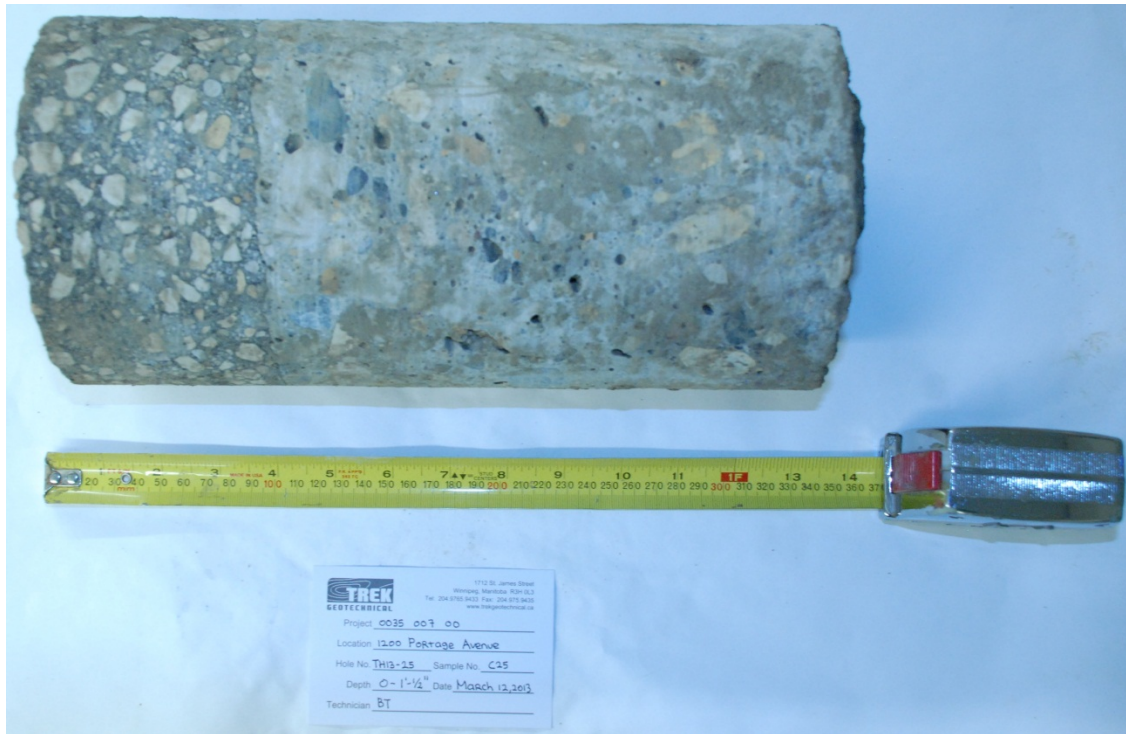
Photo 25: Asphalt and Concrete Core Sample from Test Hole TH13-25

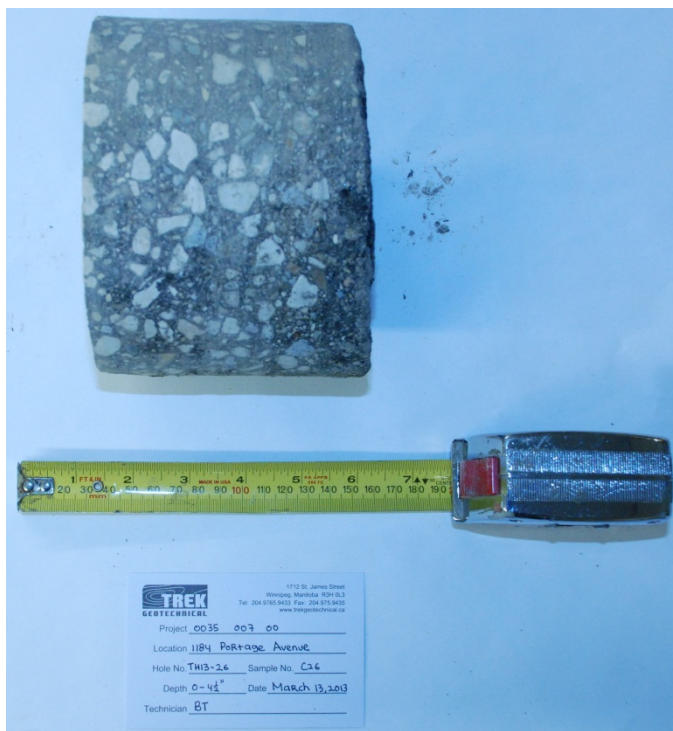
Photo 26: Asphalt Core Sample from Test Hole TH13-26

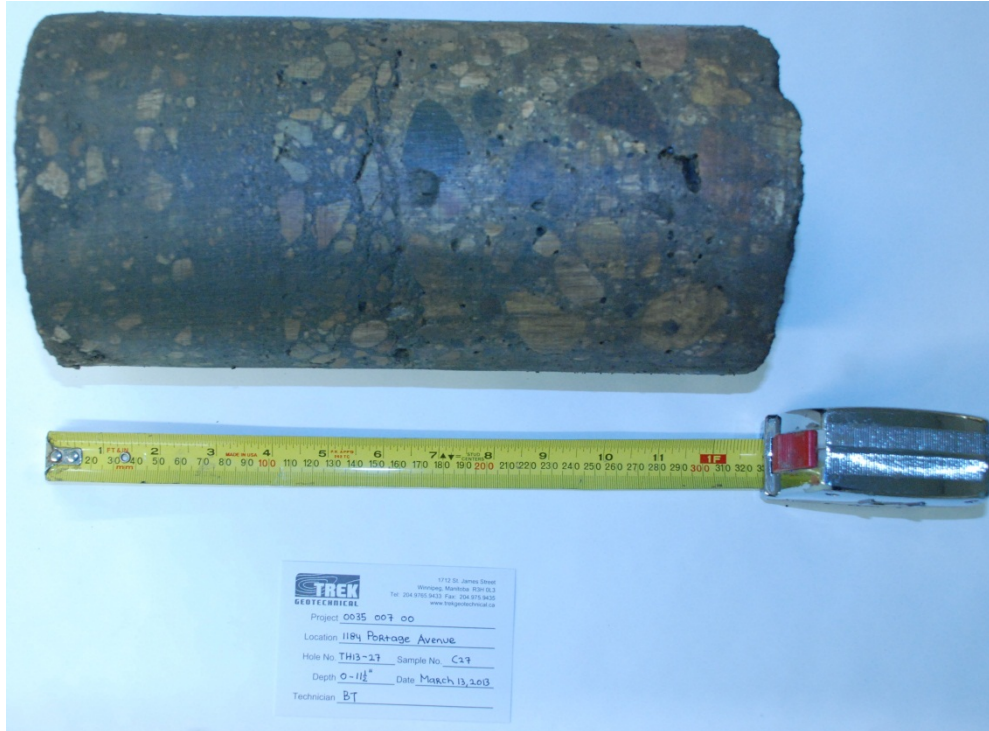
Photo 27: Asphalt and Concrete Core Sample from Test Hole TH13-27

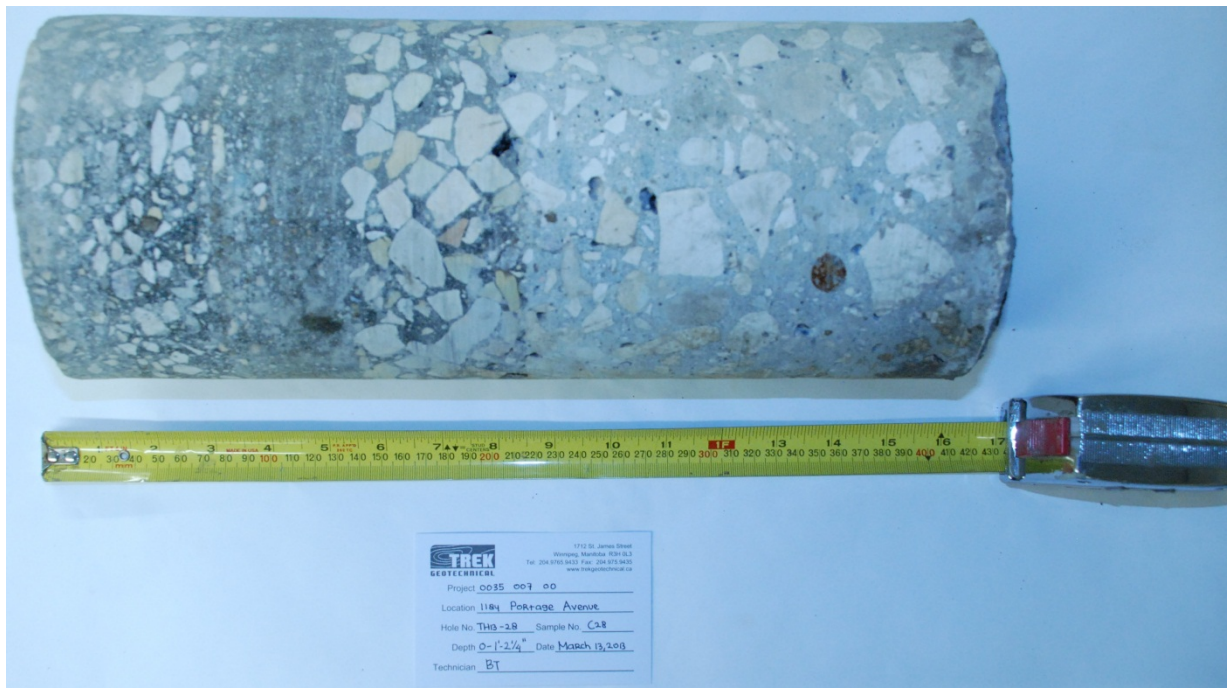
Photo 28: Asphalt and Concrete Core Sample from Test Hole TH13-28

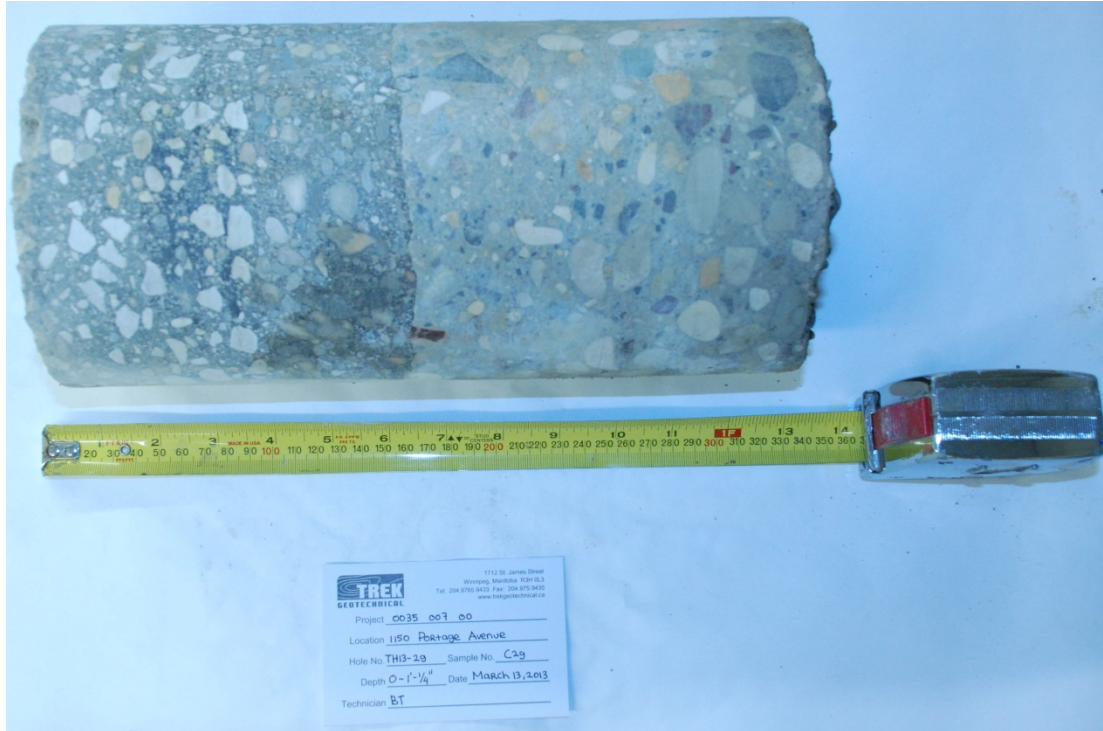
Photo 29: Asphalt and Concrete Core Sample from Test Hole TH13-29

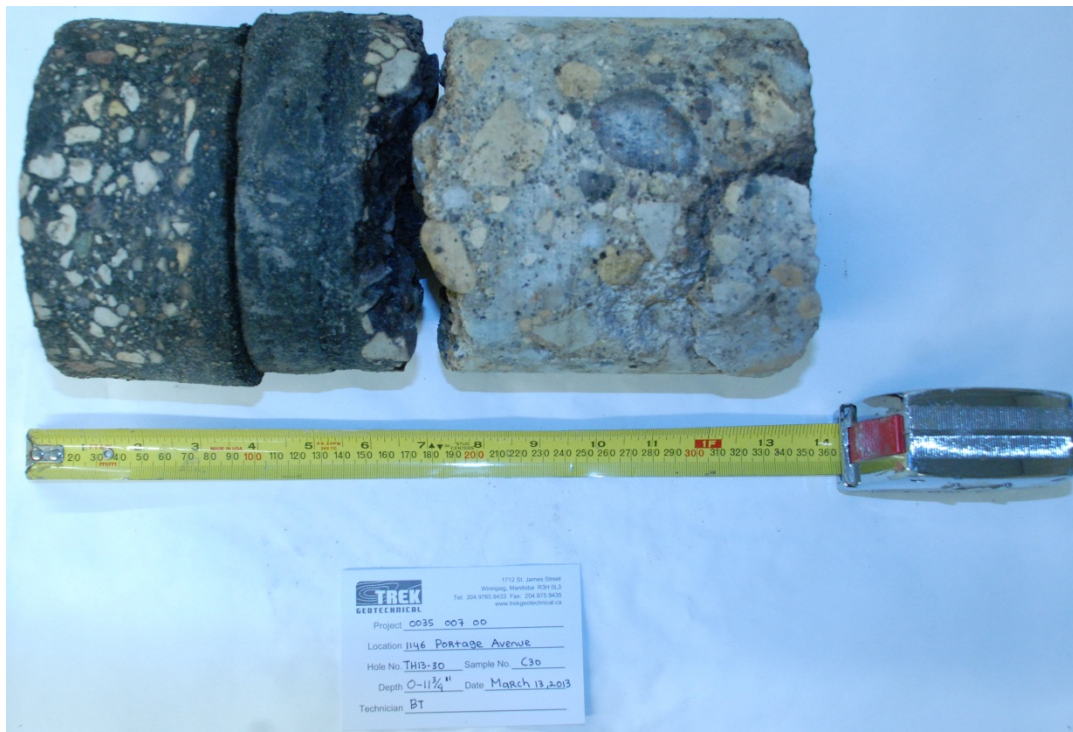
Photo 30: Asphalt and Concrete Core Sample from Test Hole TH13-30
