## **2013 City of Winnipeg Regional and Local Street Renewals – Portage Avenue Package (I3-C-03)**

**RE: Pavement Structure Investigation Report for  
2013 City of Winnipeg Regional and Local Street Renewals – Portage Ave Package**

TREK Geotechnical Inc. is pleased to submit our Report for the pavement structure investigation on Portage Avenue from St. John's Ambulance Way to Sherburn Avenue.

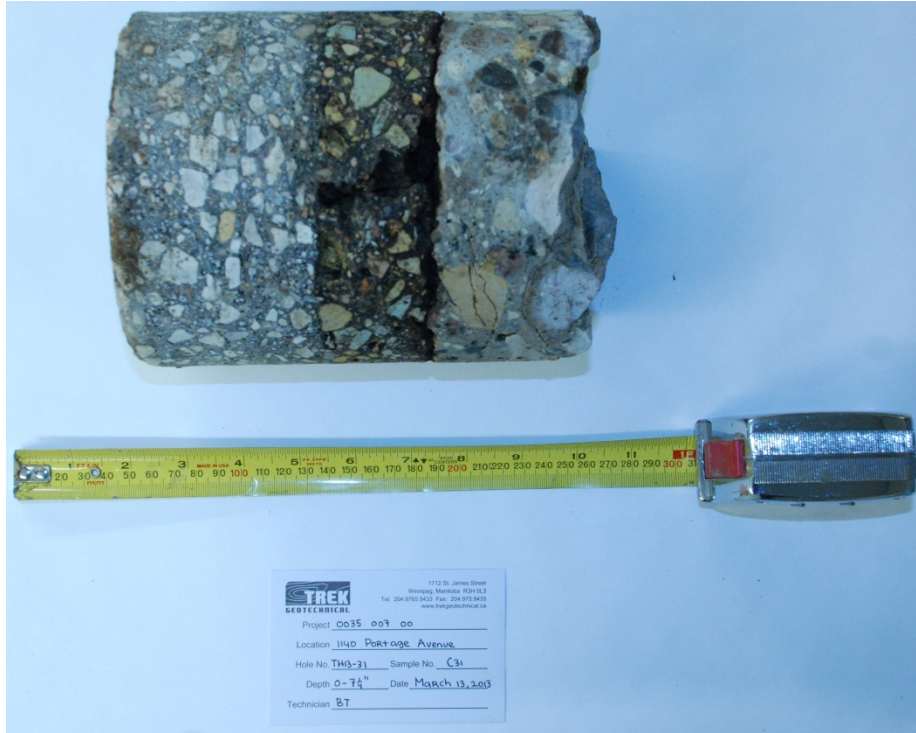
Photo 31: Asphalt and Concrete Core Sample from Test Hole TH13-31

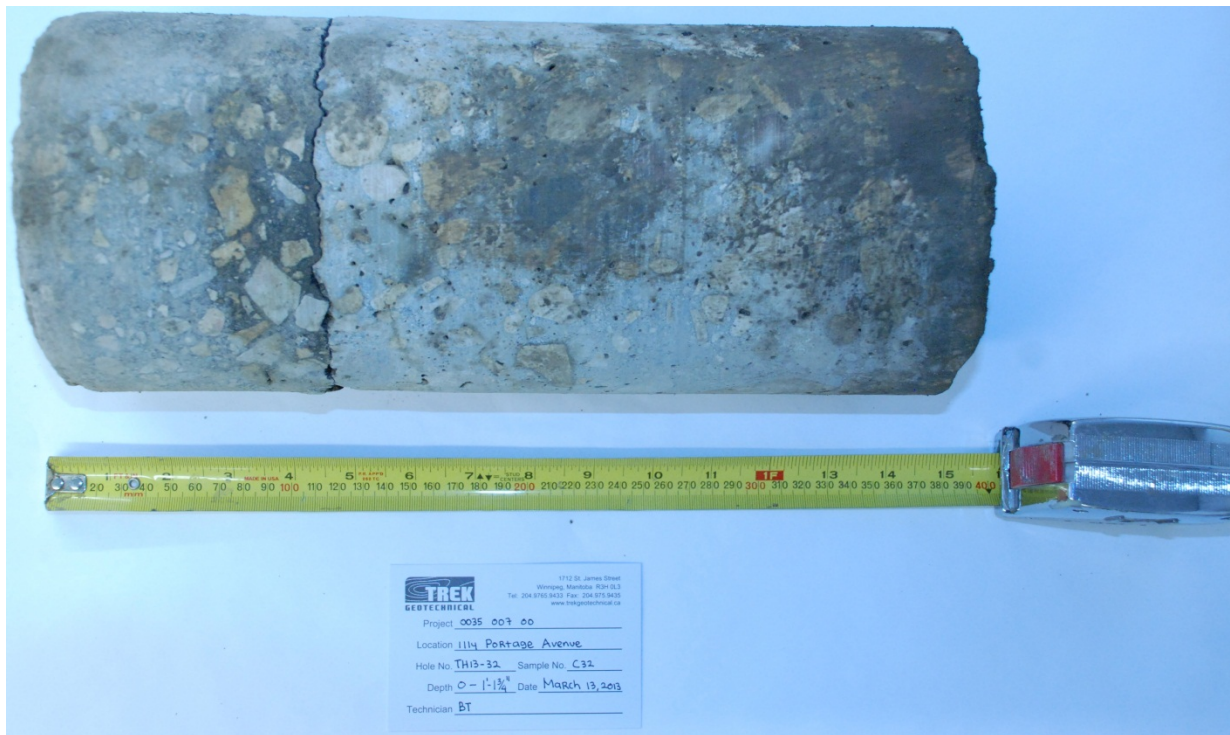
Photo 32: Asphalt and Concrete Core Sample from Test Hole TH13-32

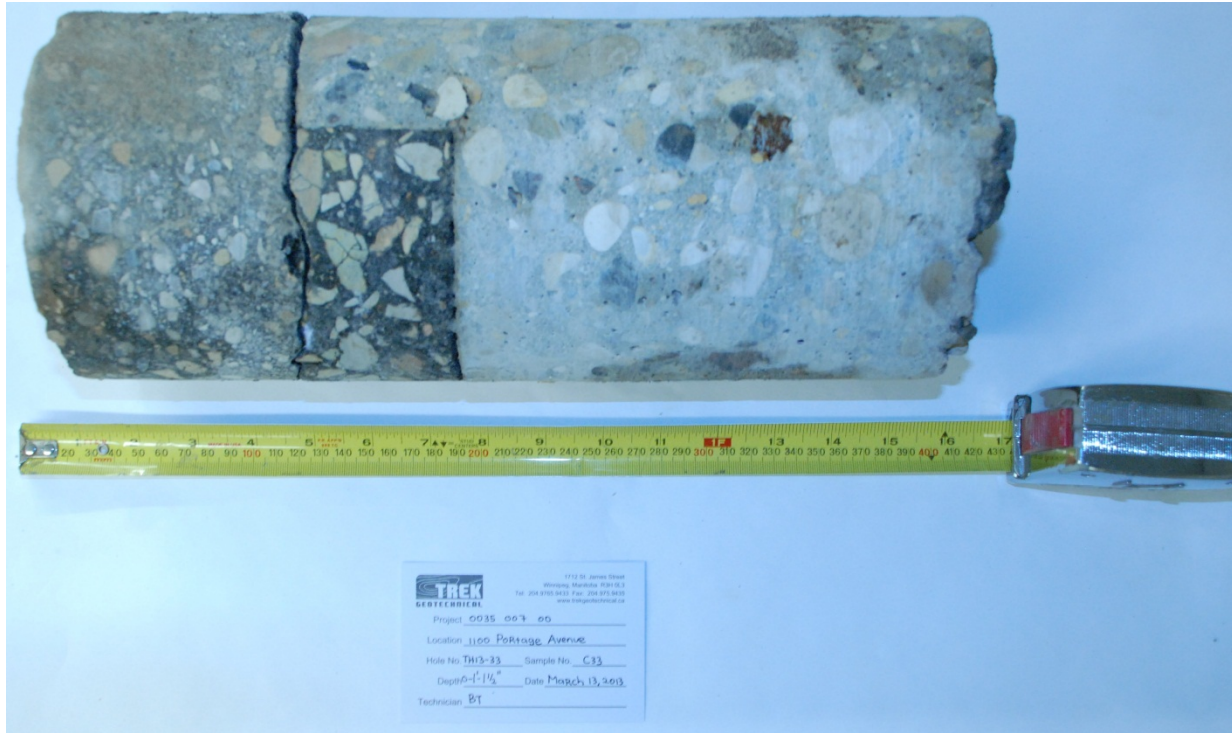
Photo 33: Asphalt and Concrete Core Sample from Test Hole TH13-33

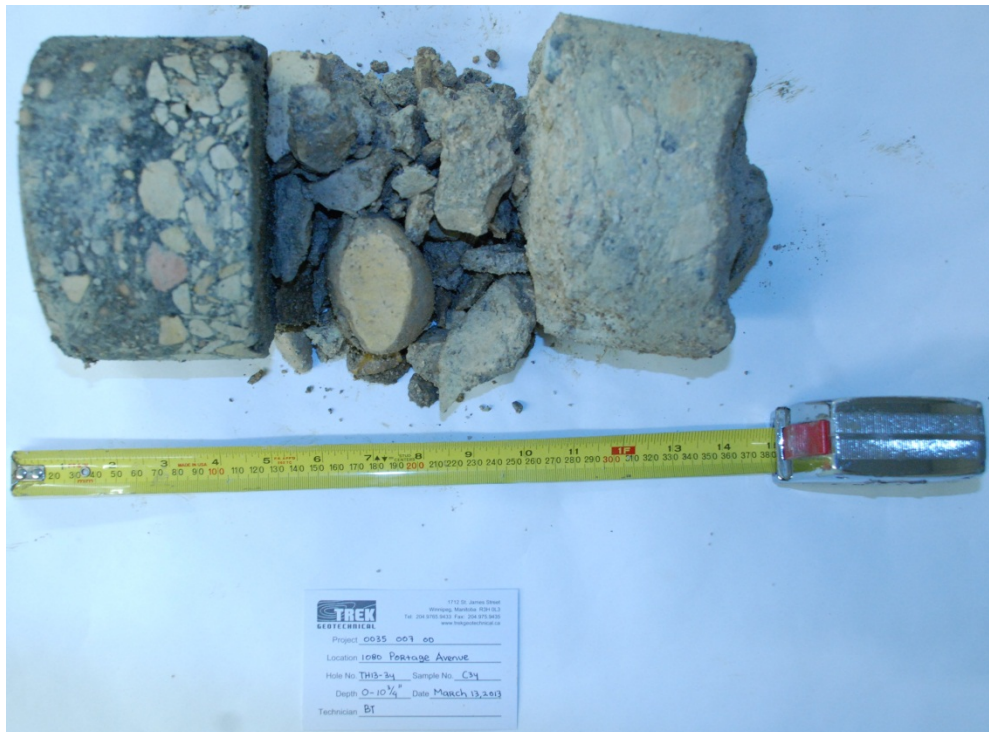
Photo 34: Asphalt and Concrete Core Sample from Test Hole TH13-34

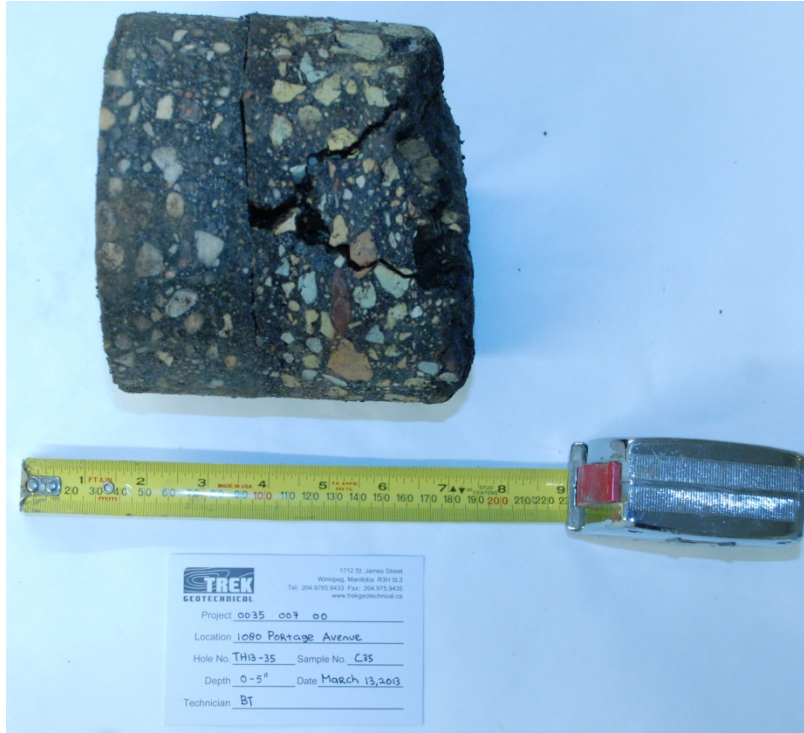
Photo 35: Asphalt Core Sample from Test Hole TH13-35

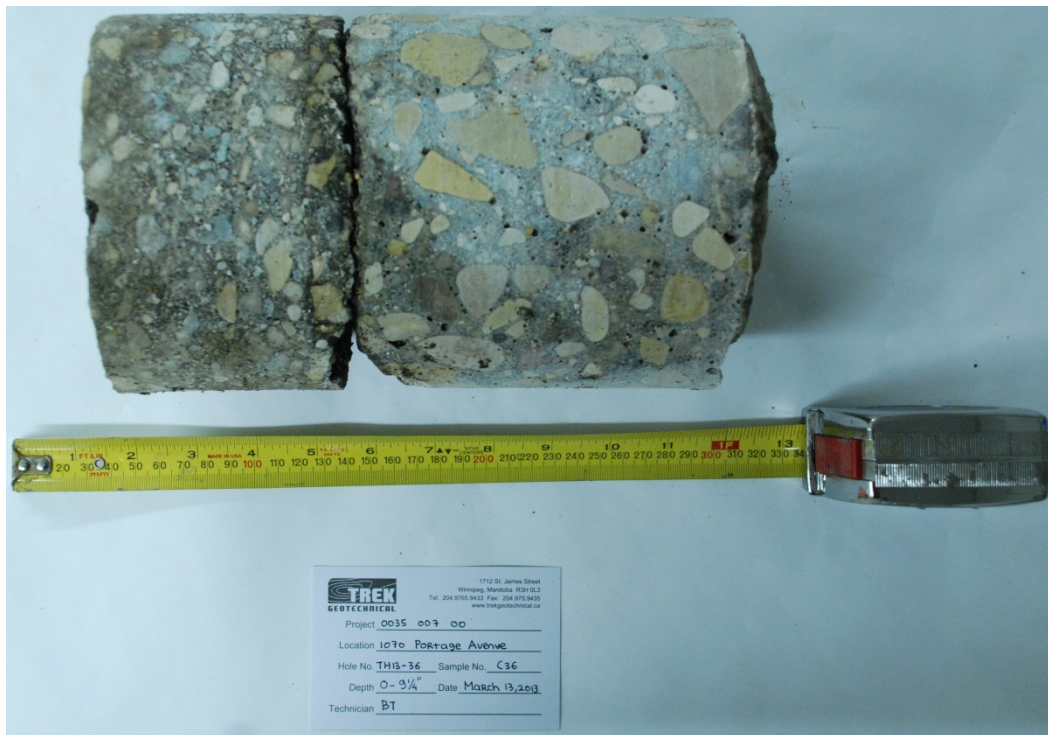
Photo 36: Asphalt and Concrete Core Sample from Test Hole TH13-36

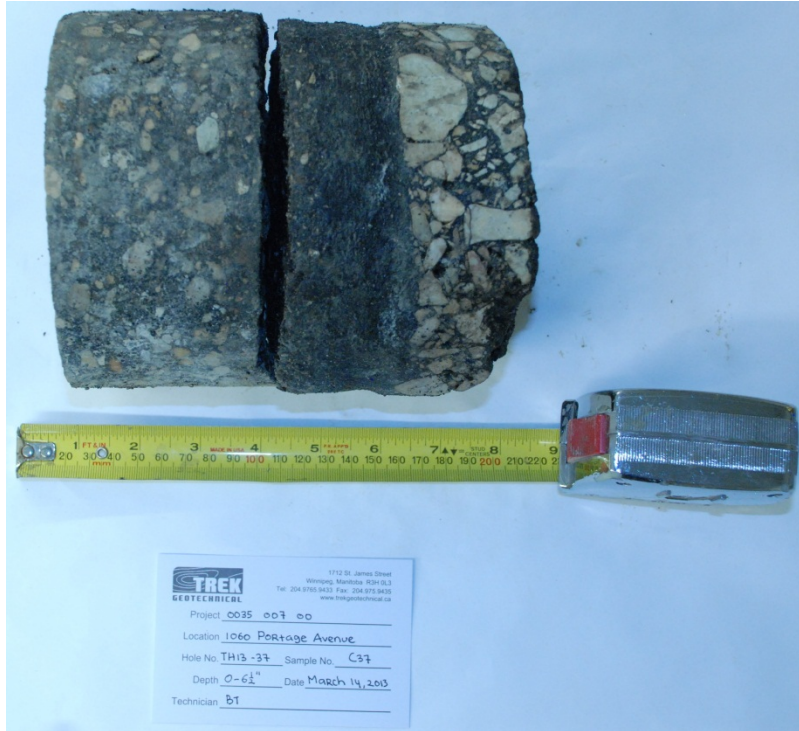
Photo 37: Asphalt and Concrete Core Sample from Test Hole TH13-37

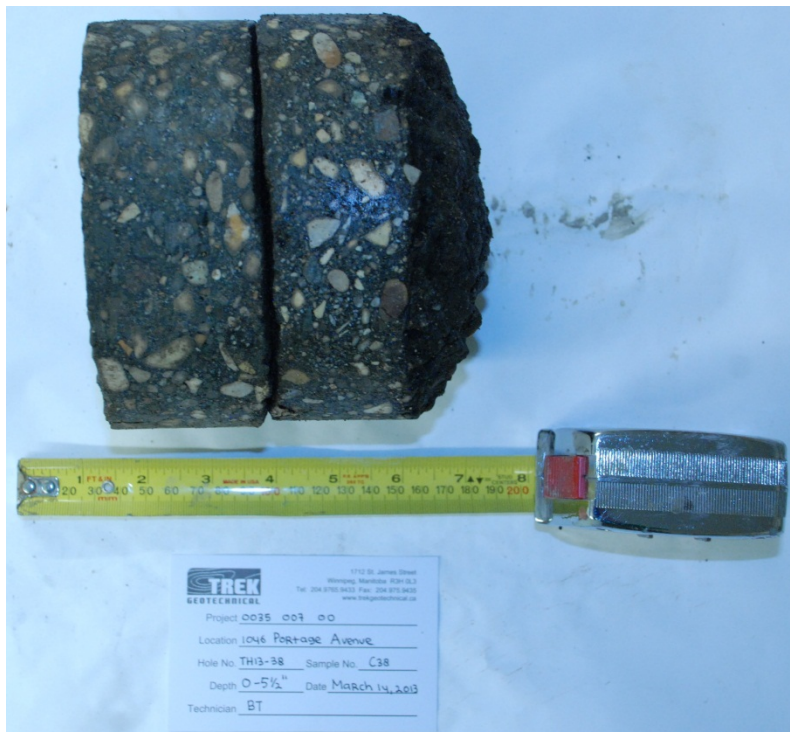
Photo 38: Asphalt Core Sample from Test Hole TH13-38

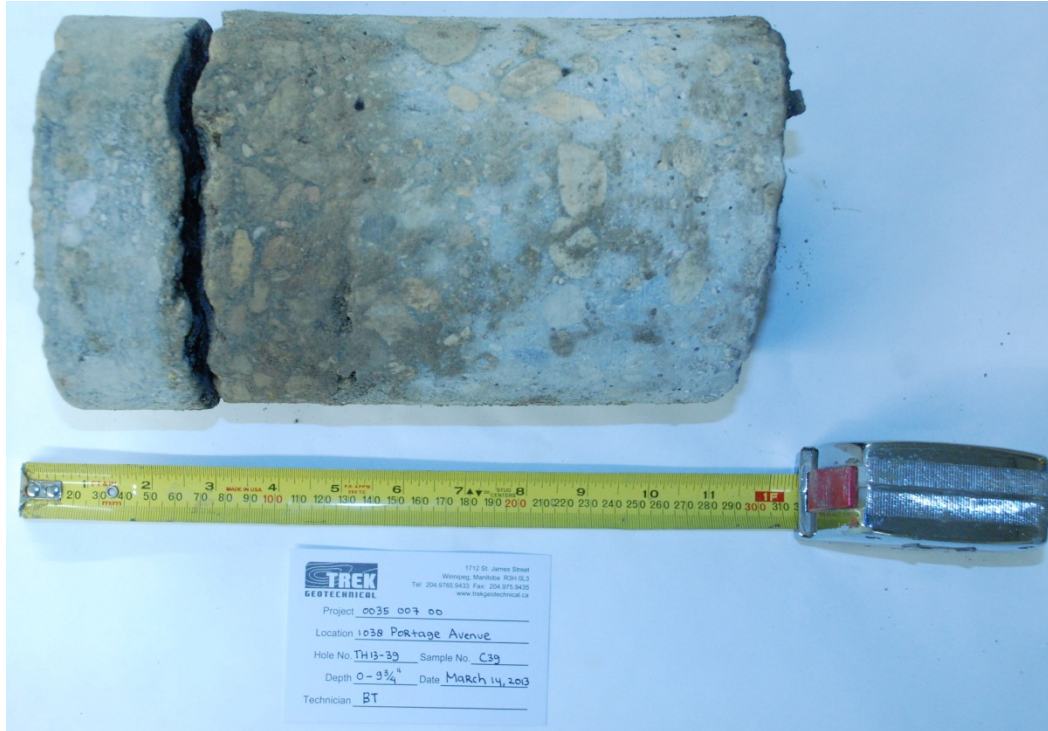
Photo 39: Asphalt and Concrete Core Sample from Test Hole TH13-39

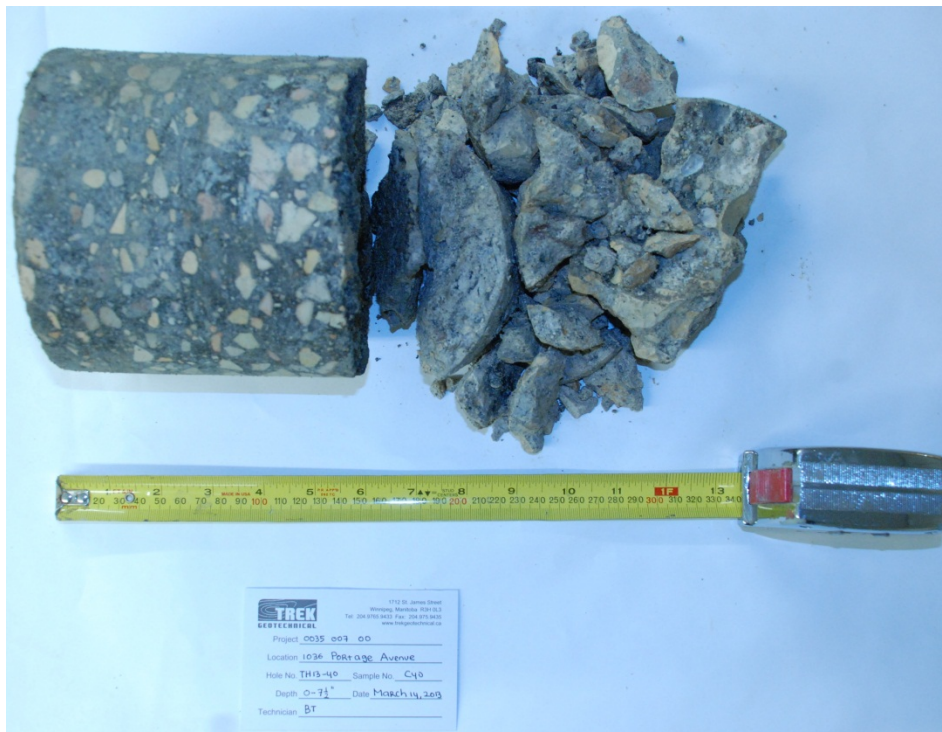
Photo 40: Asphalt and Concrete Core Sample from Test Hole TH13-40
