The City of Winnipeg RFP No. 408-2013

APPENDIX C – AUBREY WASTEWATER PUMPING STATION HOIST DEVICES AND LIFTING CAPACITIES REPORT

Station Name: Aubrey Lift Station

Date of Inspection: February 17, 2010

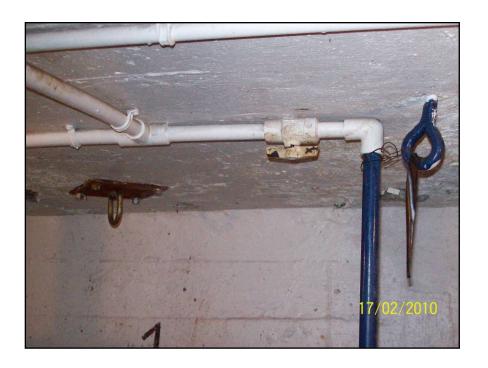
The analysis of the U-shaped hook, located in the fourth floor pump room, determined a capacity of 1.0 tons due to the bending of the plates. However due to the surface corrosion of the steel, a factor of safety of 2 must be applied, to yield a **load rating of 0.5 tons.**

<u>Photograph No. 1</u> Various hooks in the pump room

Ref.	Description	Priority
4.1	Paint U-shaped hooks to prevent further rusting.	В

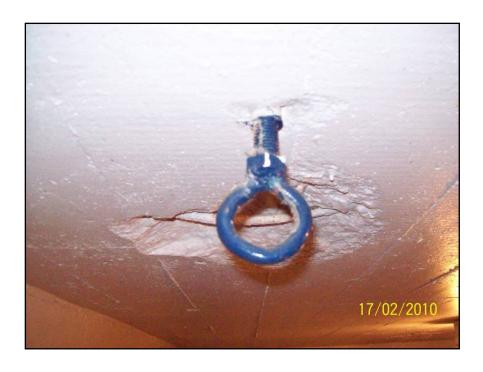
Photograph No. 2

The six (6) eye-shaped hooks, located in the third floor motor room and the fourth floor pump room, were analyzed for pullout resistance of the embedment and tension resistance of the hook. A thickness of 200mm for the cast-in-place concrete floor and an embedment length of 150mm were used. The pullout resistance was the governing factor in the hooks, which was calculated to be 3.5 tons per hook. However, it is recommended that an additional factor of safety of 3.5 be applied to the hooks, to yield a load rating of 1.0 ton.

Cast-in-place concrete deteriorated near one of the eyeshaped hooks

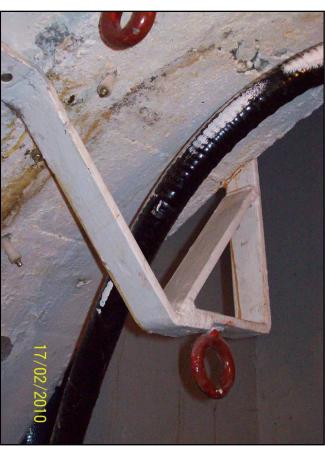
The bracket hook, located in the third floor motor room, was analyzed for tensile resistance of the hook, pullout of the floor anchor bolts, shear resistance of the wall anchor bolts, and the shear resistance of the bracket. The pullout resistance was the governing factor in the hook, which was calculated to be 3.3 tons. However, due to the surface corrosion and the unconventional bracket design, a factor of safety of 3.3 was applied, to yield a **load rating of 1.0 ton.**

<u>Photograph No. 3</u> Motor room bracket hook

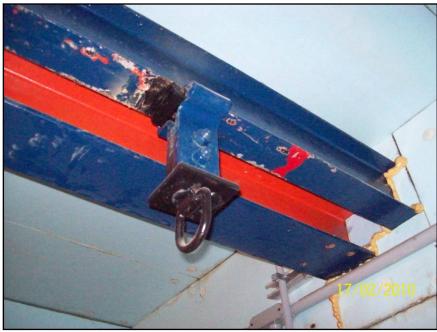
The main floor has two (2) steel lifting beams are beam approximately 2400mm above the top of main floor spanning approximately 3120mm. One (1) lifting beam is an S150x19 steel beam. A sliding steel beam clamp is bolted onto the bottom flange of the lifting beam. The other lifting beam is a W150x22 steel beam. Sliding steel beam clamps are bolted onto the bottom flange of the reference lifting beams. The lifting beam support connections were unable to be observed due to wall insulation.

Both beams on the main floor were analyzed for bending resistance. Bending resistance in the S-beam was determined to be 3.0 tons, and the W-Beam was determined to be 4.8 tons. This capacity was reduced by factors of 3.0 and 3.2 respectively, due to unknown wall connections to yield a **load rating** of 1.0 tons for the S150x19 beam and 1.5 tons for the W150x22 beam.

<u>Photograph No.4</u> Side by side lifting beams on the main floor
