Crosier Kilgour & Partners Ltd.

June 21, 2013

Our File No. 2013-0588

**Re: 550 Dale Blvd.
Westdale Pool Investigation**

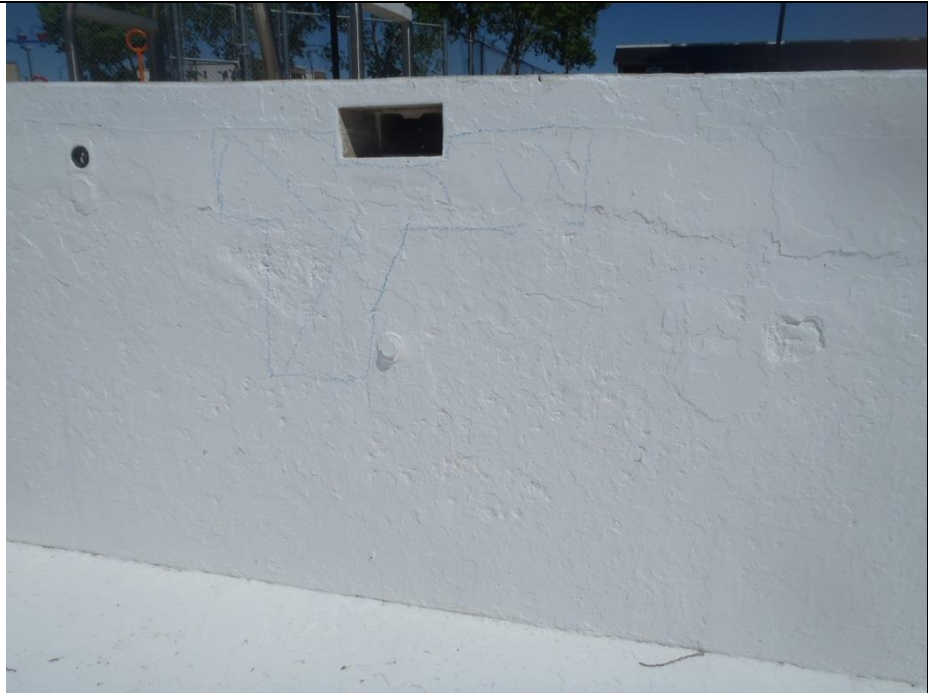
- The walls of the pool only showed signs of delamination along what would be the normal water line. See Photograph #1. The north wall had 6 locations of repair totaling +/- 45 square feet.

- The south wall had 7 locations of delamination totaling +/- 20 square feet and 3 locations on the west wall totaling 7 +/- square feet. This totals 72 square feet of repair area minimum 3 inches deep.

Photograph #1:
Delaminated area (blue
chalk outline) on pool wall.

To summarize, the structural condition of the pool was generally good. However, there is visual evidence of cumulative freeze-thaw deterioration. Concrete repairs are clearly required along the tank bottom, walls, and deck. Normally when estimating these types of repairs we allow a 15 – 20% increase in the area due to growth caused by corroded reinforcing and or concrete that was not yet sounding delaminated. The approximate costs for this type of repair are \$150.00 per square foot and would include accessing the area (i.e. scaffold) saw-cutting the perimeter, hammer excavating the deteriorated material to a sound substrate, surface preparation (sandblasting), forming, and infilling. Thus, present areas exhibiting delamination would be removed and infilled with repair mortar.

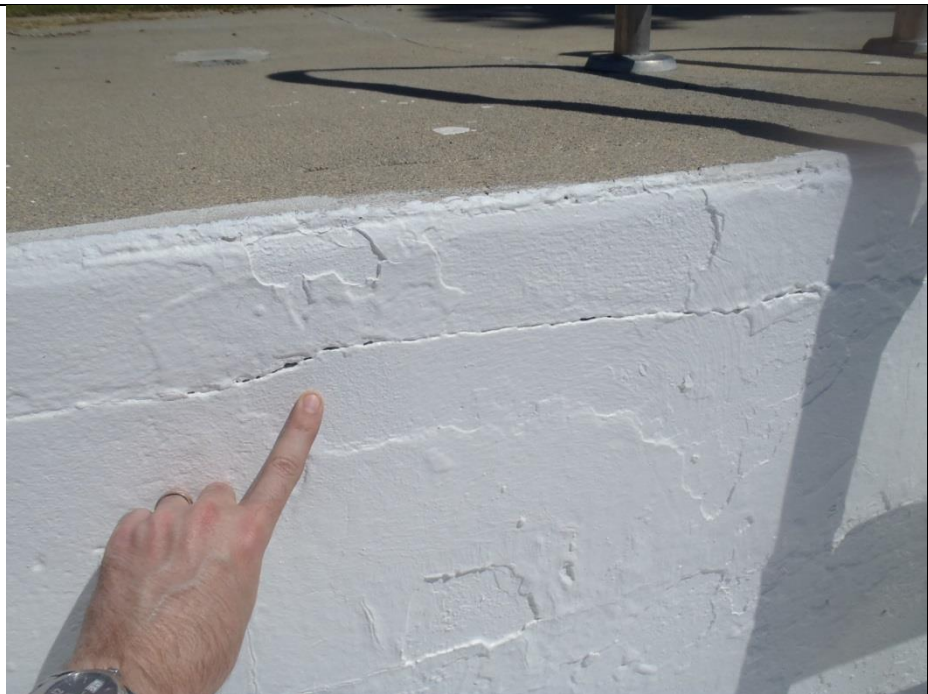
- The "Pour Joint" between the pool deck and the top of the pool wall has separated around the pools perimeter, see Photograph #2. The concrete itself appears to be sound, which would suggest that a system of stitching the two surfaces back together with dowels and epoxy may be a logical repair method.

The continuous “crack” at the deck slab/pool wall interface appears to be a failed cold joint, versus a delamination plane. Thus, it does not appear that removal and replacement is warranted. Rather, we would dowel the sections together and inject the gap with structural grade epoxy to re-connect the two concrete sections. The separation or joint is sealed on both sides with epoxy paste and injection ports are placed on the exterior crack at regular intervals.

Photograph #2:
Pour line separation
between deck and pool
wall.

Holes are drilled at regular intervals intersecting the deck and wall and steel reinforcing dowels are epoxy grouted into the drill holes.

Once the surface seal has cured, liquid epoxy resin is injected into the ports and allowed to travel from port to port indicating that the entire gap is filled and the two surfaces are bonded together. After the epoxy injection resin is cured the exterior seal would be removed by grinding to the original concrete surface. The approximate costs for this style of repair including access would be \$85.00 per lineal foot.

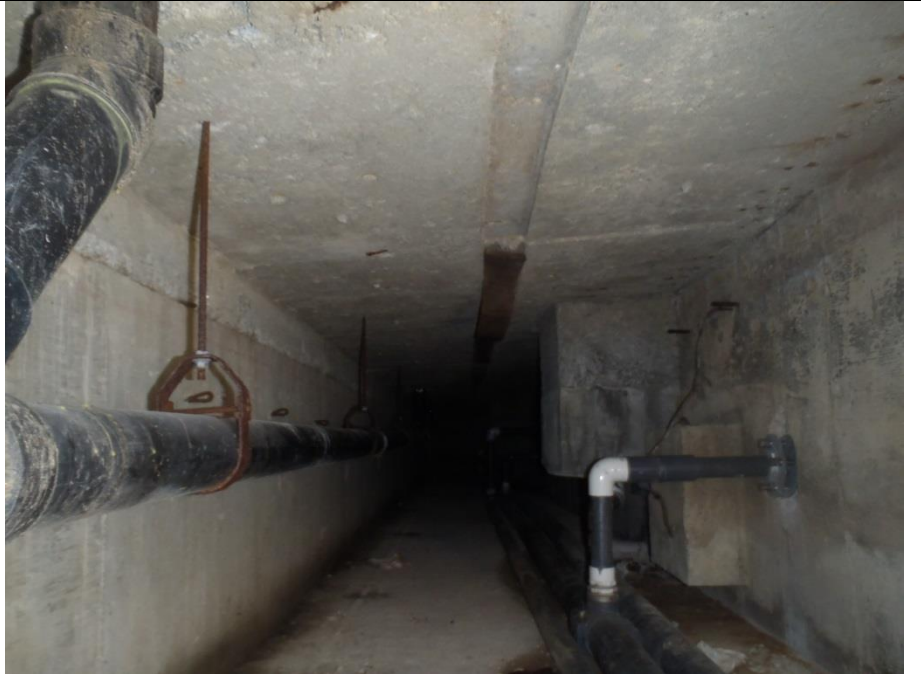
- The pool mechanical tunnel walls, ceiling and floor are in generally good condition. No significant evidence of differential movement are indicated.
- The outside tunnel wall and concrete deck soffit were observed to have no signs of concrete deterioration or evidence of leaking. There was no delamination or cracking observed in the outside wall and soffit. (Refer to Photograph #3).

Photograph #3:
Mechanical tunnel – outside
wall on left.

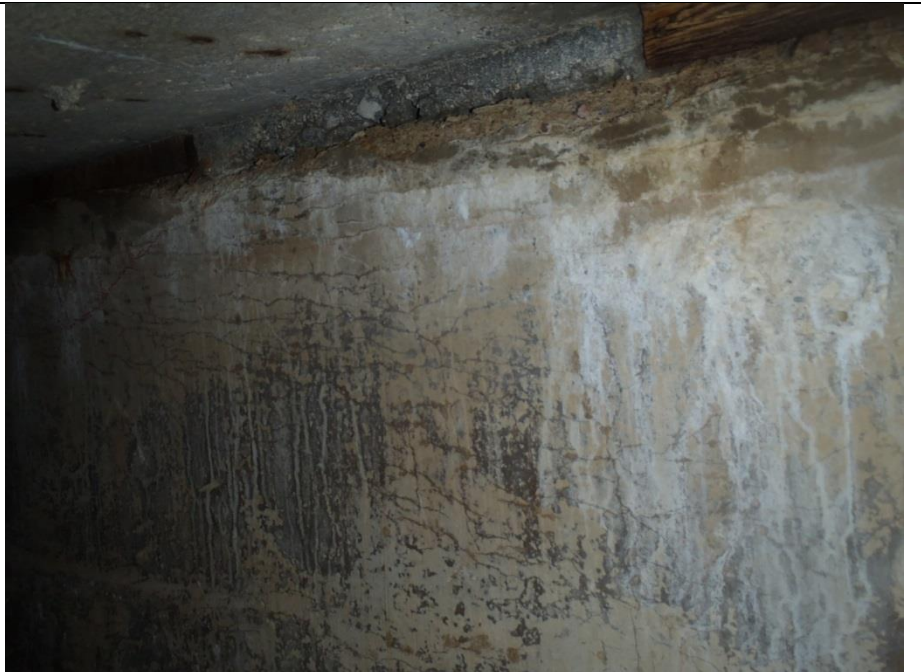
- The inside tunnel wall was also observed to be in generally good condition, however it was typical to observe evidence of water leaking known as efflorescence at most locations where a concrete block-out contains a pool scupper or a pool jet line, and at locations of pipe intrusions into the concrete wall. Also in several locations, efflorescence was observed coming from the top of the wall at the pour line, where the top deck is cast on top of the inner wall.

- It was also typical to observe concrete deterioration that appeared to be caused by continued freeze/thaw cycles of the wall structure at the edge of the pour line around the entire perimeter of the pool; refer to photograph #4. There was only one area of delamination noted (+/- 2.0 ft²) and it is located in the middle of the North wall at the top of the wall directly under the pour line. The freeze/thaw deteriorated area when hammer tested appeared to be sound for the present.

Photograph #4:
Mechanical tunnel – pool
wall – efflorescence and
freeze/thaw cracking.

Regarding repairs, the tunnel walls presently do not require any significant structural intervention. However, there is clearly evidence of freeze-thaw related deterioration to the walls which will continue to progress. Given the visual indicators, one would assume that repairs may be required to the tunnel walls in the next 5 to 10 years. This repair would be quite extensive because the top 12 -18 inches (approx.) of the supporting wall for the deck would be completely removed and would be completed in sections to maintain the support of the deck structure. An approximate cost for this repair would be \$500.00 to \$700.00 per lineal foot considering the extent of the repair and future costs.

The multiple coating layers are entrapping moisture in the swing-seasons and aggravating freeze-thaw deterioration. We therefore recommend that consideration be given to blasting the concrete to remove residual coatings followed by supply and installation of a new coating system.
