SODIUM HYDROXIDE TANK S320A INSPECTION

City of Winnipeg WTP

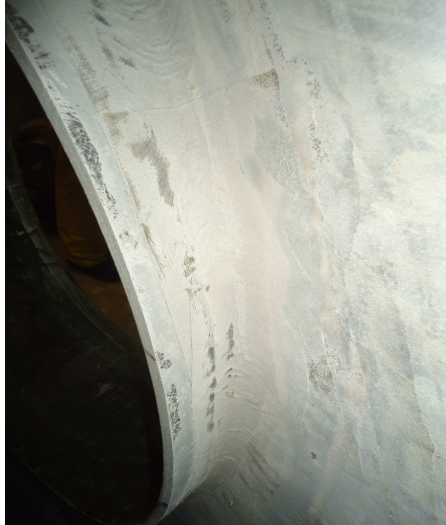
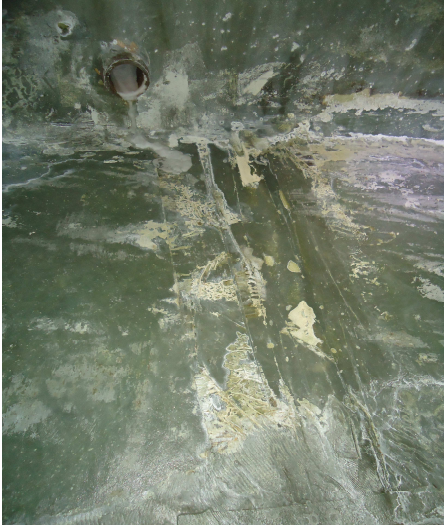
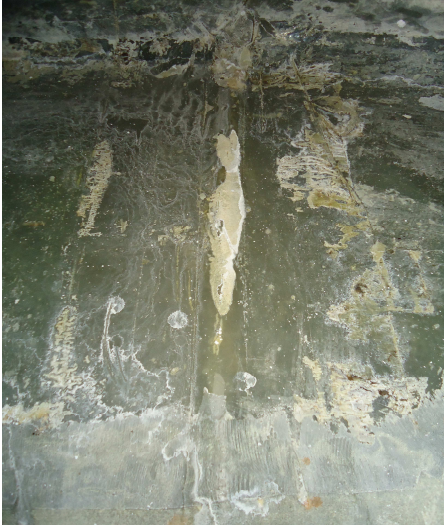
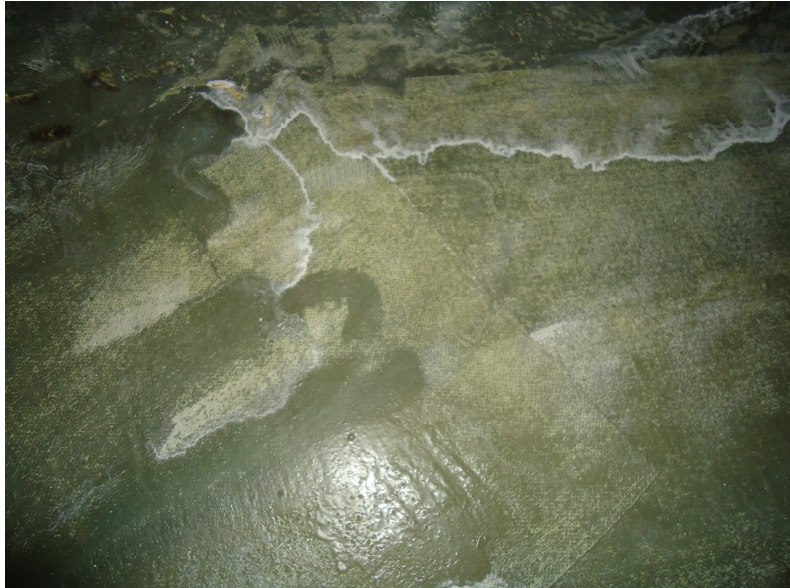
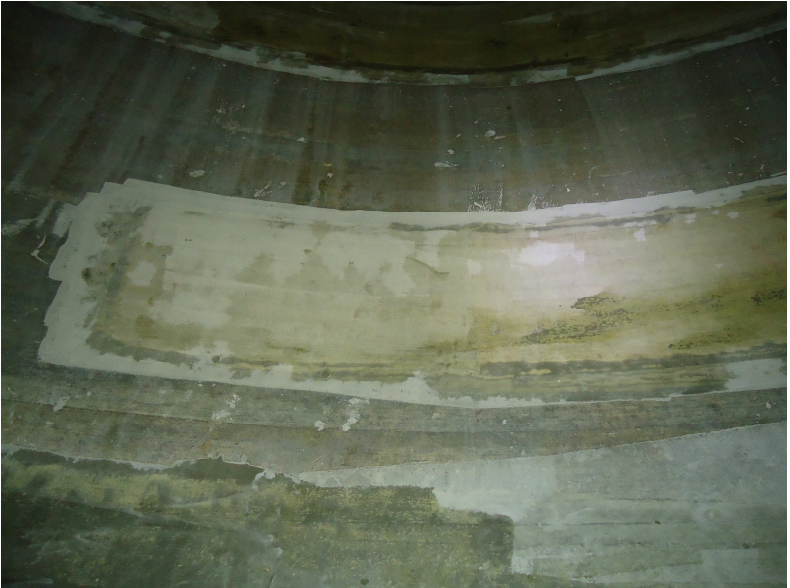
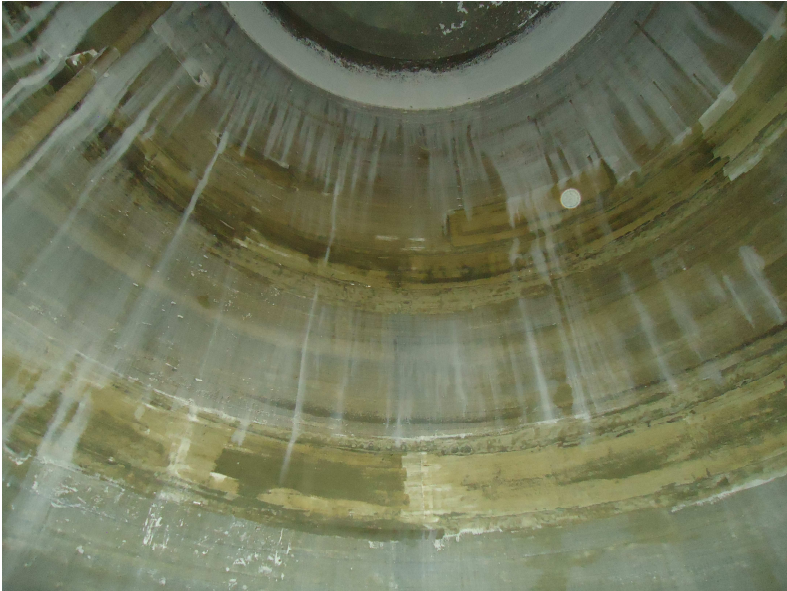
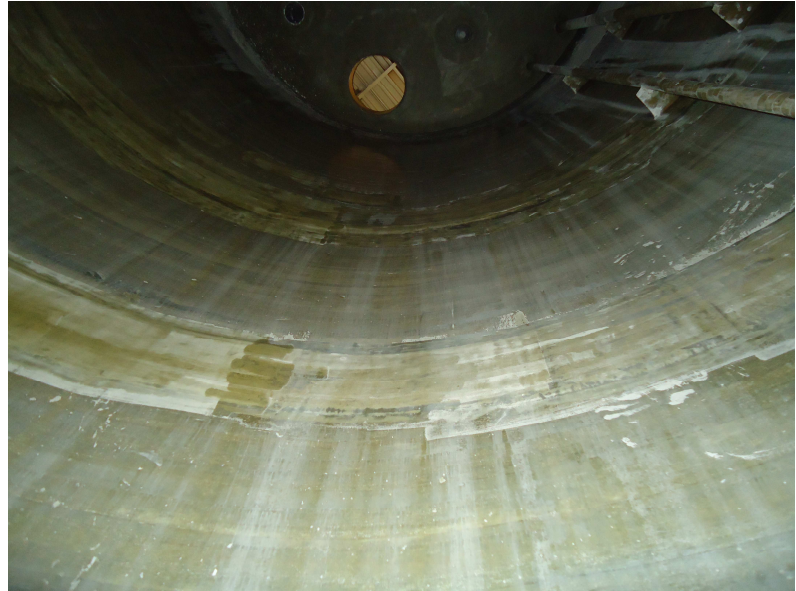
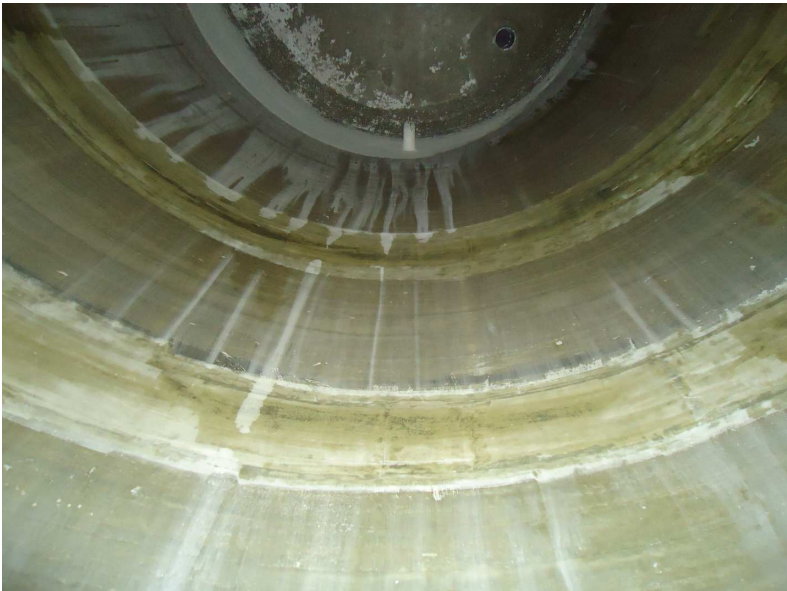
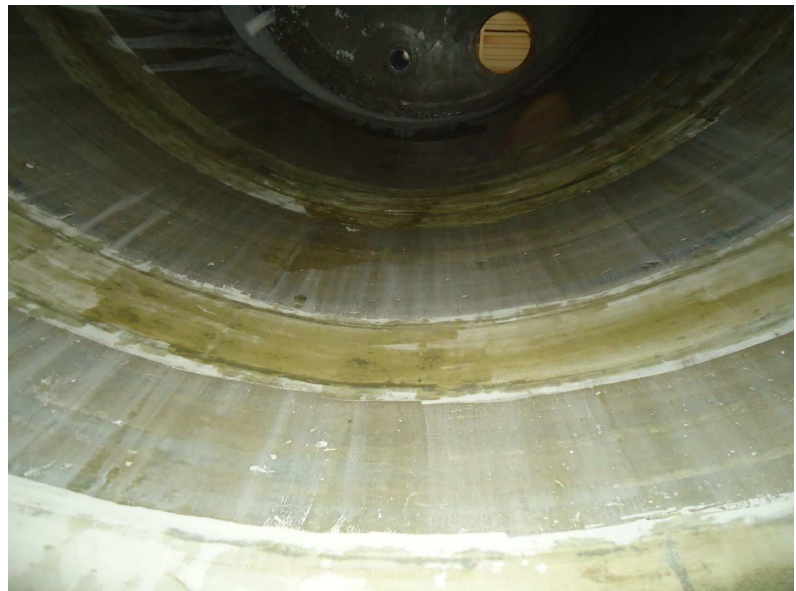
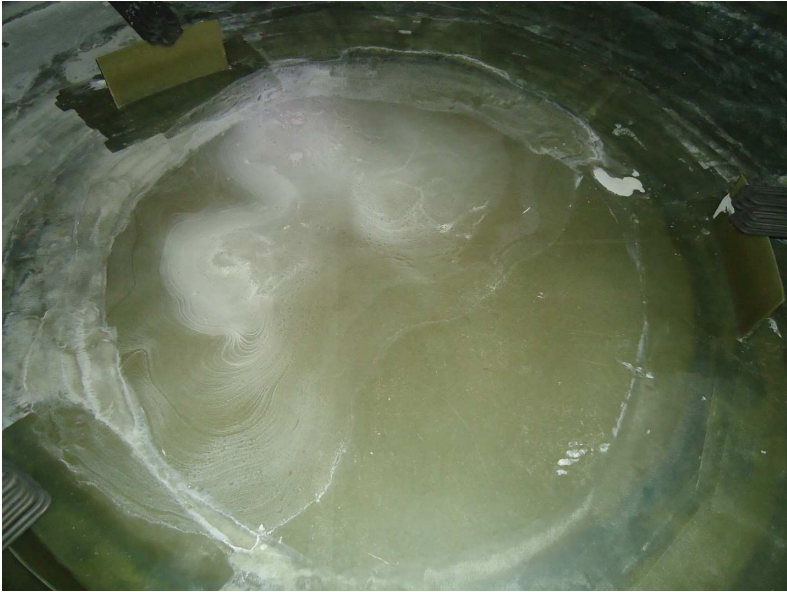
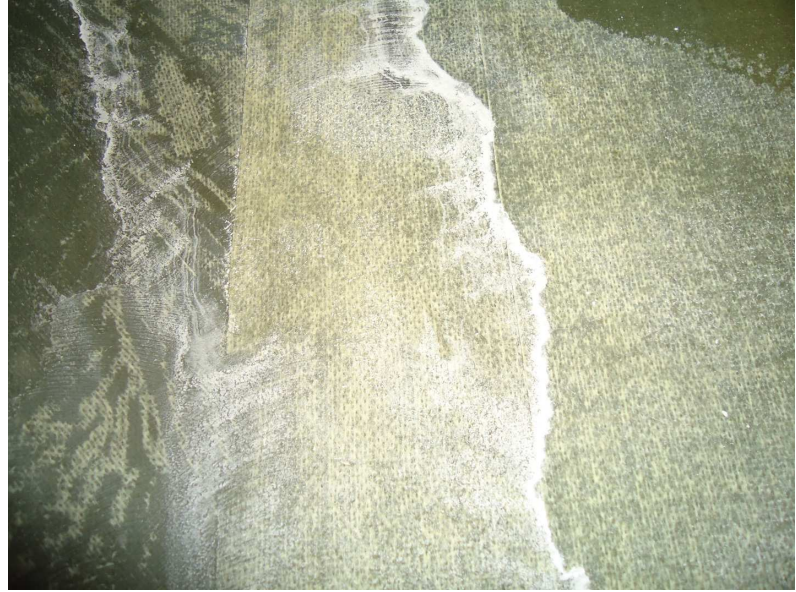
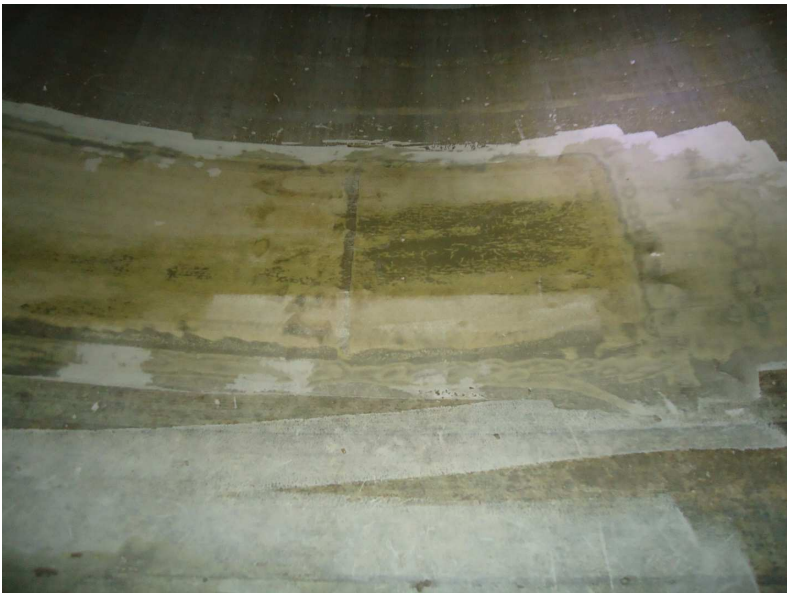
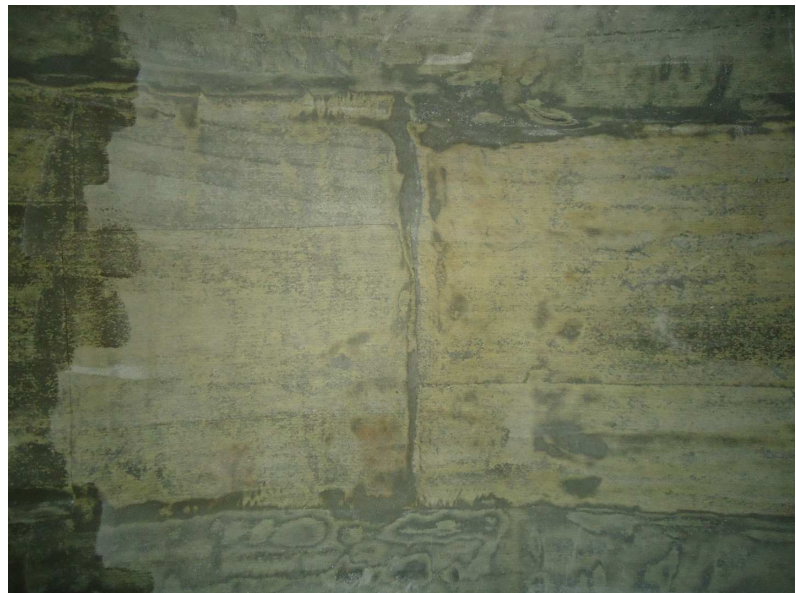
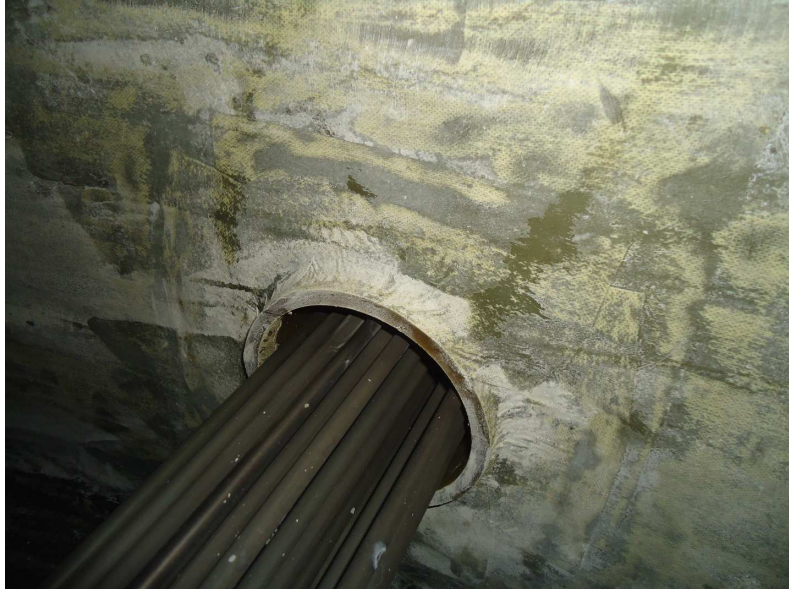
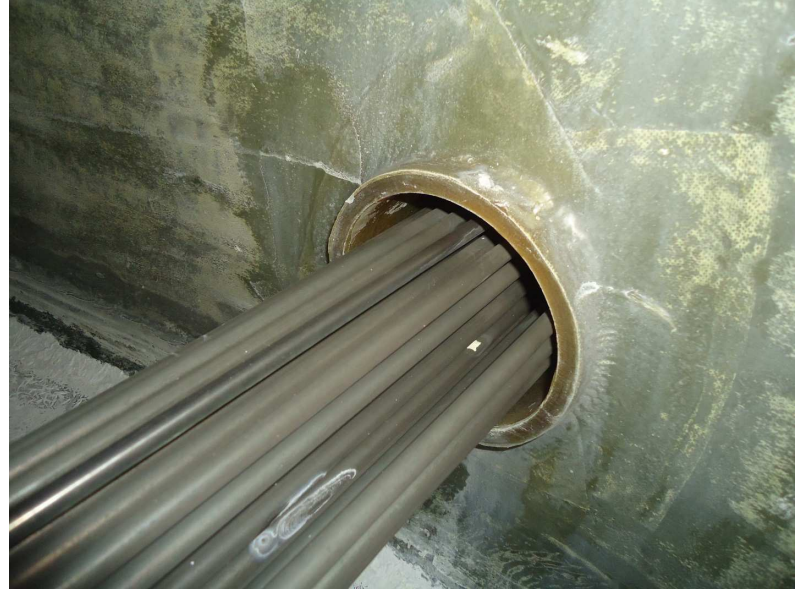
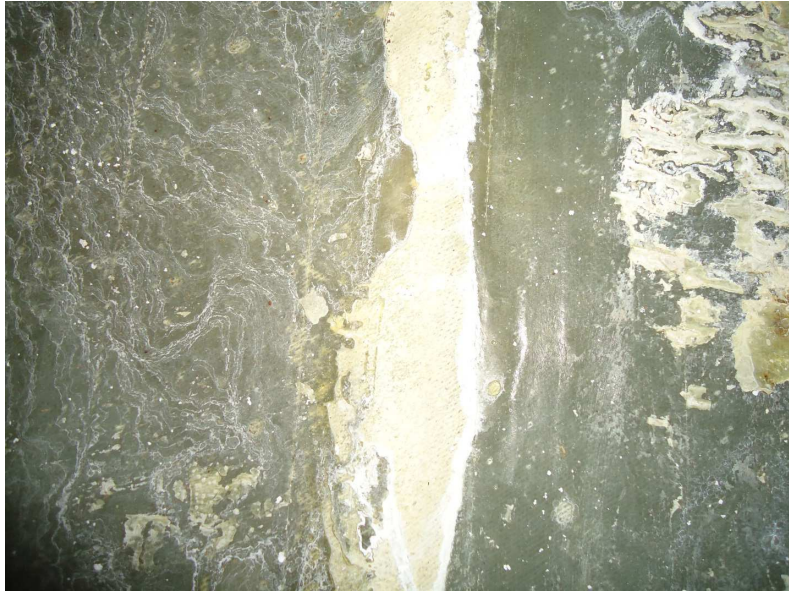
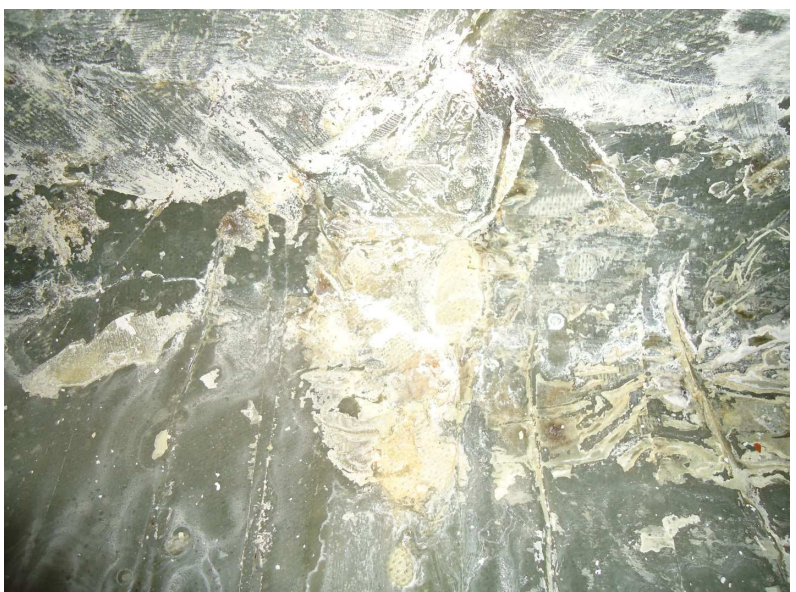
Internal Surface:

- Liner – majority of the tank liner appears to be in good condition with the exception of some sections (see Internal Surface Photos).
- The areas of concern mention on the previous bullet appear to be needing service – the Nexus® veil used on the liner appears to be drying out instead of having a resin-rich surface. This is possibly a result of a combination of chemical attack and/or excessive heat introduced into the tank.
- No cracks observed on internal joints – nozzle bonds and brackets.

- ❖ The areas of concern on the tank liner should be repaired as soon as practicable. The tank can be put back to service for now but it is recommended that the liner be serviced within the next 6 – 12 months.
- ❖ Repair recommended is as follows:
 - Grind the sections affected;
 - This will remove the dried out layer;
 - Re-line the surface with 2 plies of 1.5 oz. per square foot chopped strand mat and 2 plies of Nexus® Synthetic Veil using premium vinyl ester resin – Derakane Momentum 411-350;
 - Resin-rich flood coat the repaired liner with Derakane Momentum 411-350 c/w paraffin wax (Air Dry).
 - Post cure tank to attain a barcol hardness of over 35.

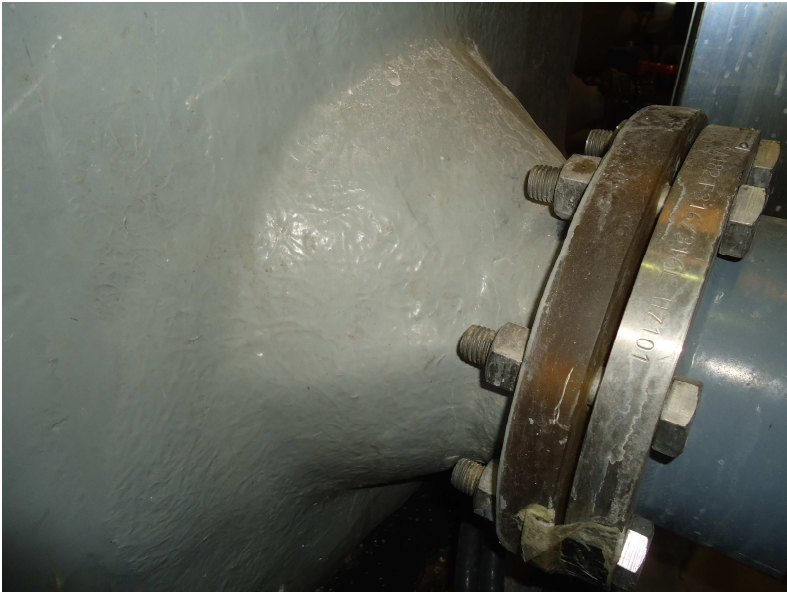
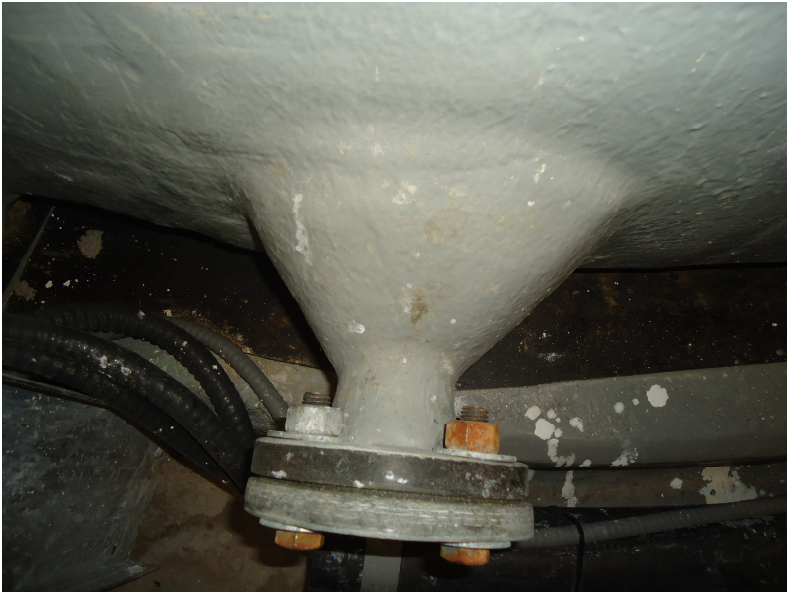
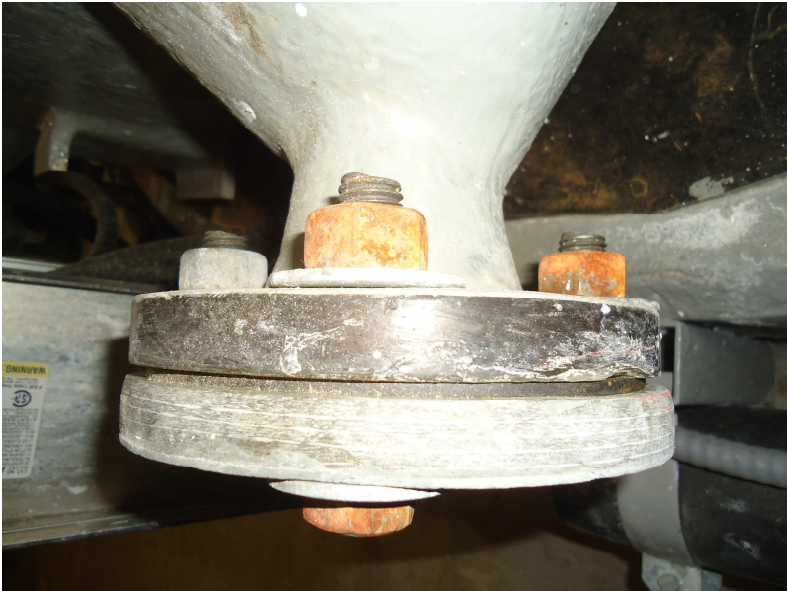
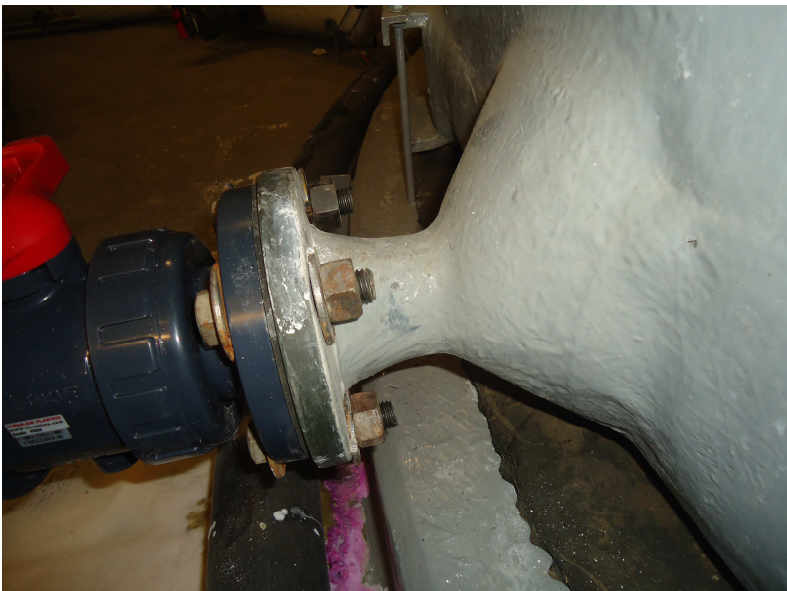
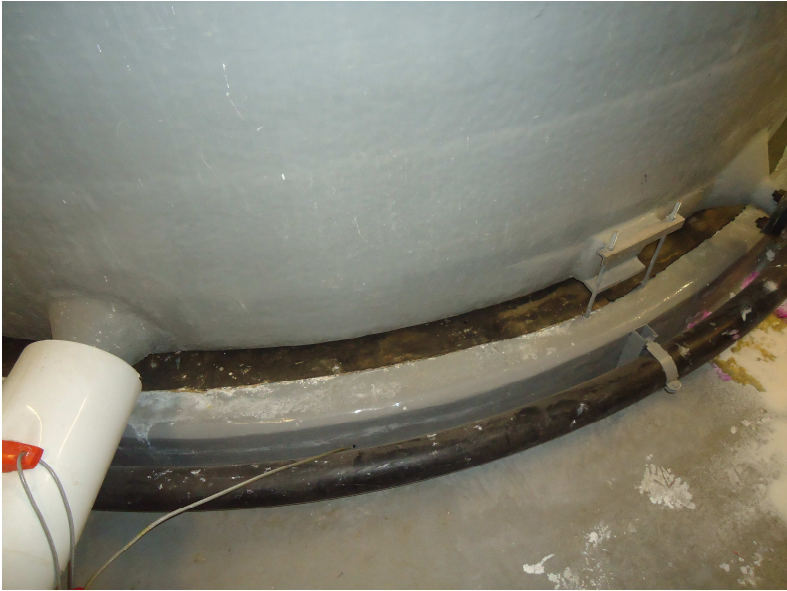
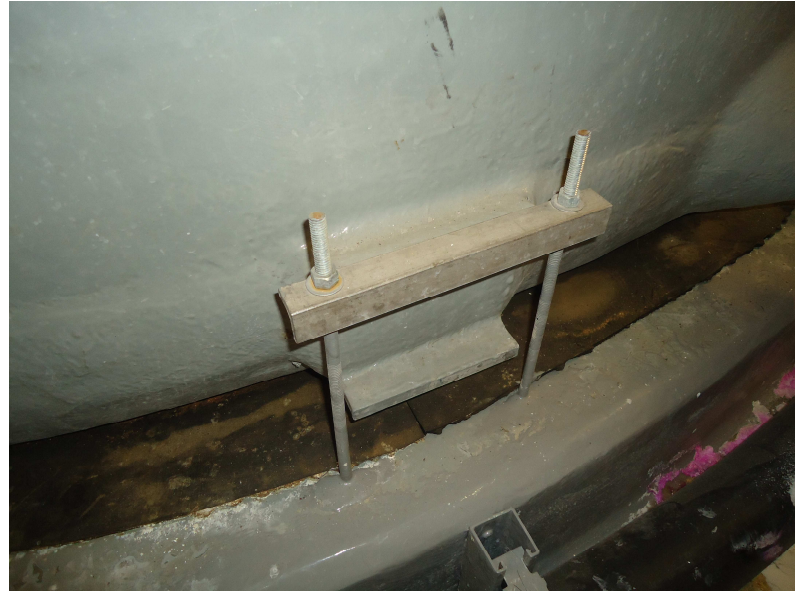
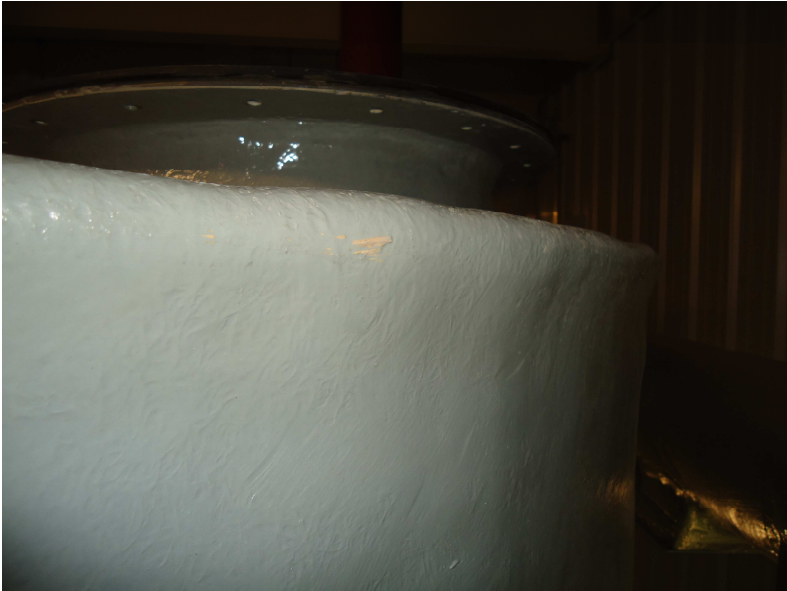
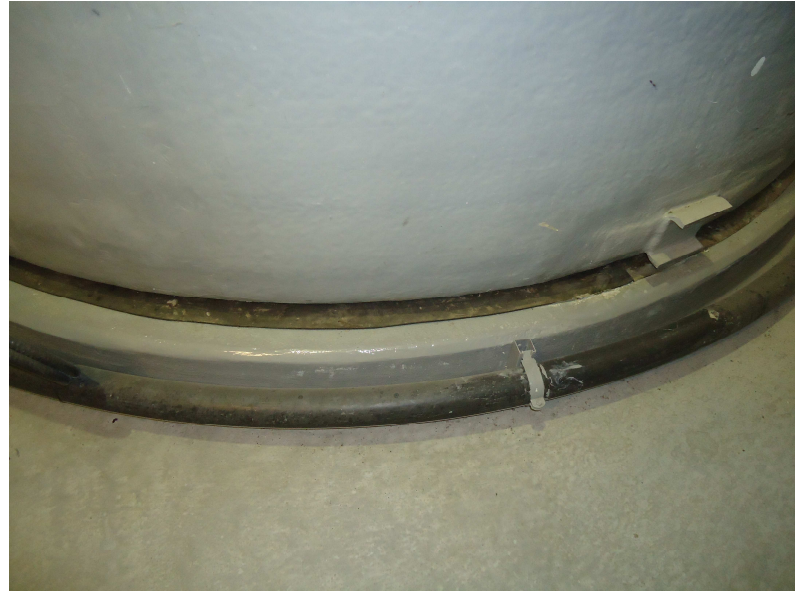
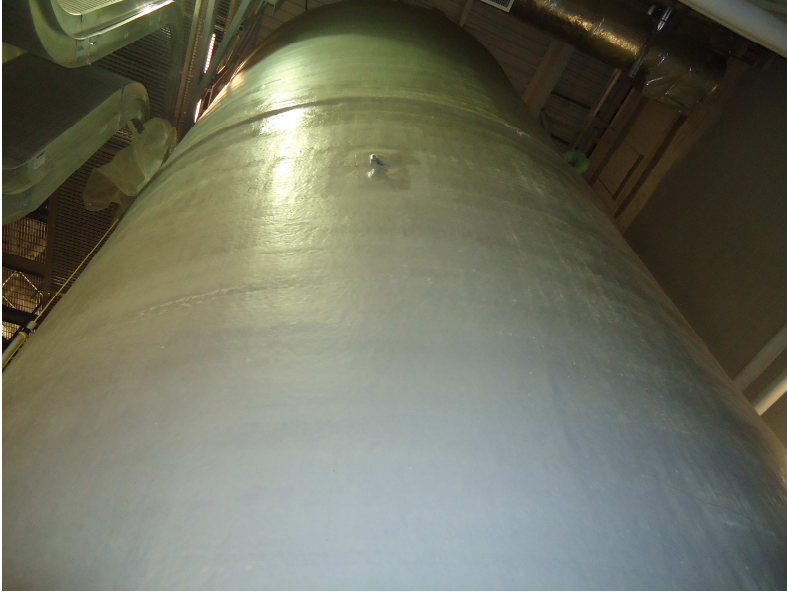
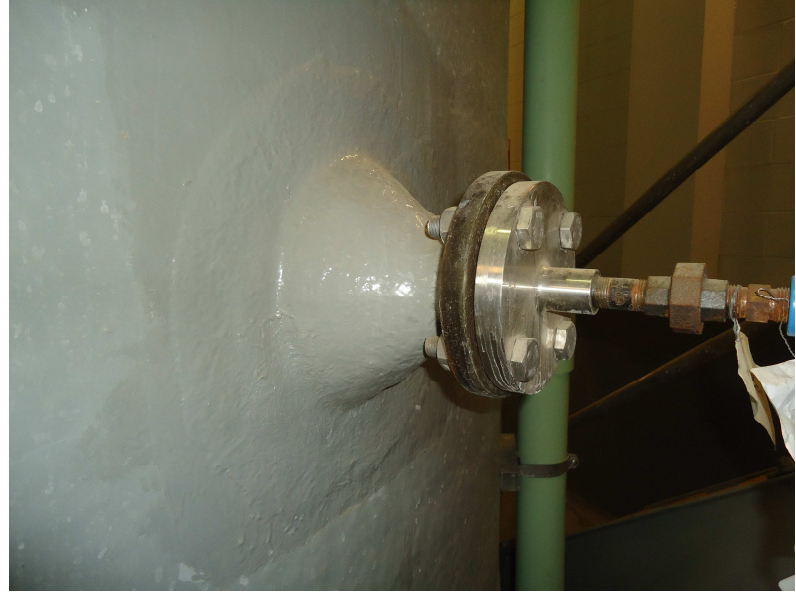
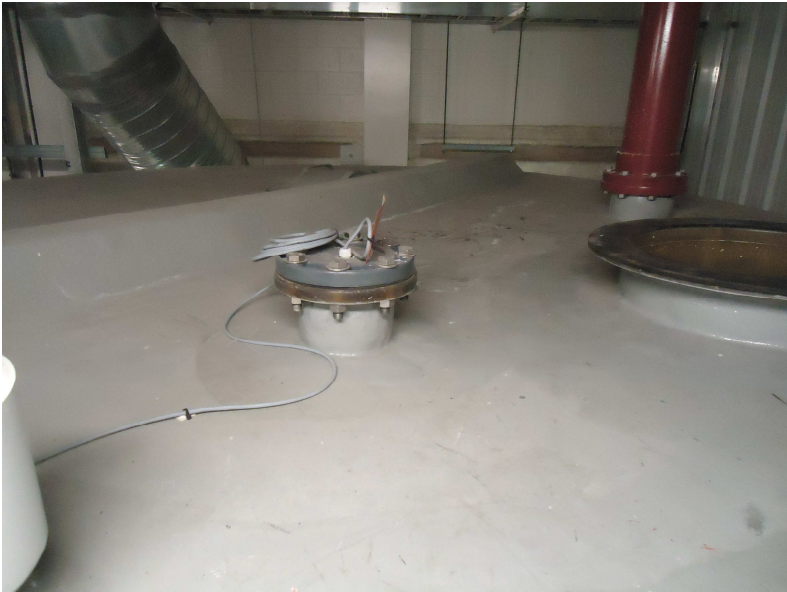
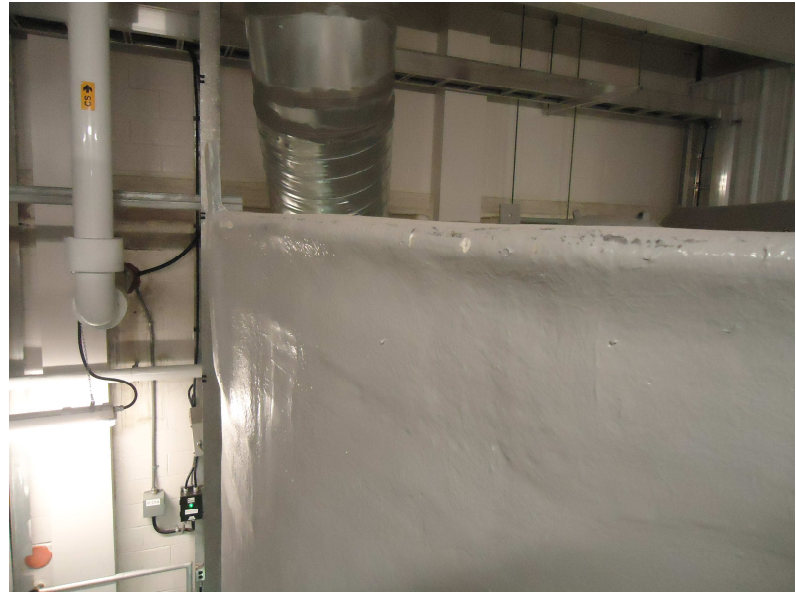
External Surface:

- External surface of the tank appears to be in good condition.
- No cracks or signs of corrosion observed.
- Nozzle flanges appear to be in good condition – no cracks found on the face and stub.
- Body joints and nozzle stub joints appear to be still in good condition.
- No signs of leak observed from the outside.
