## **APPENDIX B – OLIVE PUMPING STATION EXISTING HOIST DEVICES AND LIFTING CAPACITIES REPORT**

<b>Station Name:</b>	<u>Olive Lift Station</u>
<b>Location of Station:</b>	<u>Assiniboine Crescent east of Olive Street</u>
<b>Date of Inspection:</b>	<u>February 10, 2010</u>
<b>Inspected By:</b>	<u>Damir Muhurdarevic, EIT</u>
<b>Inspecting Firm:</b>	<u>MMM Group Limited (MMM)</u>
<b>Client:</b>	<u>City of Winnipeg – Water and Waste Department</u>

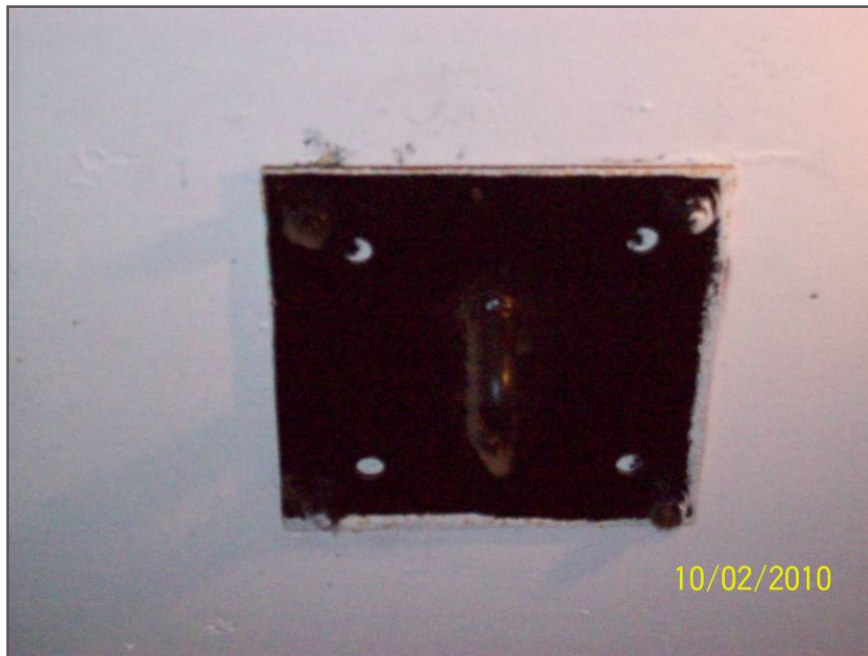
**Photograph No. 1**

U-shaped lifting hook welded to a steel plate, located on the bottom floor

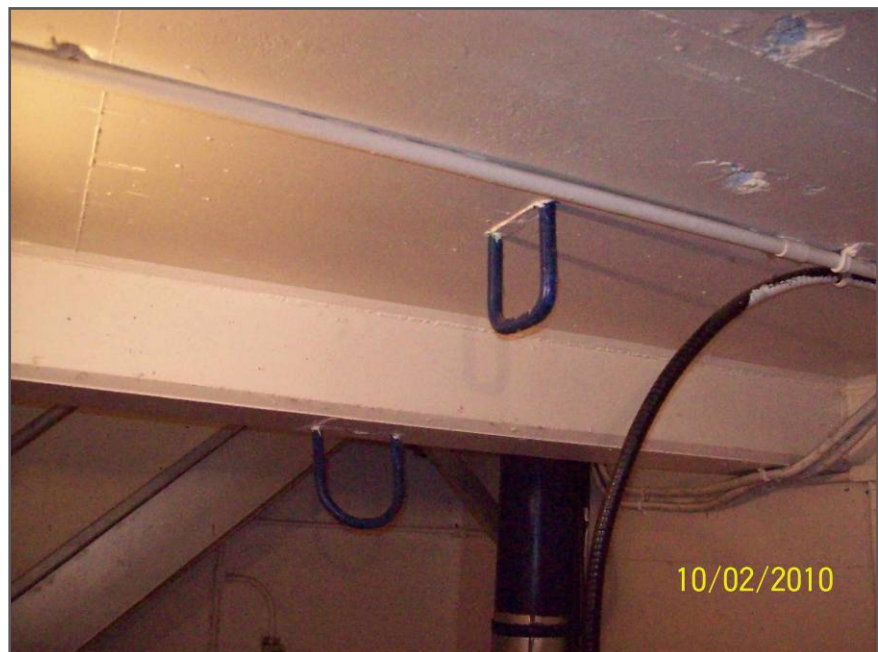
**Photograph No. 2**

The combination chamber on the first floor below ground and the motor room on the second floor below ground each have four (4) U-shaped lifting hooks that are fabricated of 19.4mm diameter steel rod and are embedded into the underside of the main and first floor cast-in-place concrete slabs. During the inspection it was observed that one of the hooks in the motor room on the second floor below ground is bent.

All U-hooks were analyzed for pullout resistance of and the tension resistance of the hooks. The thickness of the roof and floor slabs was not observed and therefore the embedment length of the hooks was only estimated. The slabs were estimated to be 200mm thick and an embedment length of 150mm was used. The governing factor in the hooks was the pullout resistance, which was calculated to be 6.8 tons. A factor of safety of 4.5 was applied to the hooks to yield a load rating of 1.5 tons. The one (1) bent hook located in the motor room was not rated for safe use and was recommended to be replaced.

Various lifting hooks embedded in the ceiling, located in the motor room (U-shaped hook bent)

Ref.	Description	Priority
4.1	Replace bent U-shaped lifting hook located in the motor room	A
