## **Appendix D**

### **Site Photos**

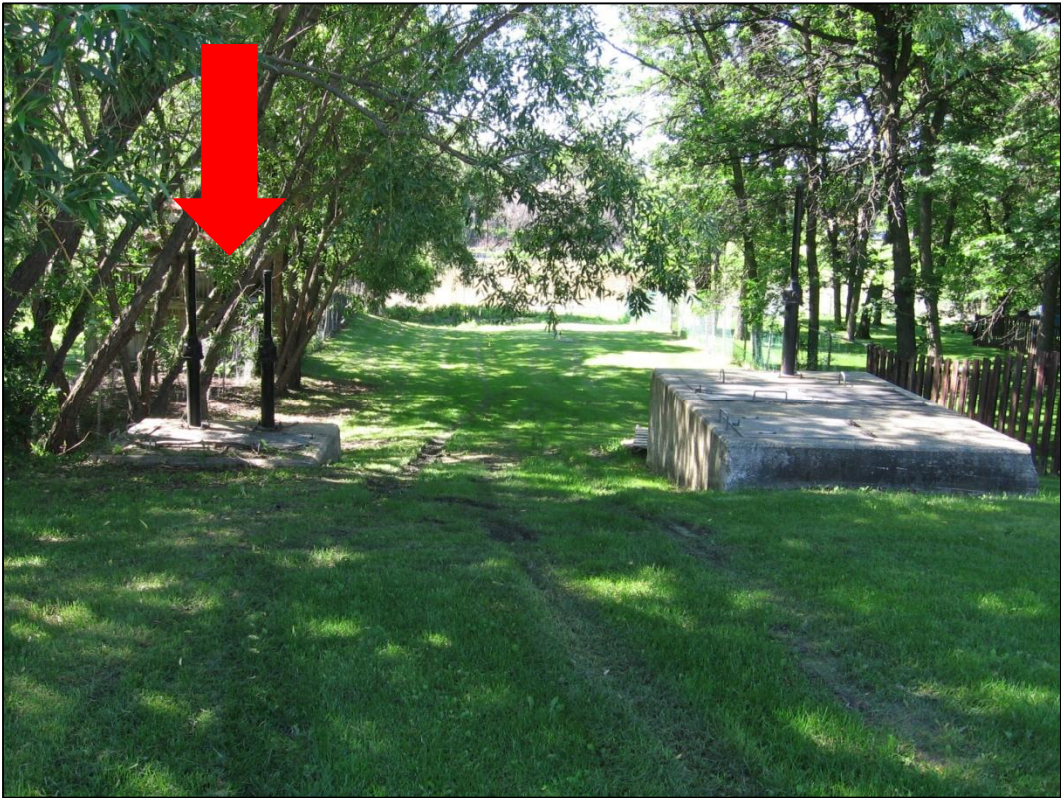
**Figure 1 – Chamber location.**

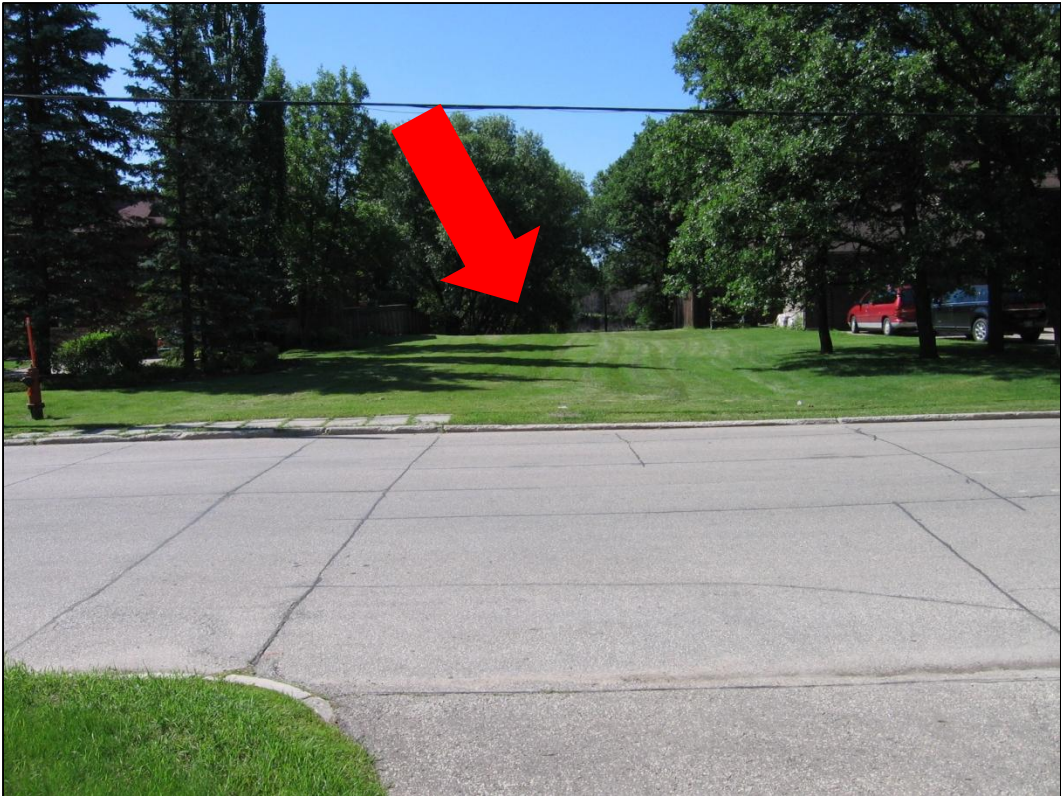
**Figure 2 – Site access from Assiniboine Avenue.**

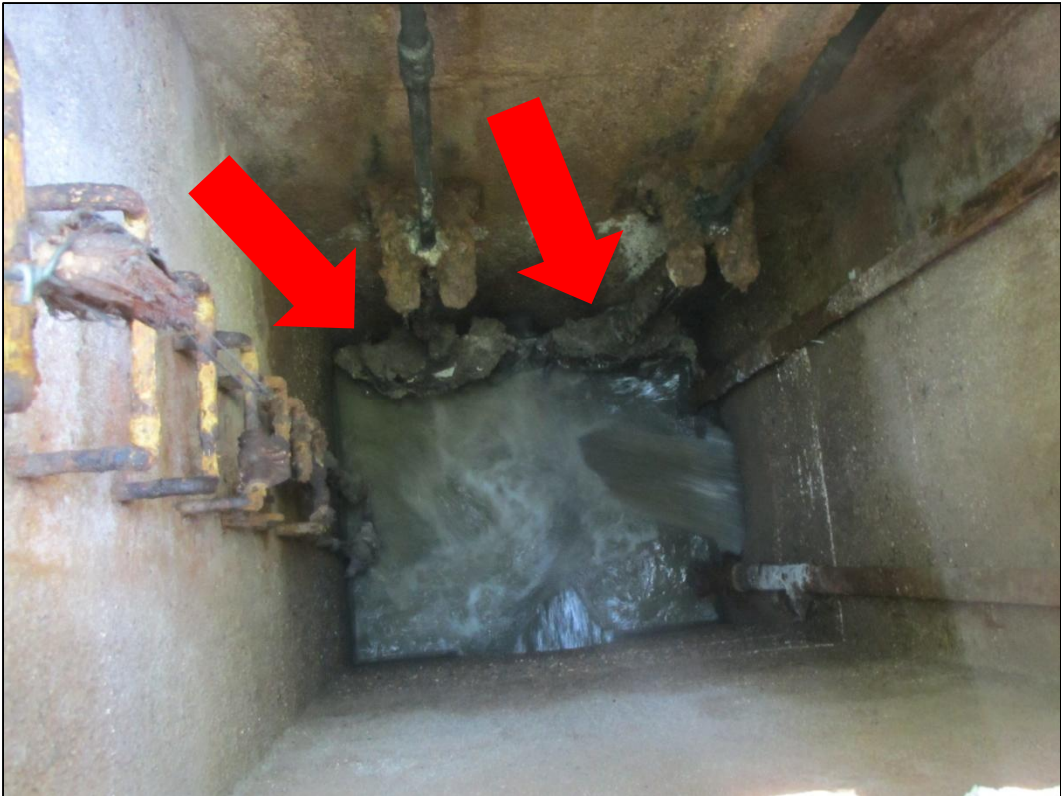
**Figure 4 – Chamber interior.**

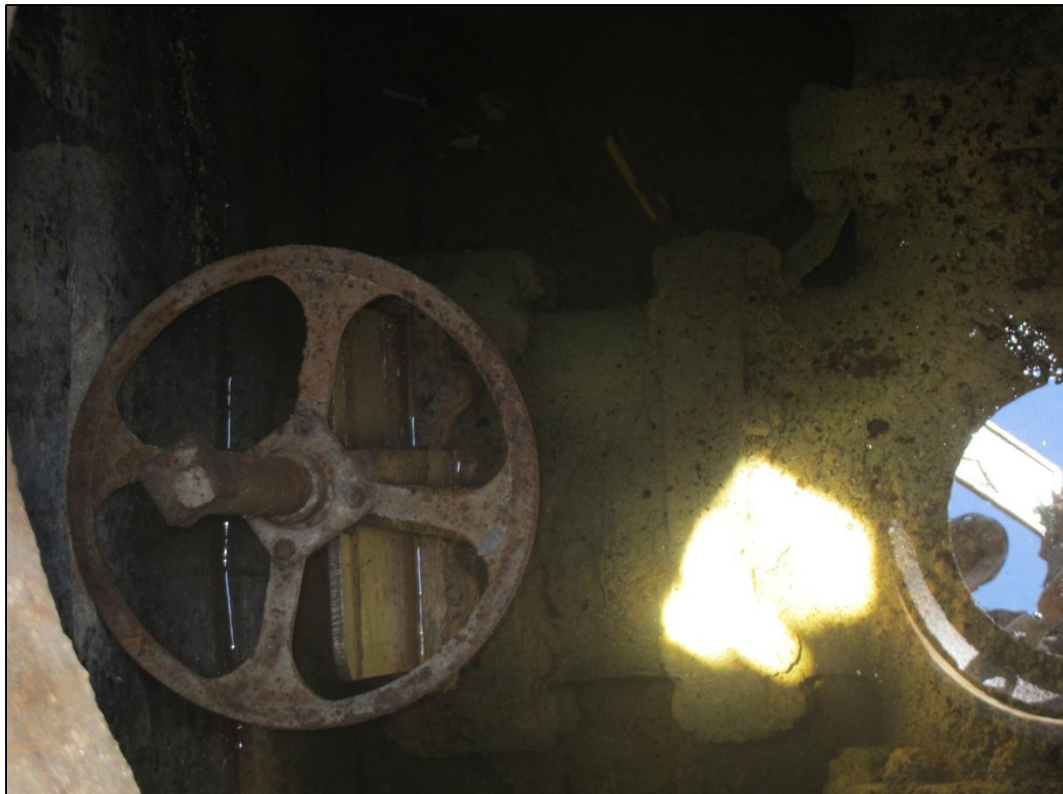
**Figure 34 – Knife gate and tee.**

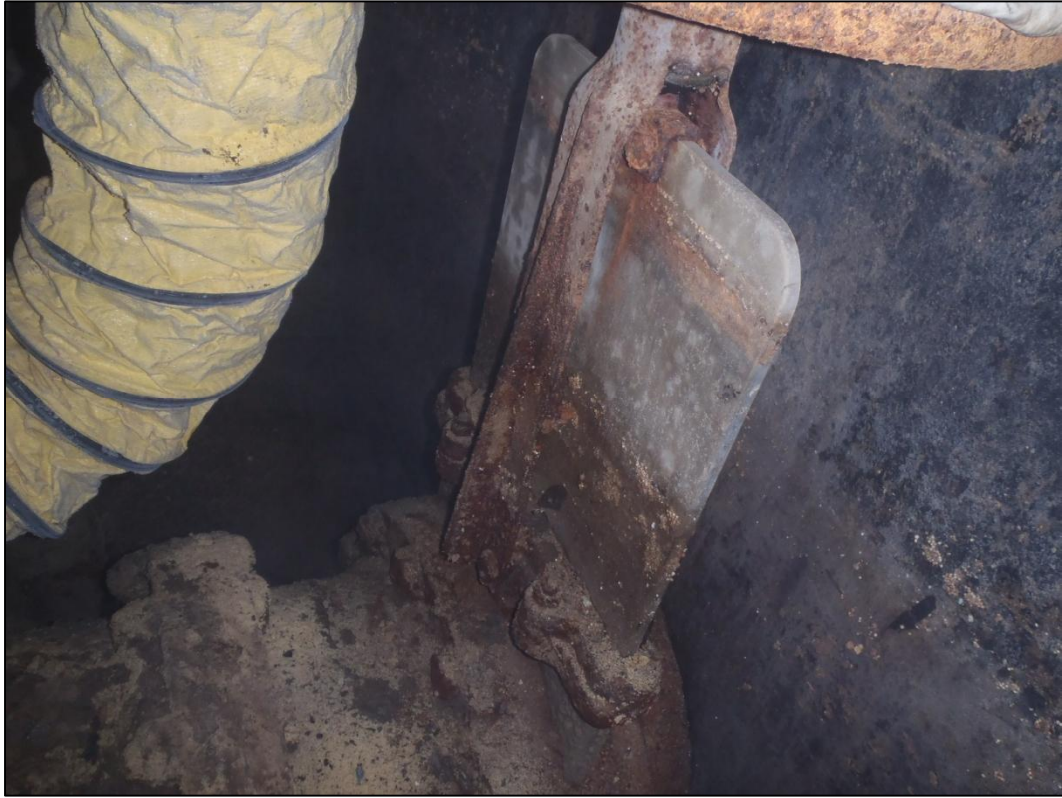
**Figure 35 – Knife gate.**

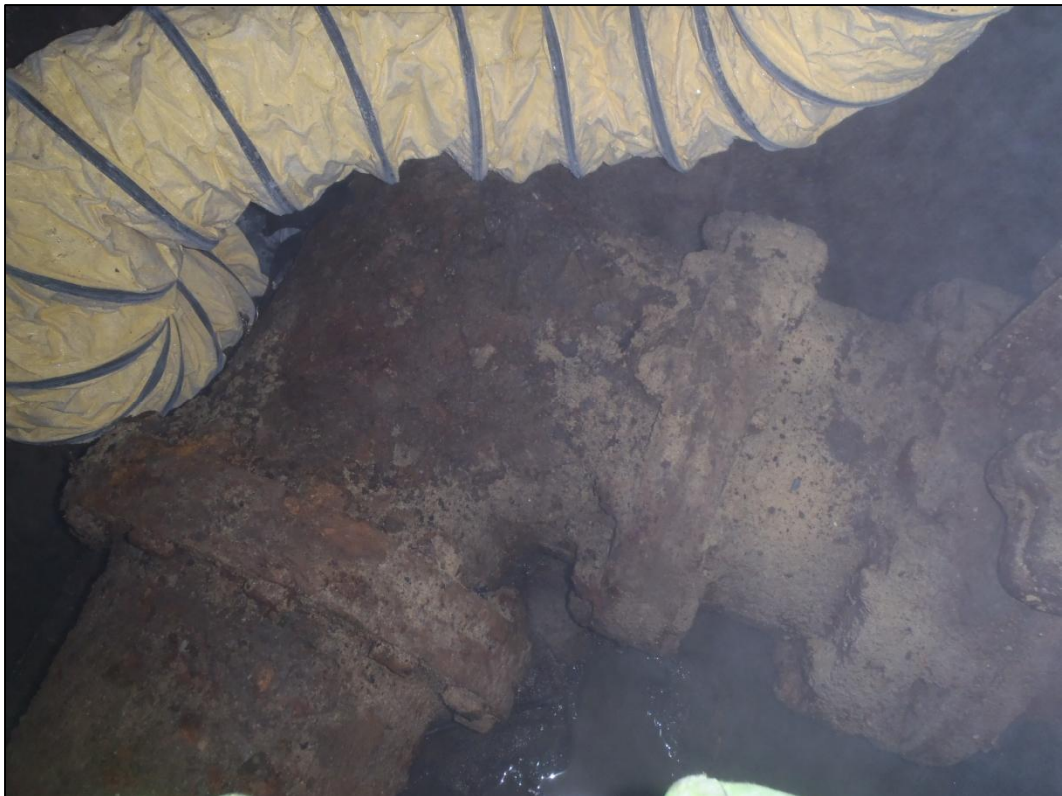
**Figure 36 – Tee.**

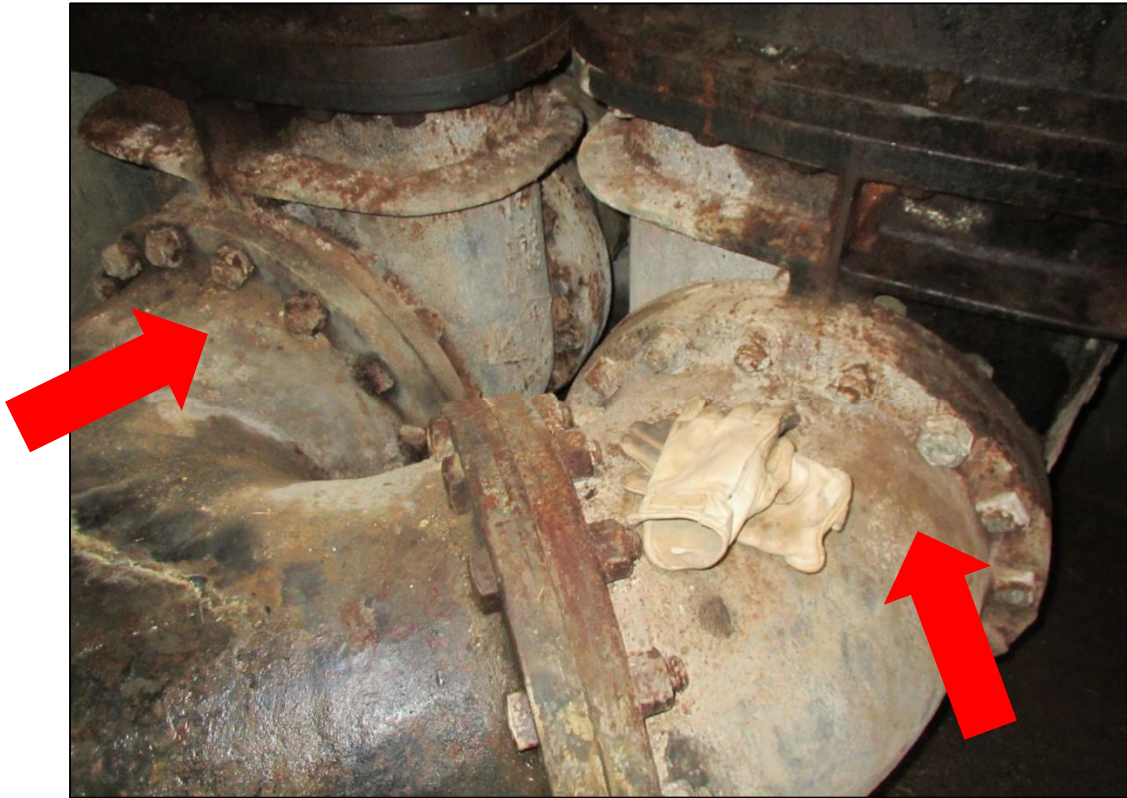
**Figure 41 – Chamber piping, facing downstream direction.**

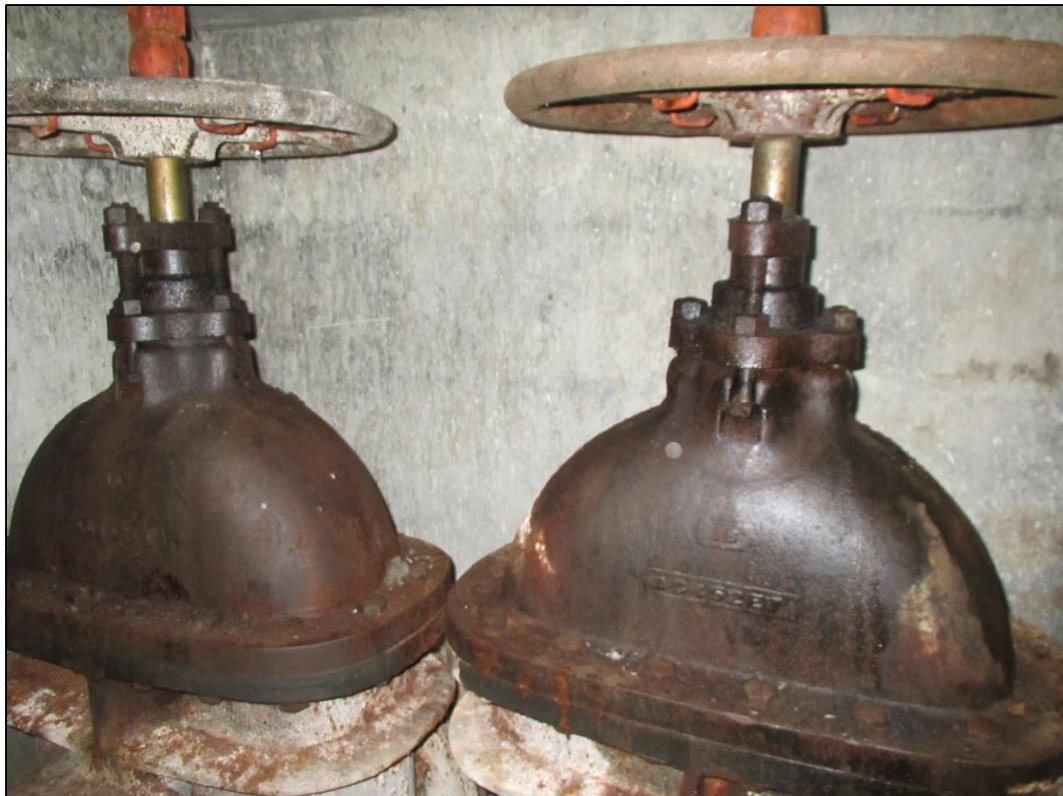
**Figure 42 – Valves.**

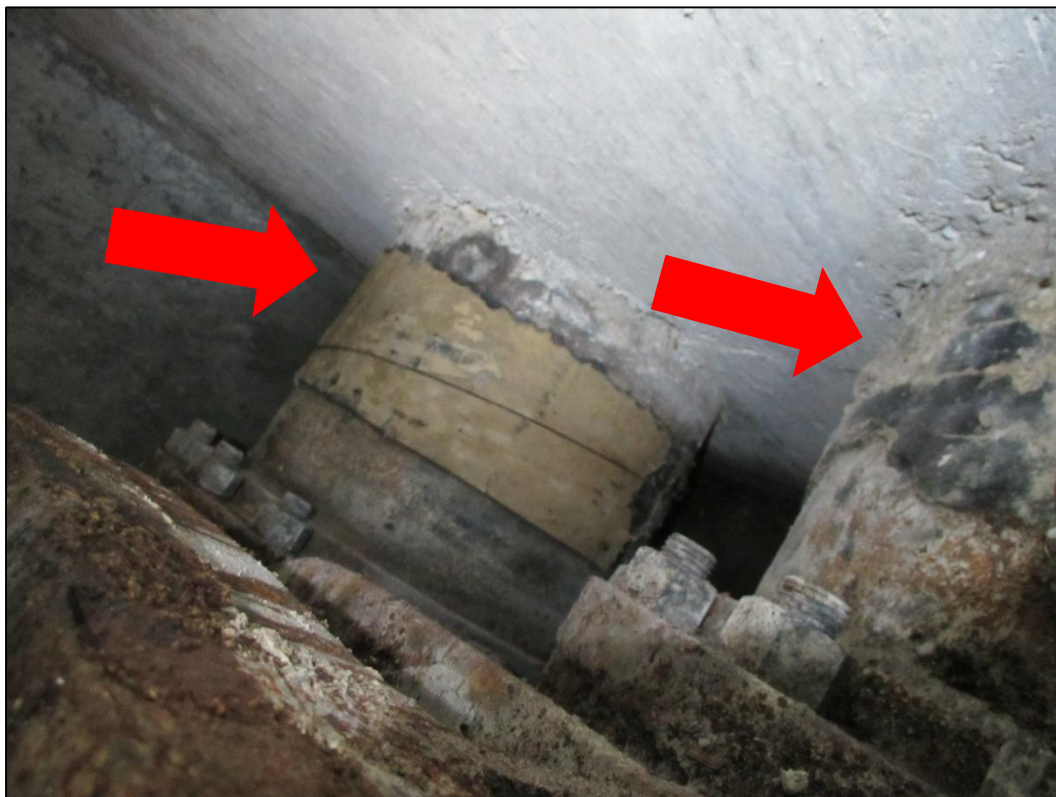
**Figure 43 – Pipes exiting downstream wall of chamber.**

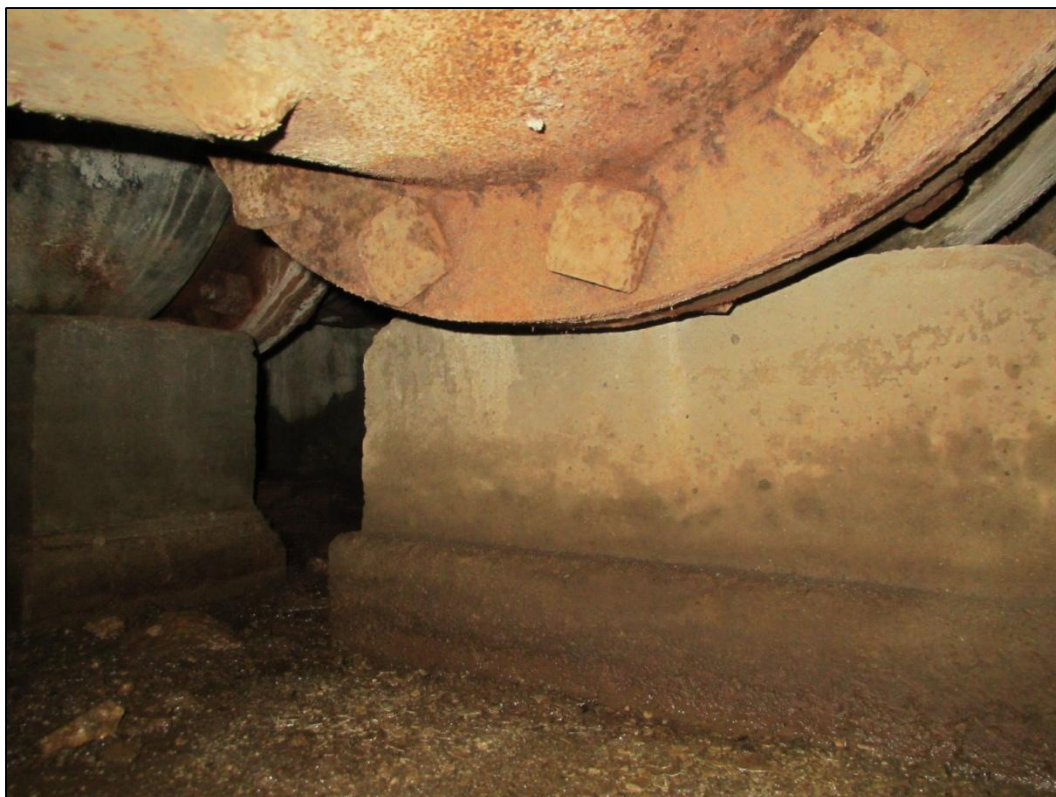
**Figure 44 – Pipe cradles.**

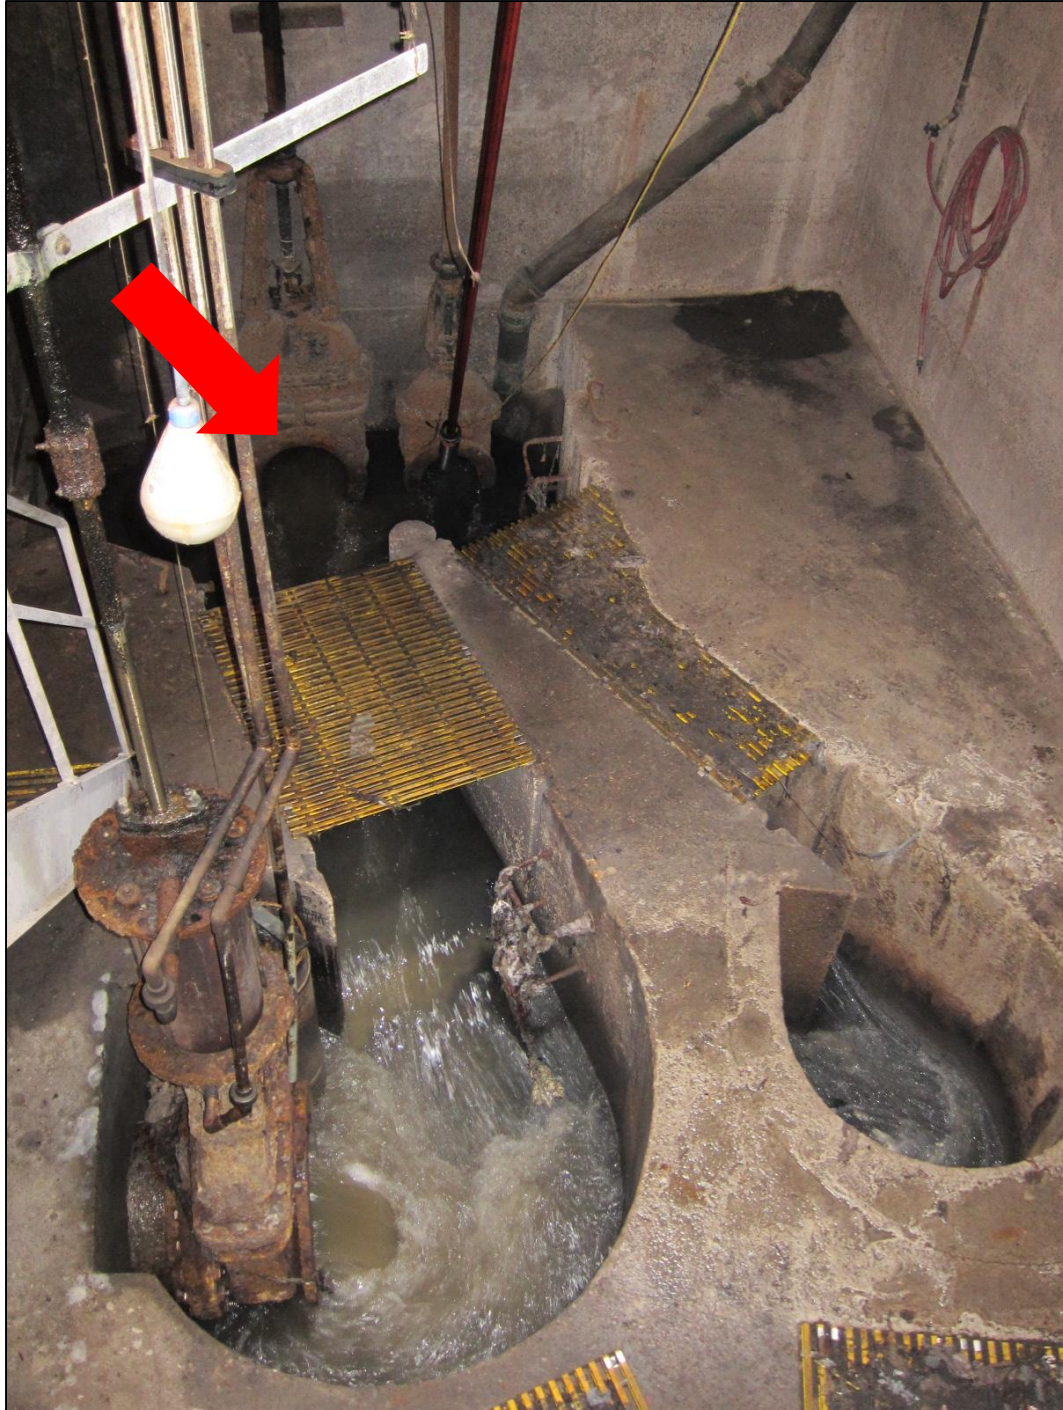
**Figure 53 – Bottom sublevel at siphon outlet.**

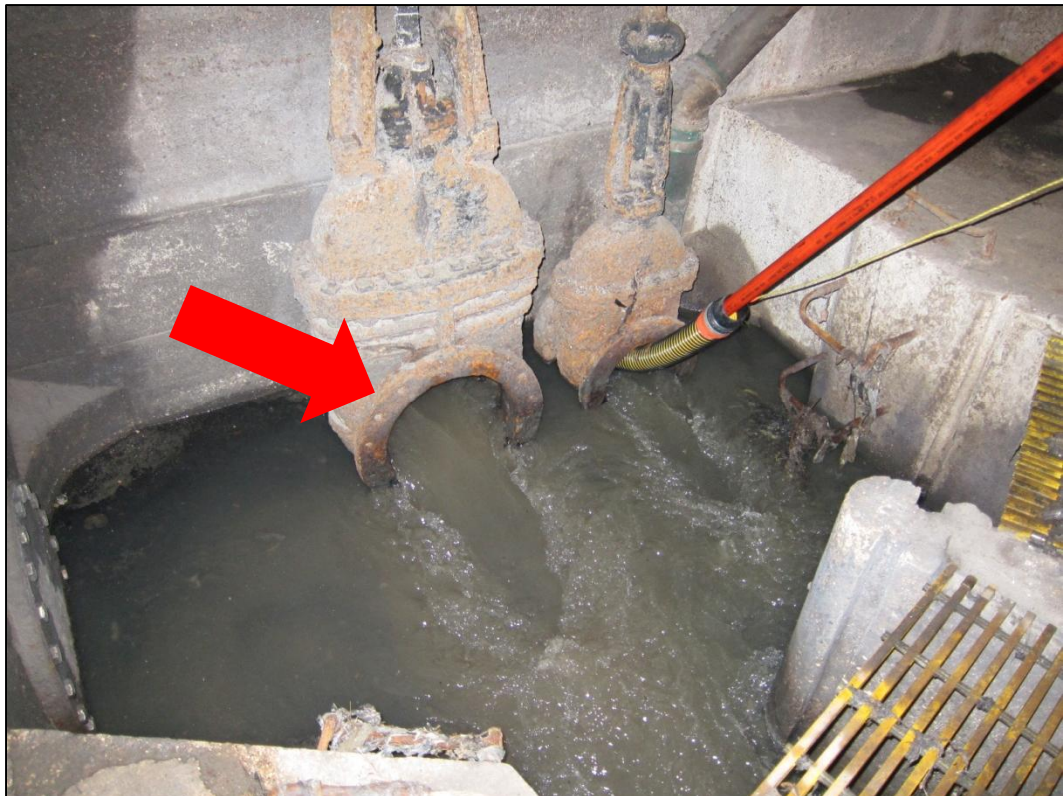
**Figure 55 – Pipe outlet.**

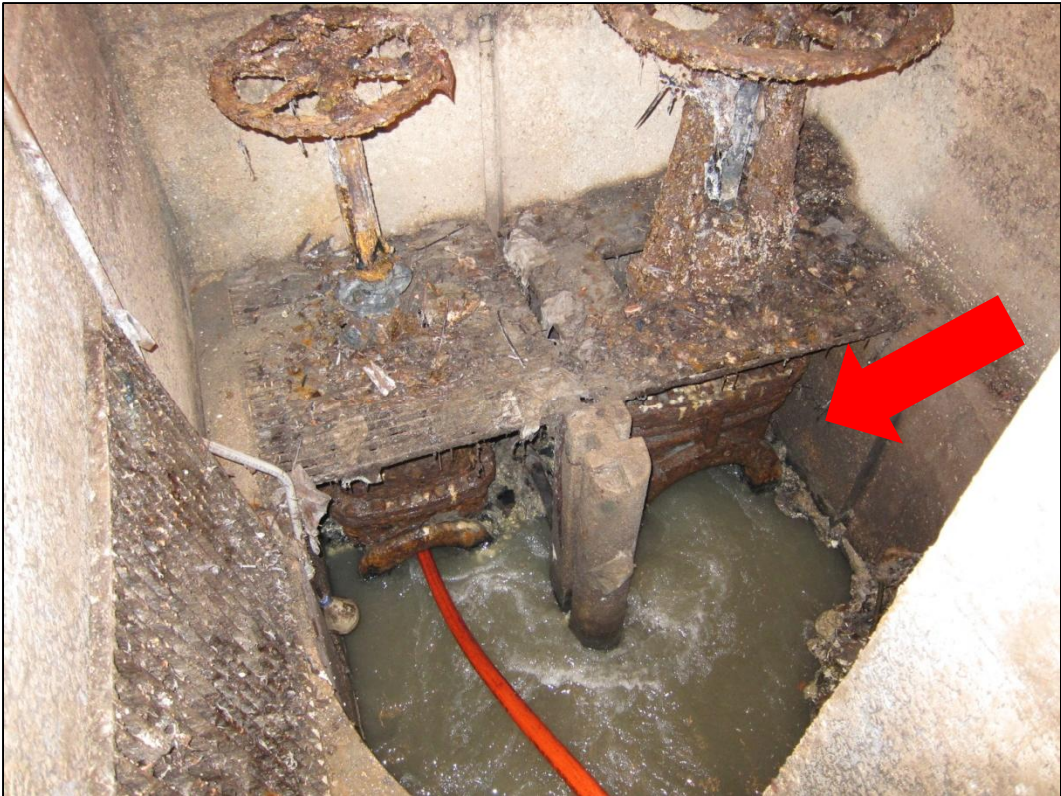
**Figure 61 – Pipe inlets.**
