# **GEOTECHNICAL REPORT**

## Geotechnical Report for Henderson Highway (Northbound) – McLeod Avenue to Springfield Road

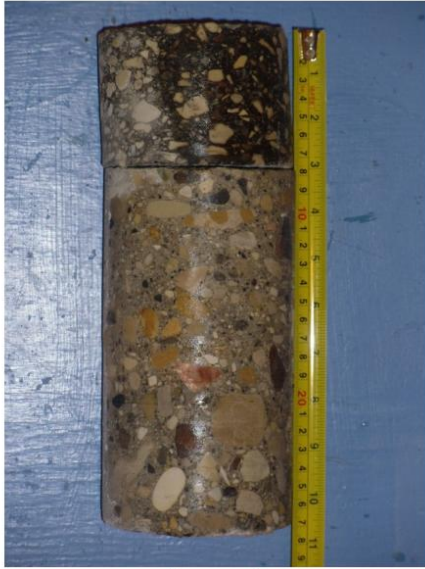
Core no. 1

Core No.	Core Location	Pavement Structure Thickness (mm)			Comments
		Asphalt	Concrete	Total	
1	Henderson Hwy, northbound curb lane, 0.5 m from curb, 18 m north of McLeod Avenue	70	190	260	Asphalt pavement not bonded to concrete surface Sound concrete below asphalt pavement
2	Henderson Hwy, northbound curb lane, 0.5 m from curb, 20 m north of Oakland Avenue	120	215	335	Asphalt pavement not bonded to concrete surface Sound concrete below asphalt pavement
3	Henderson Hwy, northbound median lane, 0.5 m from curb, 12 m south of Devon Avenue	70	210	290	Asphalt pavement not bonded to concrete surface Sound concrete below asphalt pavement Fractured asphalt due to core recovery methods
4	Henderson Hwy, northbound curb lane, 0.5 m from curb, 22 m south of Cheriton Avenue	115	200	315	Asphalt pavement not bonded to concrete surface Slight deterioration of concrete pavement at bond line with asphalt pavement; sound concrete below

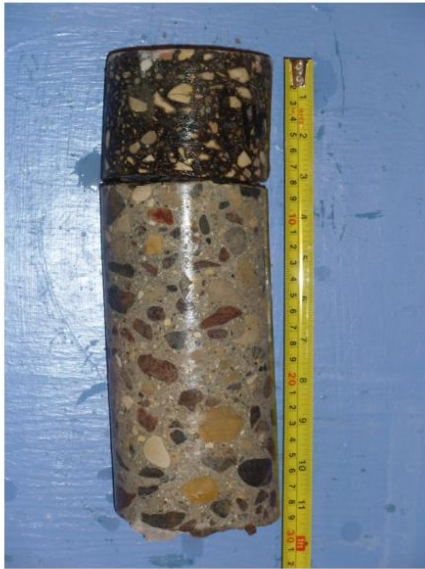
Core no. 5

5	Henderson Hwy, northbound curb lane, 0.5 m from curb, 40 m north of Cheriton Avenue	75	200	275	Asphalt pavement not bonded to concrete surface Sound concrete below asphalt pavement
6	Henderson Hwy, northbound median lane, 0.5 m from curb, 51 m north of Hawthorne Avenue	60	195	255	Fractured asphalt pavement 25 below surface Asphalt pavement not bonded to concrete surface Sound concrete below asphalt pavement
7	Henderson Hwy, northbound curb lane, 0.5 m from curb, 48 m north of Kingsford Avenue	110	200	310	Asphalt pavement not bonded to concrete surface Sound concrete below asphalt pavement
8	Henderson Hwy, northbound curb lane, 0.5 m from curb, 28 m north of Edison Avenue	40	190	230	Asphalt pavement not bonded to concrete surface Slight deterioration of concrete pavement at bond line with asphalt pavement; sound concrete below
9	Henderson Hwy, northbound median lane, 0.5 m from curb, 8 m south of McKay Avenue	60	170	230	Severely fractured asphalt pavement Moderate deterioration of concrete pavement at bond line with asphalt pavement; sound concrete below
