CLIENT:
CITY OF WINNIPEG

PROJECT:
**DYKE REPAIR - 32 LORD AVENUE,
WINNIPEG, MANITOBA**

DWG DESCRIPTION:
PHOTOGRAPHS 1-6

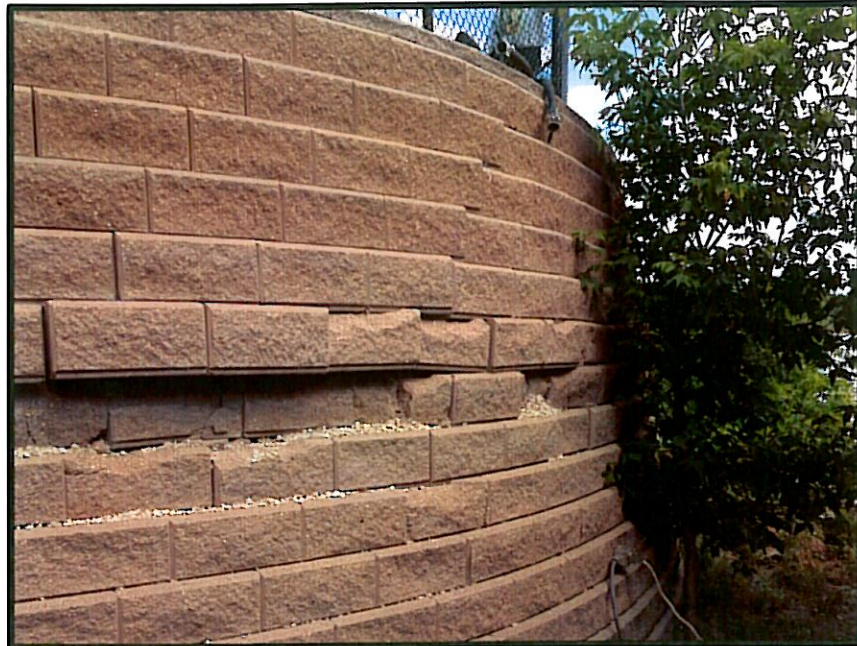
PHOTOGRAPH #1: FACING NORTH, SHOWING DAMAGED BLOCKS FROM SECTION A

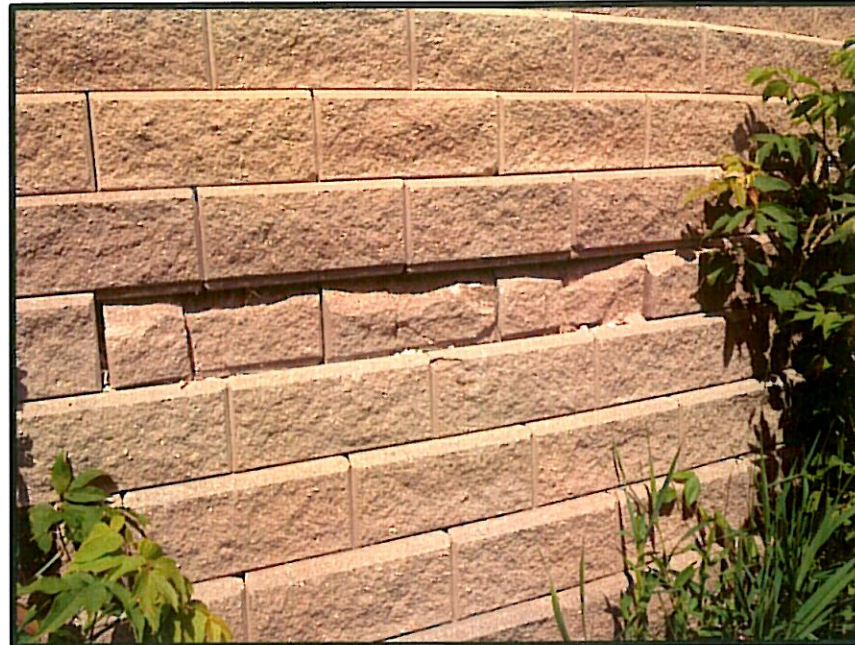
PHOTOGRAPH #2: FACING NORTHWEST, SHOWING DAMAGED BLOCKS FROM SECTION B

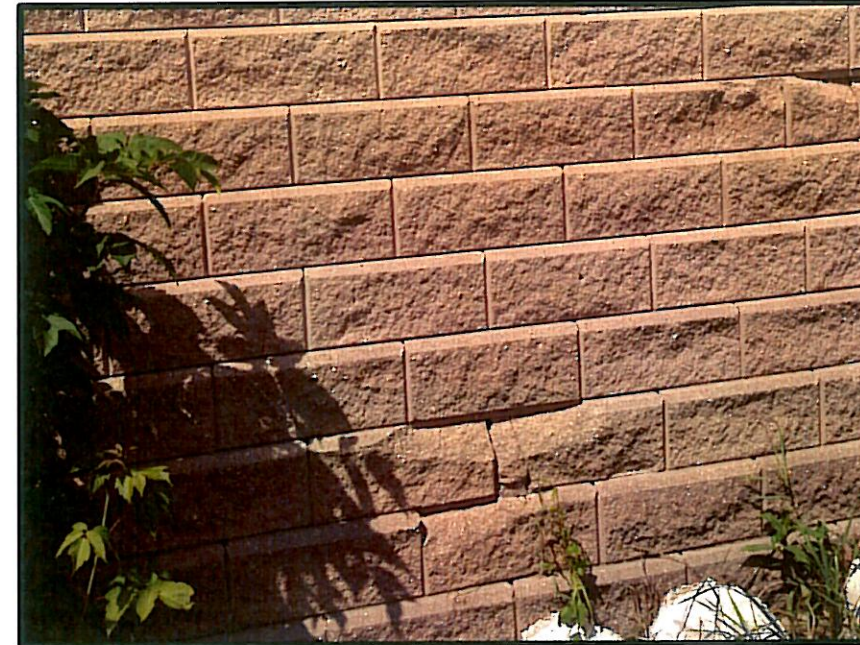
PHOTOGRAPH #3: FACING NORTHWEST, SHOWING DAMAGED BLOCKS FROM SECTION C

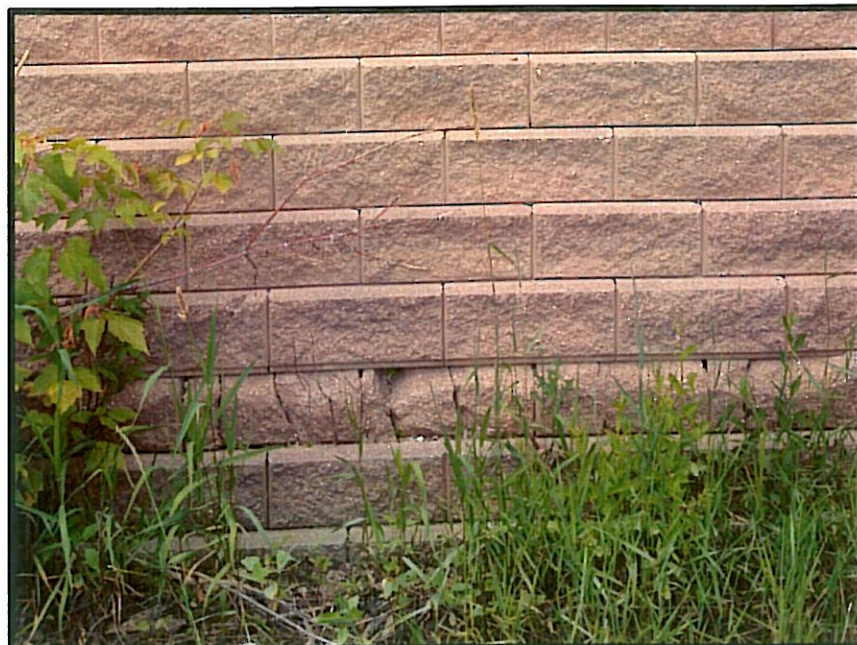
PHOTOGRAPH #4: FACING WEST, SHOWING DAMAGED BLOCKS FROM SECTION D

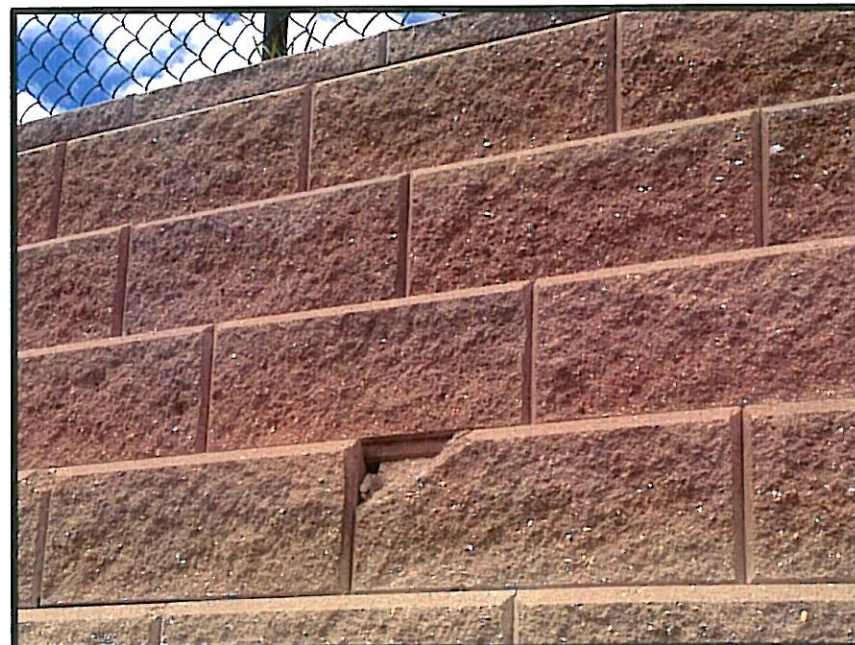
PHOTOGRAPH #5: FACING SOUTHWEST, SHOWING DAMAGED BLOCK FROM SECTION E

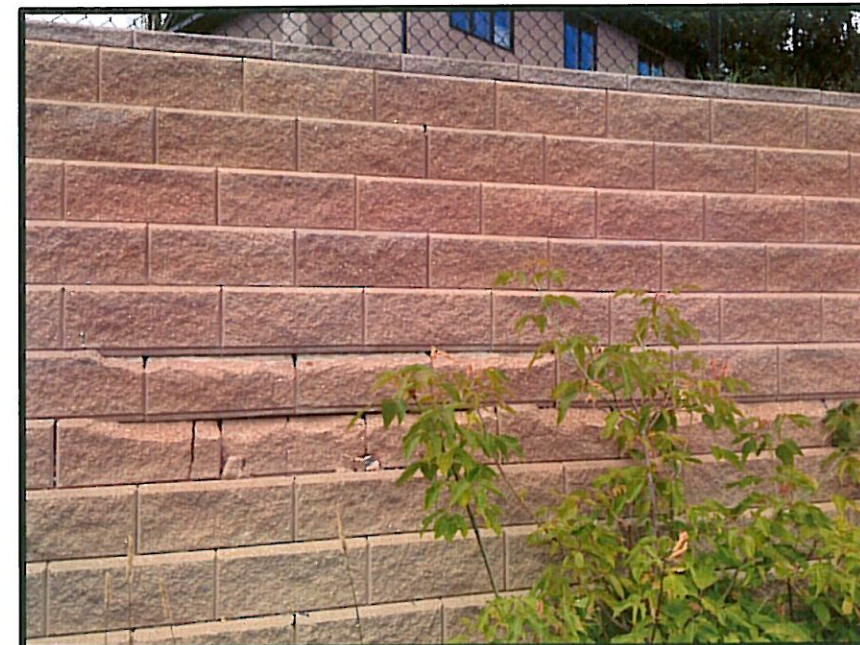
PHOTOGRAPH #6: FACING WEST TO NORTHWEST, SHOWING DAMAGED BLOCKS FROM SECTION F.
