APPENDIX C – “KING’S PARK RIVERBANK INVESTIGATION MONITORING AND ASSESSMENT” BY KGS GROUP, 2014

King's Park
Riverbank Investigation Monitoring and Assessment
FINAL

KGS Group 13-0107-008
September 2014

RE: Riverbank Investigation, Monitoring and Assessment – King's Park
Final Report

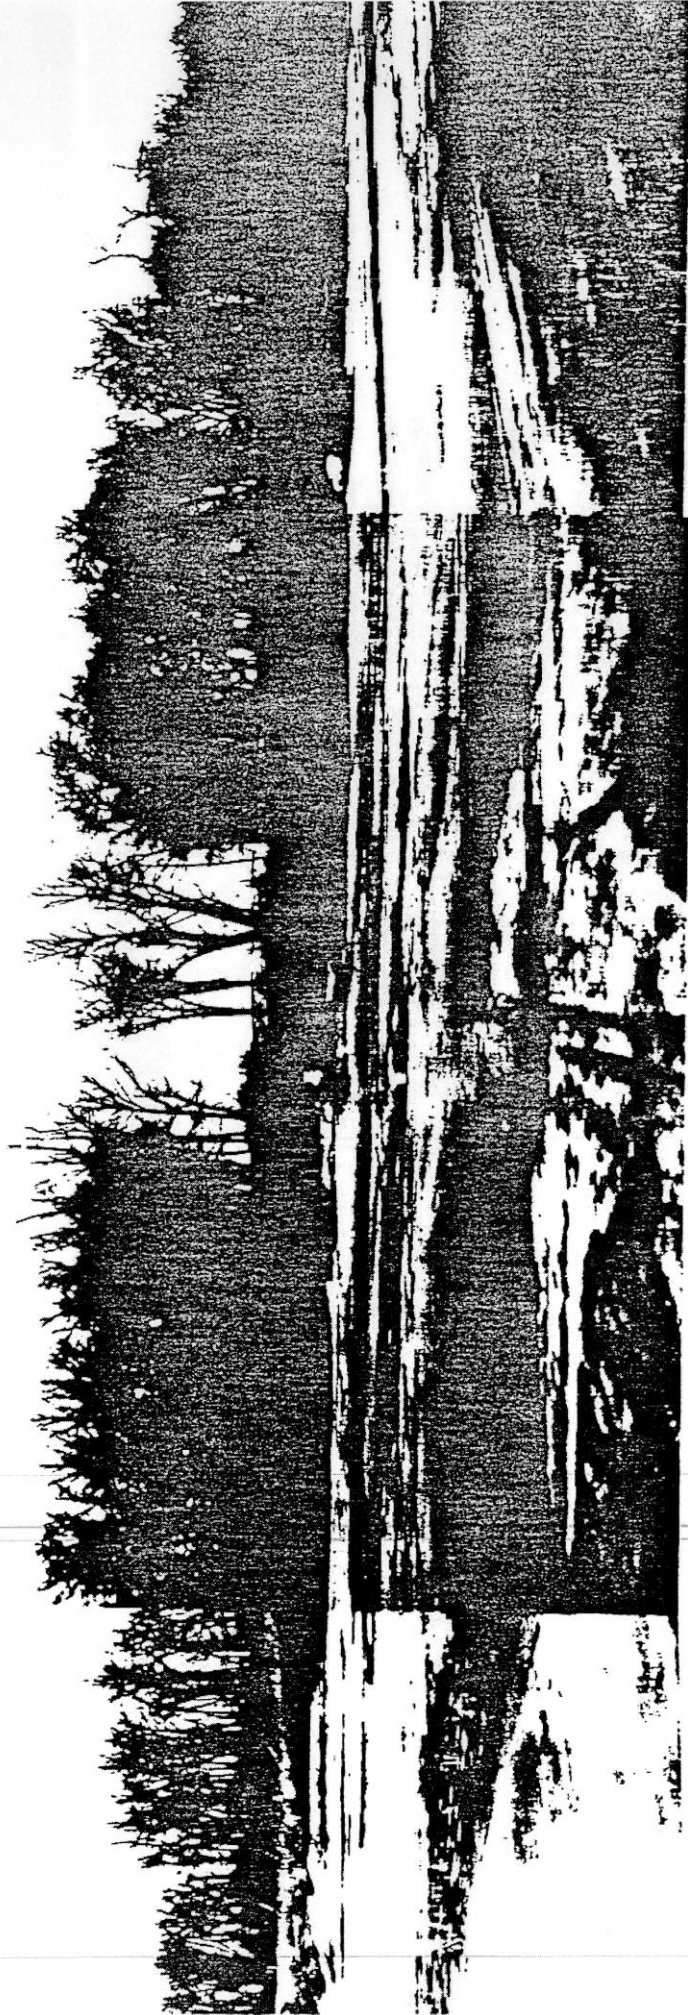
PHOTO 1: King's Park Riverbank Study Area.
Note dense tree cover on the riverbank and severe shoreline erosion. (February 27, 1988).

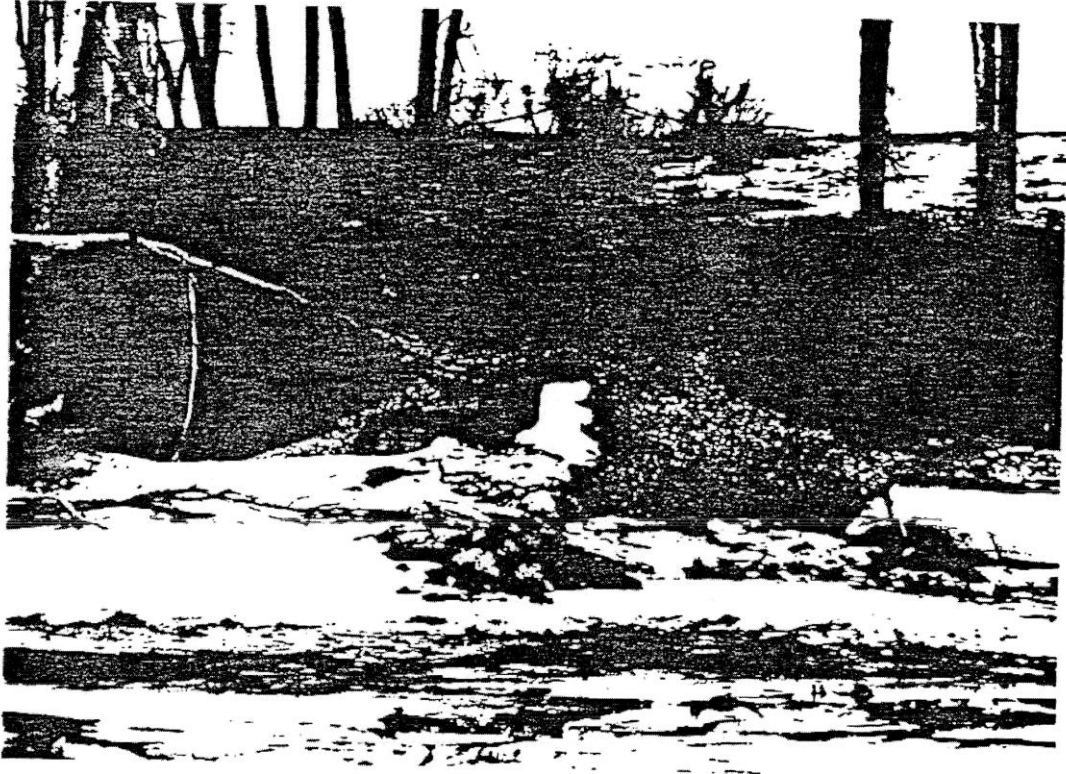
PHOTO 2: Condition of the existing riverbank at the outfall location. Note severe shoreline erosion and head failure scarp in Background (February 27, 1988).

The riverbank movements are retrogressive in nature. A head failure scarp up to 2 m high is evident both upstream and downstream of the existing outfall (Photos 3 and 4). At the outfall location, a failure scarp up to 0.3 m high is noted.

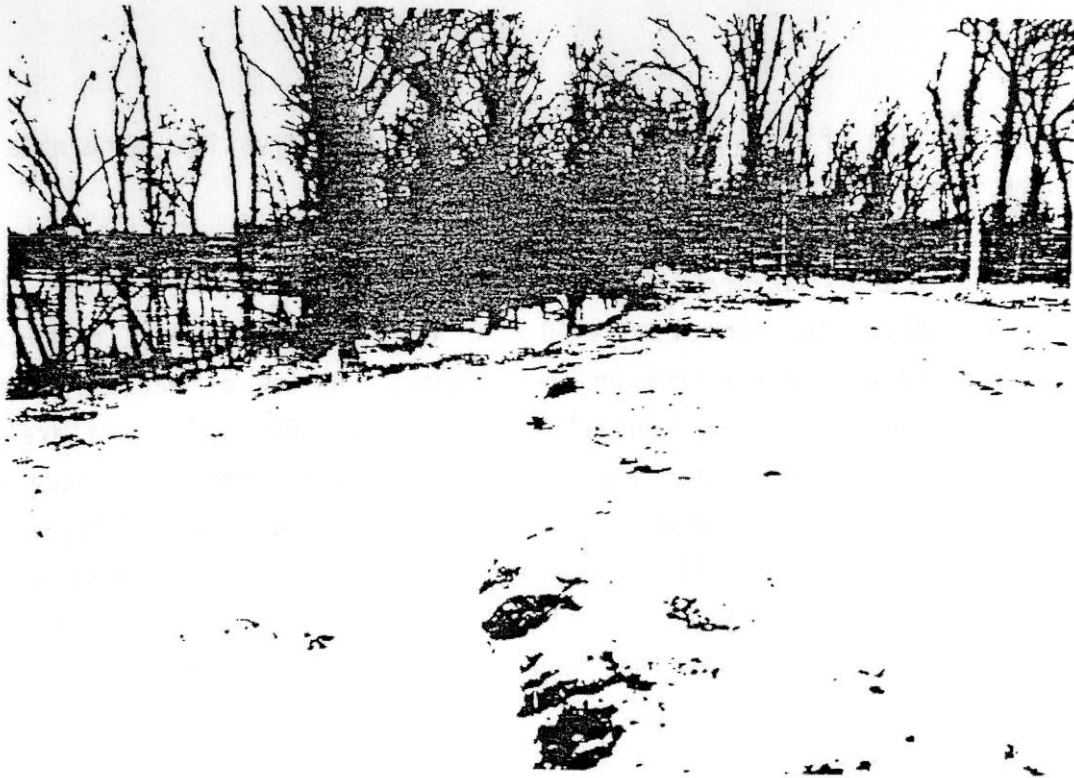
PHOTO 3: Condition of the existing riverbank upstream of the outfall. Note regraded bank with trees removed and location of failure scarp (February 27, 1983).

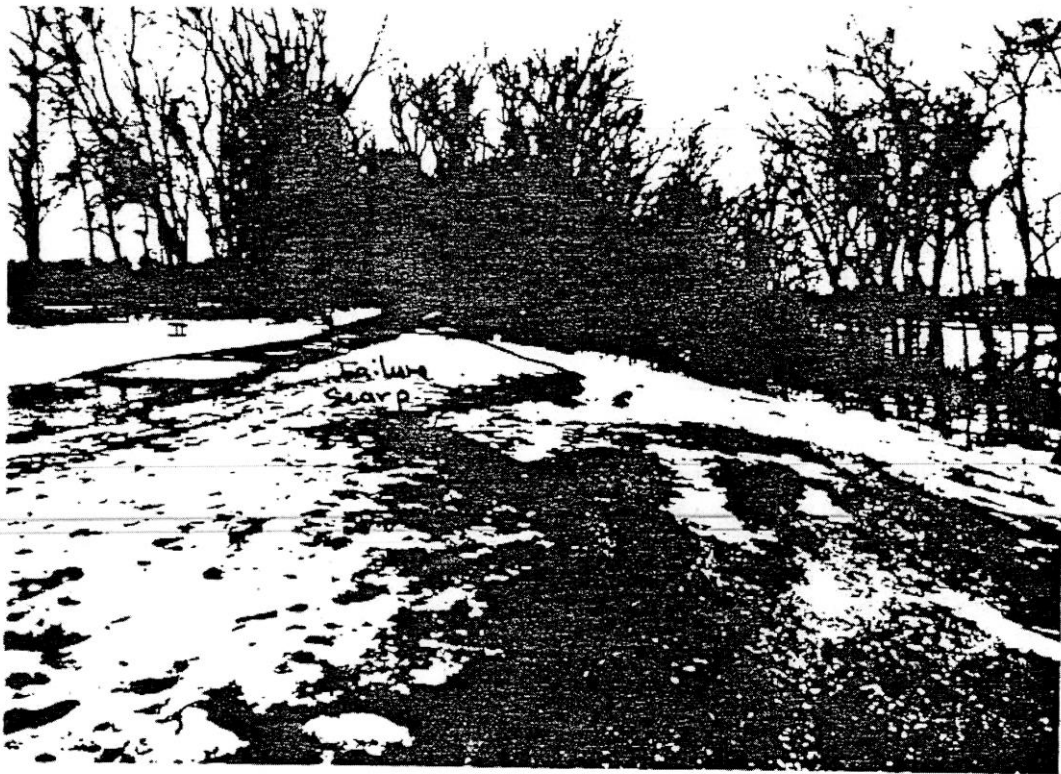
PHOTO 4: Condition of the existing riverbank downstream of the outfall. Note regraded bank with trees removed and location of failure scarp (February 27, 1983).
