## **APPENDIX C – 2006 OUTFALL INSPECTIONS CONDITION AND MAINTENANCE STUDY**

**WATER AND WASTE DEPARTMENT**

**2006 OUTFALL INSPECTIONS  
CONDITION AND MAINTENANCE STUDY**

**KGS  
GROUP**

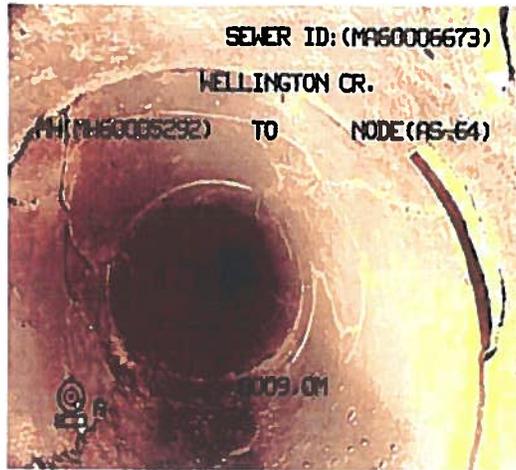
Wellington Cres. 1 (AS-64)

Multiple fractures with deformation greater than 10%.

**2006 Report Conditions:** Survey abandoned at 52.0m due to debris that plugged the pipe more than 50% of its capacity. Its has more than 10% of deformation from 8.20m to 27.8m which is caused by multiple fractures.

4.	Conway ✓	(AS-42)	Partial Collapse of Pipe
X 5.	Wellington Cres	AS-64	Repair/Replace/Reline
6.	Crane Av ✓	(RR-27#2)	CMP portion corroded or missing
X 7.	Empress St	(AS-70)	CMP portion corroded or missing
✓ 8.	Oakcrest Pl	(RR-34)	CMP portion corroded or missing
X 9.	Chataway Blvd	AS-60	CMP portion corroded or missing

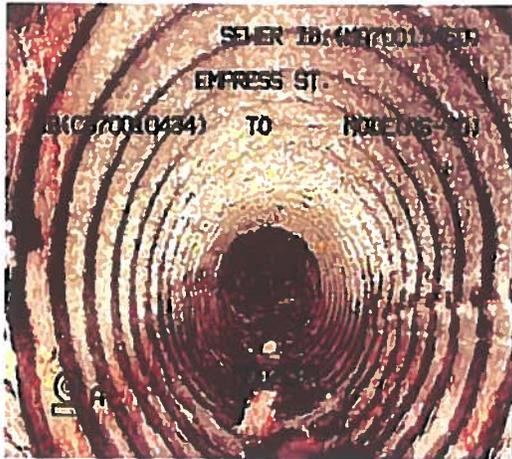
**Empress Street #1 (AS-70)**

CPS Section of Outfall is corroded to the point of failure. Outfall has no invert.

**2006 Report Conditions:** Survey abandoned at 3.40m because the bottom of the pipe is badly rotted (invert gone).

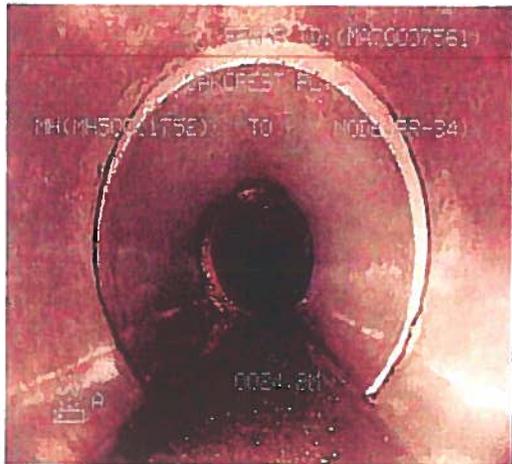
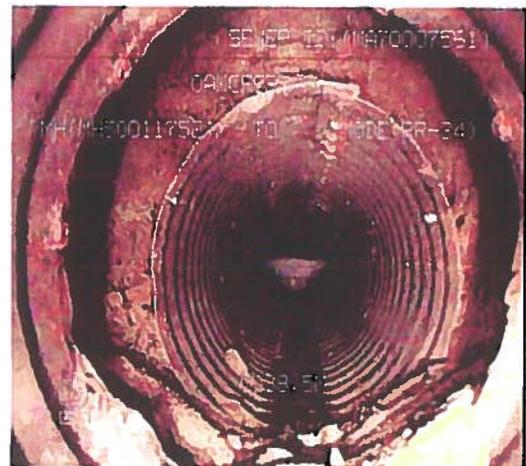
**Oak Crest Pl. (RR-34)**

Pipe has large vertical displacements of joints in the concrete portion.

CSP portion is badly corroded and has a large section of pipe missing.

**2006 Report Conditions:** Survey starts with PVC pipe and change to PCP at 3.10m. At 26.4m it changes to CMP pipe. This survey was abandoned at 38.60m due to hole at bottom of the CMP portion.

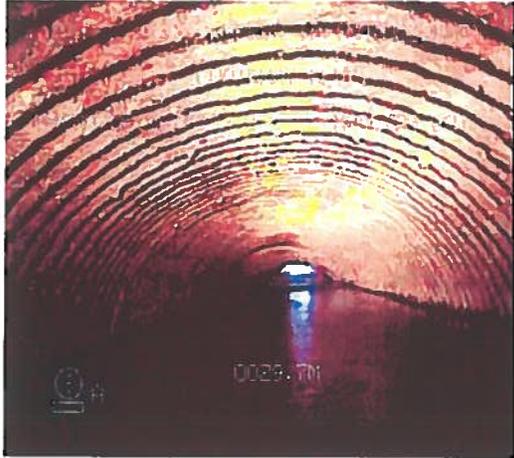
Chataway Blvd. (AS-60)

CSP portion is badly corroded.

**2006 Report Conditions:** Survey abandoned at 30.20m due to ice that filled the pipe by more than 50% of its capacity. The deformation is more than 10% and the bottom of the pipe is badly rotted (hole).

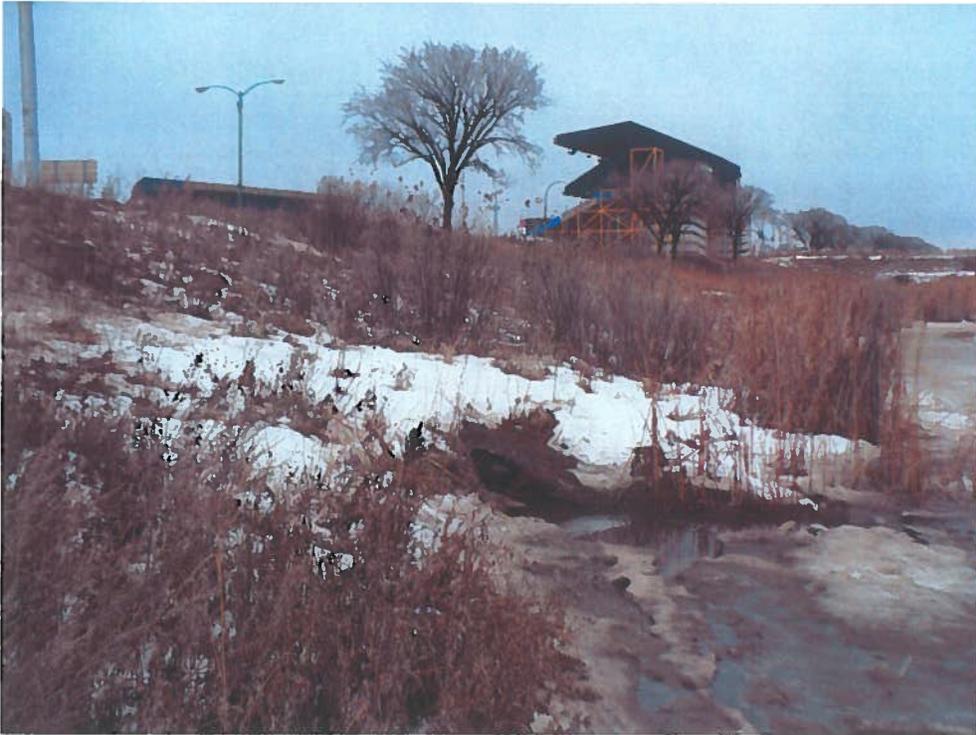
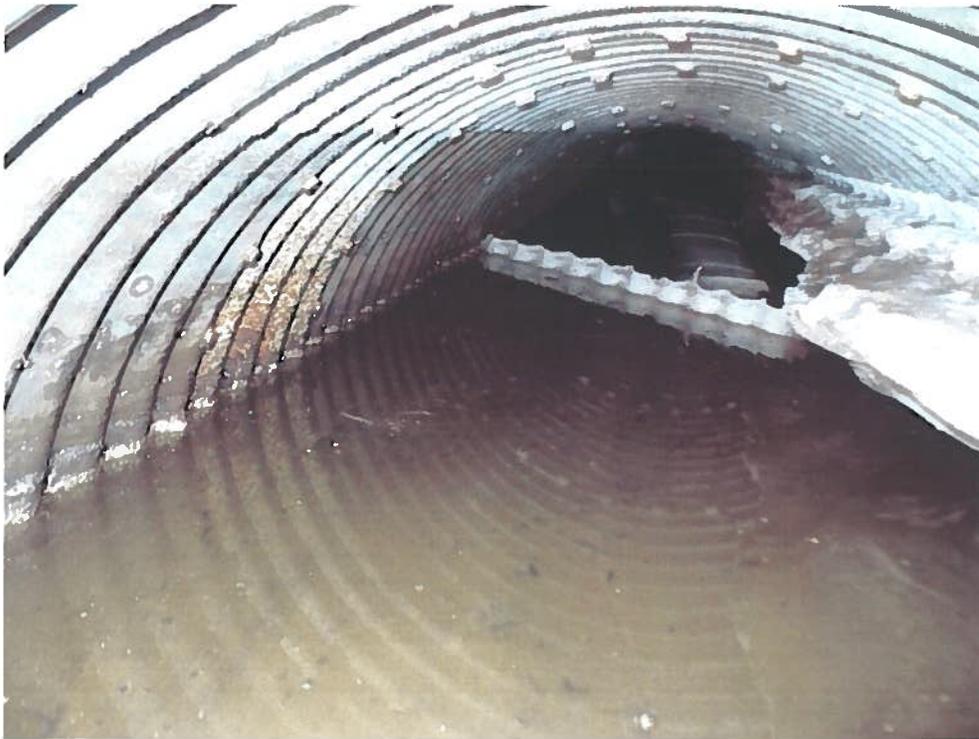
Empress #1 (OM-3)

**2006 Report Conditions:** This survey was traversed successfully. Some structural problems and a hole were noted at joint with the CMP part. The bottom of the pipe is badly rotted (invert gone).

10.	Plaza Dr ✓	(RR-22)	CMP portion corroded or missing
11.	Empress St ✓	OM-3	CMP portion corroded or missing
X 12.	Henderson Hwy	RR-105	CMP portion corroded or missing
