Winnipeg Sewage Treatment Program

NEWPCC Fecal and E-Coli Compliance Investigation Report 2014

November 2014

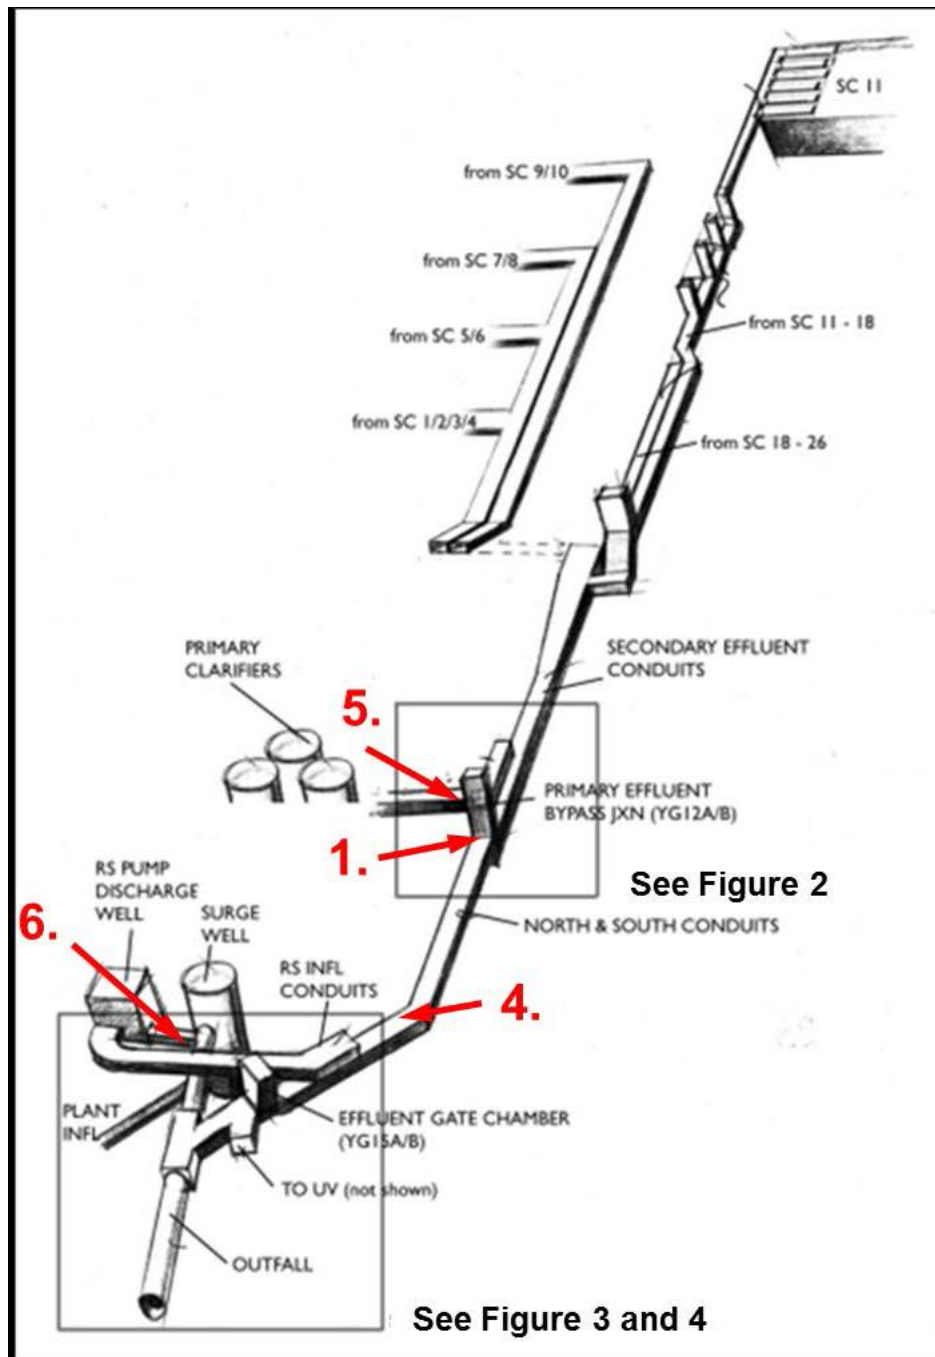
Figure 1 - NEWPCC Effluent Conduit System Overflow

1. Continuous leakage from gate YG12B (normally closed), which isolates the south secondary effluent conduit at the junction chamber located near the west end of the grit building (Figure 1 and Figure 2).

4. Continuous leakage between the North and South secondary effluent conduits (Figure 1, Figure 2, and Figure 4).
5. Occasional unintended primary effluent overflow at the junction chamber when a raw sewage pump starts (Figure 1 and Figure 2).

6. Occasional unintended raw sewage bypass or leakage at the raw sewage discharge well (Figure 1 and Figure 3).
7. Continuous leakage from gate YG11A and YG11B (both normally closed), which can provide secondary treatment bypass if required

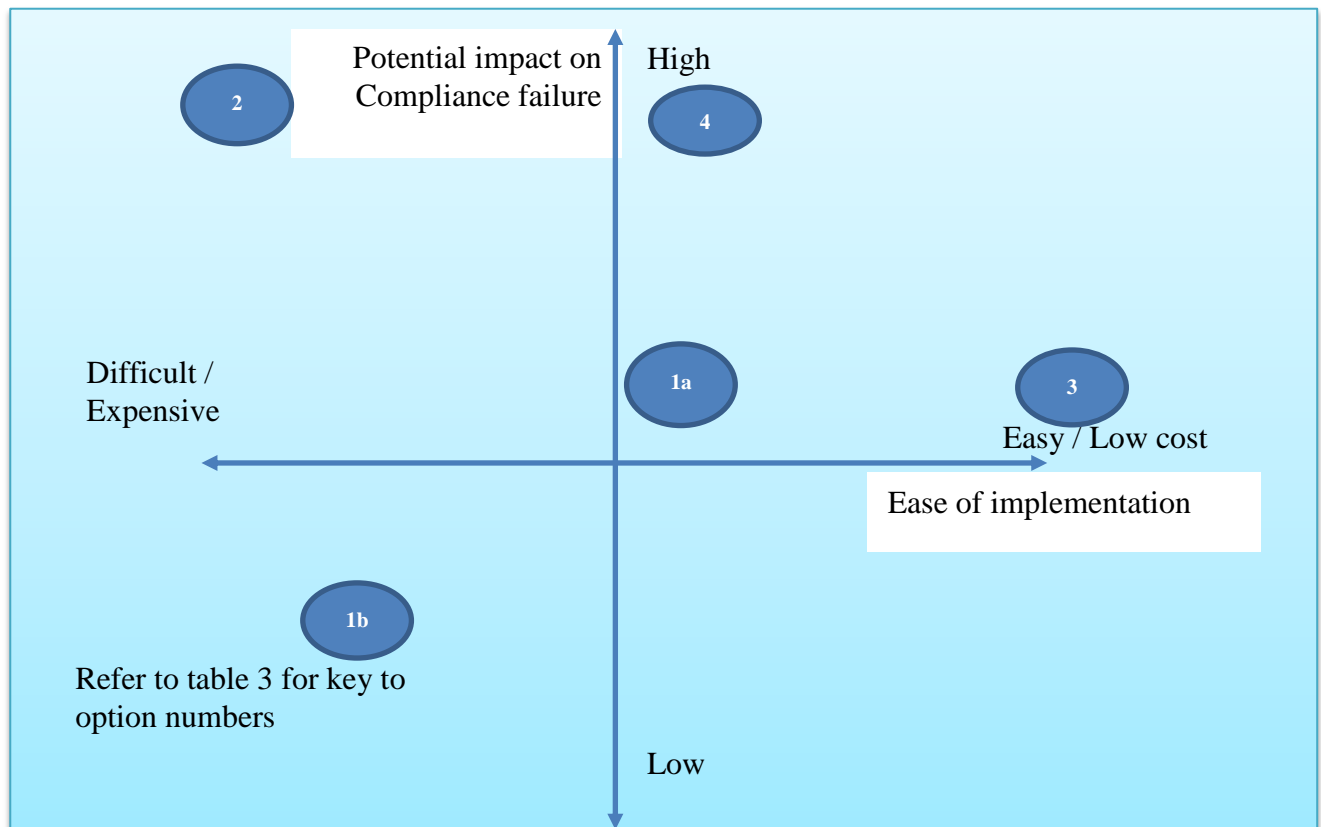
Figure 5 - Option Analysis

The results of the analysis indicated that Option 1b alone, installation of new gate YG15B, would likely provide only marginal benefit in terms of improved quality of the final effluent in reducing the geometric mean of coliform counts from 290 to 280 per 100mL. This is due to the assumed continuous leakage through the stop logs downstream of the gate position. It should be noted that actual leakage levels through the stop logs are unknown. Installation of the gate would have a medium installation cost (approximately \$200,000). This option would have significant operational consequences in terms of managing the control of the gate in conjunction with wet weather flow.

The results of the analysis indicated that sealing the stop logs could significantly reduce contamination of the final effluent to a level slightly above the regulated level. Logistically this is technically feasible by a repair such as pouring a watertight wall over the face of the stop logs. This would require one or more temporary shutdowns of the treatment plant to adequately isolate the area of work in the effluent gate chamber from outfall backwater. Sealing the stop logs would have a low to moderate cost, depending on the level of sealing required (estimated at under \$100,000).

The combination of pumping out the South conduit and sealing stop logs was examined in the hydraulic model. The modelling suggested that this effectively prevented contamination of the final effluent. These findings are based on the assumption that the stop log barrier are leaking and contribute significantly to the issue, that they can be completely sealed and that there are no other significant sources of contamination downstream of the effluent gate chamber.

Dewatering of the South conduit using the flushing water offtake is recommended as the first approach to be implemented. This approach has the lowest cost, introduces little operational complexity or risk and is anticipated to provide significant improvement in effluent quality. If the existing flushing water piping and pumps can be used for dewatering, this option requires no capital costs to implement and relatively insignificant operational costs. If piping modifications and/or separate pumps are required as part of a more permanent solution, these would incur relatively low capital and operational costs.

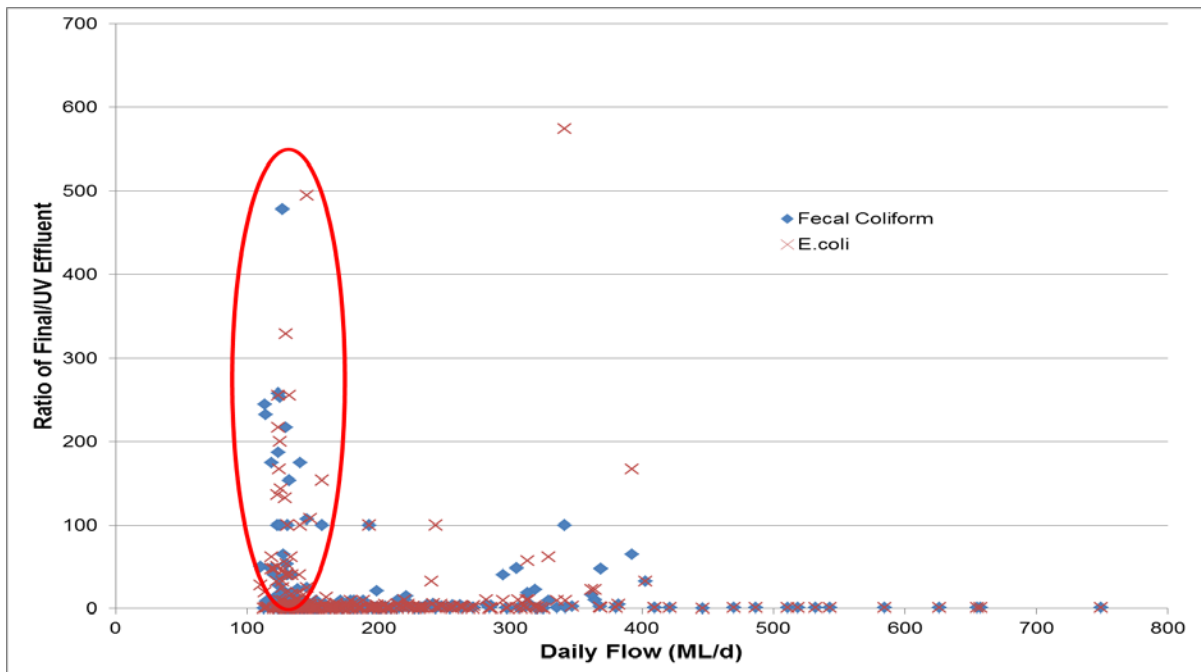
Figure 7 - Final/UV Effluent Fecal Coliform and E.coli vs Plant Daily Flow

The ratio of final to UV effluent for fecal coliform and E.coli were calculated and plotted against daily flow (Figure 7). This presentation of the data suggests that the largest discrepancies between final and UV effluent (i.e. the largest ratios) were observed during periods of low flow. In other words, that recontamination of final effluent may be more likely under DWF.

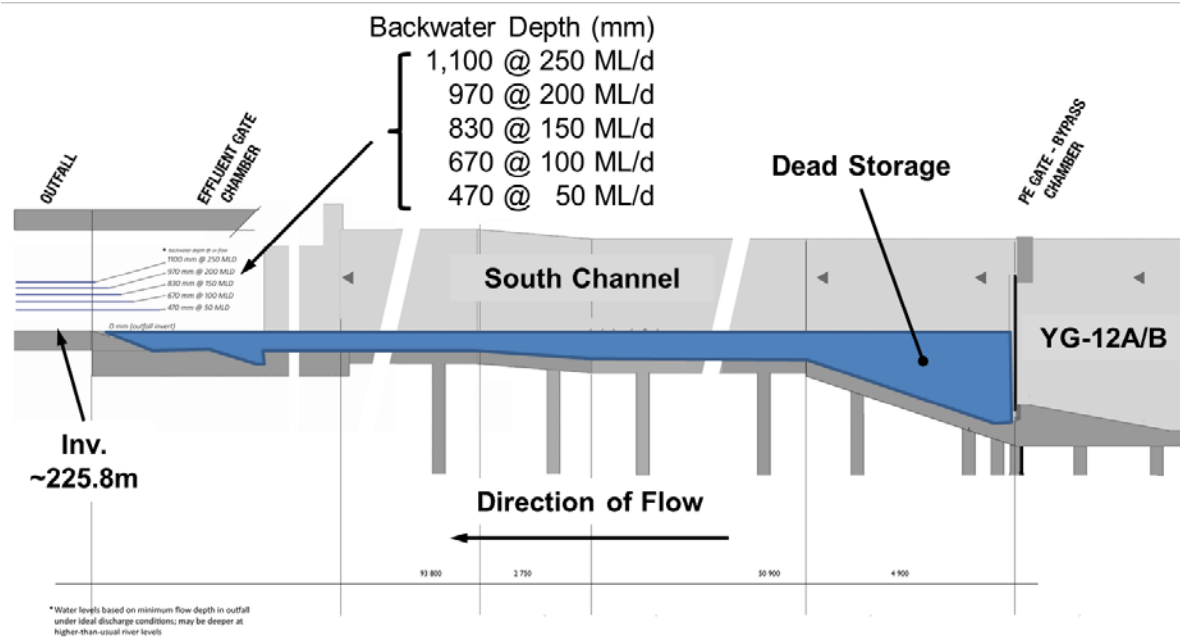
Figure 9 - Profile of the South Channel and Backwater from Outfall

At normal river levels, the depth of backwater in the South Channel (i.e. secondary bypass) is simply a function of the rate of flow in the outfall. As shown in Figure 9, even under conditions of no flow, water remains trapped in the South Channel as dead storage between the effluent gate chamber and YG-12B. The depth of water stored in the channel increases up to approximately 1 metre at a flow of between 200 and 250 ML/d.

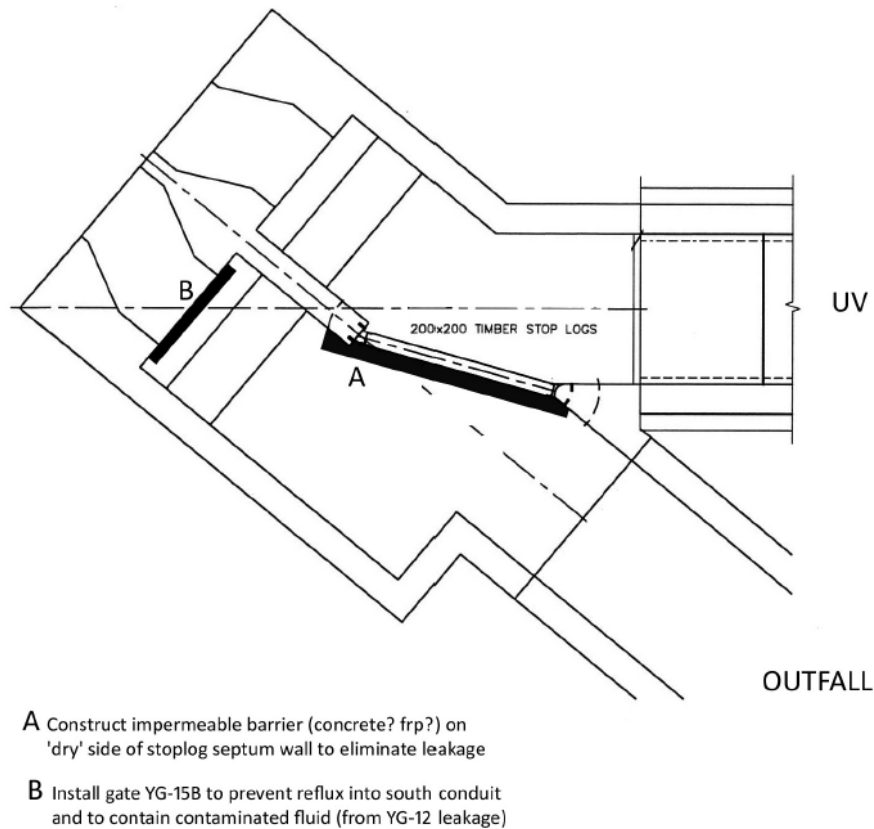
Figure 12 - Effluent Gate Chamber Proposed Modification (Plan)

The advantages of this solution are that the gate infrastructure (mounting face, access hatches) is already in place; the working area is nominally isolated and it may therefore be less difficult to upgrade the baffle wall (longer shutdown period available, easier to keep dewatered).

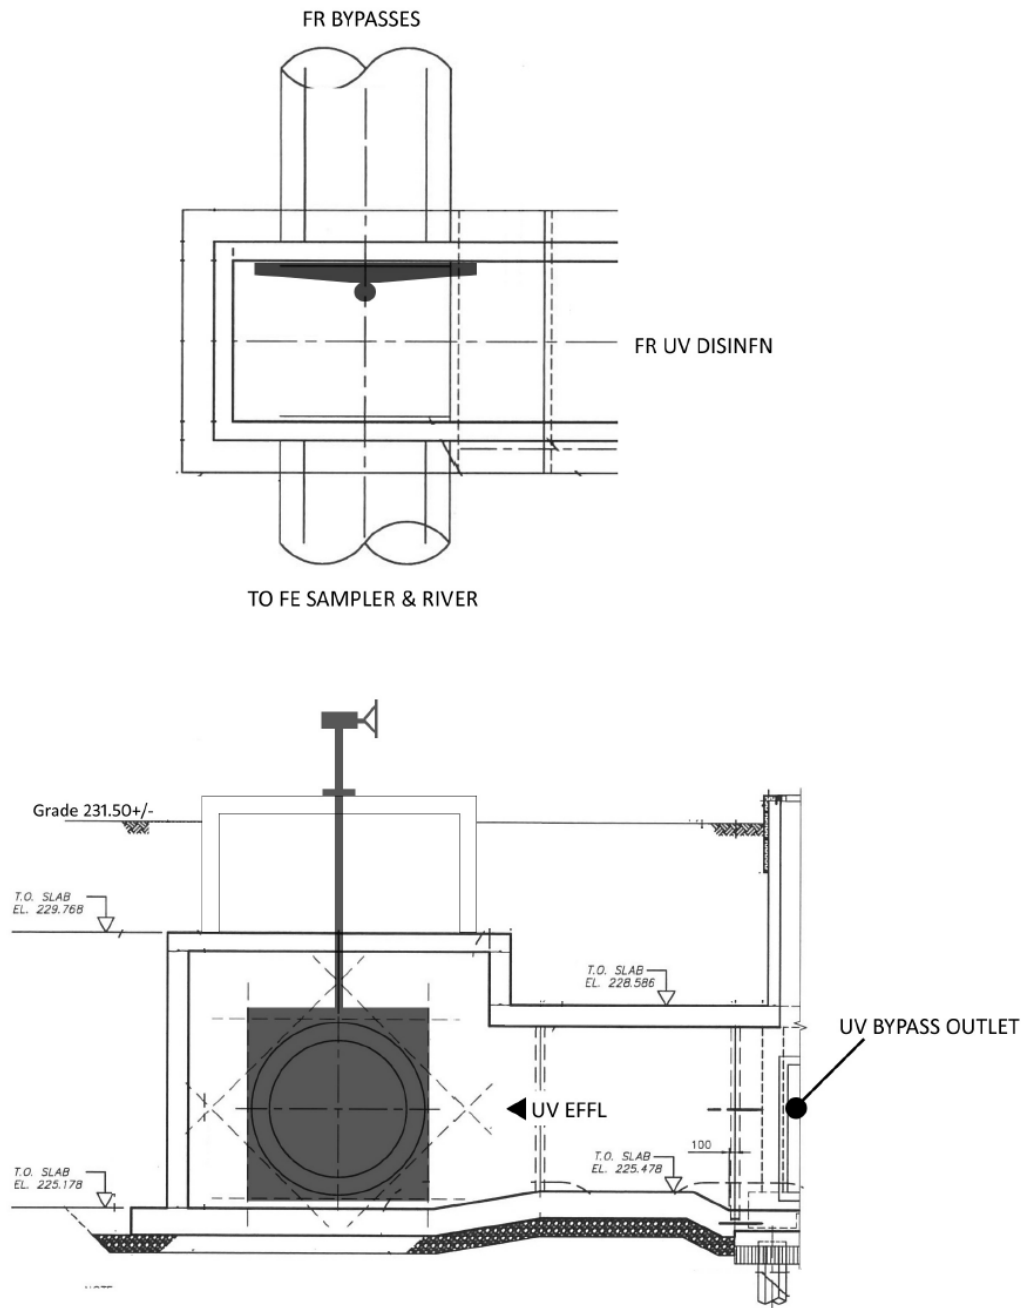
Figure 13 - Proposed Isolation Gate at UV-Outfall Junction Gate Chamber

The advantage of this approach is that is the least complex and easiest to implement. This could be a first step before deciding whether the more intrusive proposals (additional gates, enhanced control systems) are required.

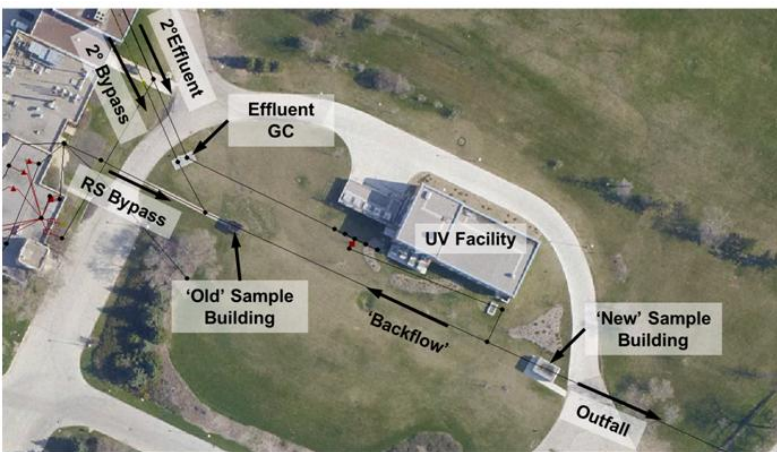
- Observation of Backflow (November, 2006)
 - During inspection of effluent conduit by Civil Maintenance
 - UV pumps accidentally restarted, rapid backflow up bypass conduits
 - Physical observation of backflow confirmed

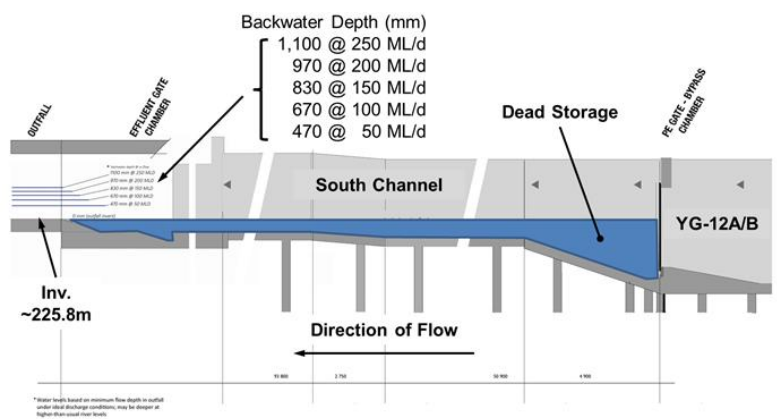
- Hydraulic Analysis
 - Depth of backwater in South Channel a function of flow rate in outfall
 - Even under no flow, effluent trapped as dead storage in South Channel between YG12B and Effluent GC

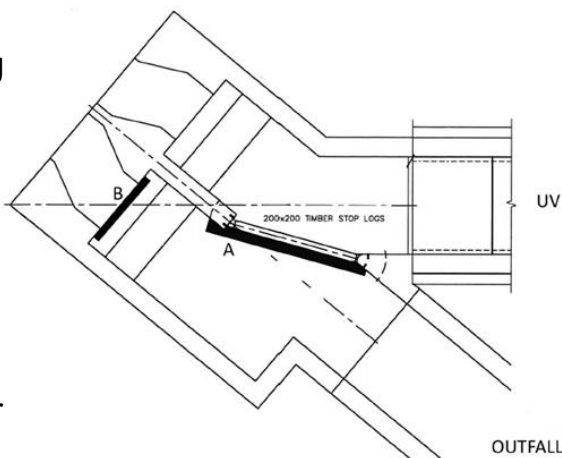
- North and South conduits separated by wooden stop logs
- All that could be constructed during short shut down, some leakage of 2° effluent (likely in order of a few L/s)
- Replace removed YG15 to isolate 'dead storage' in South conduit
- Some of the gate infrastructure already in place
- Would add second gate to open for 2° bypass

A Construct impermeable barrier (concrete? frp?) on 'dry' side of stoplog septum wall to eliminate leakage
B Install gate YG-15B to prevent reflux into south conduit and to contain contaminated fluid (from YG-12 leakage)

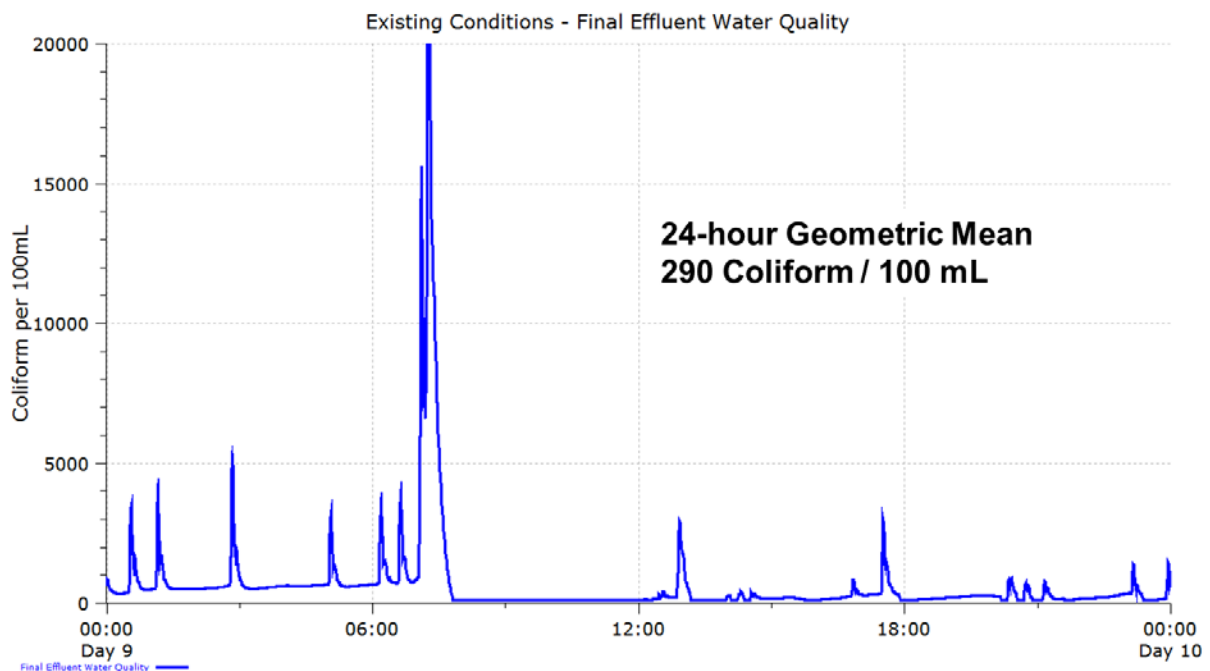
Figure 2.2 – 24 Hour Diurnal of Final Effluent Water Quality Predicted by the InfoWorks CS Hydraulic Model – Existing Conditions

On average, this represents an additional 190 counts per 100 mL over the assumed quality of the UV effluent. Coincidentally, this is roughly consistent with the average difference measured between final and UV effluent grab samples collected over the last year by the WWD.

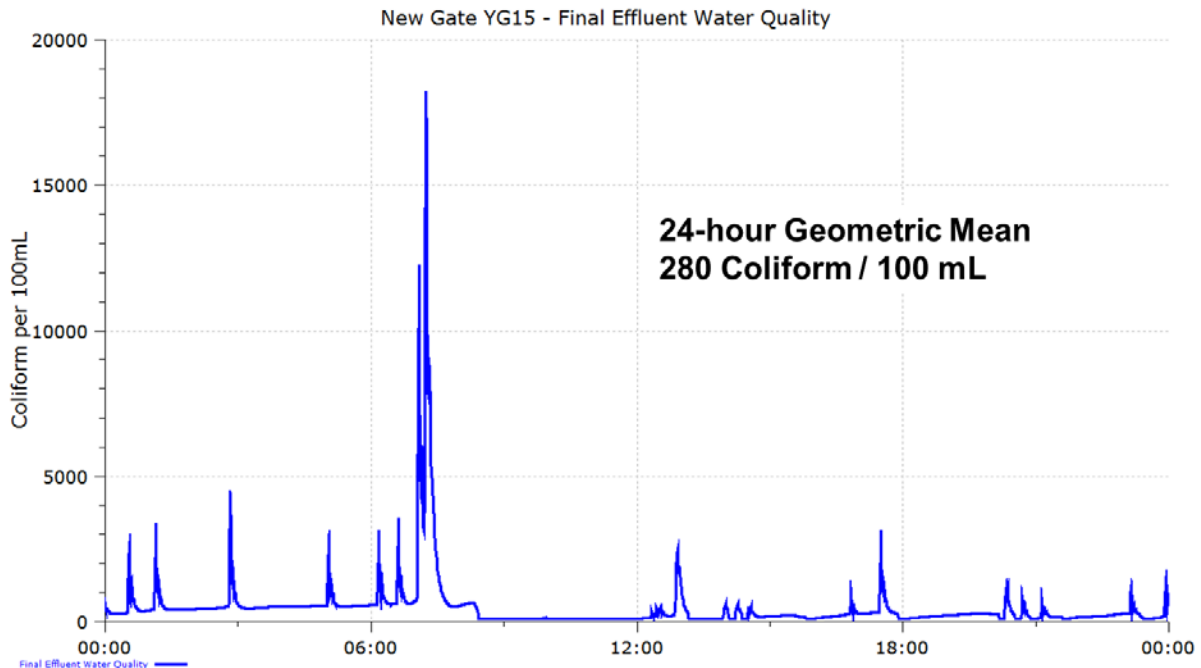
Figure 2.3 – 24 Hour Diurnal Final Effluent Water Quality Predicted by the InfoWorks CS Hydraulic Model – New Gate YG15

The results of the hydraulic analysis, illustrated in Figure 2.3, indicate that the proposed gate alone would likely provide only a marginal benefit in terms of improved quality of the final effluent in reducing the geometric mean of coliform counts from 290 to 280 per 100 mL. This is due to the continued leakage of the estimated 5 L/s from the stop logs in the EGC downstream of the proposed gate.

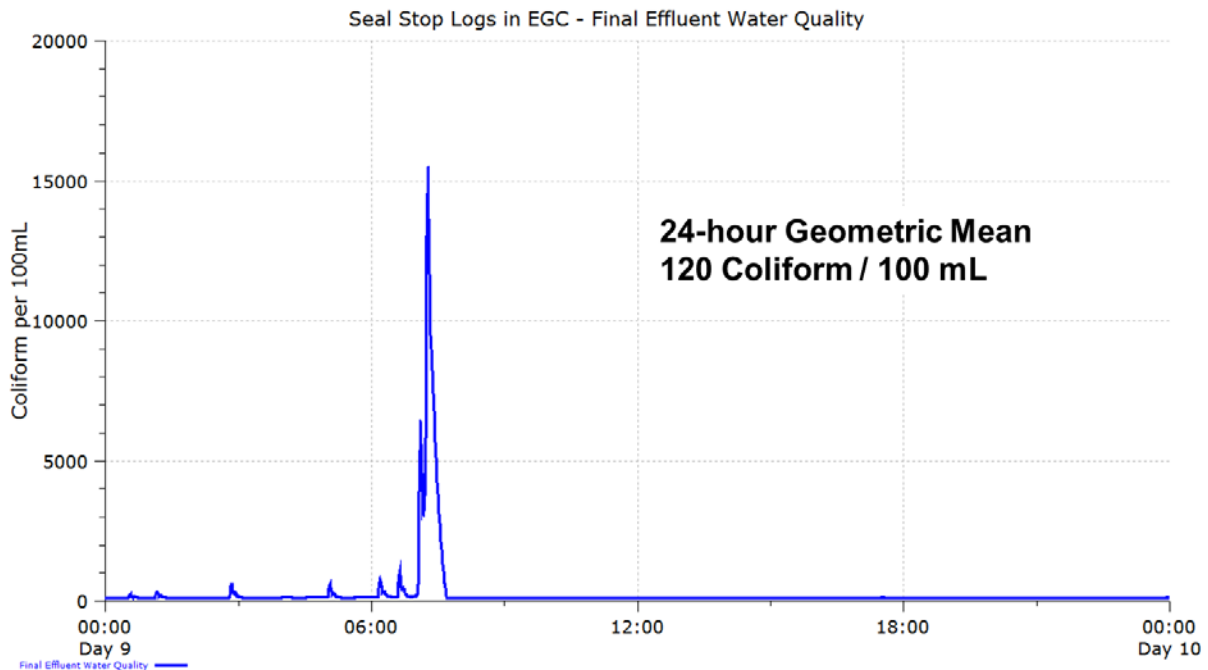
Figure 2.4 – 24 Hour Diurnal Final Effluent Water Quality Predicted by the InfoWorks CS Hydraulic Model – Seal Stop Logs

The results of the analysis, illustrated in Figure 2.4, indicate that sealing of the stop logs could significantly reduce contamination of the final effluent to only 20 coliform counts above the estimated 100 per 100 mL in the UV effluent. However, it appears that this approach would not be sufficient to completely eliminate the potential for contamination of the final effluent, particularly at the diurnal low (at approximately 7:30 a.m.) when water from the unused south conduit mixes with UV effluent.

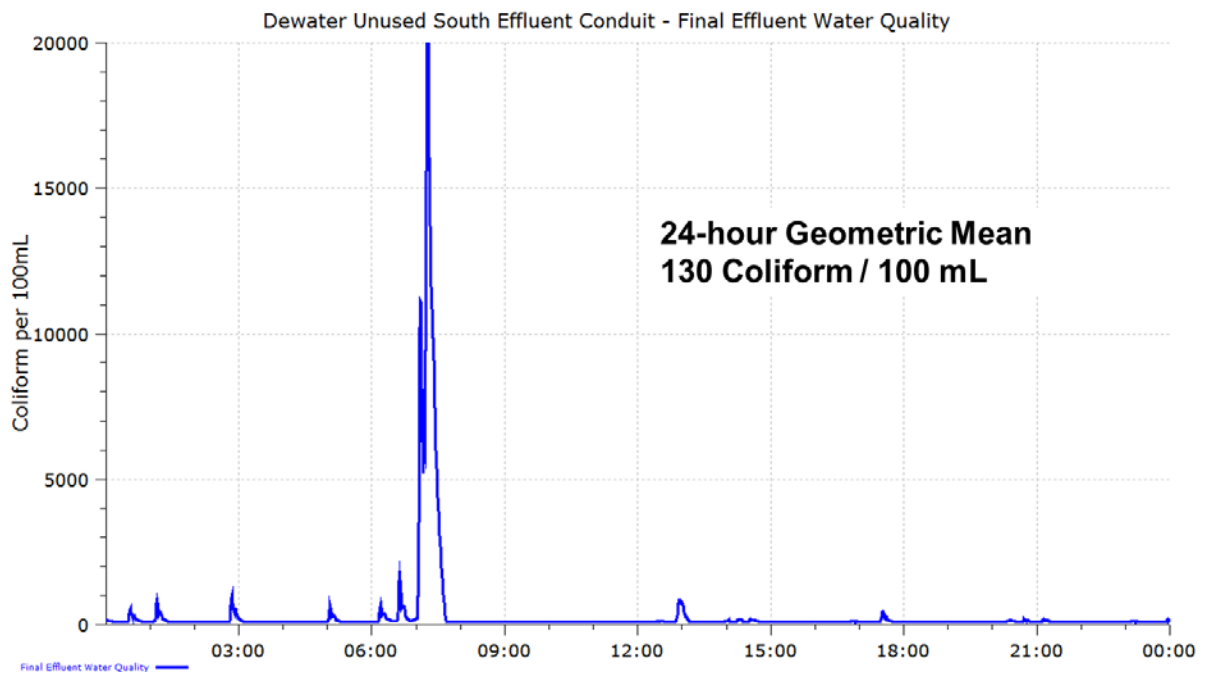
Figure 2.6 – 24 Hour Diurnal Final Effluent Water Quality Predicted by the InfoWorks CS Hydraulic Model – Dewater South Effluent Conduit

The results (Figure 2.6) indicate that dewatering could also be very effective at reducing contamination of the final effluent. However, as was the case for sealing of the stop logs, this approach would not necessarily eliminate potential contamination of the final effluent. This is also based on the dewatering rate being approximately equal to the total rate of leakage into the south conduit, a value which has been estimated herein but needs to be verified through measurements in a controlled test after dewatering.

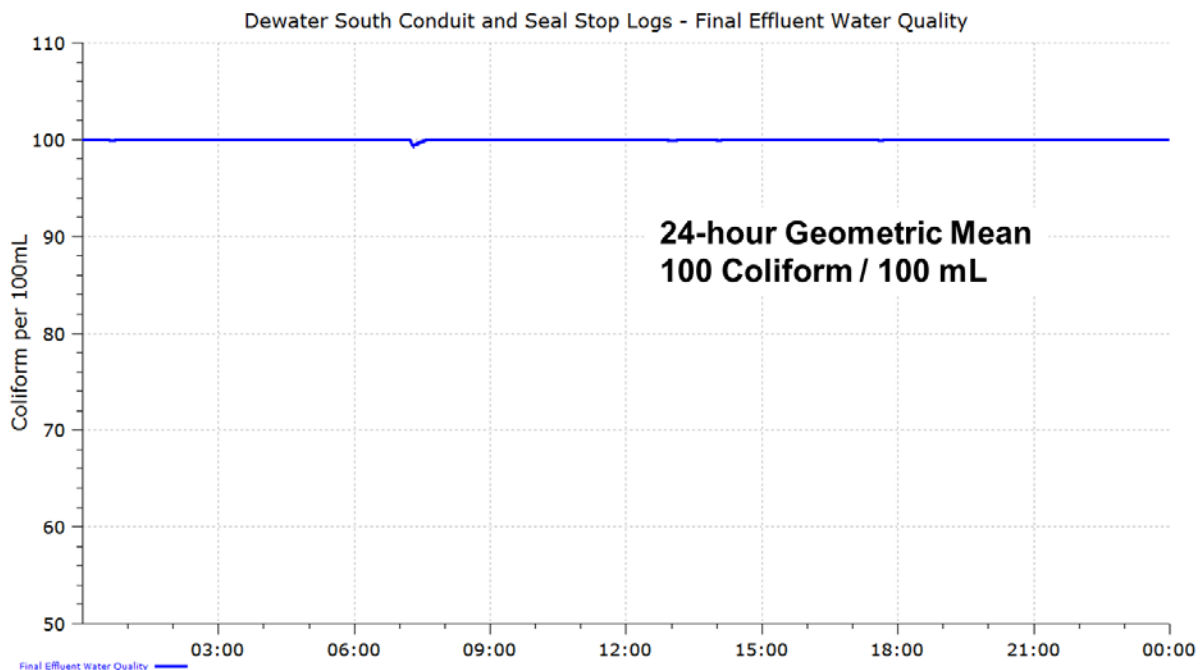
Figure 2.7 – 24 Hour Diurnal Final Effluent Water Quality Predicted by the InfoWorks CS Hydraulic Model – Dewater South Effluent Conduit and Seal Stop Logs in EGC

These findings are based on the assumption that the stop log septum can be completely sealed and that there are no other sources of contamination downstream of the effluent gate chamber. The analysis also does not take into account any other sources of recontamination which may exist from previous bypasses and overflows such as debris within the pipe or bacterial film on pipe walls in the unused conduits. However, dewatering via the flushing water offtake would continuously refresh the water in the unused south conduits with UV effluent which would help prevent future recontamination of the final effluent. From this perspective, the provision of a new gate YG15 in the effluent gate chamber could be somewhat detrimental as it would inhibit the ability to refresh the water in the south conduit.
