GEOTECHNICAL REPORT

Geotechnical Report for Henderson Highway (Southbound) – Munroe Avenue to Hespeler Avenue

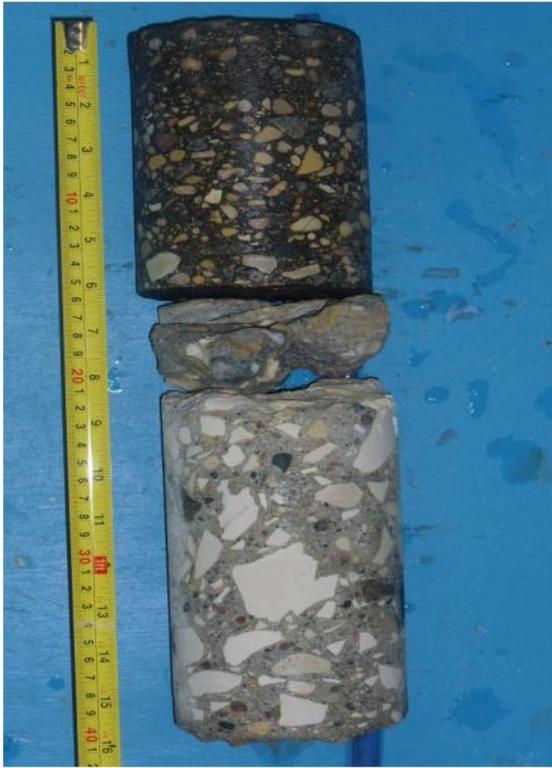
Core no. 1

Core No.	Core Location	Pavement Structure Thickness (mm)			Comments
		Asphalt	Concrete	Total	
1	Henderson Hwy, southbound curb lane, 0.5 m from curb, 6 m south from pedestrian crosswalk north of Munroe Avenue	150	250	400	<ul style="list-style-type: none"> Asphalt pavement not bonded to concrete surface Moderate deterioration of concrete pavement at bond line with asphalt pavement; sound concrete below 225 mm from top of pavement Limestone base below pavement
2	Henderson Hwy, southbound curb lane, 1.4 m from curb, 20 m north from north entrance to 480 Henderson Highway	75	250	325	<ul style="list-style-type: none"> Asphalt pavement not bonded to concrete surface Moderate deterioration of concrete pavement at bond line with asphalt pavement; sound concrete below 160 mm from top of pavement Granular base below pavement
3	Henderson Hwy, southbound curb lane, 1 m from curb, 5 m north from south wall of 442 Henderson Highway	75	255	330	<ul style="list-style-type: none"> Asphalt pavement not bonded to concrete surface Moderate deterioration of concrete pavement at bond line with asphalt pavement; sound concrete below 130 mm from top of pavement Granular base below pavement

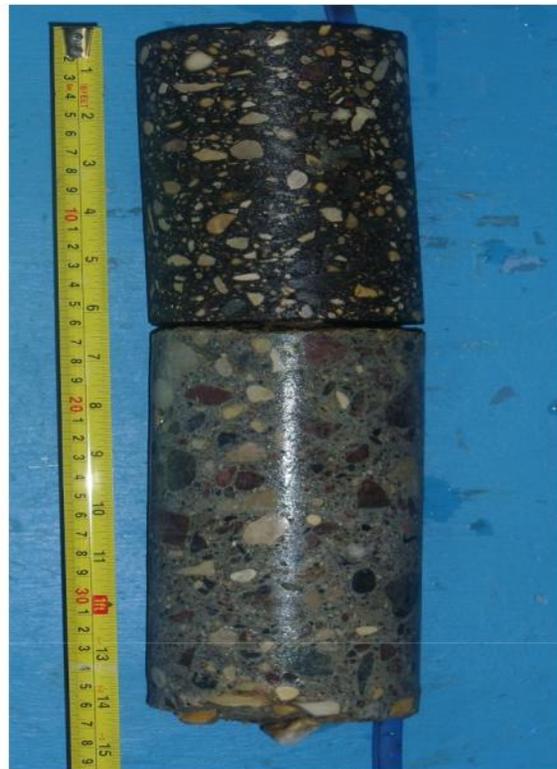
Core no. 4

4	Henderson Hwy, southbound median lane, 0.5 m from curb, 1 m south from south wall of 415 Henderson Highway	155	205	360	<ul style="list-style-type: none"> Asphalt pavement not bonded to concrete surface Sound concrete below asphalt pavement Granular base below pavement
5	Henderson Hwy, southbound curb lane, 0.5 m from curb, 7 m south from pedestrian crosswalk north of Larsen Avenue	155	250	405	<ul style="list-style-type: none"> Fractured asphalt pavement 75mm below surface Asphalt pavement not bonded to concrete surface Severe deterioration of concrete below asphalt pavement Granular base below pavement

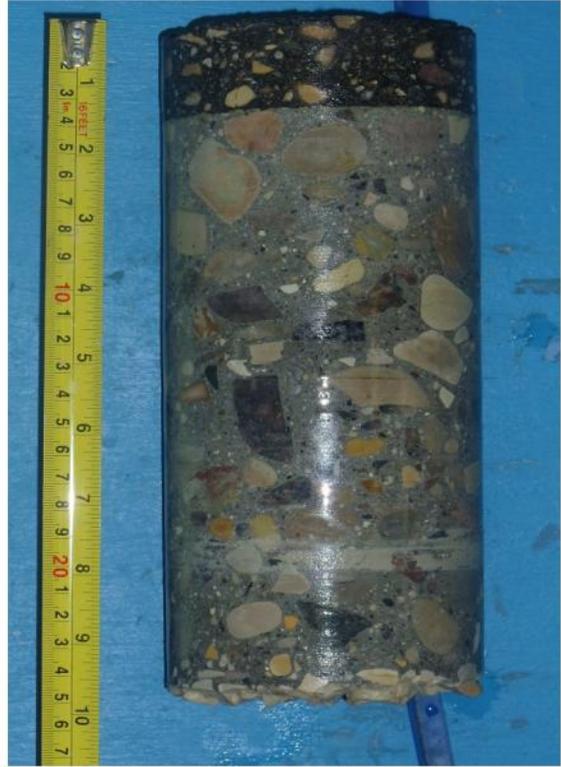
Core no. 6

Core No.	Core Location	Pavement Structure Thickness (mm)			Comments
		Asphalt	Concrete	Total	
6	Henderson Hwy, southbound curb lane, 1.4 m from curb, 1 m north from north wall of 336 Henderson Highway	35	210	245	<ul style="list-style-type: none"> Asphalt pavement bonded to concrete surface Sound concrete below asphalt pavement Limestone base below pavement
7	Henderson Hwy, southbound curb lane, 1.4 m from curb, 7 m south from south wall of 276 Henderson Highway	35	235	270	<ul style="list-style-type: none"> Asphalt pavement not bonded to concrete surface Slight deterioration of concrete pavement at bond line with asphalt pavement; sound concrete below 60 mm from top of pavement Limestone base below pavement
8	Henderson Hwy, southbound median lane, 0.5 m from curb, 9 m south from south wall of 263 Henderson Highway	115	220	335	<ul style="list-style-type: none"> Asphalt pavement not bonded to concrete surface Moderate deterioration of concrete pavement at bond line with asphalt pavement and at 210 mm below top of pavement Granular base below pavement

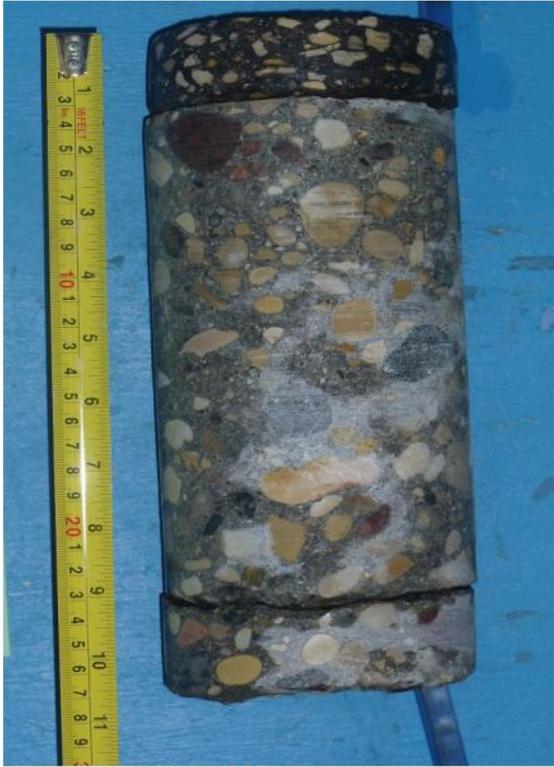
Core no. 9

9	Henderson Hwy, southbound curb lane, 0.6 m from curb, 8 m south from pedestrian crosswalk north of Johnson Avenue W	35	235	270	<ul style="list-style-type: none"> Asphalt pavement not bonded to concrete surface Sound concrete below pavement to a depth of 230 mm where fracture was identified Clay/Granular mix below pavement
10	Henderson Hwy, southbound curb lane, 0.6 m from curb, 3 m south from south wall of 200 Henderson Highway	25	275	300	<ul style="list-style-type: none"> Asphalt pavement not bonded to concrete surface Moderate deterioration of concrete pavement at bond line with asphalt pavement; sound concrete below 100 mm from top of pavement Limestone base below pavement
11	Henderson Hwy, southbound median lane, 0.5 m from curb, 4 m south from south wall of 186 Henderson Highway	40	195	235	<ul style="list-style-type: none"> Asphalt pavement not bonded to concrete surface Sound concrete below asphalt pavement Clay subgrade below pavement
